May 2, 2024 Ref. No. CO947.01

Slope Stability Assessment Report Wateridge Village, Blocks 5 and 6, Ottawa, Ontario

Terrapex Environmental Ltd. (**Terrapex**) was retained by Rohit Communities Ontario Inc. (Rohit) to conduct a visual slope stability assessment for Blocks 5 and 6, located within the northern portion of 1255 Hemlock Rd. to satisfy City of Ottawa's Minimum Requirements for Slope Stability Assessment.

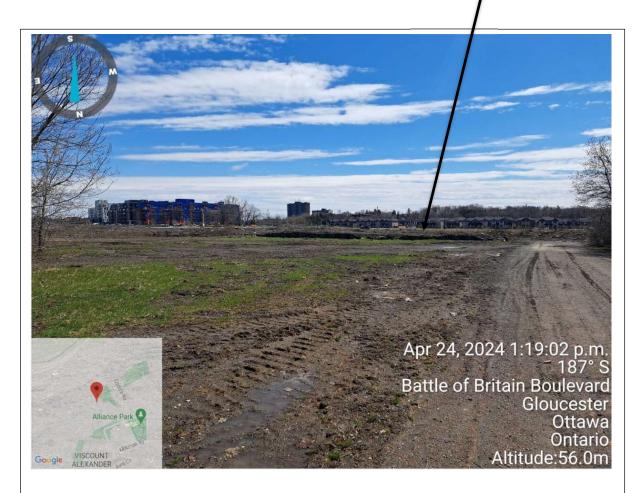
Proposed Street No.1

Standing at Northwest side of Block 6 and Looking towards south: No indications of existing slope greater or equal to 2 m in height or any settlement.

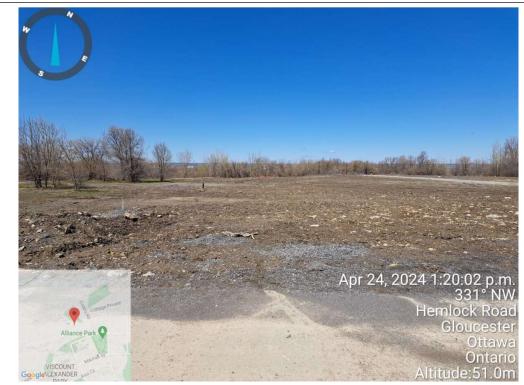
Standing at southeast side of Street No.1 and Looking towards northwest of Block 6: No indications of existing slope greater or equal to 2 m in height or any settlement.

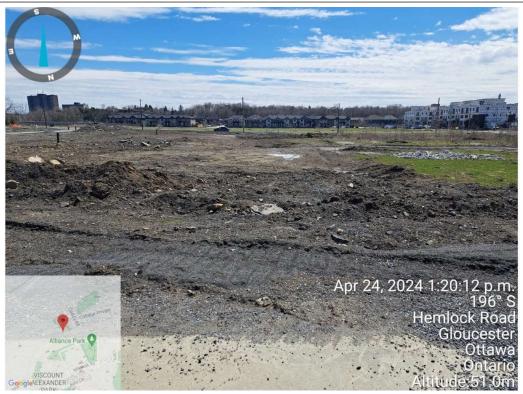
Standing at northside of Street No.1 and looking towards south of Block 5: No indications of existing slope greater or equal to 2 m in height or any settlement.

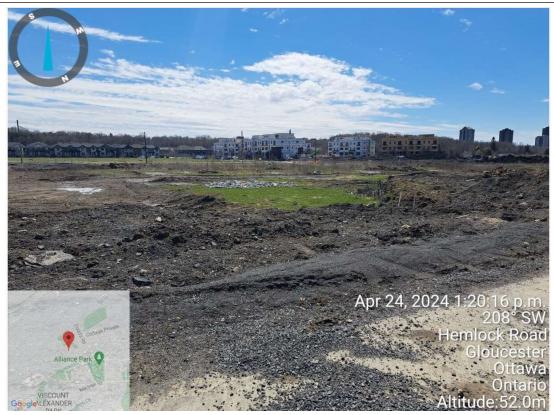
Standing at northeast side of Street No.1 and looking towards southwest of Block 5: No indications of existing slope greater or equal to 2 m in height or any settlement. Presence of vegetation such as grasses and small trees.

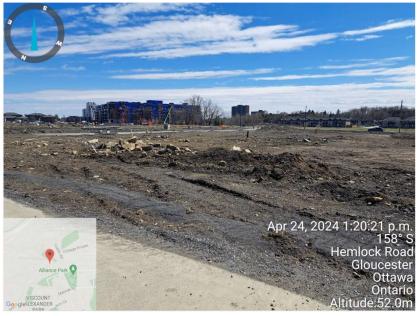
Standing at northwest side of Street No.1 and looking towards southeast of Block 5: No indications of existing slope greater or equal to 2 m in height or any settlement. Presence of a pile of concrete block pieces.

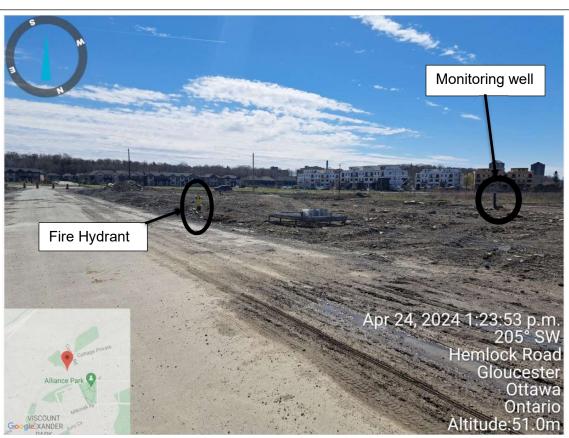
Standing at northeast side of Oshedinaa St. and looking towards southwest of Block 6 and **Block 5**: No indications of existing slope greater or equal to 2 m in height or any settlement. Presence of service lines, monitoring wells, etc.

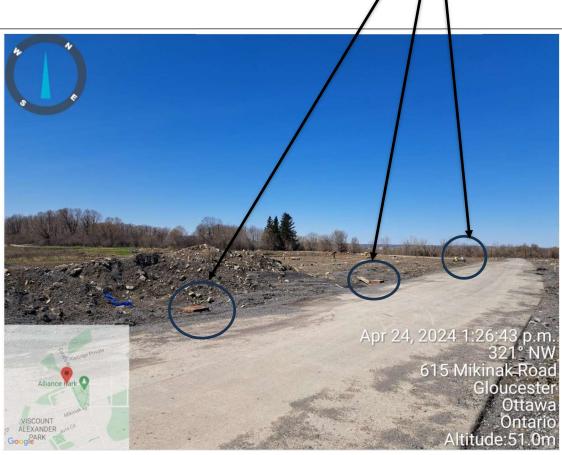
Service lines along **Oshedinaa Street**

Standing at southeast - close intersection of **Odshedinaa St.** and **Hemlock Rd.** and looking towards Northwest of Block 5: No indications of existing slope greater or equal to 2 m in height or any settlement. Presence of a pile of mixed topsoil, organics, debris, monitoring wells and service lines.
