# **Phase I Environmental Site Assessment**

4405 & 4409 Innes Road  
Ottawa, Ontario

Prepared for 1000772034 Ontario Inc.

Report: PE6827-1  
November 14, 2024

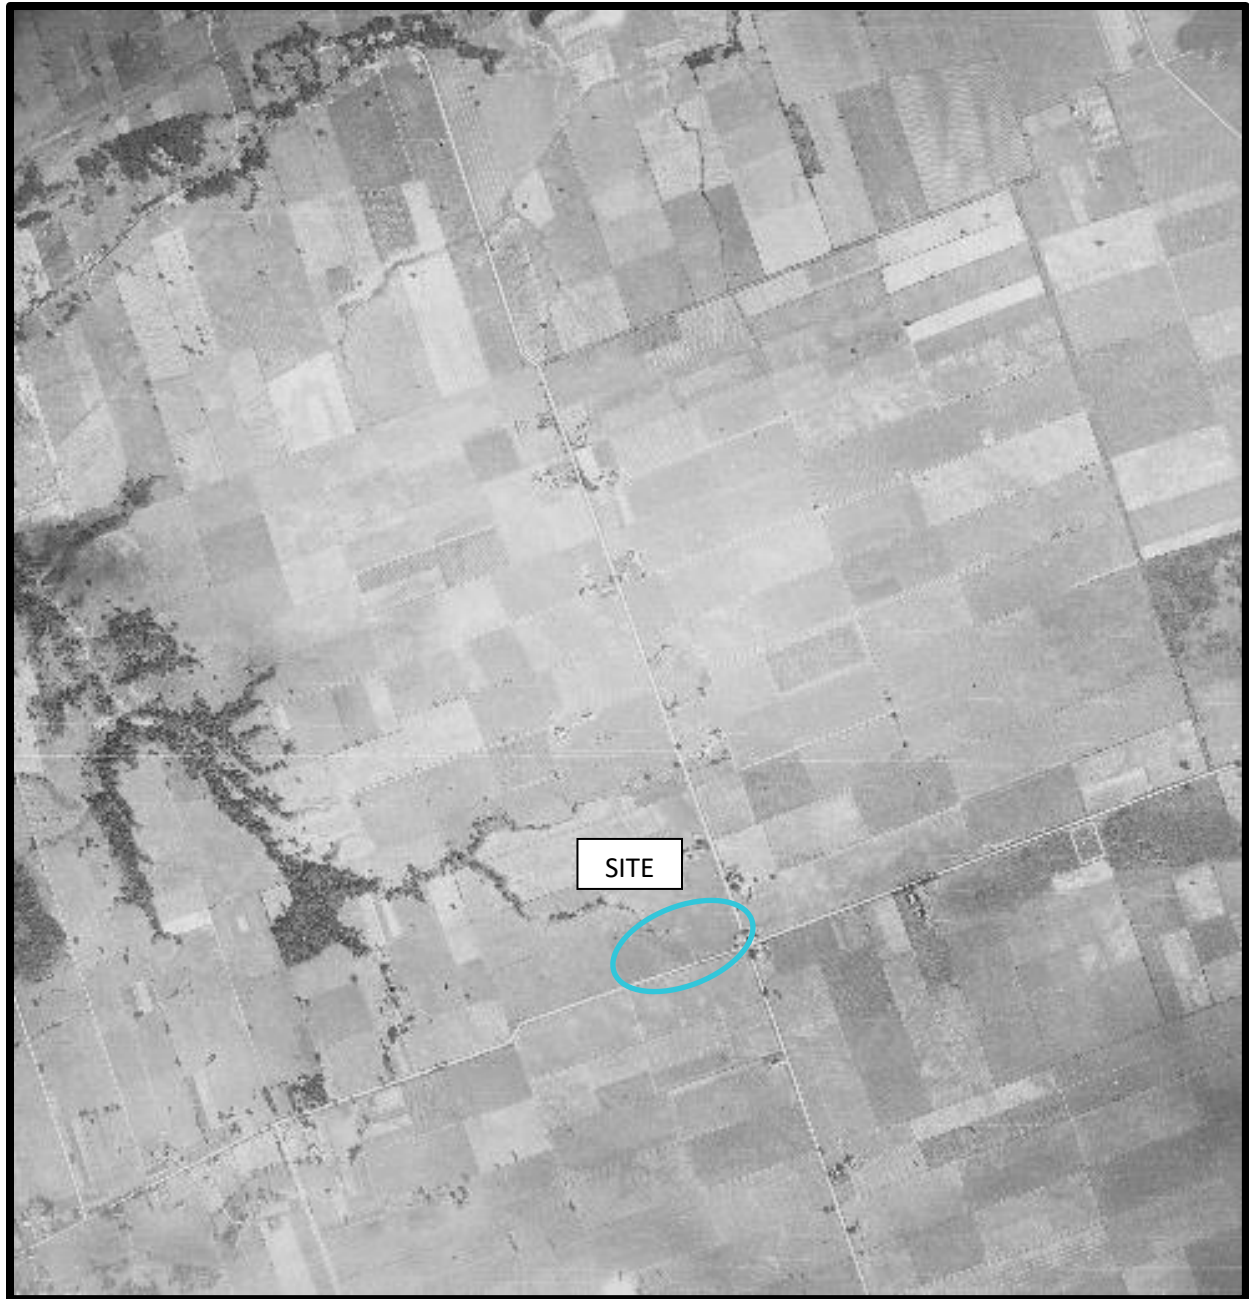
AERIAL PHOTOGRAPH  
1946

| 1946 | (Poor Scale) The subject and surrounding properties appear as agricultural land, with the exception of some residential dwellings along Innes Road and Tenth Line Road. |

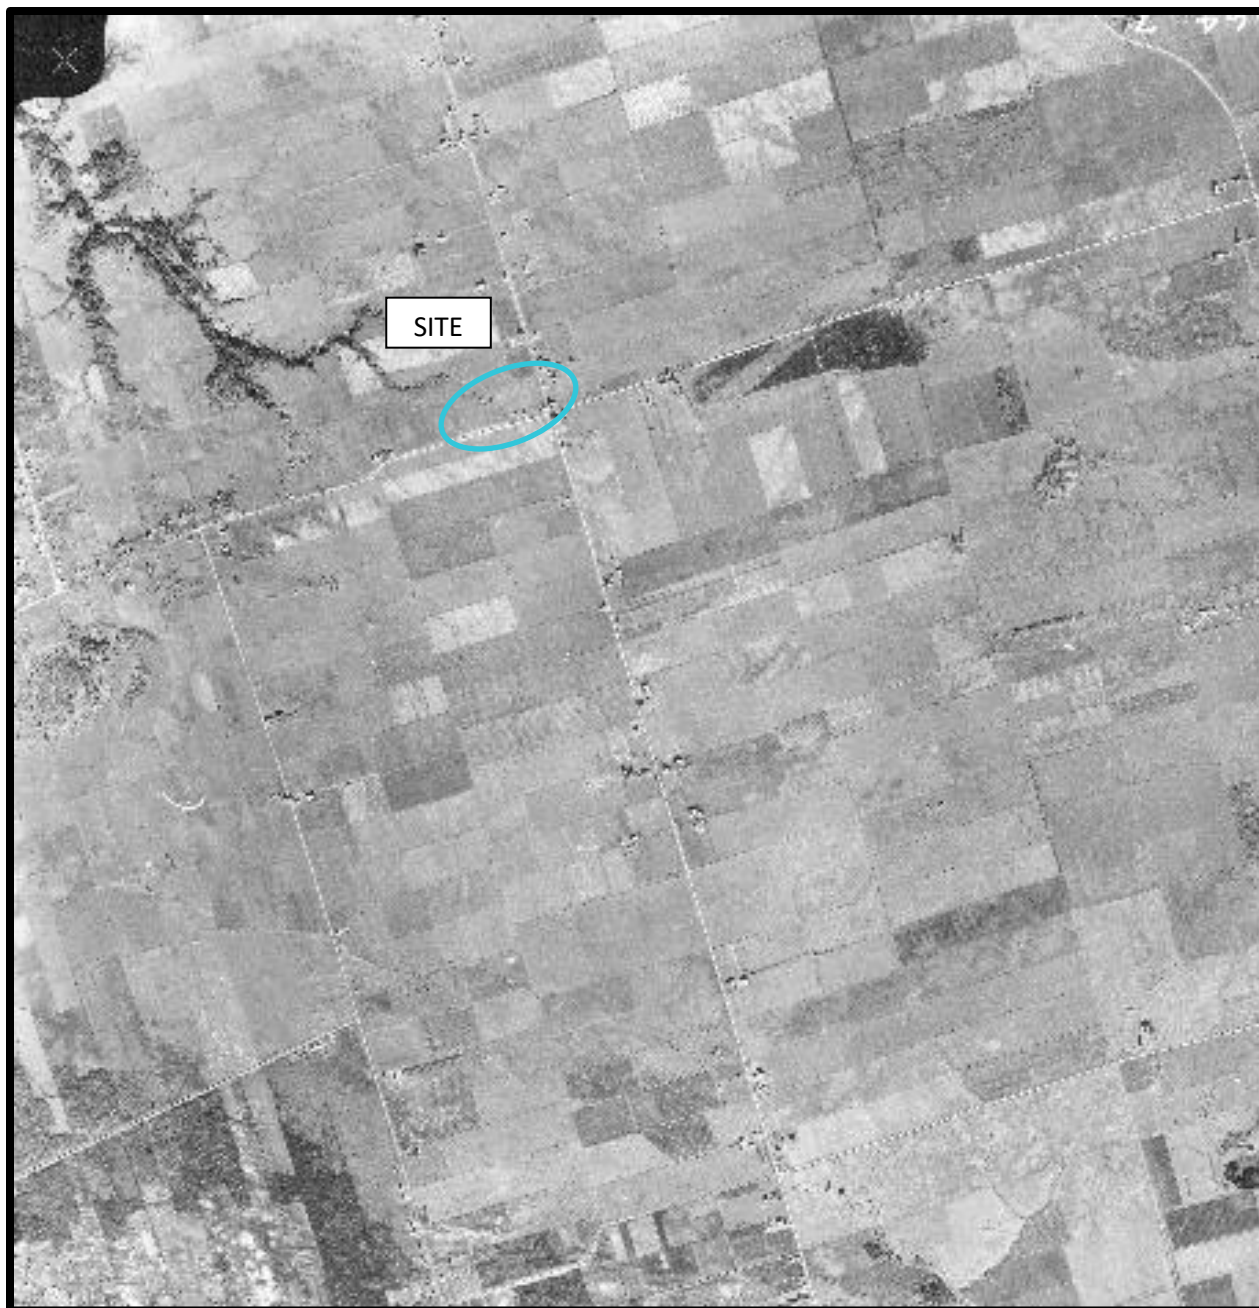
AERIAL PHOTOGRAPH  
1960

| 1960 | (Poor Scale, Poor Quality) Two buildings, assumed to be residential dwellings, have been constructed on the subject property. No significant changes have been made to the neighbouring properties since the previous aerial image. |

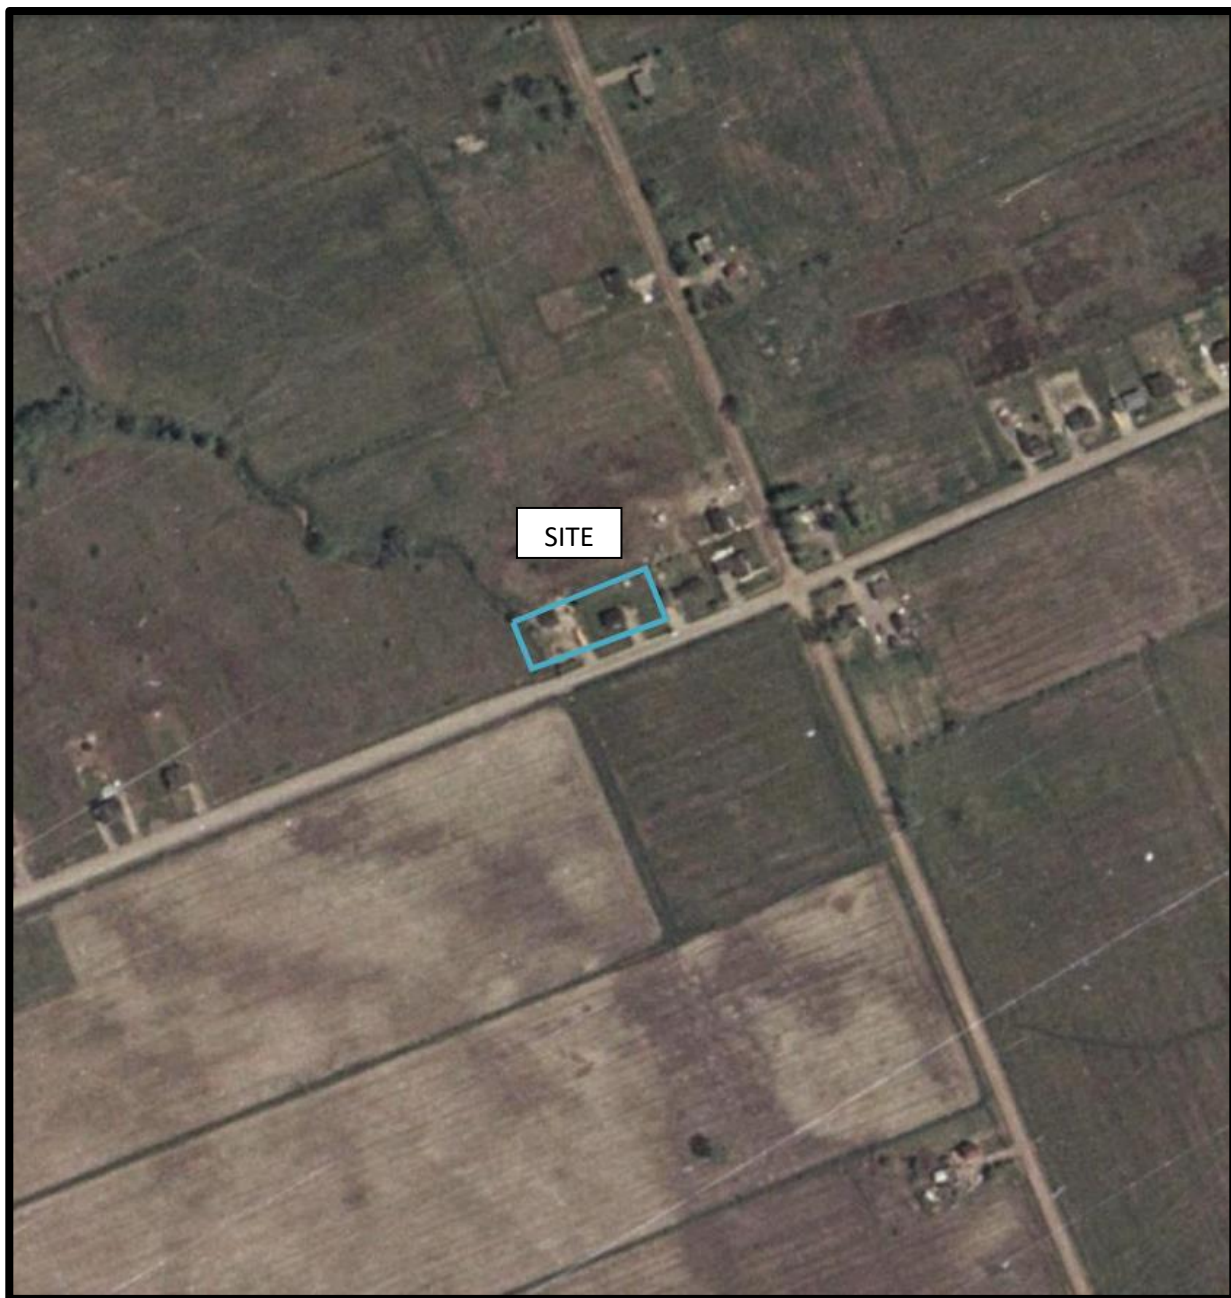
AERIAL PHOTOGRAPH  
1976

| 1976 | The subject property appears to be developed with two residential dwellings and associated driveways. No significant changes have been made to the neighbouring properties since the previous aerial image. |

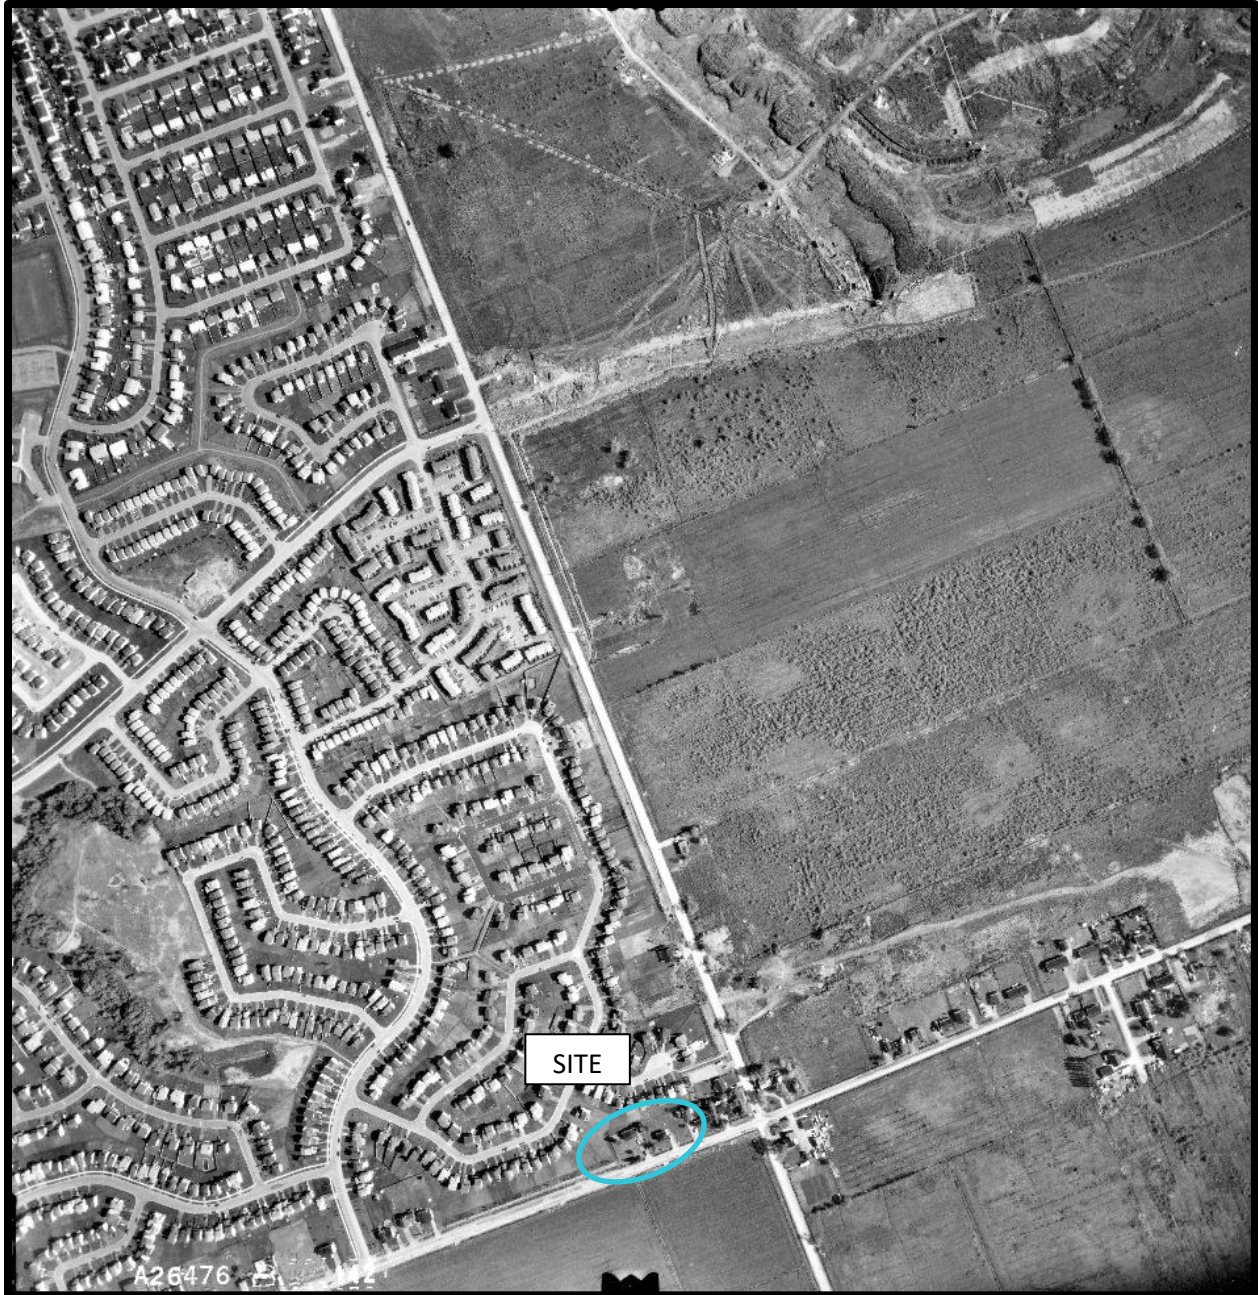
AERIAL PHOTOGRAPH  
1984

| 1984 | (Poor Scale) The subject property is unchanged since the previous aerial photograph. Significant residential development has occurred to the northwest of the site. No other changes have been made to the neighbouring properties since the previous aerial image. |

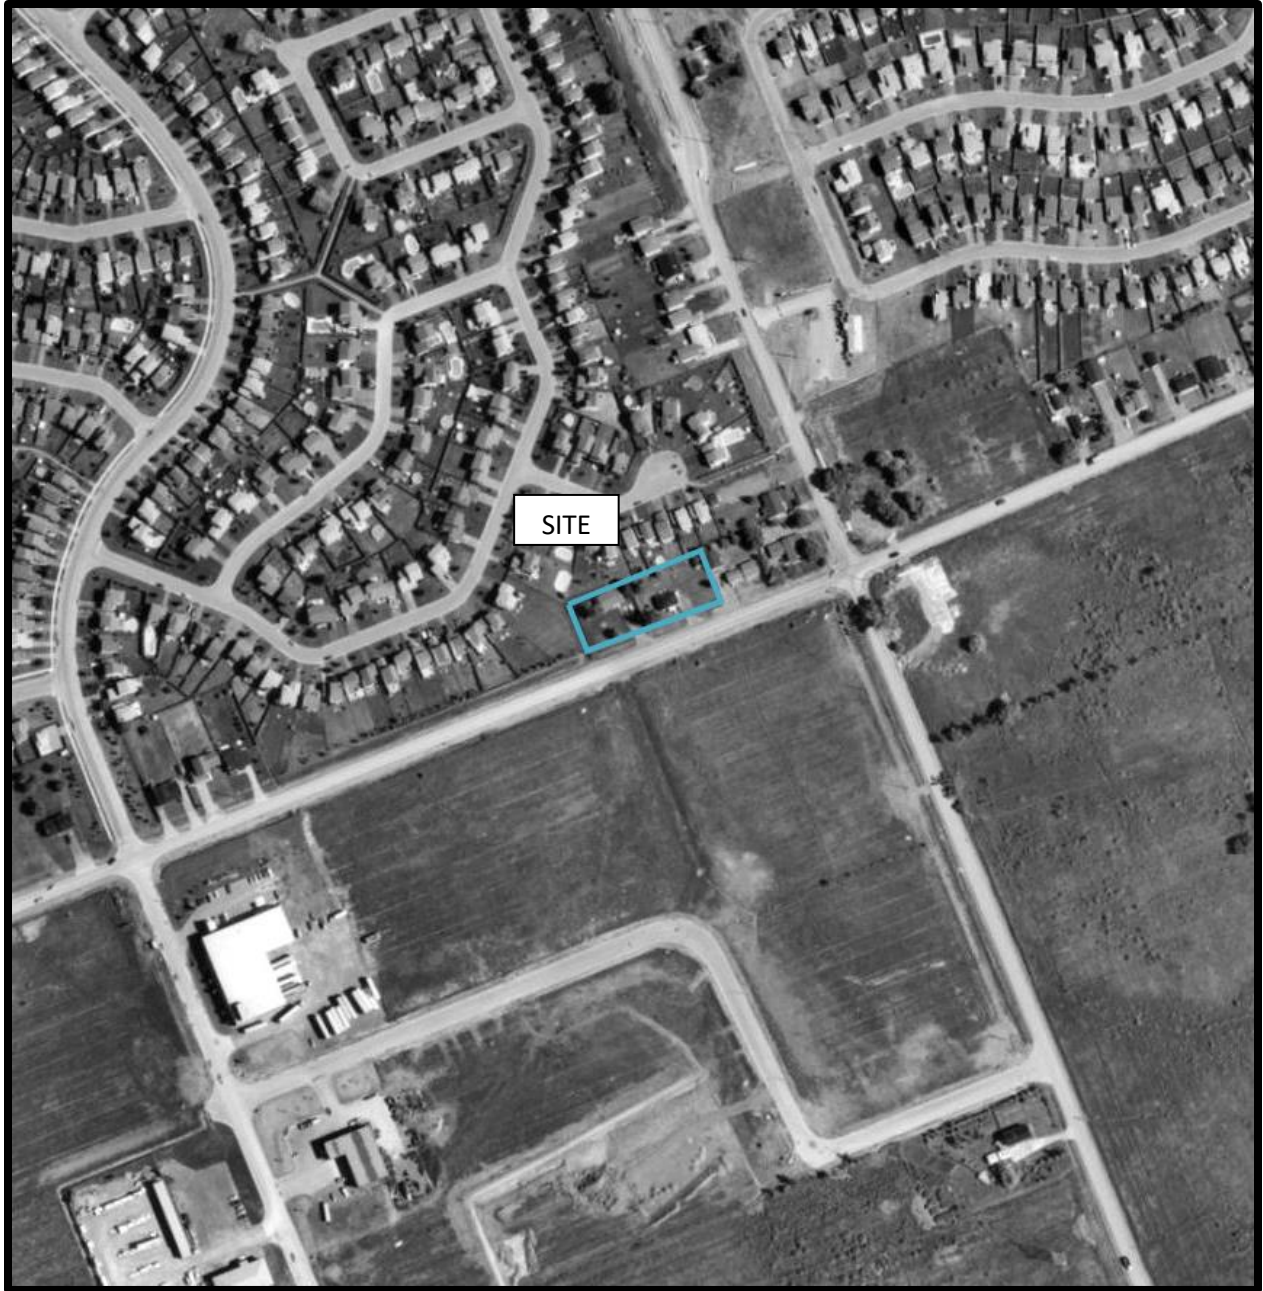
AERIAL PHOTOGRAPH  
1991

| 1991 | The subject property is unchanged since the previous aerial photograph. Additional residential dwellings were constructed to the northeast of the site. Several commercial and light industrial buildings have been constructed further southwest. No other changes have been made to the neighbouring properties since the previous image. |

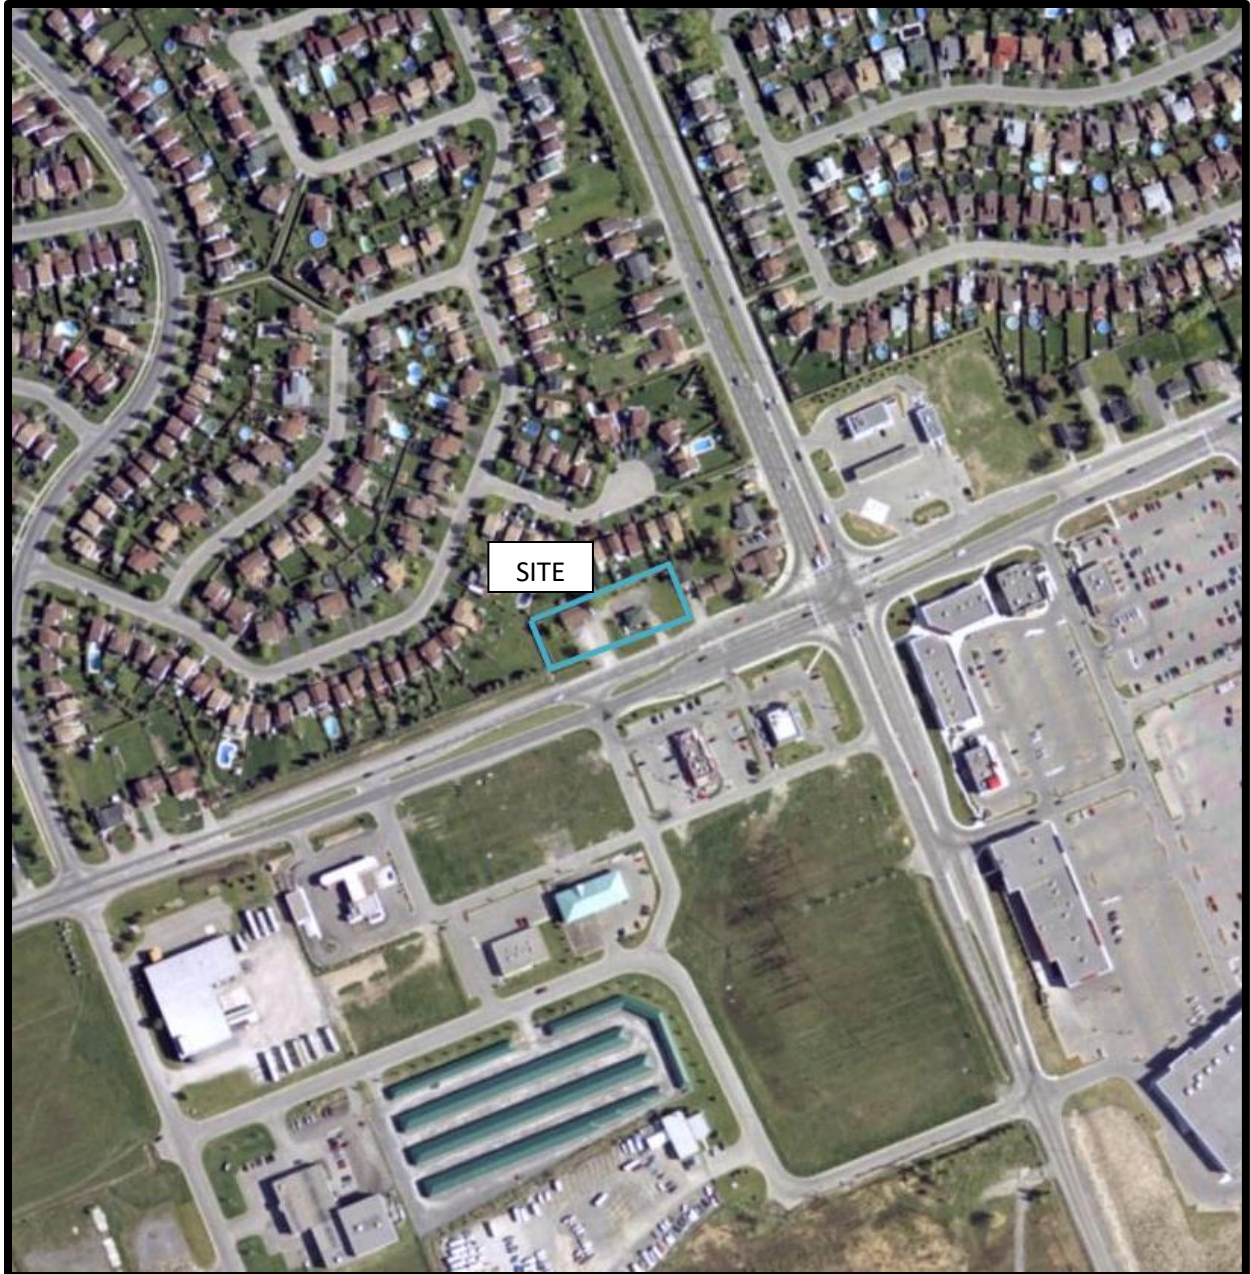
AERIAL PHOTOGRAPH  
2002

| 2002 | The subject property is unchanged since the previous aerial photograph. Significant commercial development has occurred to the south, including the addition of an auto repair shop. To the east, a retail fuel outlet was constructed. No other significant changes have been made to the subject or neighbouring properties since the previous aerial image. |

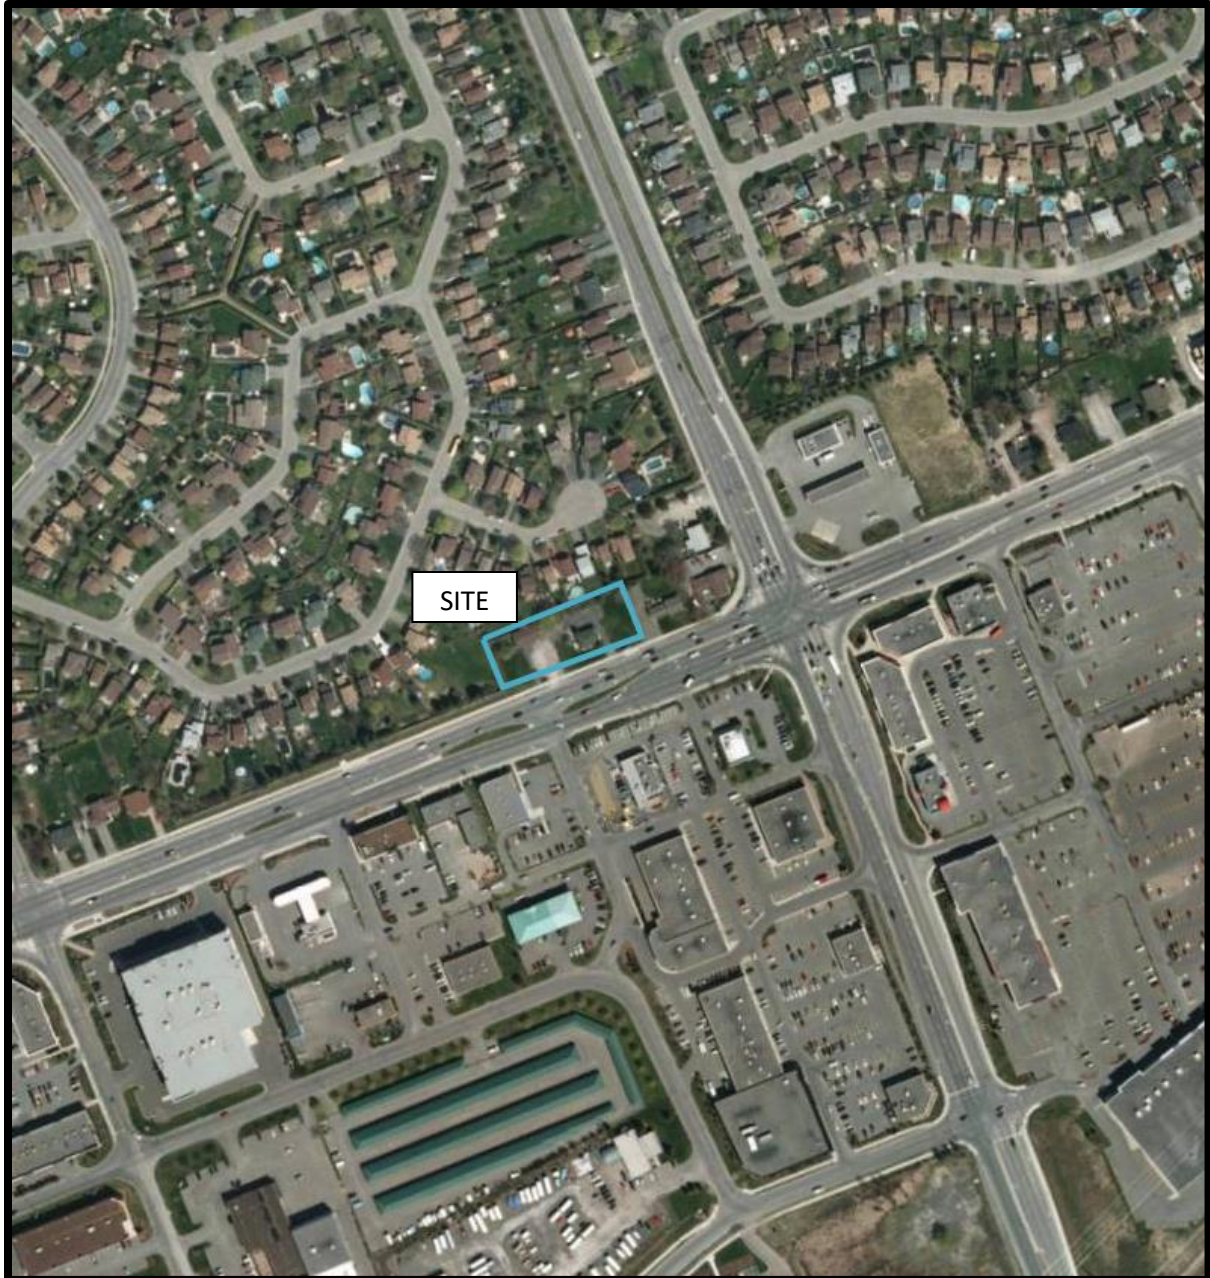
AERIAL PHOTOGRAPH  
2011

- 2011 The subject property is unchanged since the previous aerial photograph. Additional commercial buildings were constructed to the south of the site. No other changes have been made to the surrounding area since the previous aerial image.
- 2022 The residential dwelling on 4409 Innes Road was demolished. The gravel pad at 4405 Innes Road was replaced with a paved parking lot. Three buildings directly to the east of the site were demolished and replaced with the present-day veterinary hospital, pet groomers and associated paved parking lot. No other significant changes have been made to the site or neighbouring properties since the previous aerial photograph.

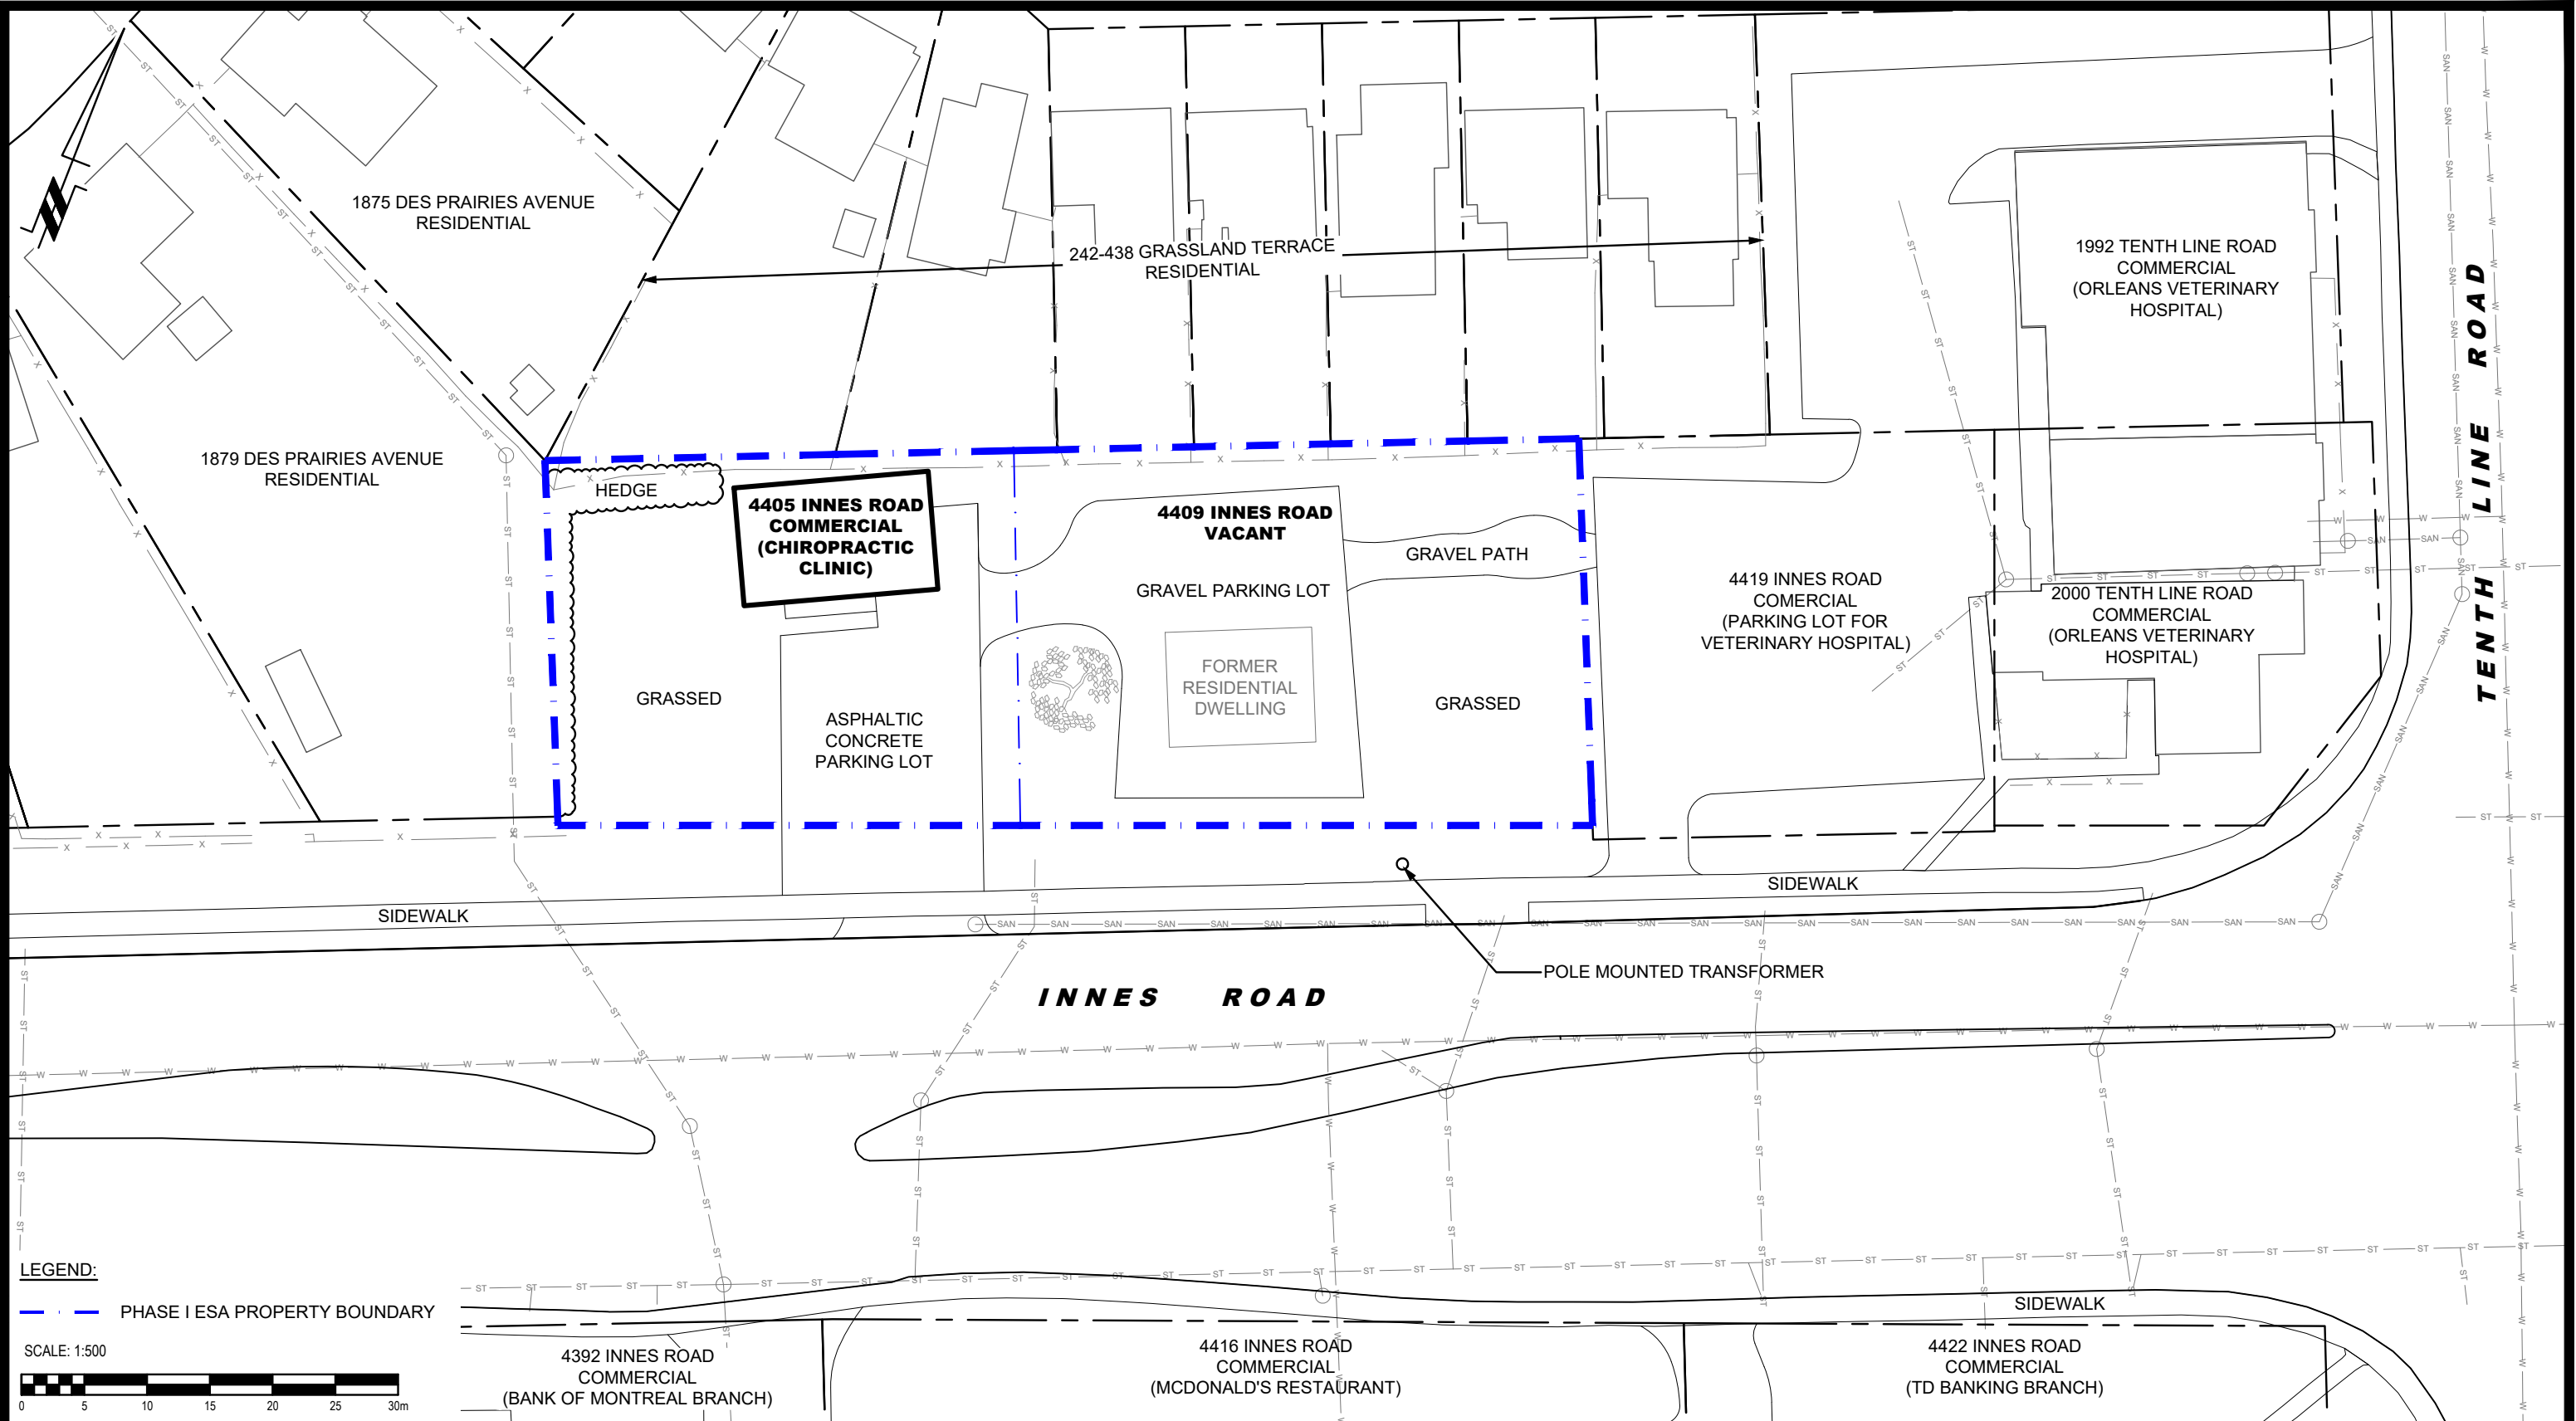
**DRAWING: PE6827-1 – SITE PLAN**

A retail fuel outlet (RFO) is located at 1993 Tenth Line Road, approximately 130m to the east of the site. An auto repair shop is located at 385 Vantage Drive, approximately 140m to the south. Based on the distances from these properties with respect to the subject site, these properties were not considered to pose a potential risk to the Phase I Property. No other concerns were identified with the

current use of the neighbouring lands. Neighbouring land use is shown on Drawing PE6827-1 – Site Plan.
