**REPORT ON  
GEOTECHNICAL INVESTIGATION  
CAMPEAU DRIVE & DIDSBURY ROAD  
KANATA, ONTARIO**

**REPORT NO.: 1475-05-G-LPL-A  
REPORT DATE: OCTOBER 31, 2005**

**LOBLAW PROPERTIES LIMITED  
3563 LAKESHORE BLVD., WEST  
TORONTO, ONTARIO  
M8W 1P4**

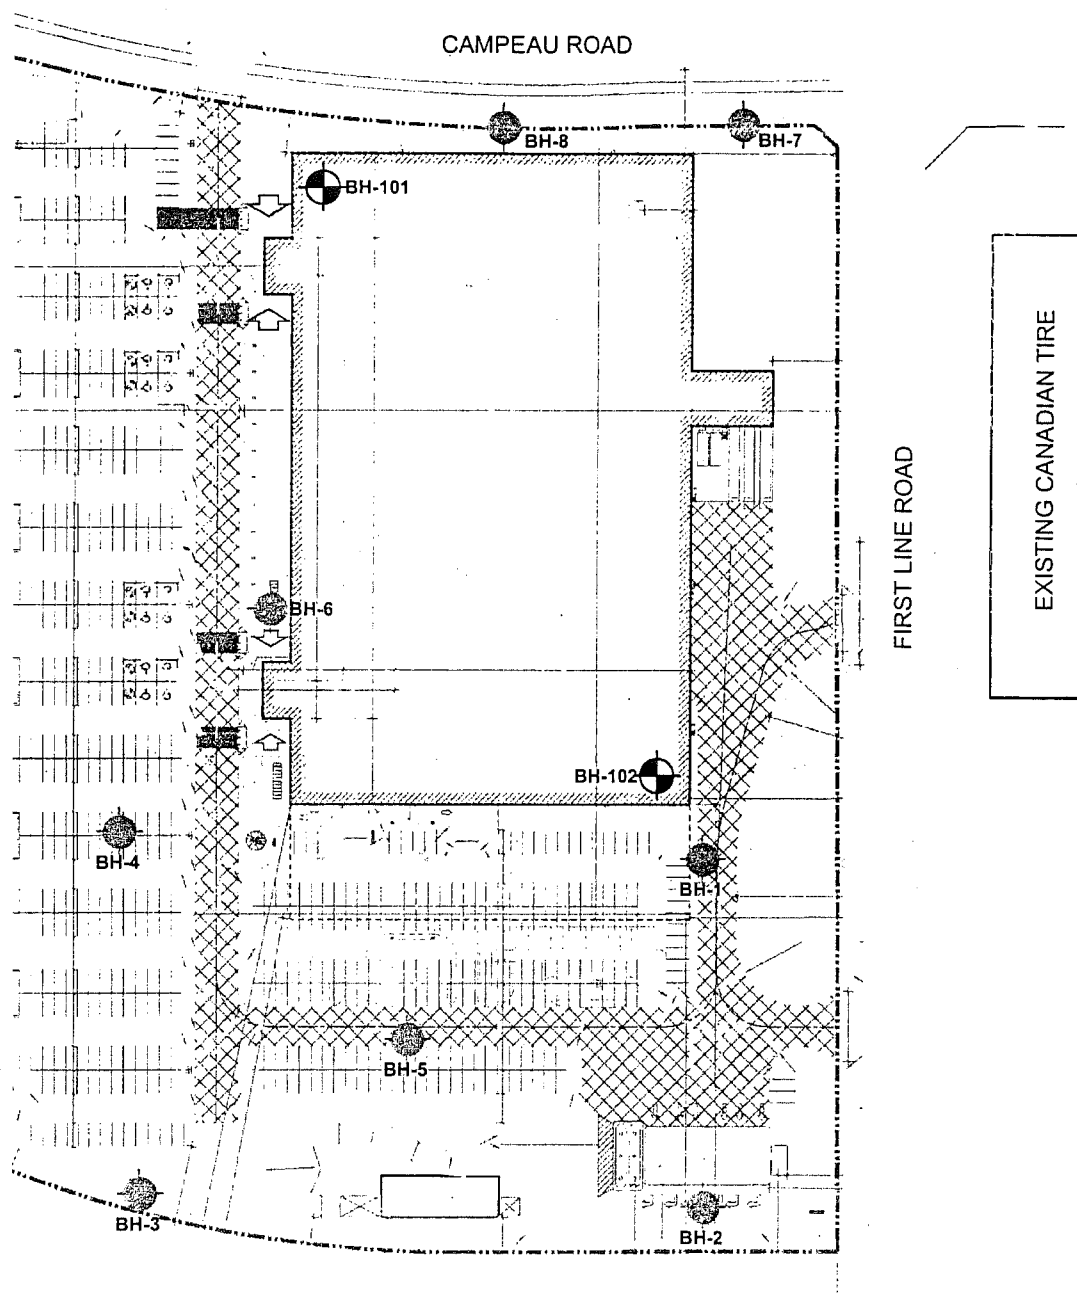
The field work for the investigation was carried out on September 9, 2005 and consisted of drilling two sampled boreholes (BH-101 and BH-102) at the locations shown on Drawing No. 1. The boreholes were advanced using a truck mounted drill rig, equipped with continuous flight hollow stem augers and sampling rods, supplied by a specialist drilling contractor.

Reference is made to the appended Borehole Location Plan (Drawing No. 1), Logs of Boreholes (Drawing Nos. 2 to 5) for details of field work, including soil classification, inferred stratigraphy, and groundwater observations carried out during the drilling of the boreholes. The current boreholes revealed that the subsoils, below the surficial topsoil,

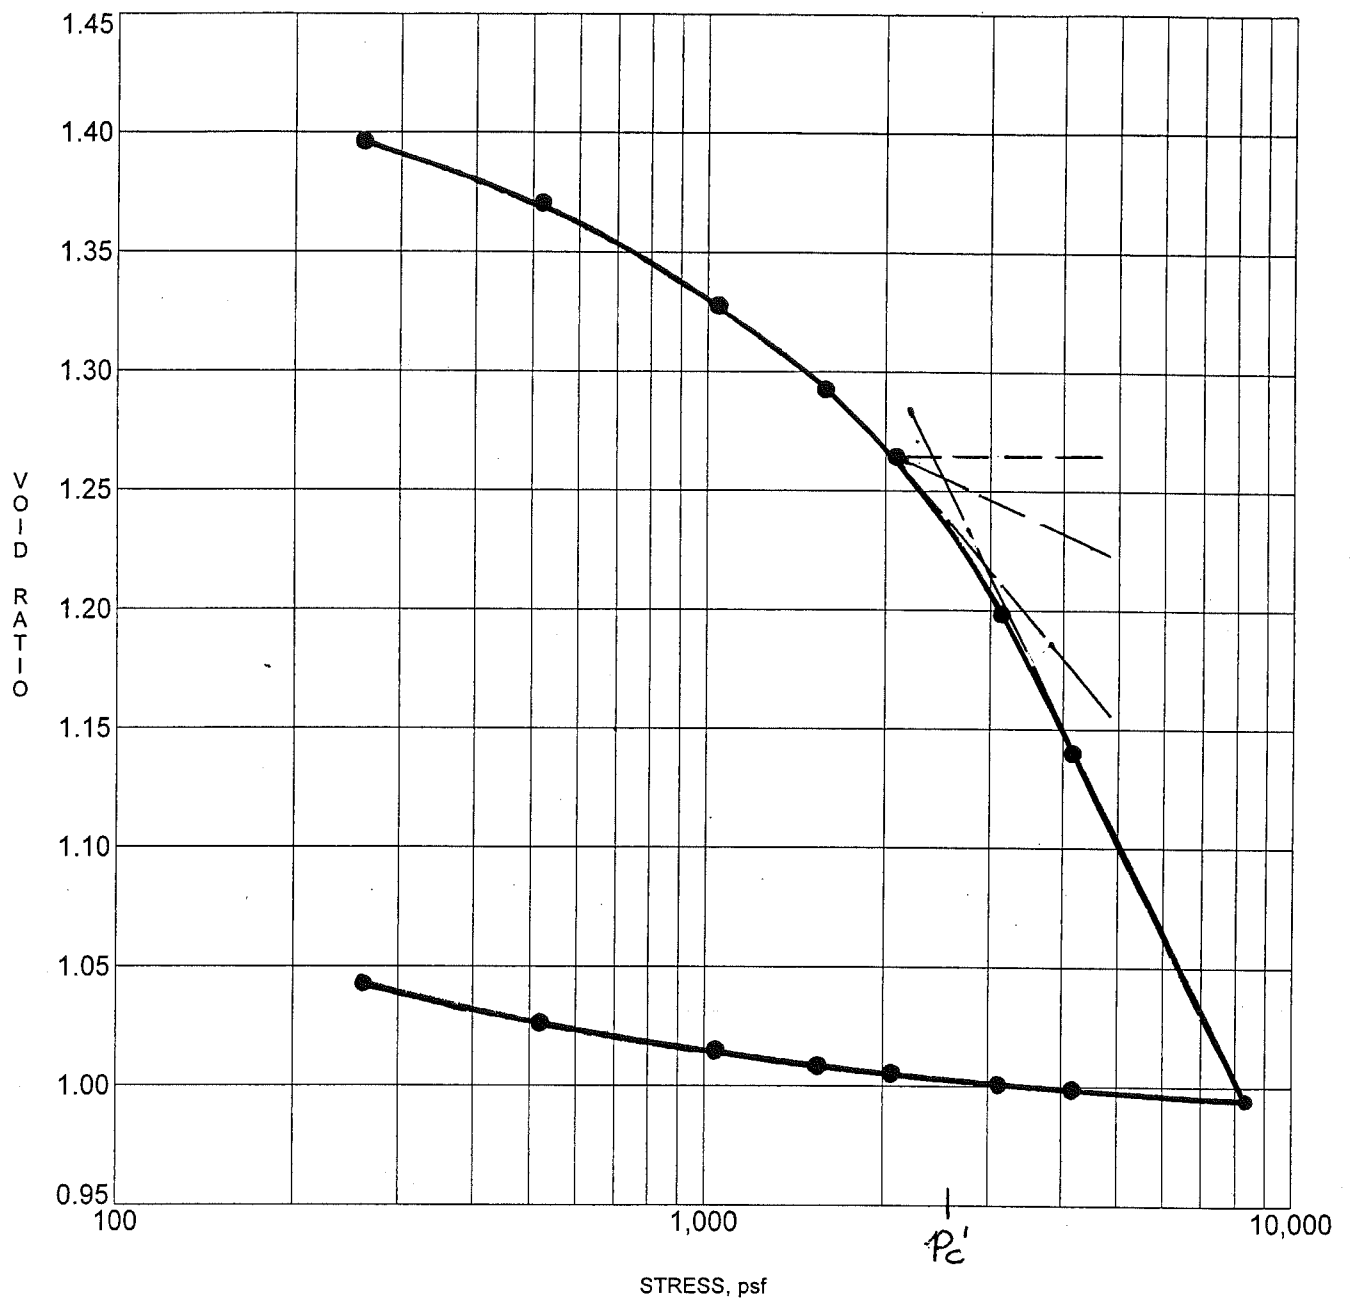
CONSOLIDATION TEST

A consolidation test was carried out on a relatively undisturbed sample of the clay, obtained using a thin wall Shelby tube from BH101, at a depth of 11.0m from grade. The results, shown on Figure 2, indicated that the deposit, at the test location, has a pre-consolidated pressure ( $p_c'$ ) of about 130 kPa (2,600 psf), around 30 kPa over the existing effective overburden pressure.
