# TREE CONSERVATION REPORT

85 Gemini Way

Tree Conservation Report submitted as Partial  
Requirements for a Site Plan Control Application,  
November 28, 2024

**Date of Report:** November 28, 2024

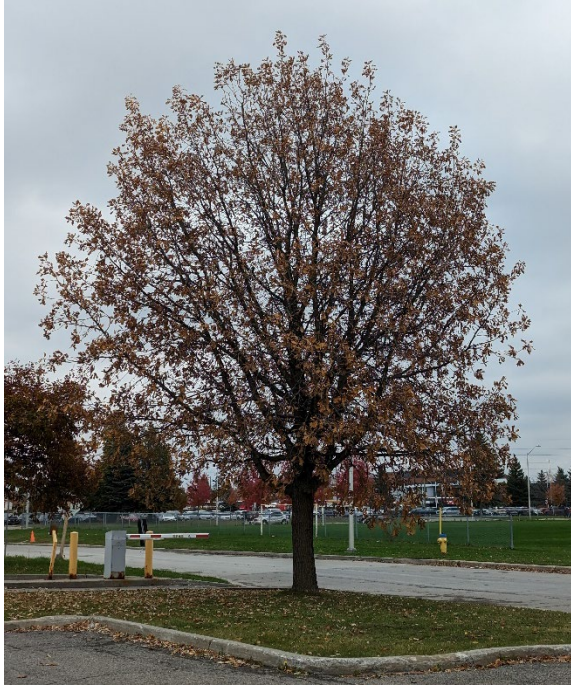
| Tree <sup>1</sup> | Species | DBH (cm) | Ownership <sup>2</sup> | Tree Condition | Forester recommendation |
|---|---|---|---|---|---|
| 2 | White oak ( <i>Quercus alba</i> ) | 36 | Subject property | Good: crossing branches | Remove – within excavation footprint. |

Tree 2 - private oak to be removed.

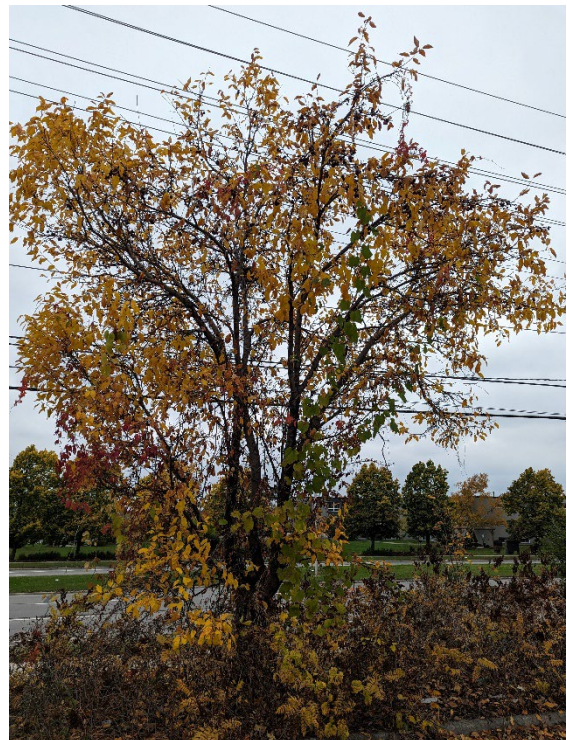
| Tree <sup>1</sup> | Species | DBH (cm) | Ownership <sup>2</sup> | Tree Condition | Forester recommendation |
|---|---|---|---|---|---|
| 29 | Crabapple ( <i>Malus spp.</i> ) | 12, 12, 10, 12 | Subject property | Fair: large limb prune near main union; poor form - four leaders growing from main union | Remove – within excavation footprint. |

Tree 29 – private crab apple to be removed.
