TREE CONSERVATION REPORT

5580 Manotick Main Street

Tree Conservation Report submitted as Partial
Requirements for a Site Plan Control Application.

August 14, 2025

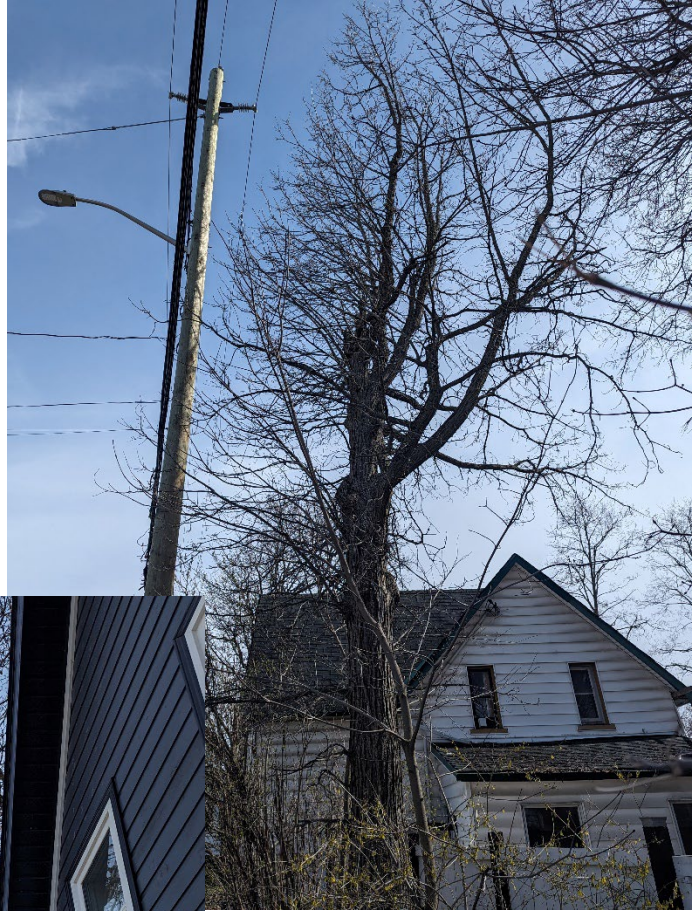
Tree ¹	Species	DBH (cm)	Ownership ²	Tree Condition	Action	Forester recommendation
1	Bur oak (<i>Quercus macrocarpa</i>)	51	City	Fair: pruned around wires – asymmetrical crown – pruning wounds with decay – epicormic shoots	Remove	Remove – in line with proposed entryway.
2 ⁴	Norway maple (<i>Acer platanoides</i>)	8	City	Good/Fair: leaning to road for sunlight	Remove	Remove – in line with proposed entryway.
3 ⁴	Norway maple (<i>Acer platanoides</i>)	7, 5, 6, 8	City	Fair/Poor: stems are sprouts from old stump; leaning heavily; growing under wires	Remove	Remove due to health status.
4	Black locust (<i>Robinia pseudoacacia</i>)	38	Boundary – 5576 Manotick Main	Fair: poor growing location; crowded	Remove	Remove – opportunities to retain may be explored during site works.
5	Norway maple (<i>Acer platanoides</i>)	17	Boundary – 5576 Manotick Main	Fair: young and vigorous; poor growing location; suppressed by larger trees	Remove	Remove – opportunities to retain may be explored during site works.

Above: Tree 1 - City oak to be removed.

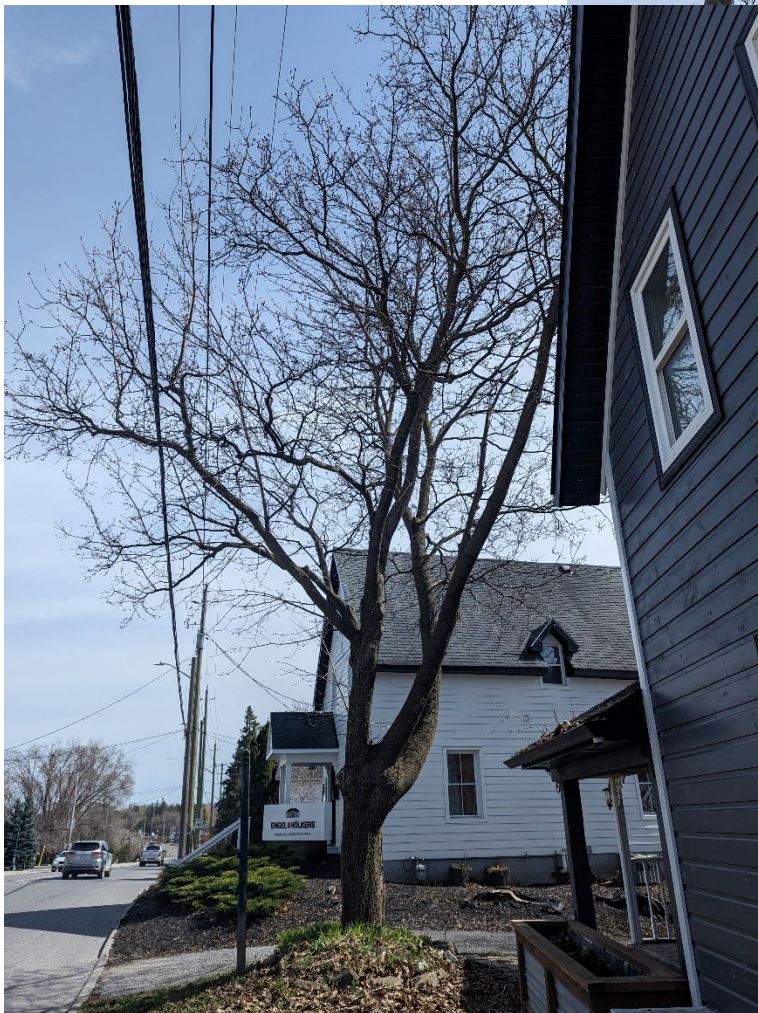
Left: Tree 10 - private Norway maple to be removed.

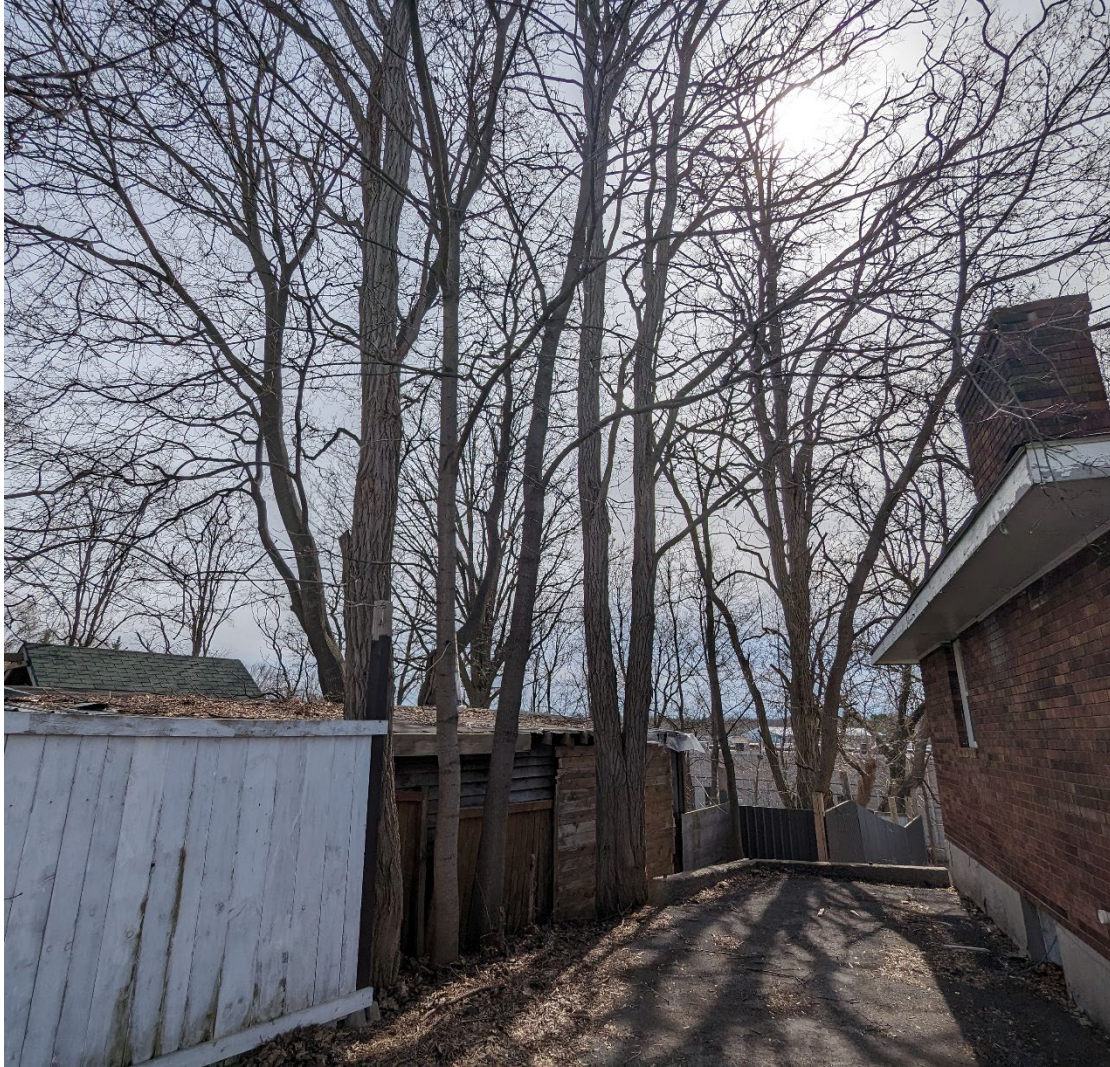
There are many trees located on the boundary, or just within the adjacent property at 5576 Manotick Main Street that are listed in the tree inventory, including **trees 4-8 and 21-24**. Most of these are in fair/poor health and have seeded in naturally and are being suppressed by larger trees. The rooting zones of these trees are in conflict with the proposed development, and removal and replacement is recommended at this time. Opportunities may exist to protect **Trees 4 and 5**, but this would require further details about on-site construction methods and in-situ mitigations, including root cutting and sensitive removal of other trees. Because these trees are located on the adjacent boundary, permission from the adjacent property owner will be sought prior to removal and issuance of a tree permit.

Trees 4-8 – boundary black locust and Norway maples to be removed.

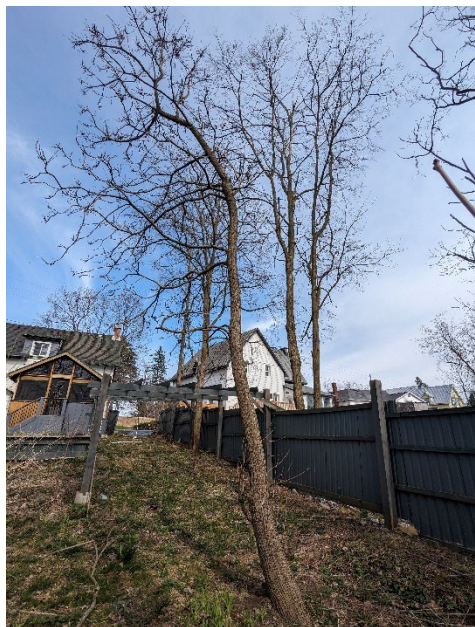
Right: Tree 14 - private catalpa to be removed. Trees 11-13 visible in background.

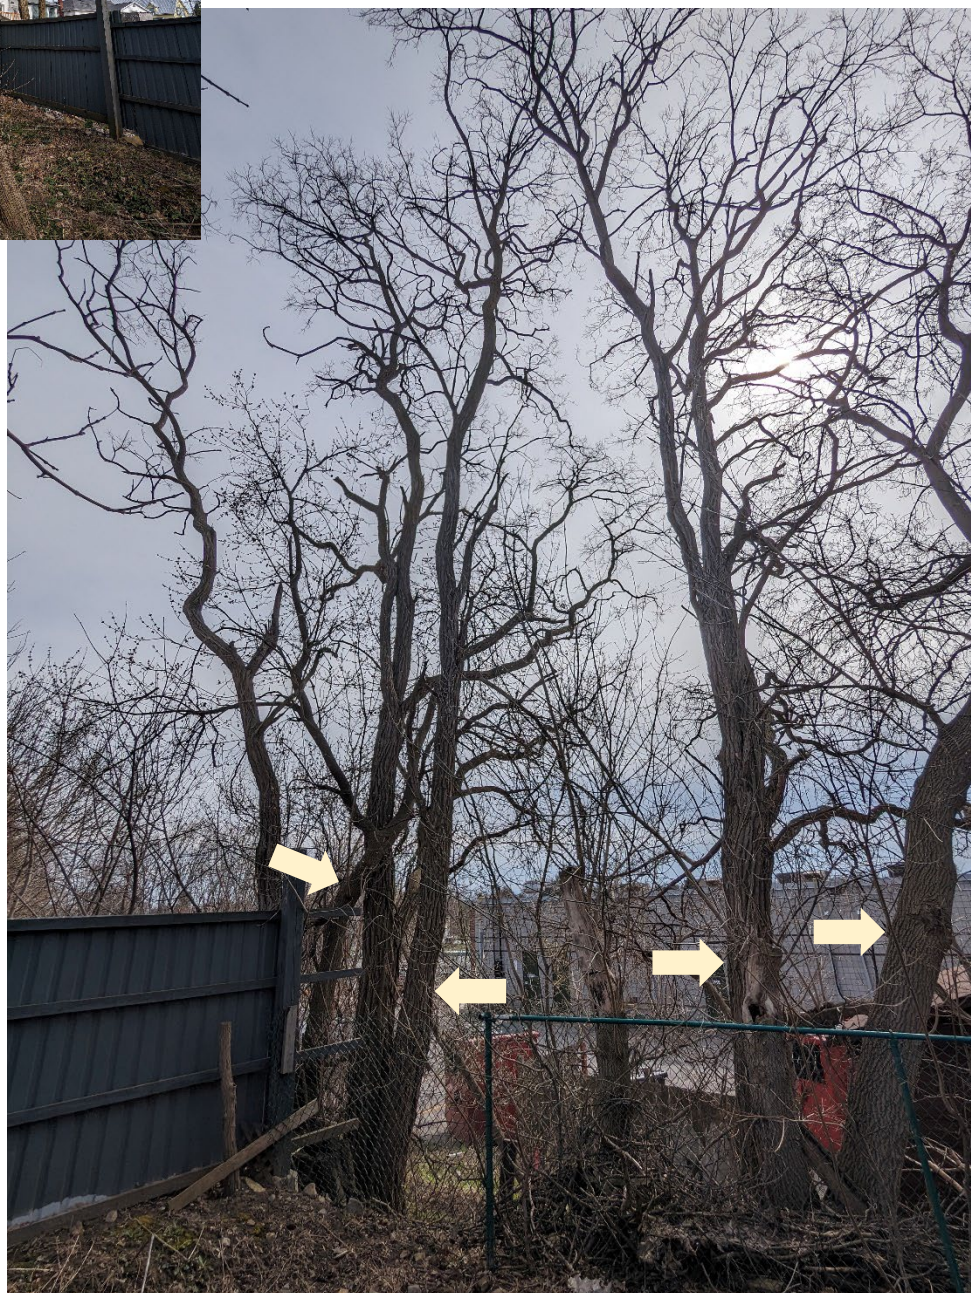
Trees 11-13 located on the adjacent property at 5582 Manotick Main are not in good condition but should be far enough from excavation to be effectively protected. All roots along the line of excavation on the south property line are to be cleanly severed by hand. **Trees 17 and 18** are also on this adjacent property and due to their poor health combined with proximity to excavation are recommended for removal. Permission from the adjacent property owner will be sought prior to removal and issuance of a tree permit. In the event that permission from the adjacent property is not granted, adjustments to the TCR will be made to retain and mitigate to retain **trees 17 and 18**.

Below: (left to right) Tree 15 & 16 – adjacent trees to be retained and 17 & 18 – adjacent trees to be removed.

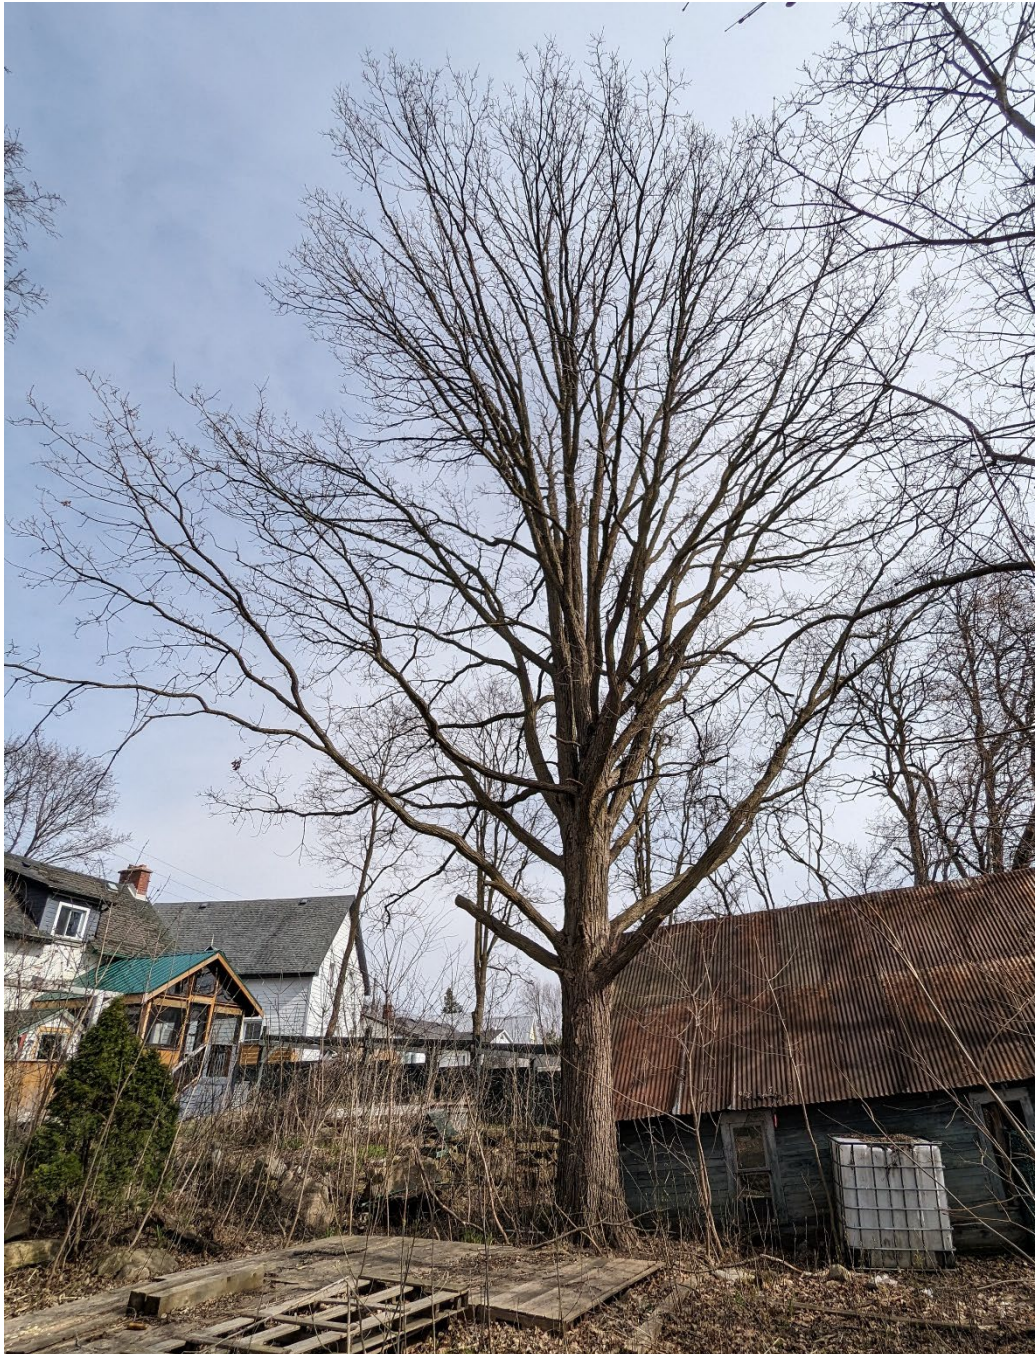
Tree 19 - private oak to be removed.

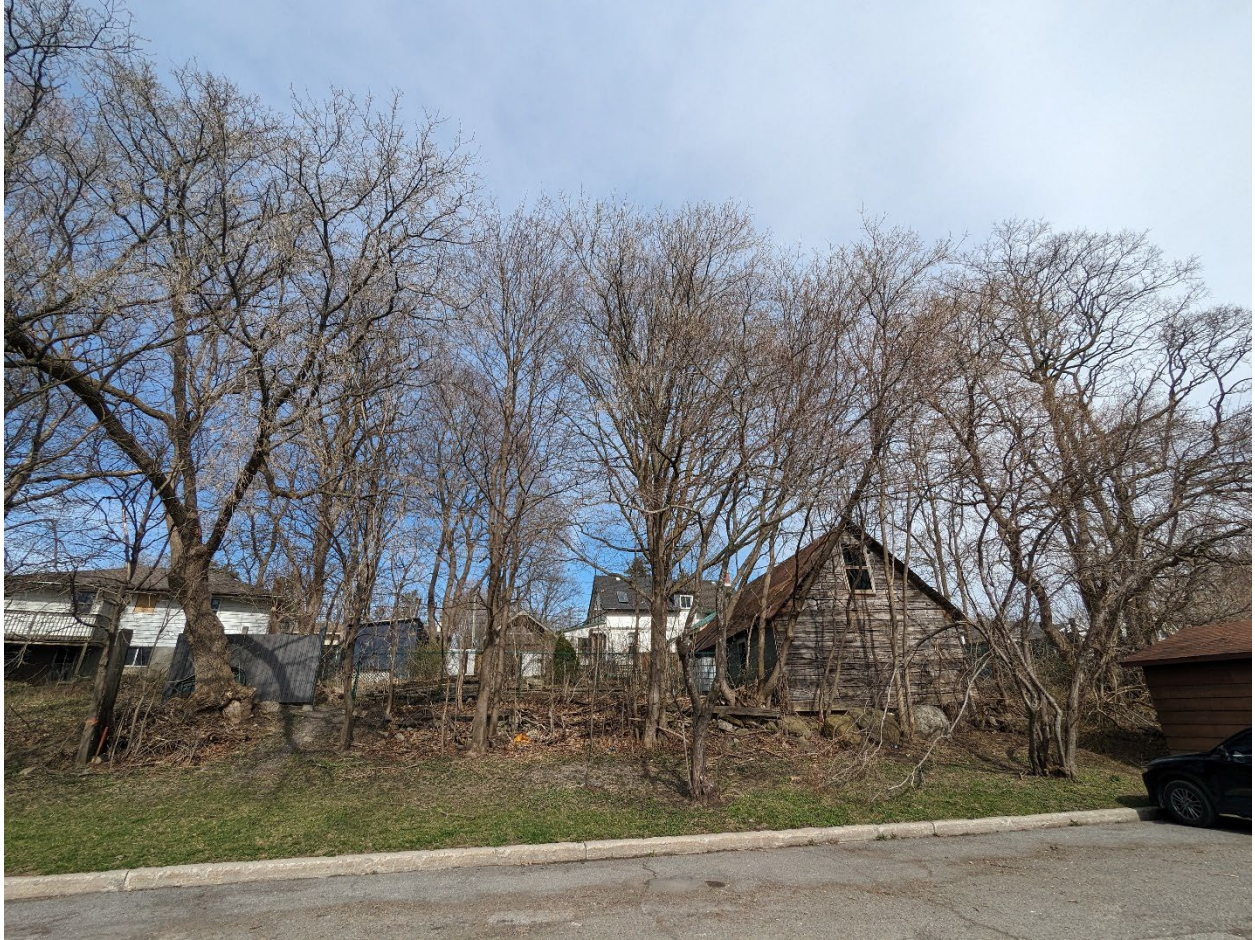
Above: view from adjacent commercial area - Group 1 and Tree 20 (far left) along the rear of the property.

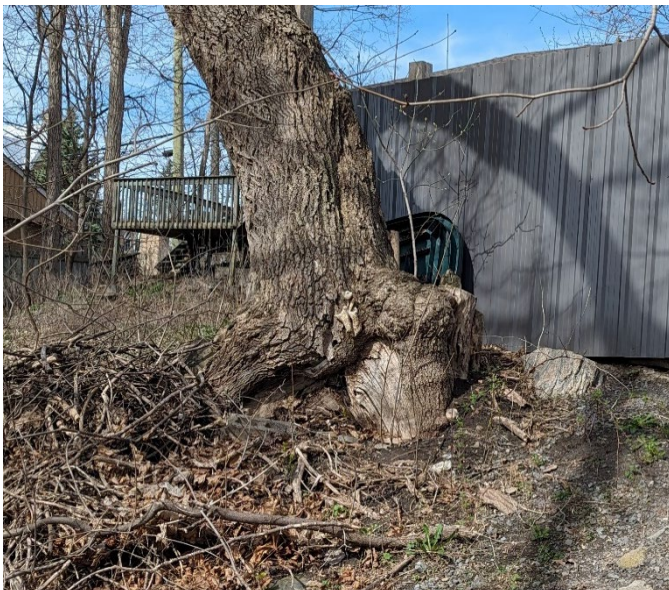
20	Manitoba maple (<i>Acer negundo</i>)	85	Boundary – 5576 Manotick Main	Poor: decay and fungal bodies at base; lean to northwest; woodpecker activity in canopy	Retain	Remove – in line with proposed parking.
21	Manitoba maple (<i>Acer negundo</i>)	27	Boundary – 5576 Manotick Main	Poor: top has been removed – only sprouts remain as canopy	Remove	Remove due to grade changes to install parking.
22	Black locust (<i>Robinia pseudoacacia</i>)	53	Boundary – 5576 Manotick Main	Poor: Very little live canopy	Remove	Remove due to grade changes to install parking.
23	Black locust (<i>Robinia pseudoacacia</i>)	43	Boundary – 5576 Manotick Main	Poor: large wound on trunk – decay present	Remove	Remove due to grade changes to install parking.
24	Manitoba maple (<i>Acer negundo</i>)	24	Boundary – 5576 Manotick Main	Poor: crack in trunk; lean to northeast	Remove	Remove due to grade changes to install parking.
25	Norway maple (<i>Acer platanoides</i>)	66, 43	Subject property	Poor: canker on smaller stem; decay at main union – 10cm deep hole – small crack from this hole to base; large branch stub	Remove	Remove due to health status and impacts from construction – in line with proposed parking.

Below: base of Tree 20

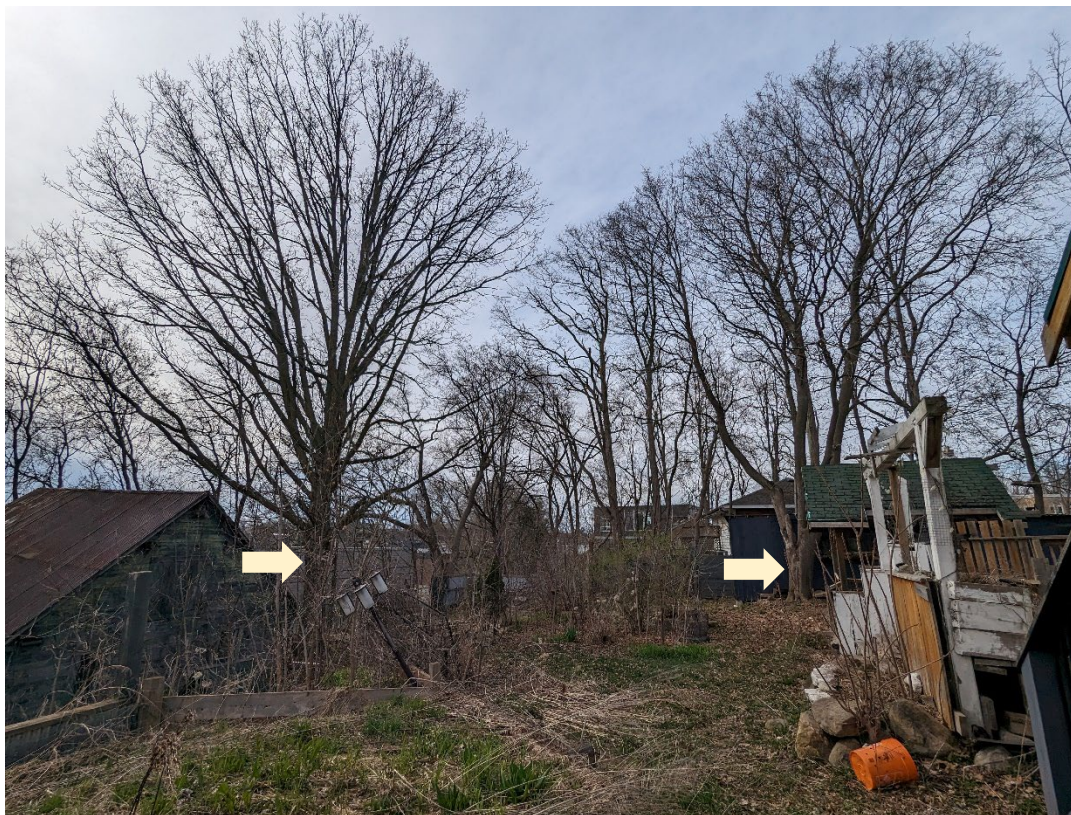
Above: western corner and northern property line. Tree 19 at left of image and Tree 25 in front of far structure at right.

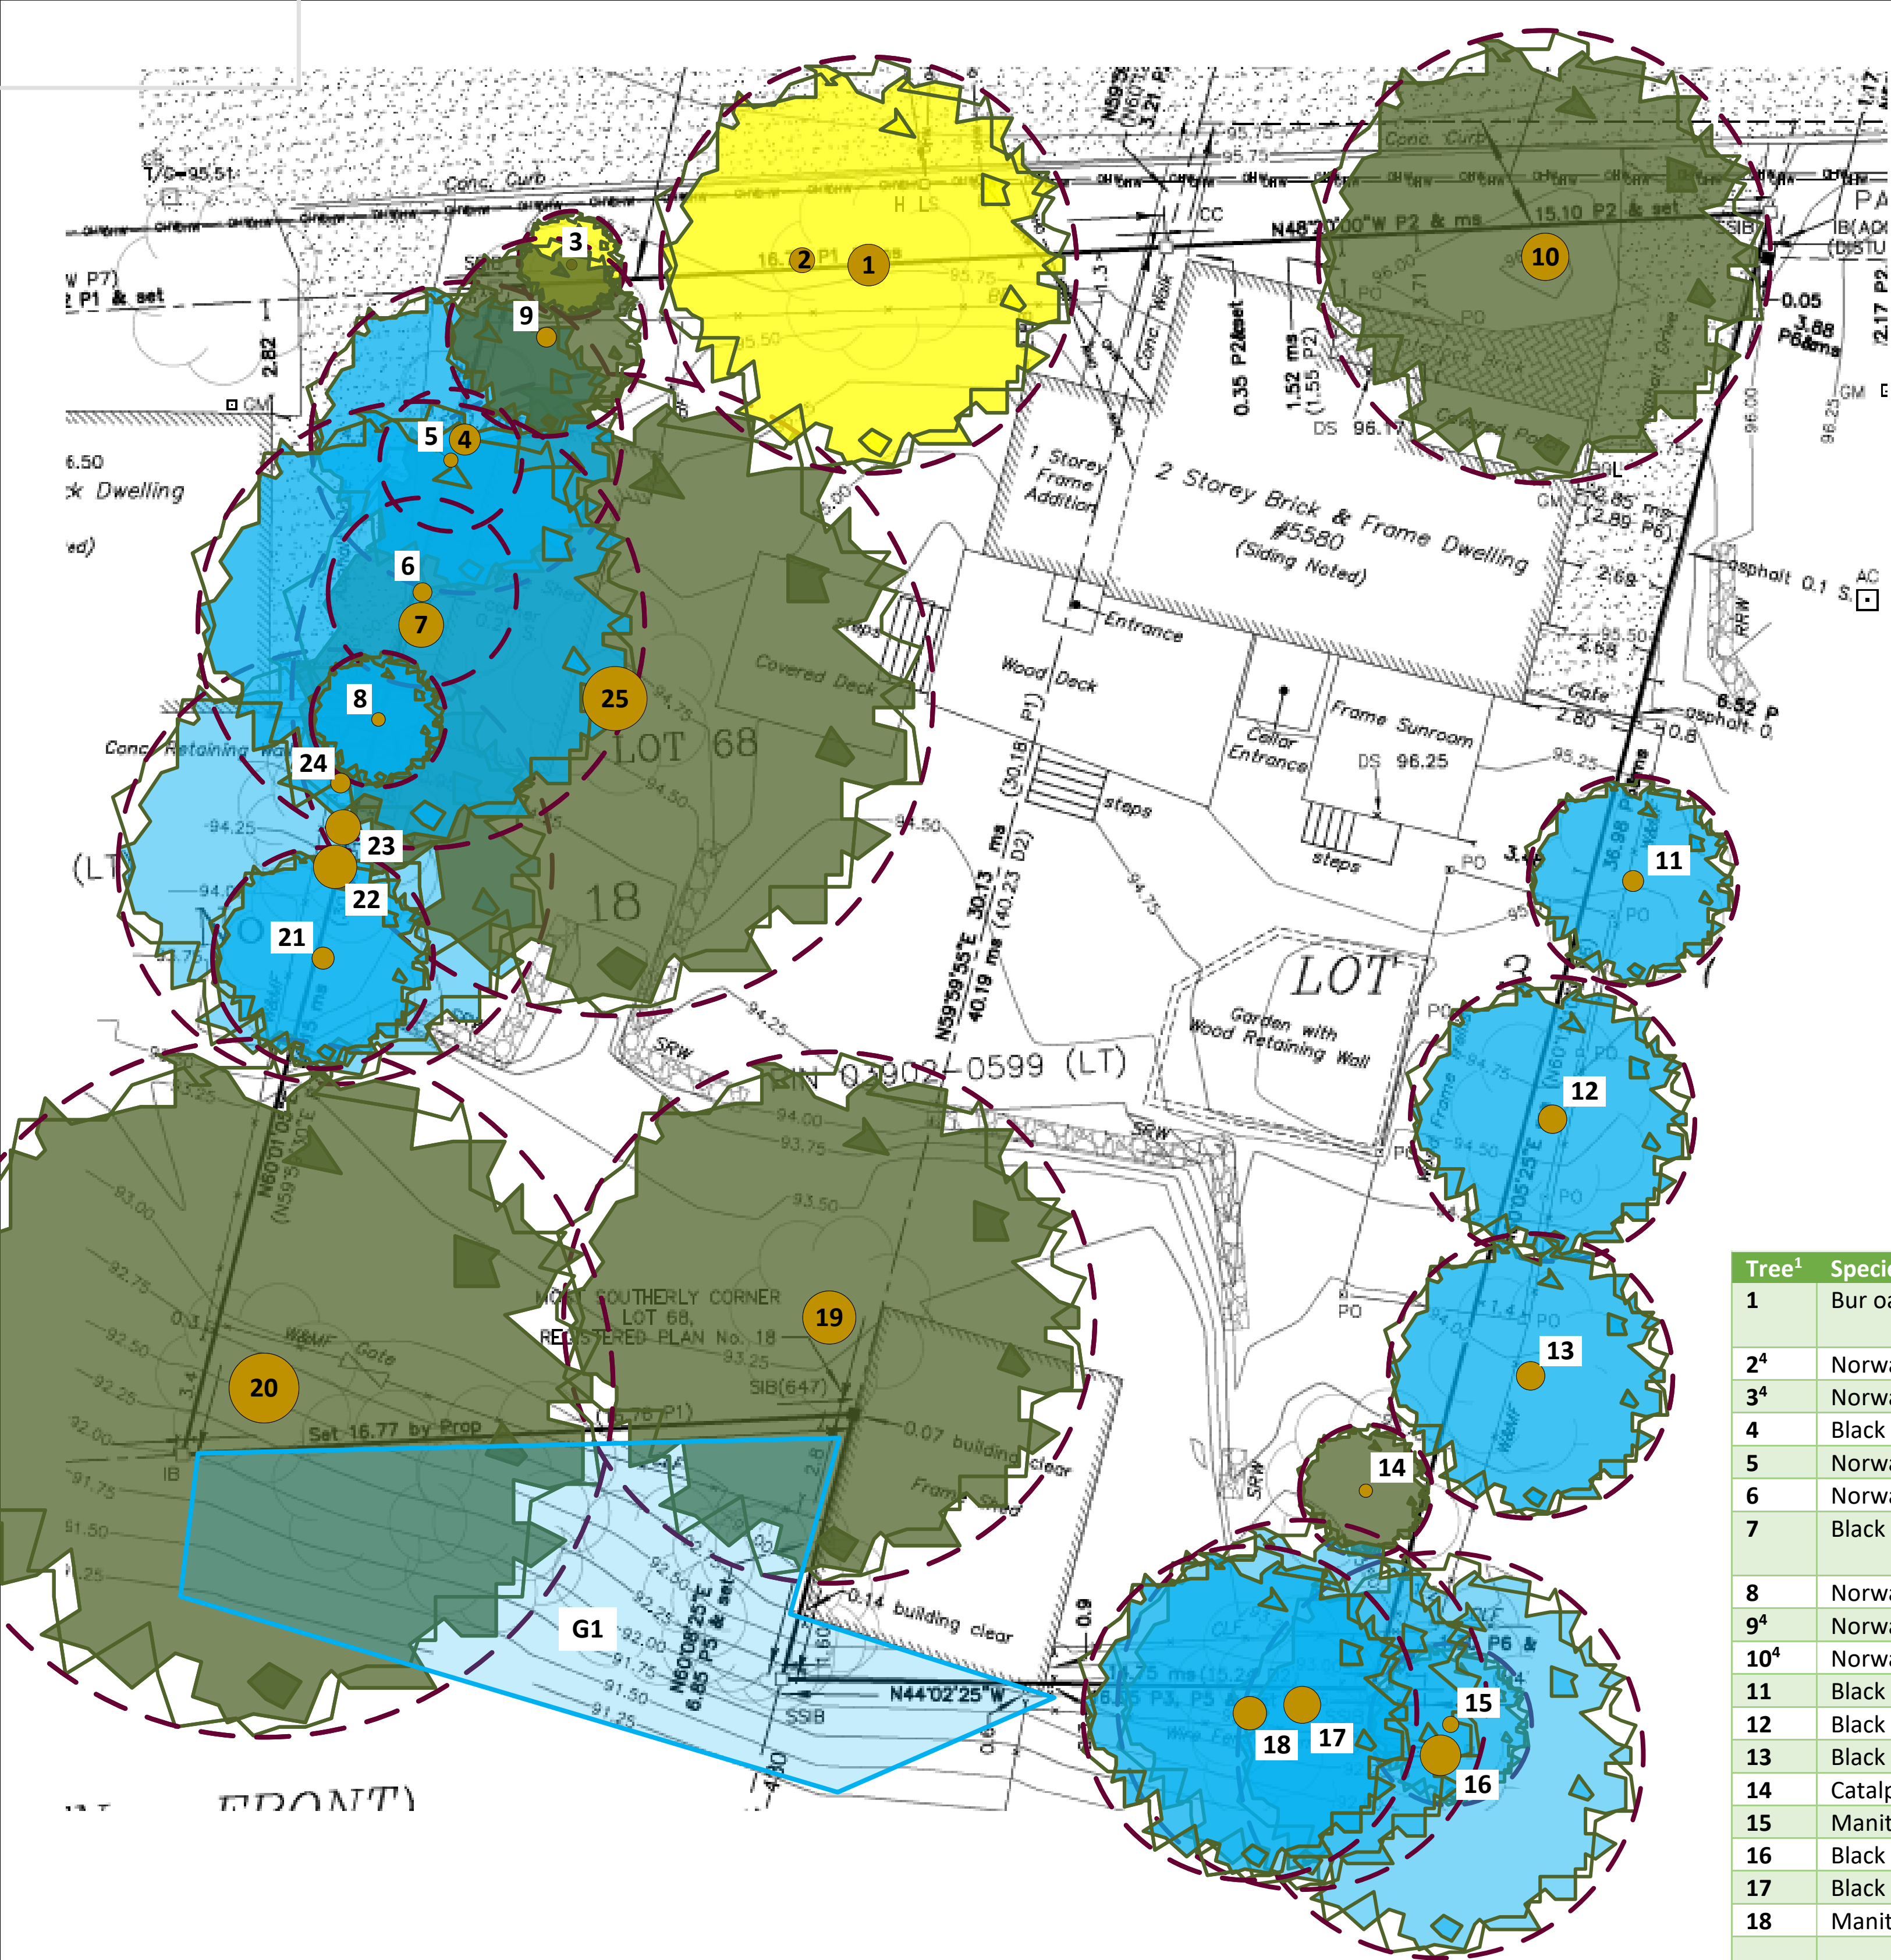
TCR Map #1 – 5580 Manotick Main

Tree ¹	Species	DBH (cm)	Tree Condition
1	Bur oak (<i>Quercus macrocarpa</i>)	51	Fair: pruned around wires – asymmetrical crown – pruning wounds with decay – epicormic shoots
2 ⁴	Norway maple (<i>Acer platanoides</i>)	8	Good/Fair: leaning to road for sunlight
3 ⁴	Norway maple (<i>Acer platanoides</i>)	7, 5, 6, 8	Fair/Poor: stems are sprouts from old stump; leaning heavily; growing under wires
4	Black locust (<i>Robinia pseudoacacia</i>)	38	Fair: poor growing location; crowded
5	Norway maple (<i>Acer platanoides</i>)	17	Fair: young and vigorous; poor growing location; suppressed by larger trees
6	Norway maple (<i>Acer platanoides</i>)	23	Fair: young and vigorous; poor growing location; suppressed by larger trees
7	Black locust (<i>Robinia pseudoacacia</i>)	54	Fair: codominant stems @1.5m – included bark at union; dead branches; poor growing location
8	Norway maple (<i>Acer platanoides</i>)	16	Fair: young and vigorous; poor growing location; suppressed by larger trees

9 ⁴	Norway maple (<i>Acer platanoides</i>)	24	Poor: growing around roof of shed
10 ⁴	Norway maple (<i>Acer platanoides</i>)	55	Poor/Fair: canker in canopy; slight lean to west; poor form at base; large dead branch
11	Black locust (<i>Robinia pseudoacacia</i>)	25	Fair/Poor: grade raised around base; wound – possibly canker
12	Black locust (<i>Robinia pseudoacacia</i>)	35	Fair/Good: dead branches in canopy; pruning wounds
13	Black locust (<i>Robinia pseudoacacia</i>)	30, 18 (estimate)	Fair/Poor: many dead branches; possible canker on trunk
14	Catalpa (<i>Catalpa speciosa</i>)	16	Fair: lean and asymmetrical crown to south; broken branches
15	Manitoba maple (<i>Acer negundo</i>)	20 (estimate)	Fair/Poor: heavy lean south; growing into Tree 16; sprouts at base; growing on slope
16	Black locust (<i>Robinia pseudoacacia</i>)	40, 30 (estimate)	Poor: very little live canopy remaining; lean to south
17	Black locust (<i>Robinia pseudoacacia</i>)	45 (estimate)	Fair/Poor: very little live canopy remaining

18	Manitoba maple (<i>Acer negundo</i>)	40 (estimate)	Fair: heavy lean northwest; vigorous growth
19	Bur oak (<i>Quercus macrocarpa</i>)	65	Good/Fair: some crossing branches; branch stubs from pruning with epicormic shoots
20	Manitoba maple (<i>Acer negundo</i>)	85	Poor: decay and fungal bodies at base; lean to northwest; woodpecker activity in canopy
21	Manitoba maple (<i>Acer negundo</i>)	27	Poor: top has been removed – only sprouts remain as canopy
22	Black locust (<i>Robinia pseudoacacia</i>)	53	Poor: Very little live canopy
23	Black locust (<i>Robinia pseudoacacia</i>)	43	Poor: large wound on trunk – decay present
24	Manitoba maple (<i>Acer negundo</i>)	24	Poor: crack in trunk; lean to northeast
25	Norway maple (<i>Acer platanoides</i>)	66, 43	Poor: canker on smaller stem; decay at main union – 10cm deep hole – small crack from this hole to base; large branch stub
G1	Norway and Manitoba maples (<i>A. negundo</i> & <i>A. platanoides</i>)	12 stems 8-29cm	Fair: young trees, mostly vigorous; growing on slope, shaded

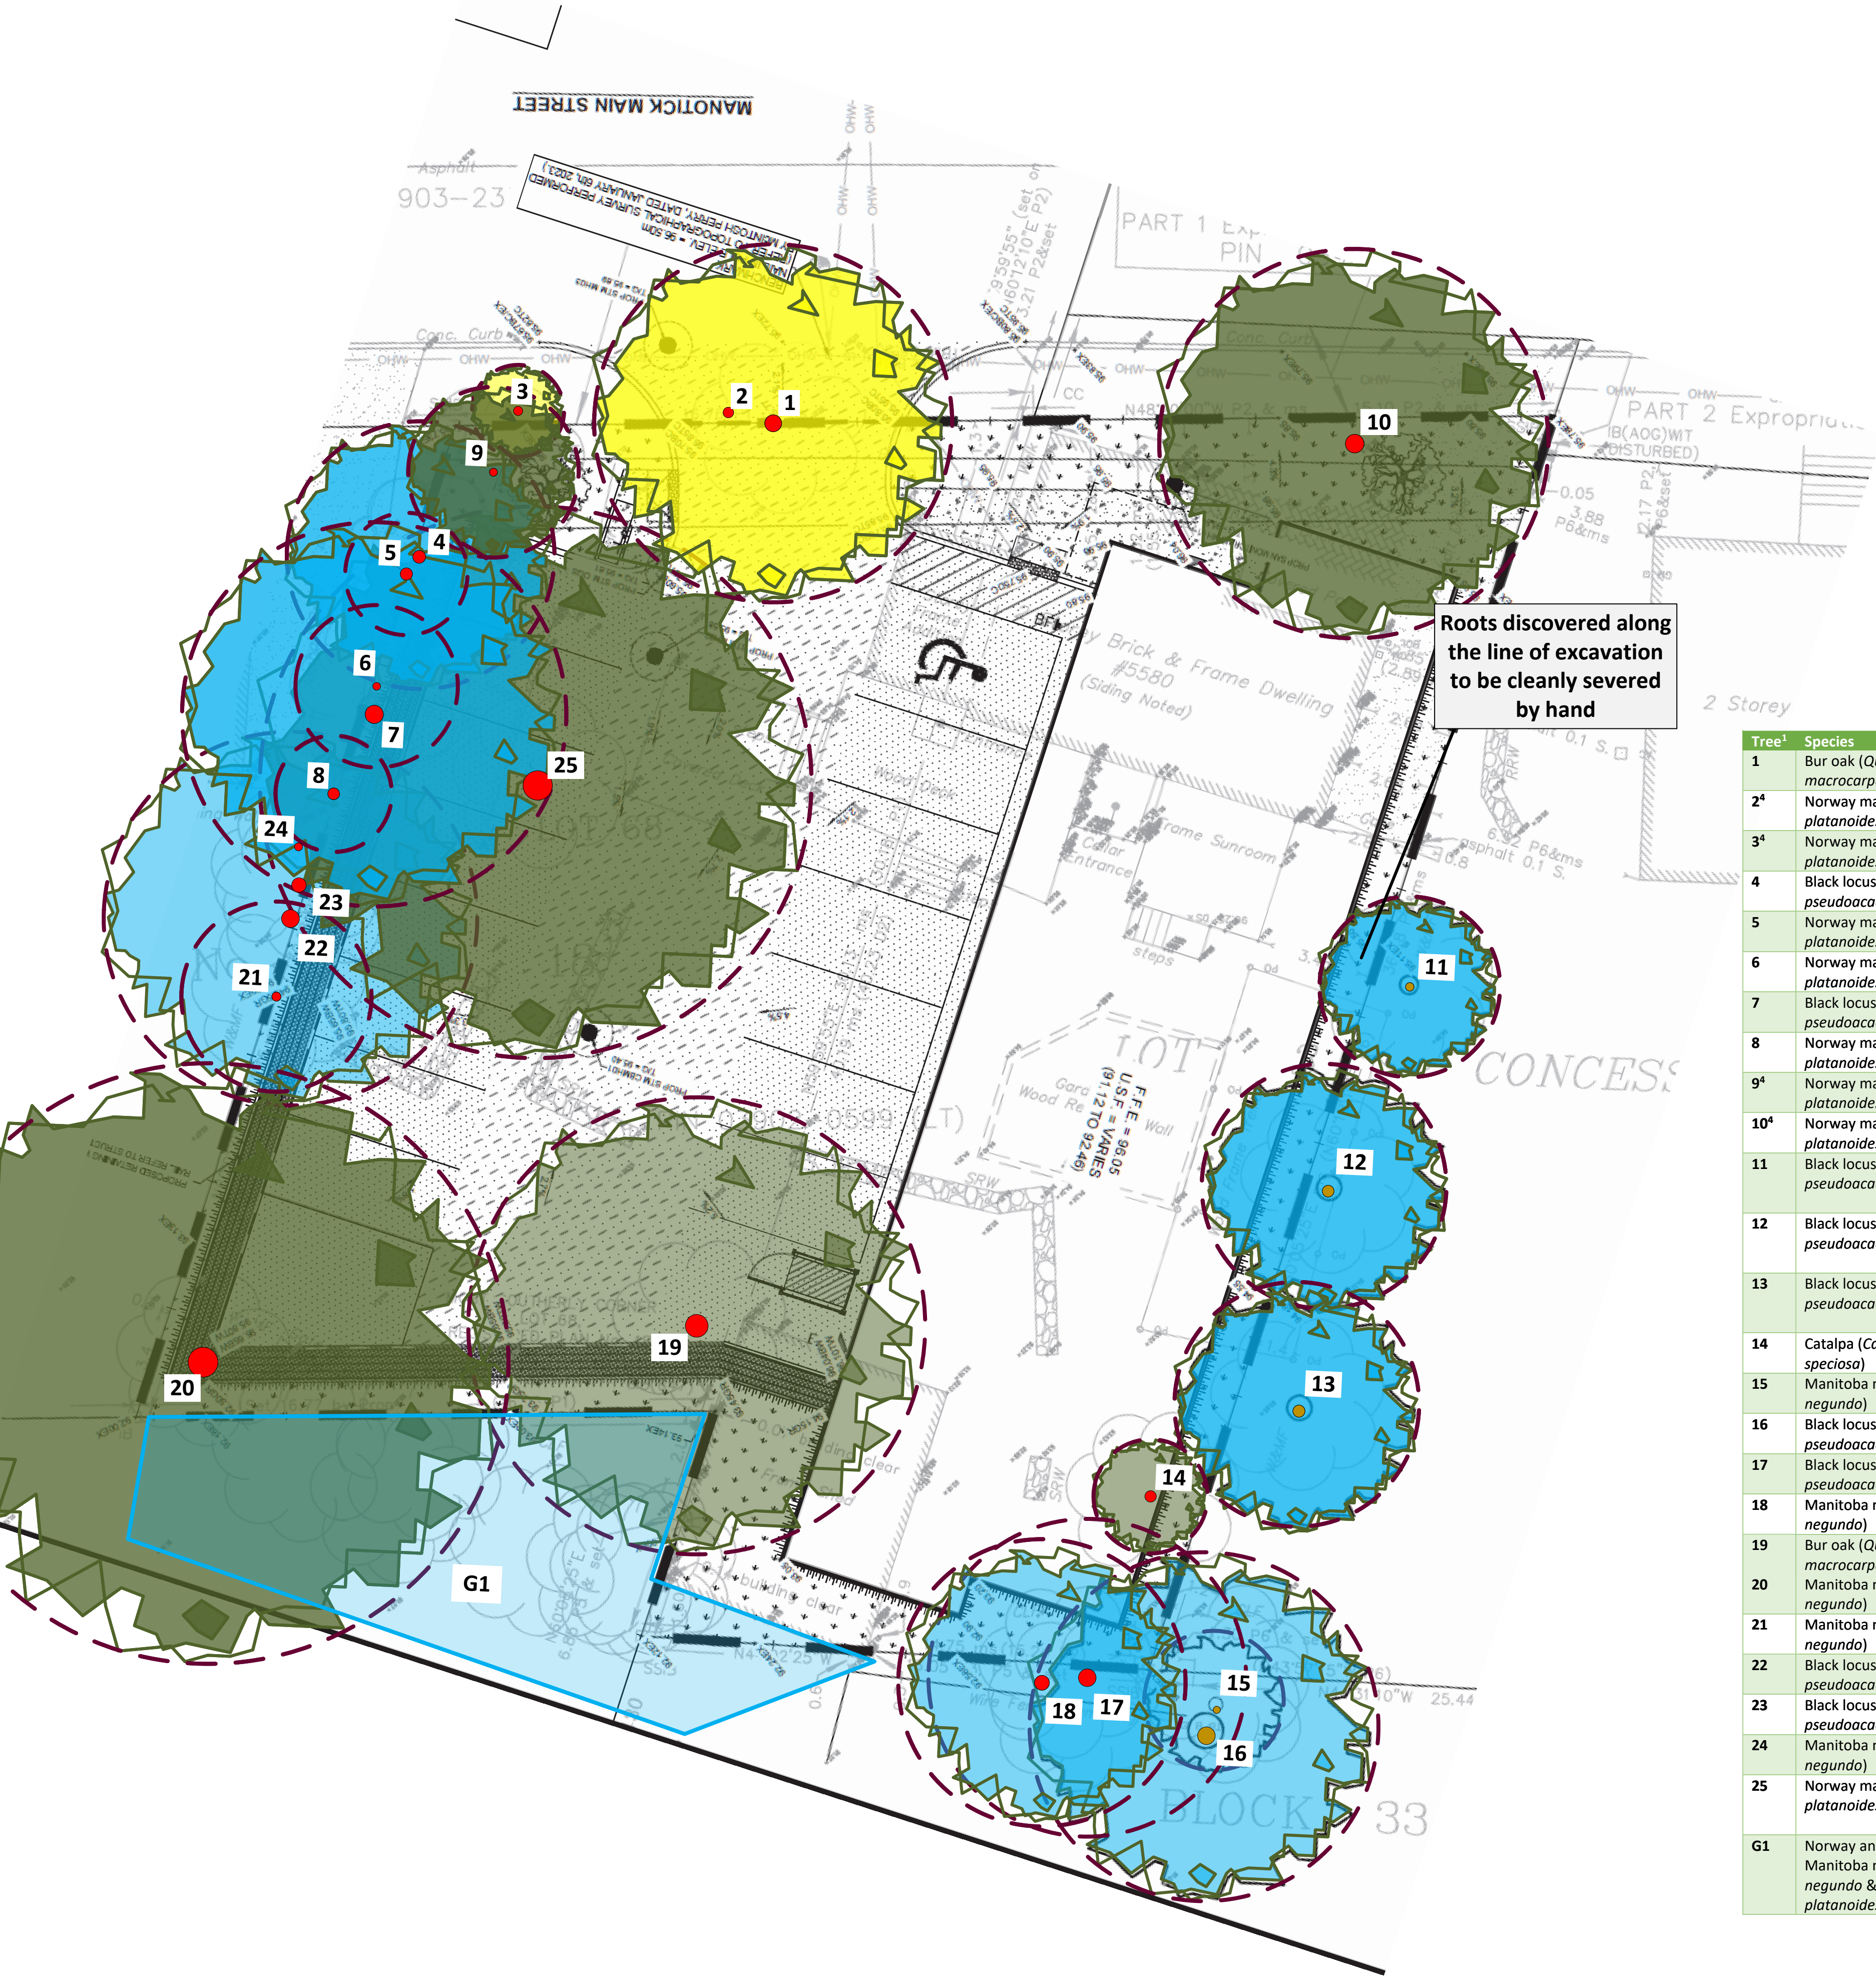
TCR Map #2 – 5580 Manotick Main

Tree ¹	Species	DBH (cm)	Tree Condition	Forester recommendation
1	Bur oak (<i>Quercus macrocarpa</i>)	51	Fair: pruned around wires – asymmetrical crown – pruning wounds with decay – epicormic shoots	Remove – in line with proposed entryway.
2 ^a	Norway maple (<i>Acer platanoides</i>)	8	Good/Fair: leaning to road for sunlight	Remove – in line with proposed entryway.
3 ^a	Norway maple (<i>Acer platanoides</i>)	7, 5, 6, 8	Fair/Poor: stems are sprouts from old stump; leaning heavily; growing under wires	Remove due to health status.
4	Black locust (<i>Robinia pseudoacacia</i>)	38	Fair: poor growing location; crowded	Remove – opportunities to retain may be explored during site works.
5	Norway maple (<i>Acer platanoides</i>)	17	Fair: young and vigorous; poor growing location; suppressed by larger trees	Remove – opportunities to retain may be explored during site works.
6	Norway maple (<i>Acer platanoides</i>)	23	Fair: young and vigorous; poor growing location; suppressed by larger trees	Remove due to grade changes to install parking.

7	Black locust (<i>Robinia pseudoacacia</i>)	54	Fair: codominant stems @1.5m – included bark at union; dead branches; poor growing location	Remove due to grade changes to install parking.
8	Norway maple (<i>Acer platanoides</i>)	16	Fair: young and vigorous; poor growing location; suppressed by larger trees	Remove due to grade changes to install parking.
9 ^a	Norway maple (<i>Acer platanoides</i>)	24	Poor: growing around roof of shed	Remove due to growing conditions and site works.
10 ^a	Norway maple (<i>Acer platanoides</i>)	55	Poor/Fair: canker in canopy; slight lean to west; poor form at base; large dead branch	Remove due to health status and grading requirements.
11	Black locust (<i>Robinia pseudoacacia</i>)	25	Fair/Poor: grade raised around base; wound – possibly canker	Retain - approximately 1.5m from excavation – any roots encountered are to be cleanly severed along the line of excavation.

12	Black locust (<i>Robinia pseudoacacia</i>)	35	Fair/Good: dead branches in canopy; pruning wounds	Retain - approximately 1.2m from excavation – any roots encountered are to be cleanly severed along the line of excavation.
13	Black locust (<i>Robinia pseudoacacia</i>)	30, 18 (estimate)	Fair/Poor: many dead branches; possible canker on trunk	Retain - approximately 2.4m from excavation – any roots encountered are to be cleanly severed along the line of excavation.
14	Catalpa (<i>Catalpa speciosa</i>)	16	Fair: lean and asymmetrical crown to south; broken branches	Remove – within excavation area
15	Manitoba maple (<i>Acer negundo</i>)	20 (estimate)	Fair/Poor: heavy lean south; growing into Tree 16; sprouts at base; growing on slope	Retain. No action required.
16	Black locust (<i>Robinia pseudoacacia</i>)	40, 30 (estimate)	Poor: very little live canopy remaining; lean to south	Retain. No action required.

17	Black locust (<i>Robinia pseudoacacia</i>)	45 (estimate)	Fair/Poor: very little live canopy remaining	Remove due to health status and proximity of excavation. Permission required from neighbor for removal.
18	Manitoba maple (<i>Acer negundo</i>)	40 (estimate)	Fair: heavy lean northwest; vigorous growth	Remove due to proximity of excavation. Permission required from neighbor for removal.
19	Bur oak (<i>Quercus macrocarpa</i>)	65	Good/Fair: some crossing branches; branch stubs from pruning with epicormic shoots	Remove – in line with proposed parking.
20	Manitoba maple (<i>Acer negundo</i>)	85	Poor: decay and fungal bodies at base; lean to northwest; woodpecker activity in canopy	Remove – in line with proposed parking.
21	Manitoba maple (<i>Acer negundo</i>)	27	Poor: top has been removed – only sprouts remain as canopy	Remove due to grade changes to install parking.
22	Black locust (<i>Robinia pseudoacacia</i>)	53	Poor: Very little live canopy	Remove due to grade changes to install parking.

23	Black locust (<i>Robinia pseudoacacia</i>)	43	Poor: large wound on trunk – decay present	Remove due to grade changes to install parking.
24	Manitoba maple (<i>Acer negundo</i>)	24	Poor: crack in trunk; lean to northeast	Remove due to grade changes to install parking.
25	Norway maple (<i>Acer platanoides</i>)	66, 43	Poor: canker on smaller stem; decay at main union – 10cm deep hole – small crack from this hole to base; large branch stub	Remove due to health status and impacts from construction – in line with proposed parking.
G1	Norway and Manitoba maples (<i>A. negundo</i> & <i>A. platanoides</i>)	12 stems 8-29cm	Fair: young trees, mostly vigorous; growing on slope, shaded	Retain to provide canopy coverage after construction. Grade changes not to occur past property line.
