# Tree Conservation Report 424 Churchill Avenue North Ottawa, Ontario

Prepared for GSI Properties  
By Arcadis IBI Group  
June 26, 2025

## Tree Conservation Plan TPP-1 and TPP-2

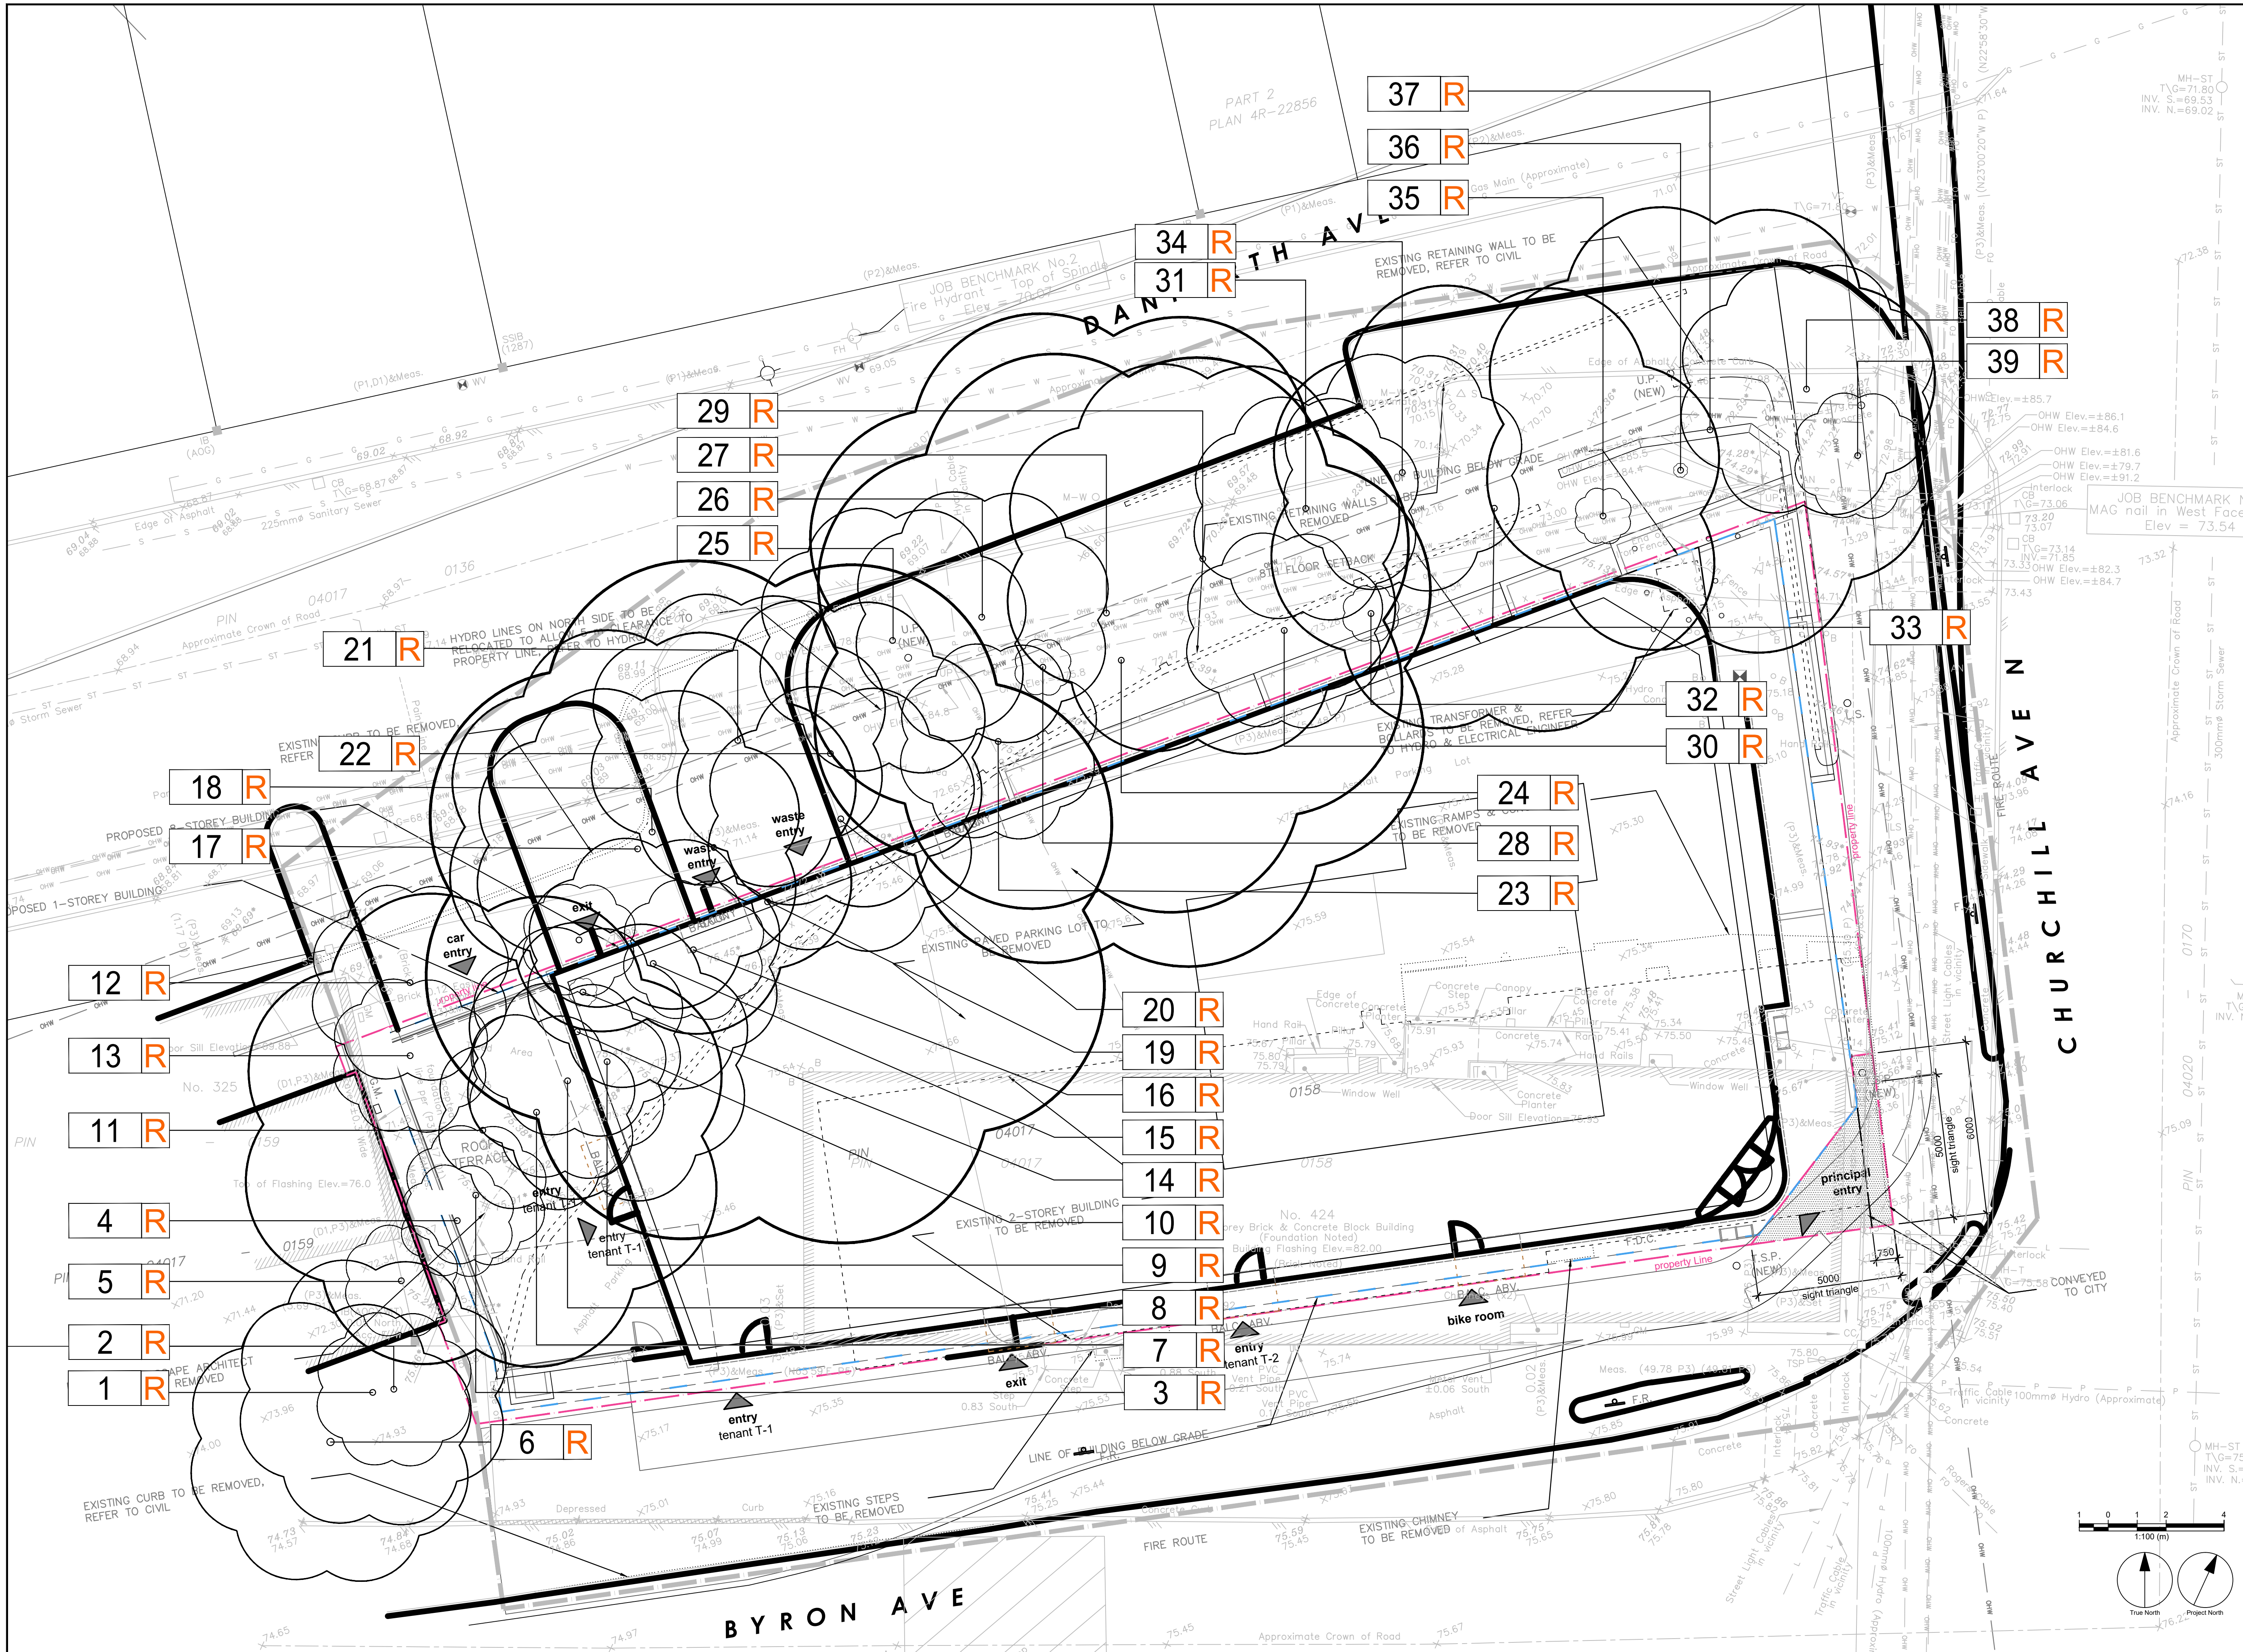
**Table 1 - Existing Tree Inventory**  
424 Churchill, Ottawa, Ontario

The limits of TPF have been indicated on the Tree Conservation Plan sheet TPP-1 and shall be considered to delineate the limits of work. All TPF shall conform to the City of Ottawa's current standards and Tree Protection Specification as shown on Detail 1-TPP2.
