Muncaster  
Environmental  
Planning Inc.

September 2, 2025

**RE: 2983 Navan Road (at Brian Coburn Boulevard)**  
**Block 16 (Gas Station) - Review of Boundary Trees - Updated**

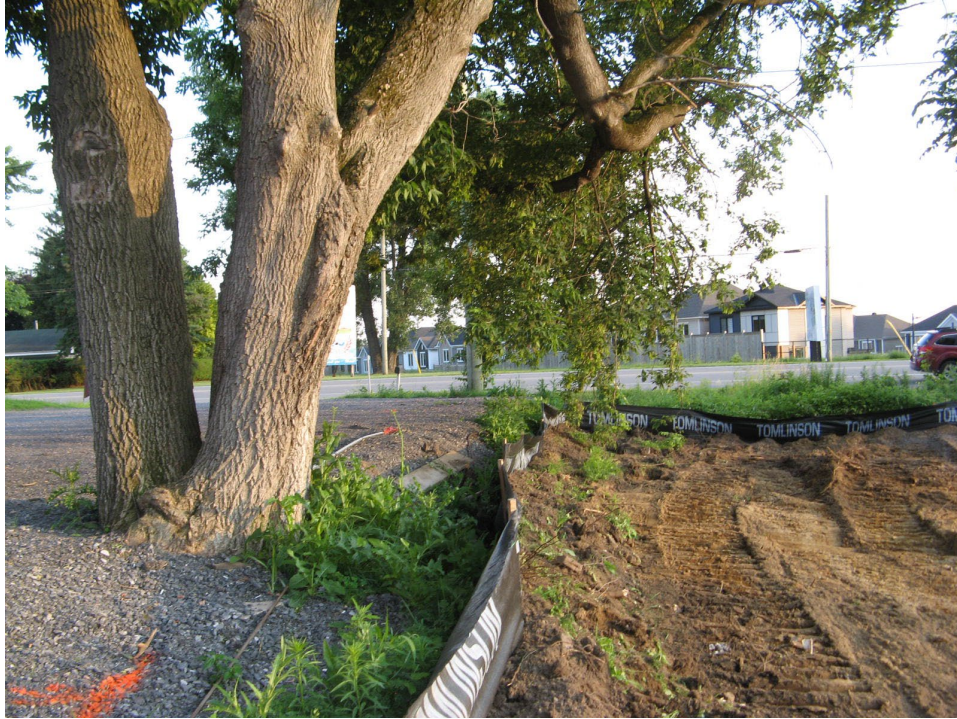
| Tree Letter | Species | dbh (cm) | Condition and Comments | Location |
|---|---|---|---|---|
| A | Manitoba maple<br>(Photos 1, 2, and 3) | 50 and 56 | Twin stem. Major trunk damage at base of east stem but leaf-out is good. The dominant leaders are in good condition for a mature Manitoba maple. Adjacent property owner prefers retention of the tree. No root exposure of note following adjacent initial regrading on site. Gravel fill from the adjacent development property surrounds the trunk (Photo 1), with minor trunk damage at base | Co-owned. Silt fencing to the west of the tree |

*Photo 1 – Co-owned Tree ‘A’, with view looking south to Navan Road*

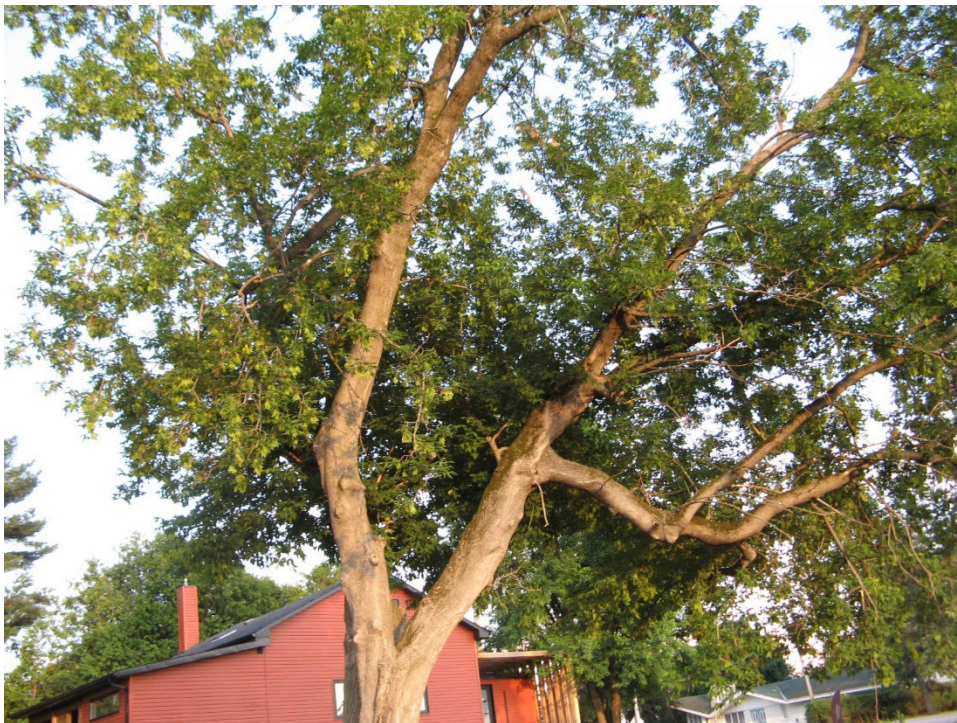
*Photo 2 – Another view of Tree ‘A’, view looking east*

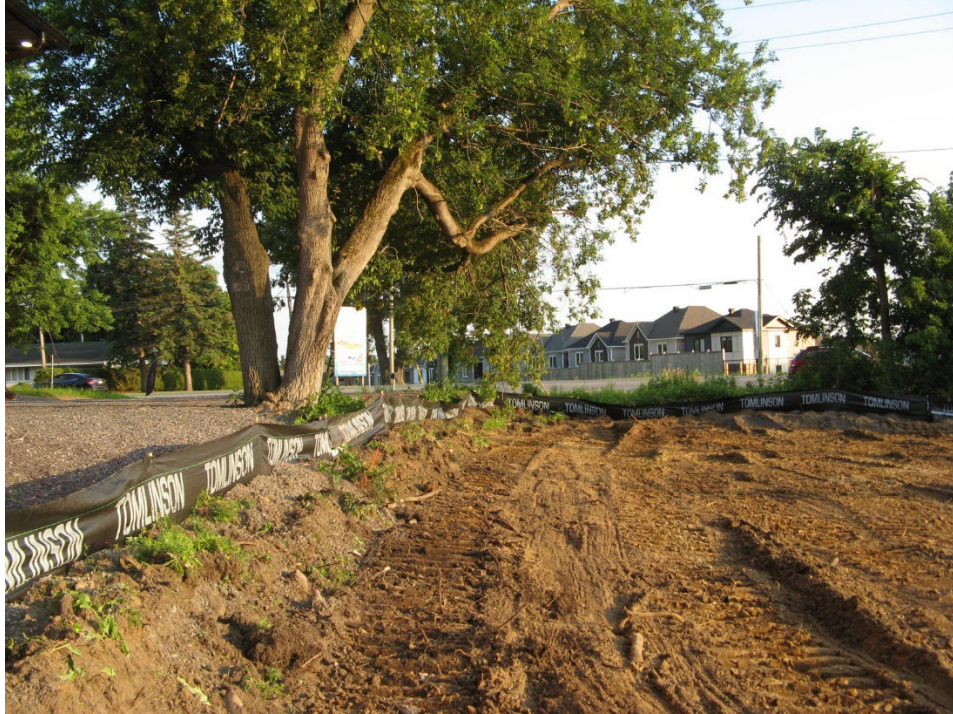
*Photo 3 – Silt fencing and initial regrading adjacent to Tree ‘A’.  
View looking south to Navan Road*

One co-owned tree is present on the west side of 2993 Navan Road. This mature Manitoba maple will be retained and is protected with silt fencing. The impacts on the critical root system are not anticipated to be significantly harmful over time. As part of the regrading, topsoil is to be added over the current surface as the surface elevation is matched at the property line.

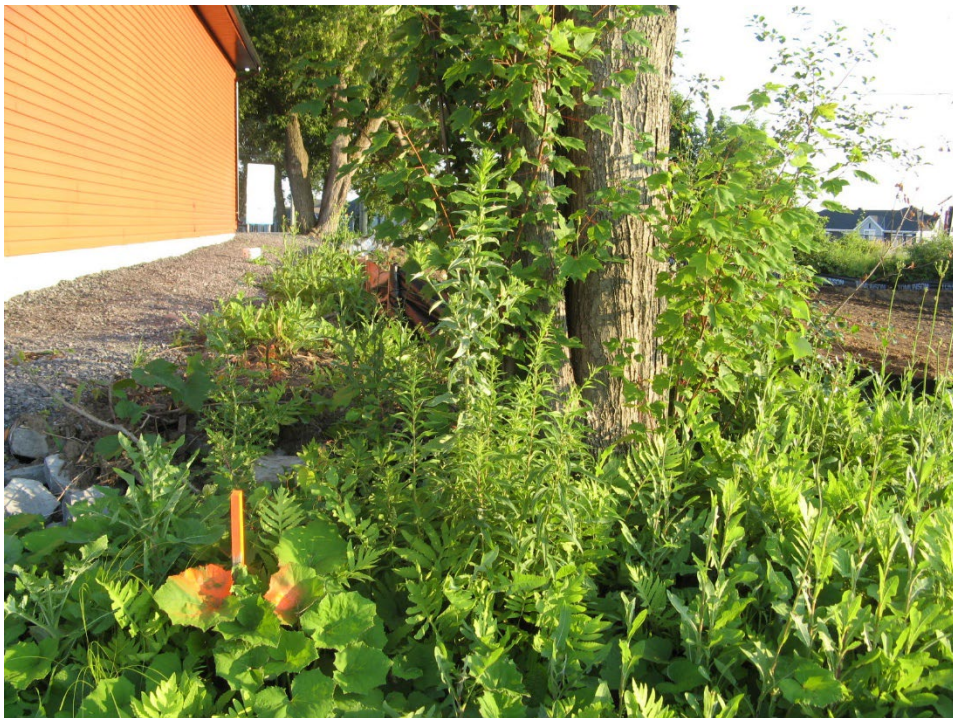
| Tree Letter | Species | dbh (cm) | Condition and Comments | Location |
|---|---|---|---|---|
| B | Red maple | 42 | Appears to be in good condition, with good leaf-out. Protected with silt fencing during initial regrading and no root exposure of note observed. | On-site, to be removed (Photo 4) |

*Photo 4 - Tree ‘B’, showing on-site location relative to stake on property line.  
View looking south*

Trees 'B' and 'E' are on-site but were not removed as the trees could not be accessed at the time of the tree removal. This material has now been removed and the trees will be removed as part of the subdivision development.

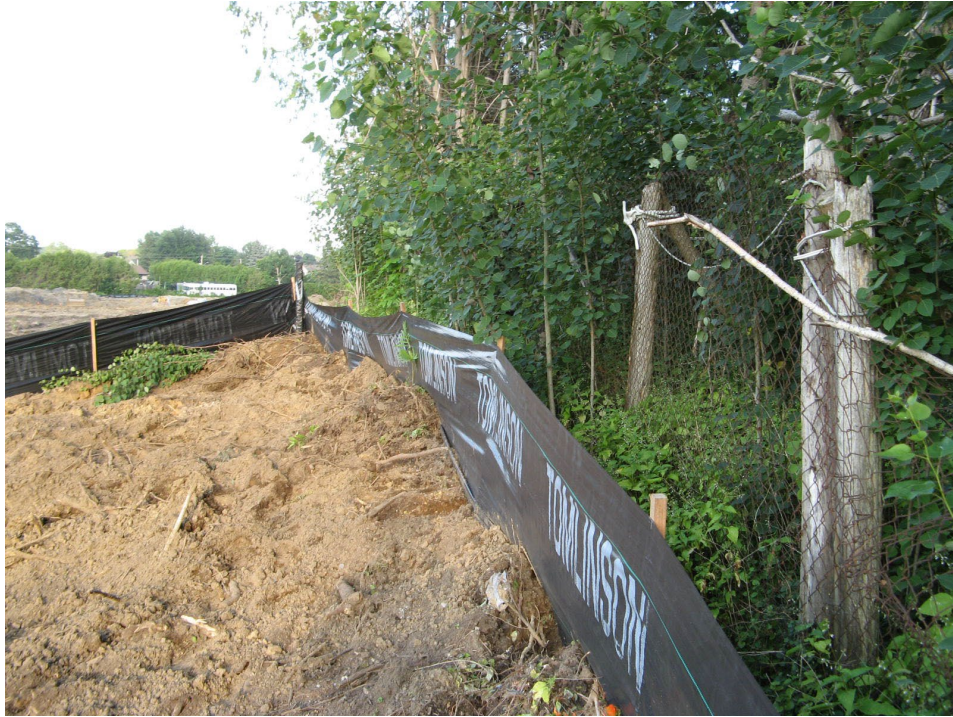
*Photo 5 – Typical initial regrading and silt fencing adjacent to the rear (north) of 2993 and 2997 Navan Road. View looking east*

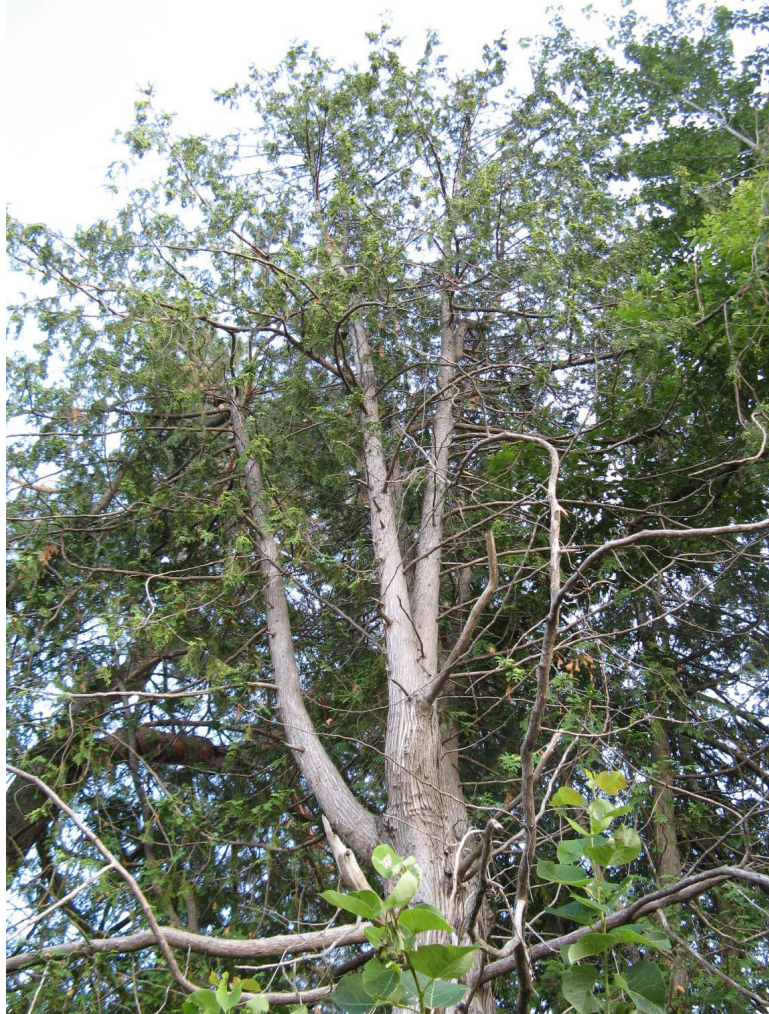
| Tree Letter | Species | dbh (cm) | Condition and Comments | Location |
|---|---|---|---|---|
| F | White cedar (Photo 6) | 42 | Some exposure of roots up to 4 cm following adjacent on-site initial regrading. Lacks a dominant leader and many of the lateral branches have poor needle coverage. | 2.5m south of site, with additional 60cm to silt fencing |

*Photo 6 – White cedar Tree ‘F’ at the rear of 2997 Navan Road. View looking south*

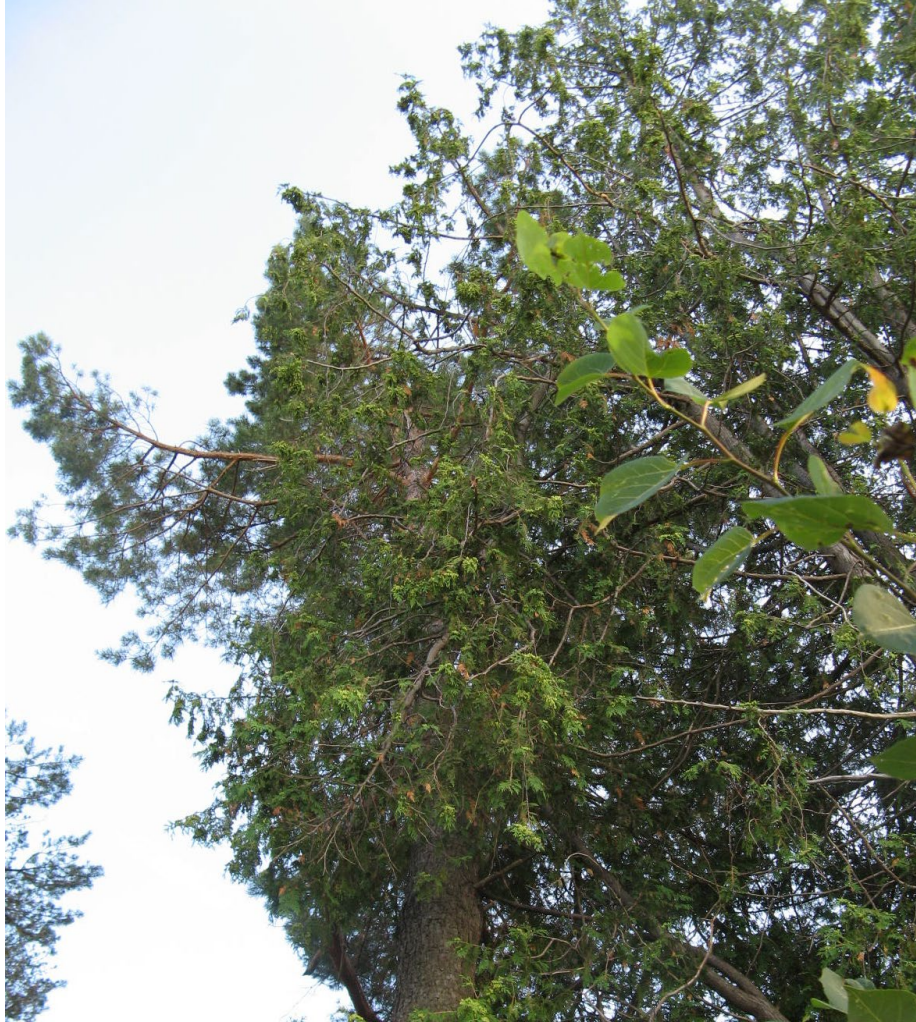
| Tree Letter | Species | dbh (cm) | Condition and Comments | Location |
|---|---|---|---|---|
| G | Scot's pine (Photo 7) | 40 | Good needle coverage and structure, with some trunk leaning. No root exposure of note after adjacent on-site initial regrading | 3cm south of site, with additional 70cm to silt fencing |

*Photo 7 – Scot's pine Tree 'G' at the rear of 2997 Navan Road. View looking southeast*
