# 110394936 CANADA INC.

## Tree Conservation Report

2940, 2944, and 2946 Baseline Road

CIMA+ file number: A0000180  
September 24, 2025 – Review 004

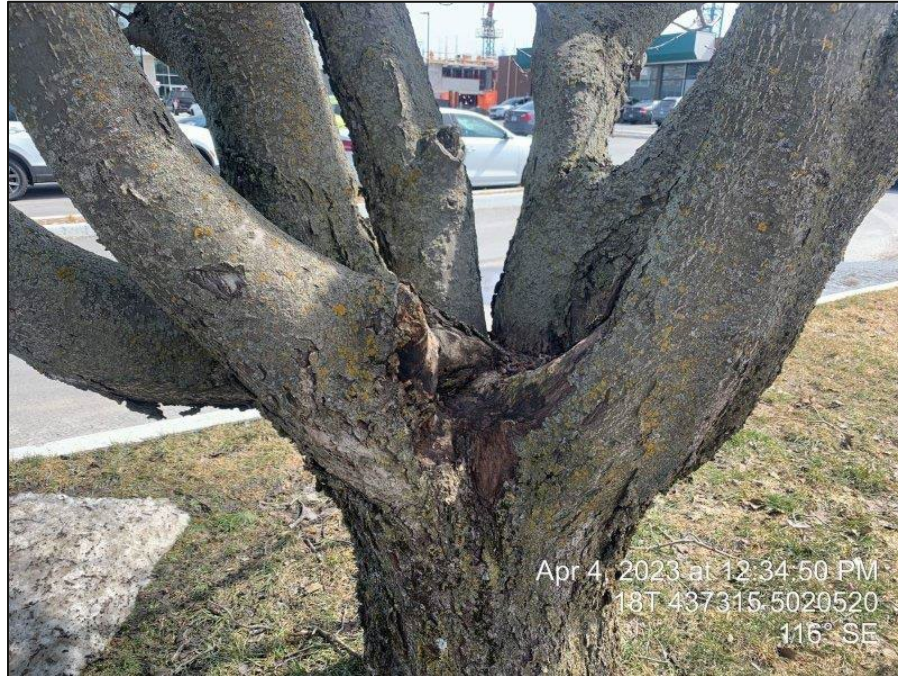
It should be noted that the one (1) oakleaf mountain ash (Tree #14 - **Appendix A**) was assessed as Fair due to its poor structure and crotch decay. The City has requested that this tree be retained. **Photo 1** below displays the deficiencies of this individual.

*Photo 1: View of the crotch decay and poor structure of Tree #14 – Oakleaf Mountain Ash*

| Tree/Tree Group No. | Common Name | Scientific Name | No. Stems | dbh (cm) | Height (m) | Crown Spread (m) | Structural Defects <sup>i</sup> | | | | | | | | Overall Condition <sup>ii</sup> | Comments | Ownership | Recommendation | CRZ (m) |
|---|---|---|---|---|---|---|---|---|---|---|---|---|---|---|---|---|---|---|---|
| 14 | Oakleaf mountain ash | <i>Sorbus x thuringiaca</i> | 1 | 70 | 8-11 | 5 | <input checked="" type="checkbox"/> | <input checked="" type="checkbox"/> | <input checked="" type="checkbox"/> | <input checked="" type="checkbox"/> | <input checked="" type="checkbox"/> | <input checked="" type="checkbox"/> | <input checked="" type="checkbox"/> | <input type="checkbox"/> | Fair | Poor structure. Crotch decay. | Private 2946 Baseline Rd | Remove | 7 |
