**St. Lawrence Testing
& Inspection Co. Ltd.**
Report No. 25C272

**Appendix L
Site Reconnaissance Photographs**

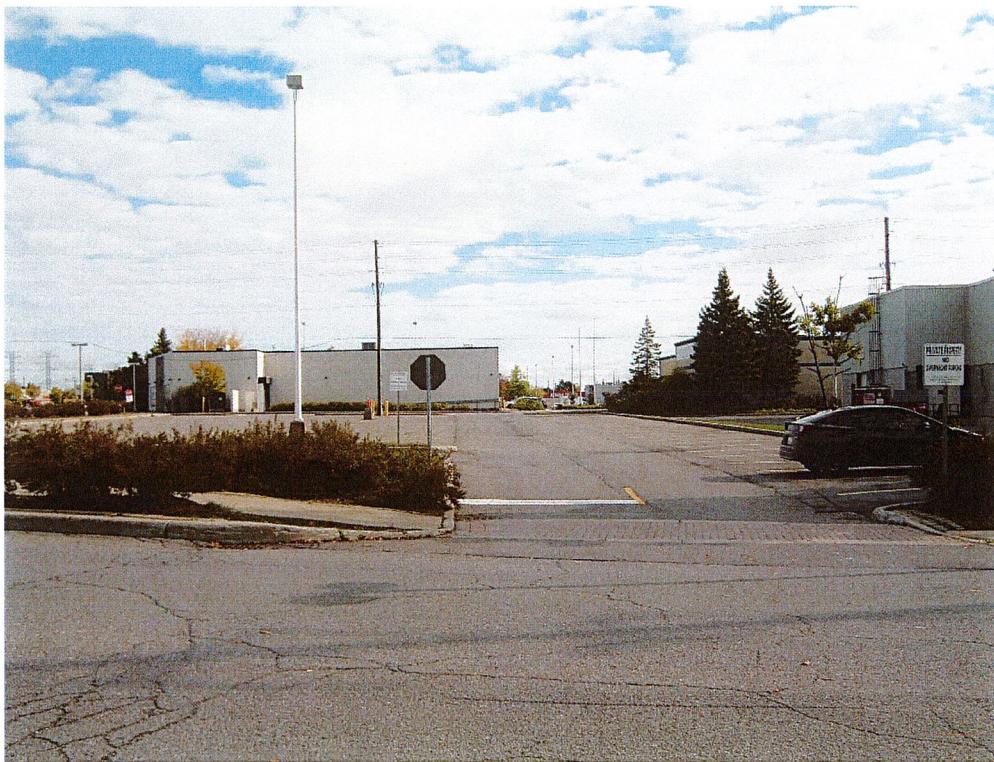
Photo 1: View of the Site property and entrance facing east off Lancelot Drive.

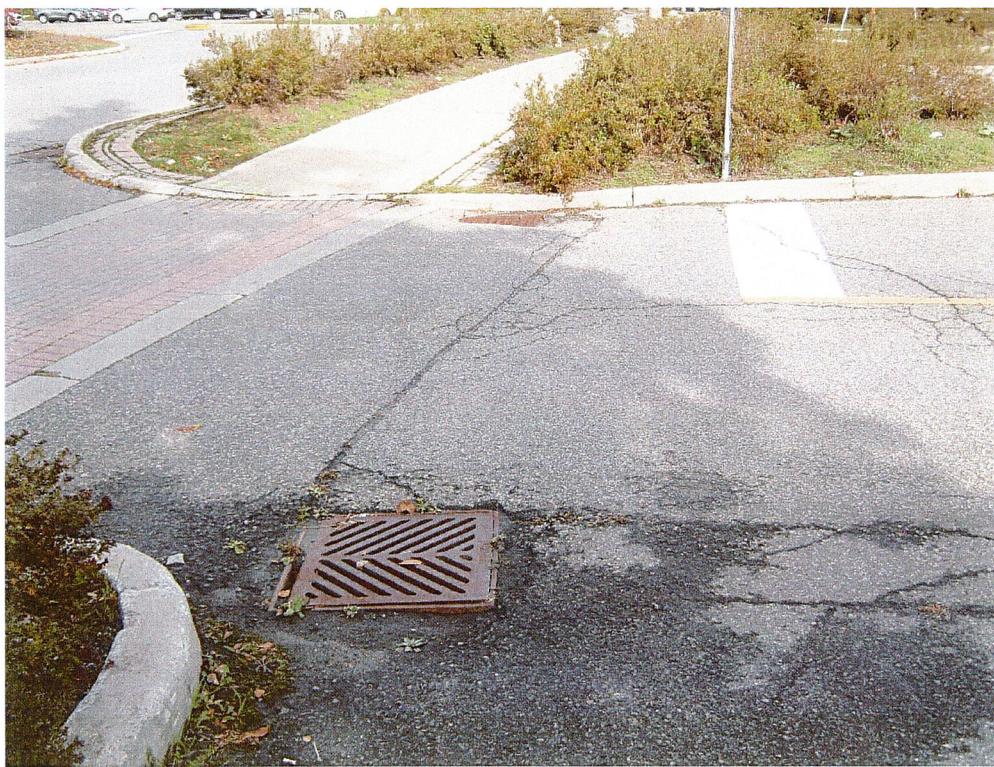
Photo 2: View facing north of 2 surface water catch basins located at the entrance onto the Site property off Lancelot Drive.

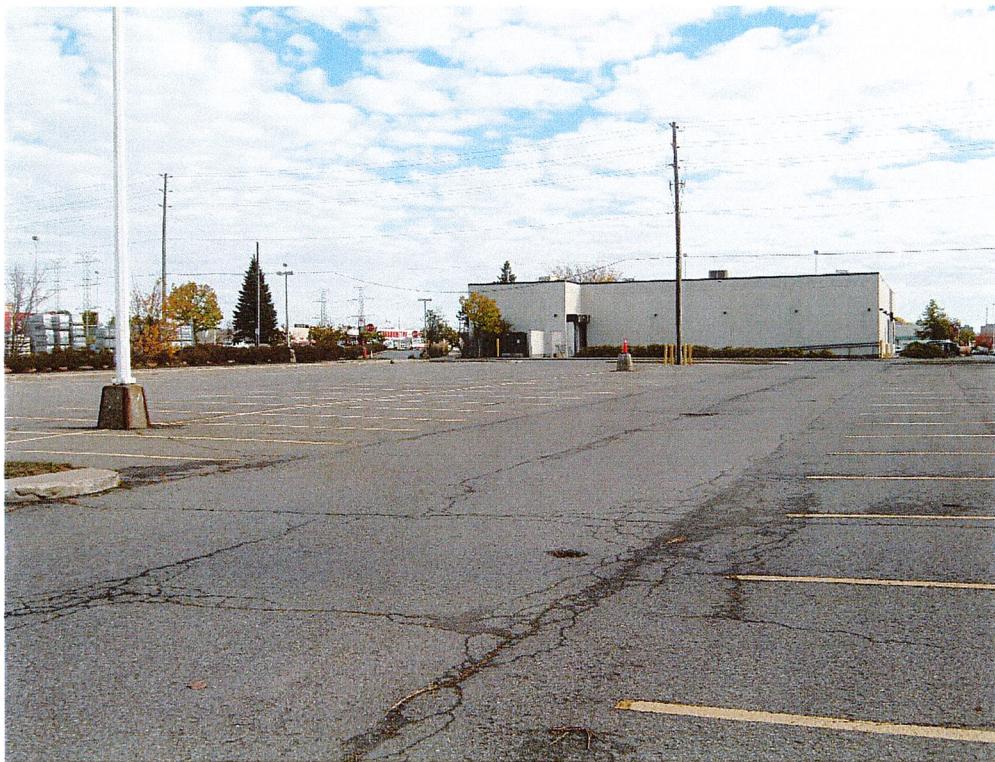
Photo 3: View facing northeast of the Site property.

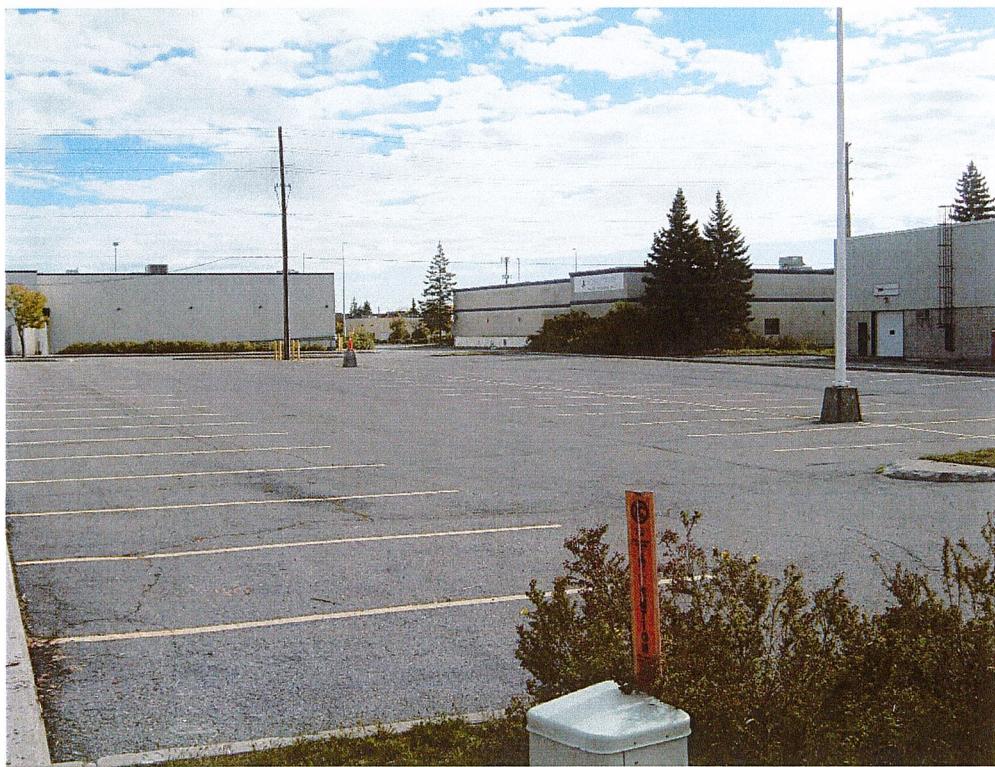
Photo 4: View facing southeast of the Site property.

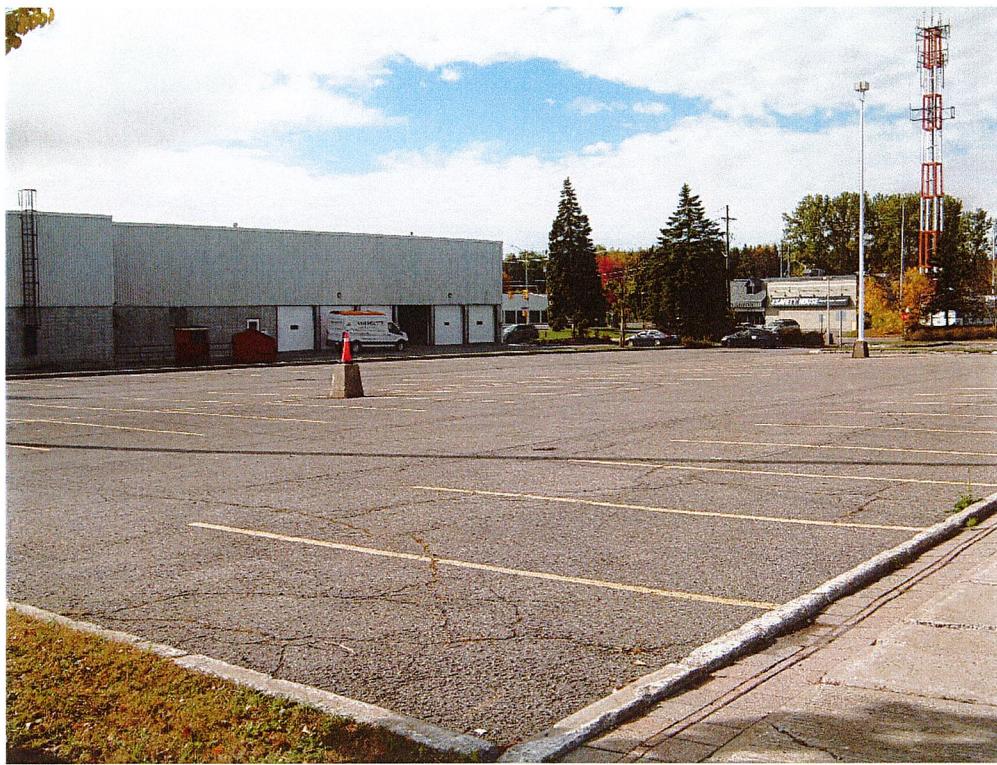
Photo 5: View facing southwest of the Site property.

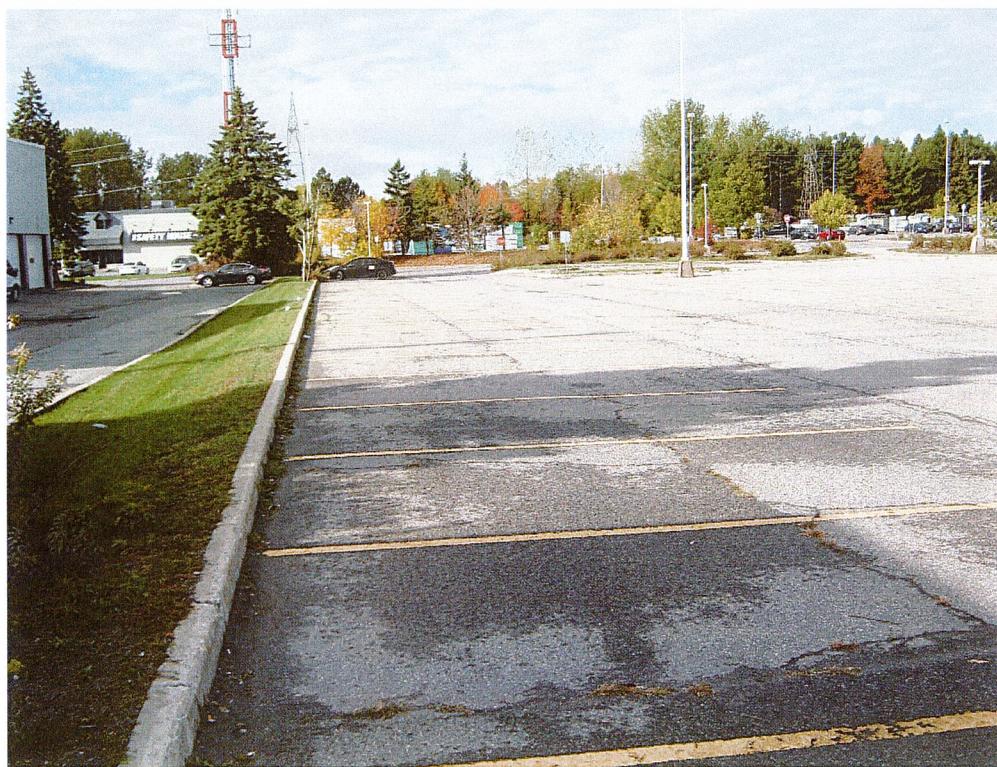
Photo 6: View of the south side of the Site property facing west.

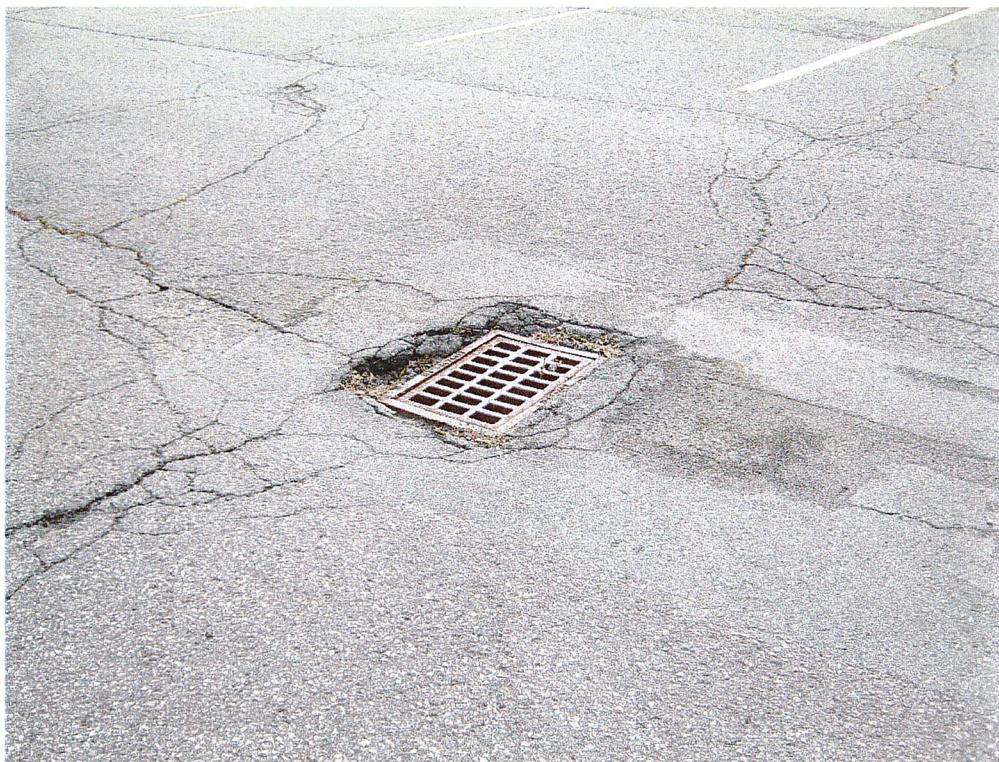
Photo 7: View of a surface water catch basin located within the Site property.

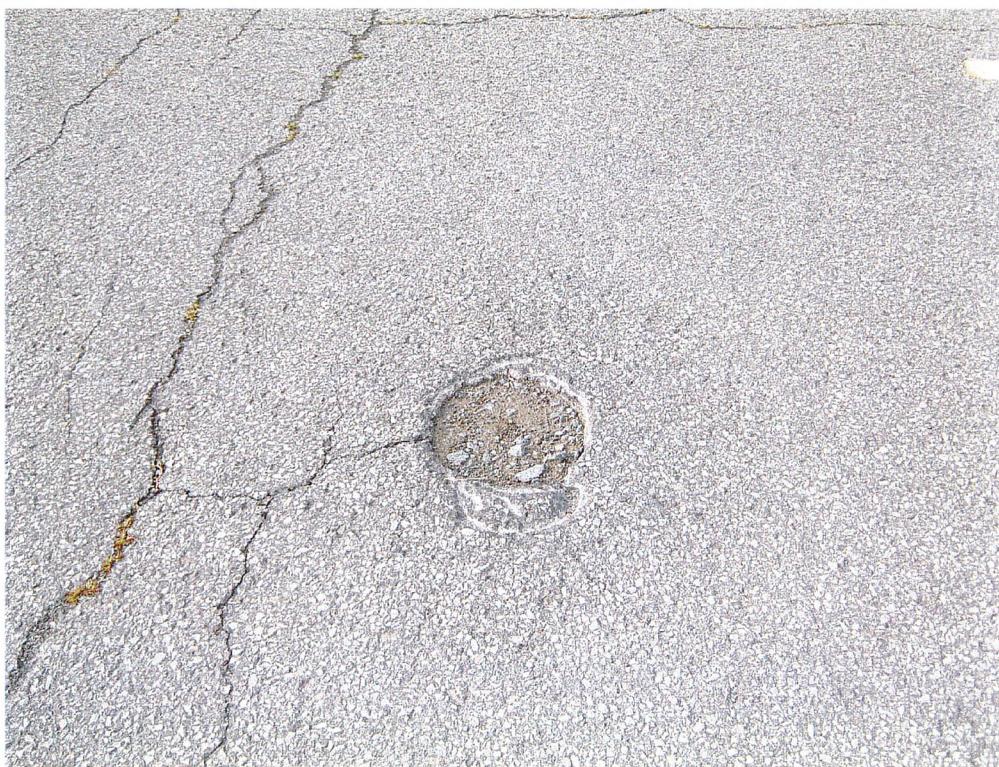
Photo 8: Evidence of previous borehole drilling on the Site property.

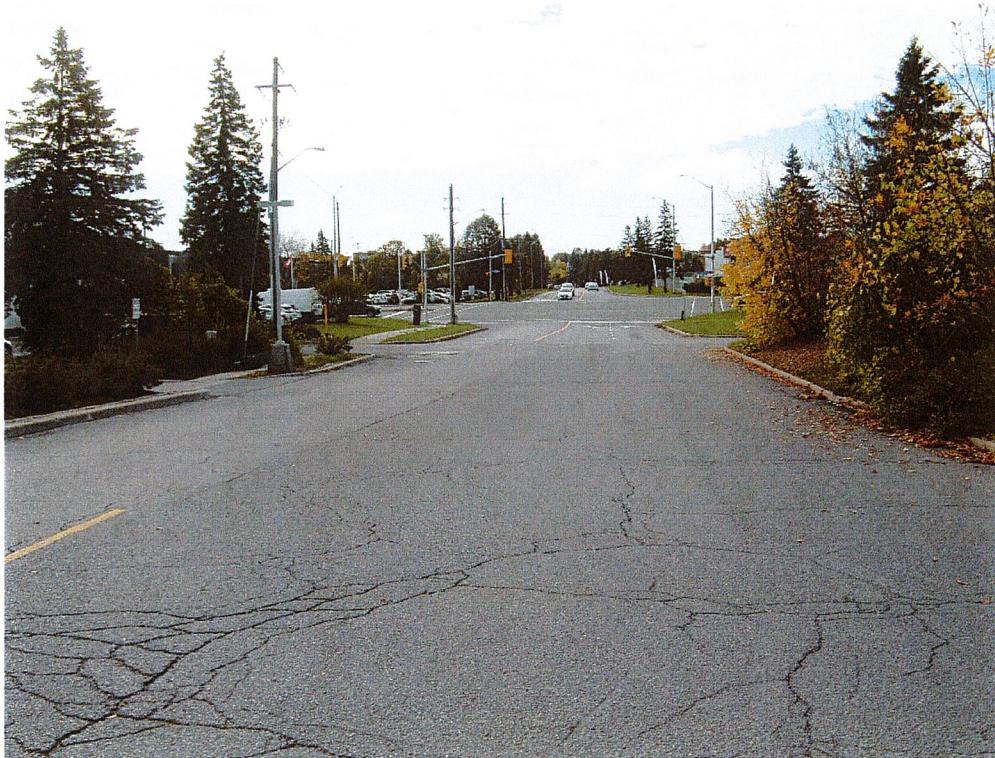
Photo 9: View facing south of Lancelot Drive located along the west side of the Site property.

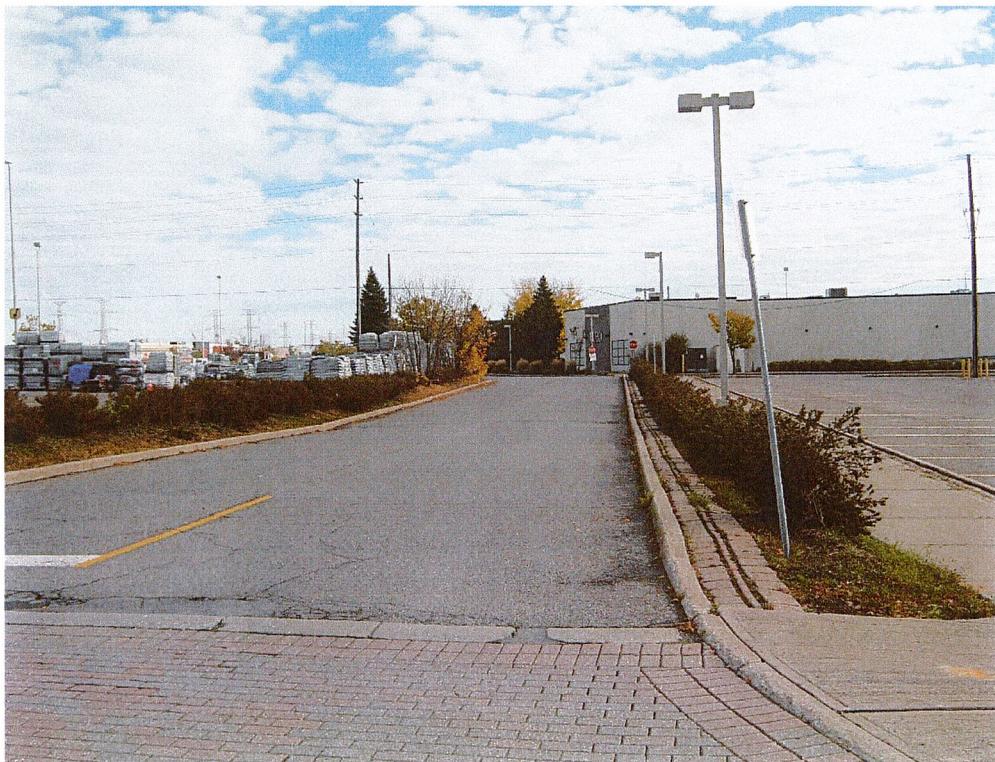
Photo 10: View facing east of the roadway located along the north side of the Site property. No access onto the Site can be made from this roadway.

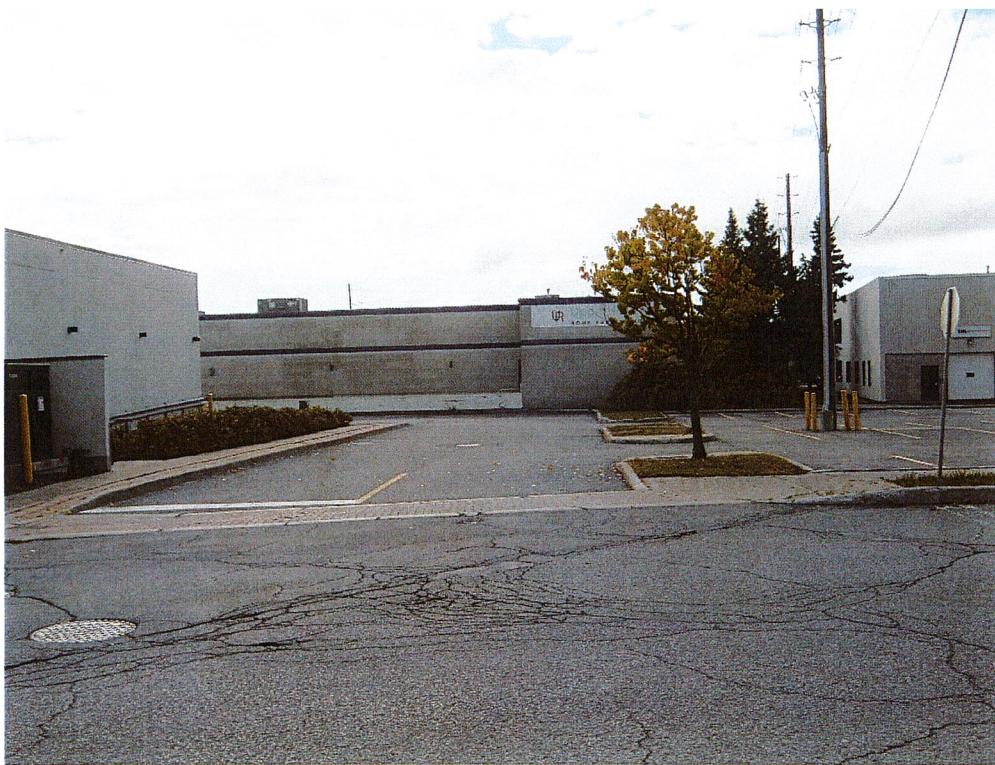
Photo 11: View facing south of the roadway located along the east side of the Site property. There are 2 entrances onto the Site from this roadway.

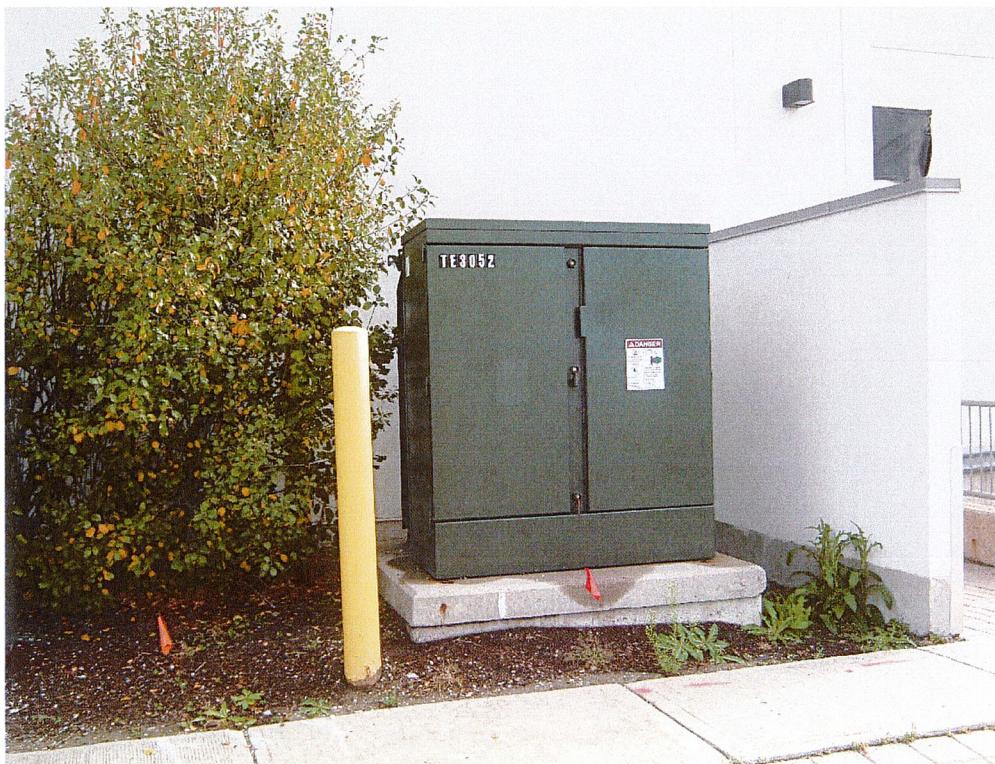
Photo 12: View of an electrical transformer located on the neighbouring LCBO property to the east.

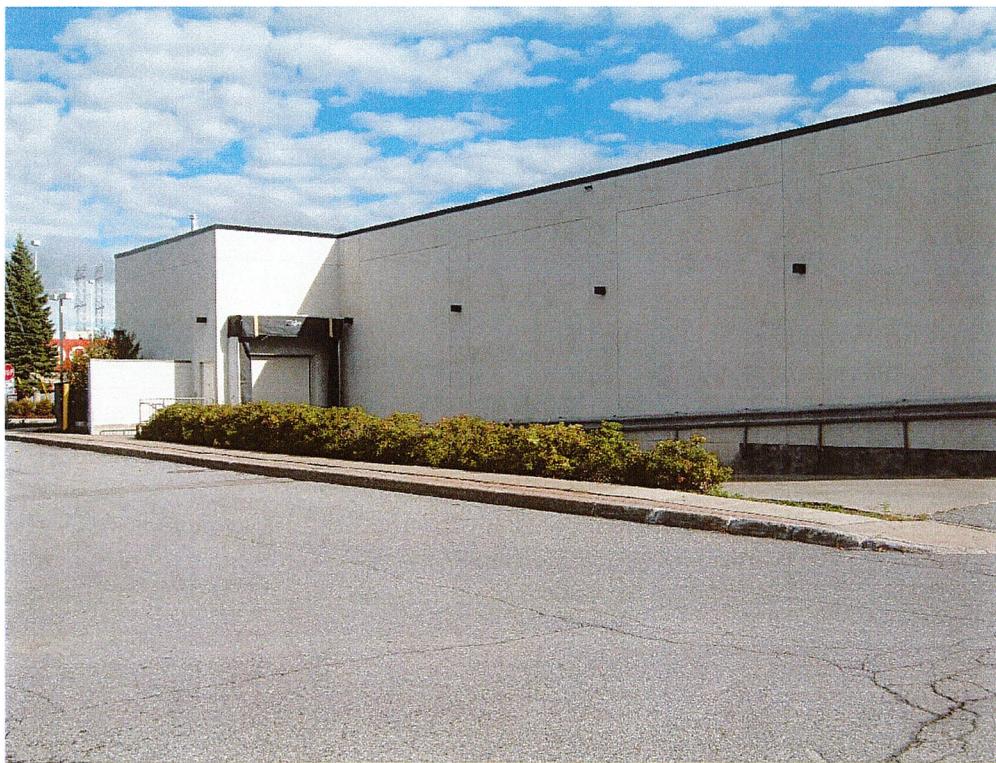
Photo 13: View facing northeast of the west side of the neighbouring LCBO property located to the east at 543 West Hunt Club Road.

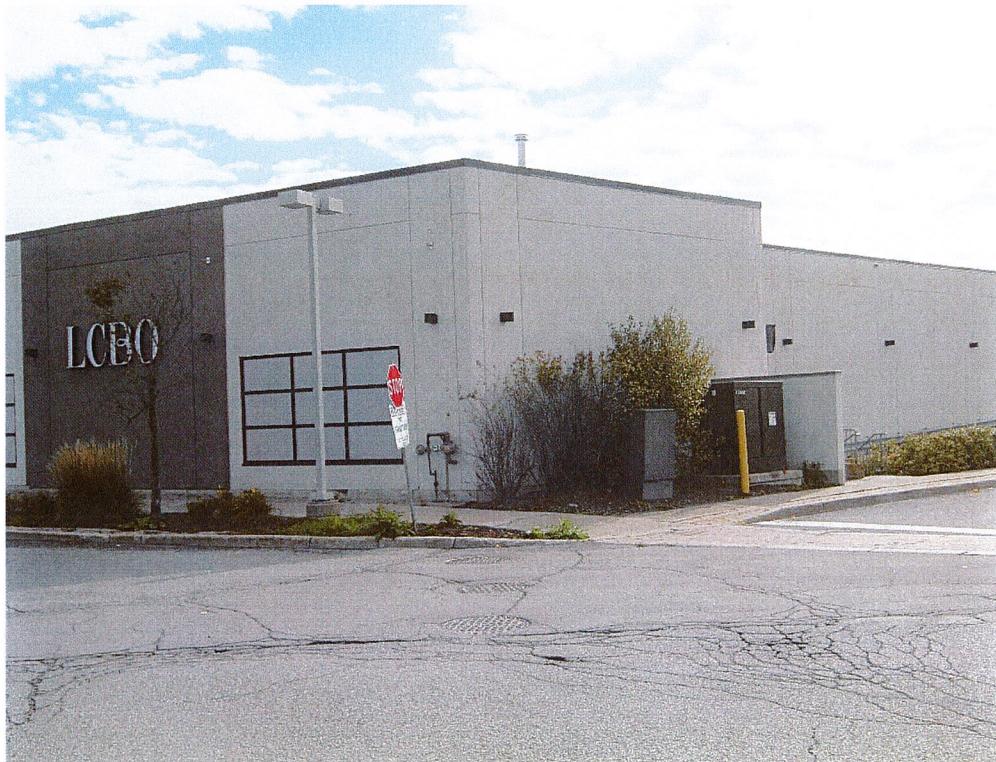
Photo 14: View facing southeast of the northwest corner of the neighbouring LCBO property located to the east at 543 West Hunt Club Road.

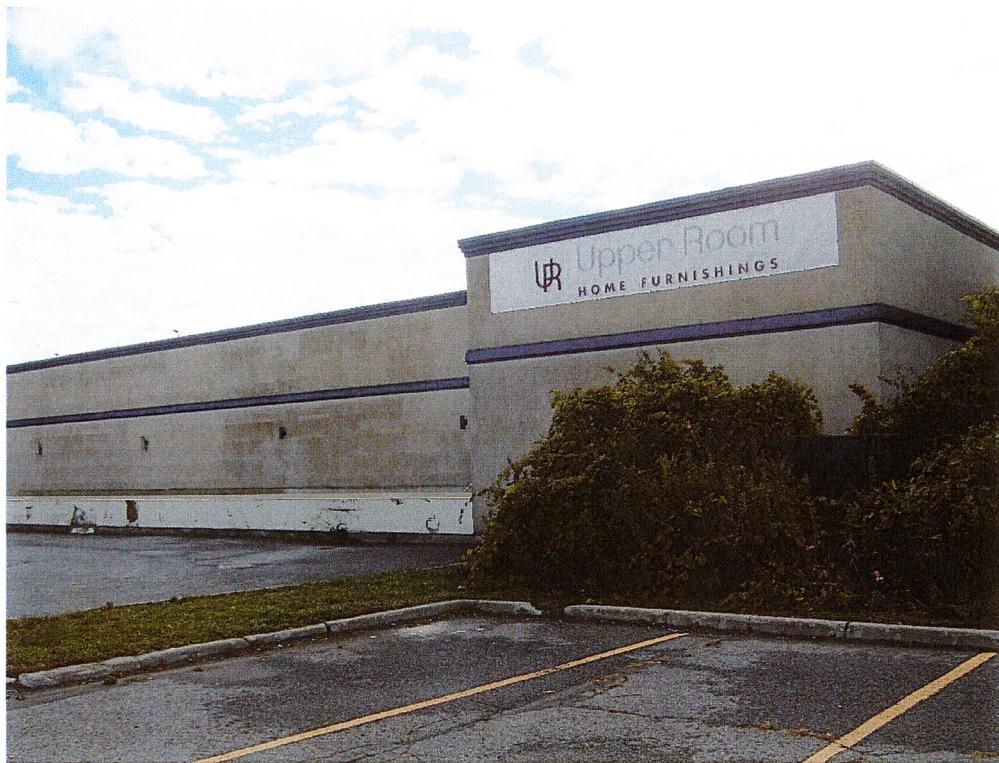
Photo 15: View facing southeast of the northwest corner of the neighbouring vacant furniture building located to the southeast of the Site.

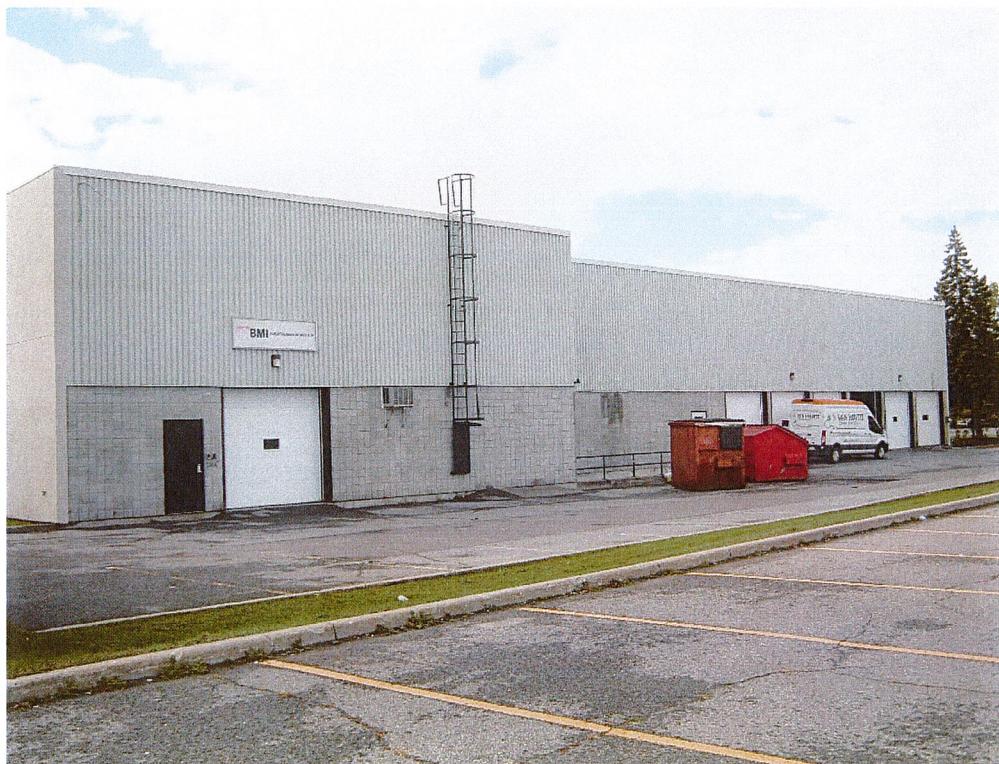
Photo 16: View facing southwest of the adjoining commercial building located to the south at 575 West Hunt Club Road.

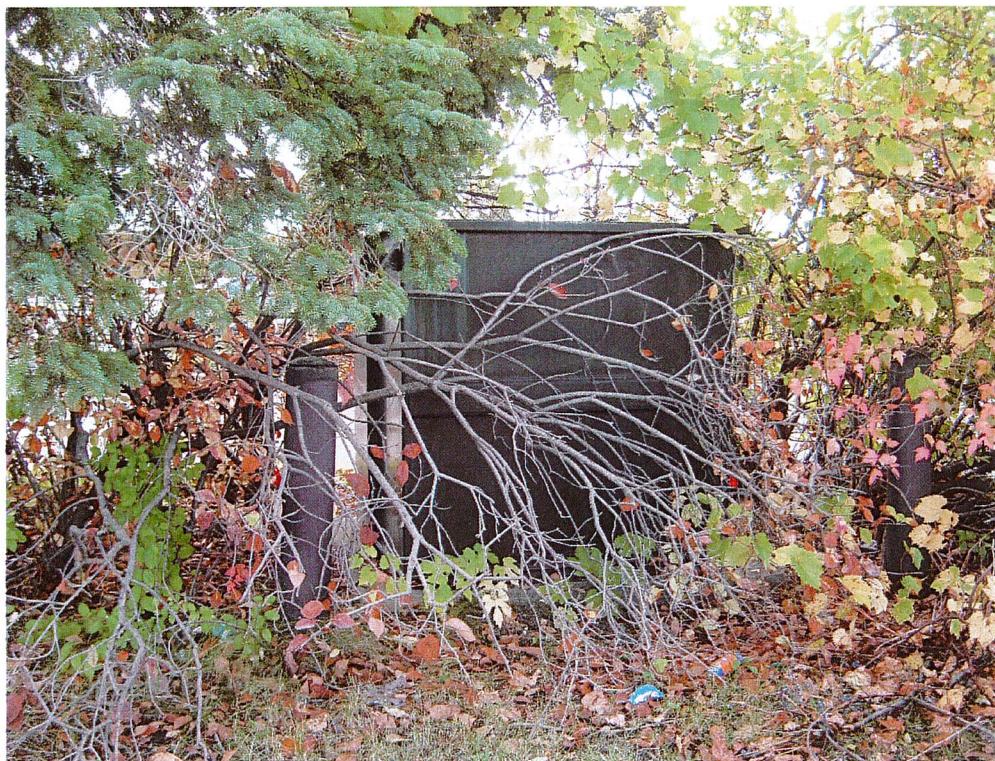
Photo 17: View facing south of an electrical transformer adjoining the Site property and located at 575 West Hunt Club Road.

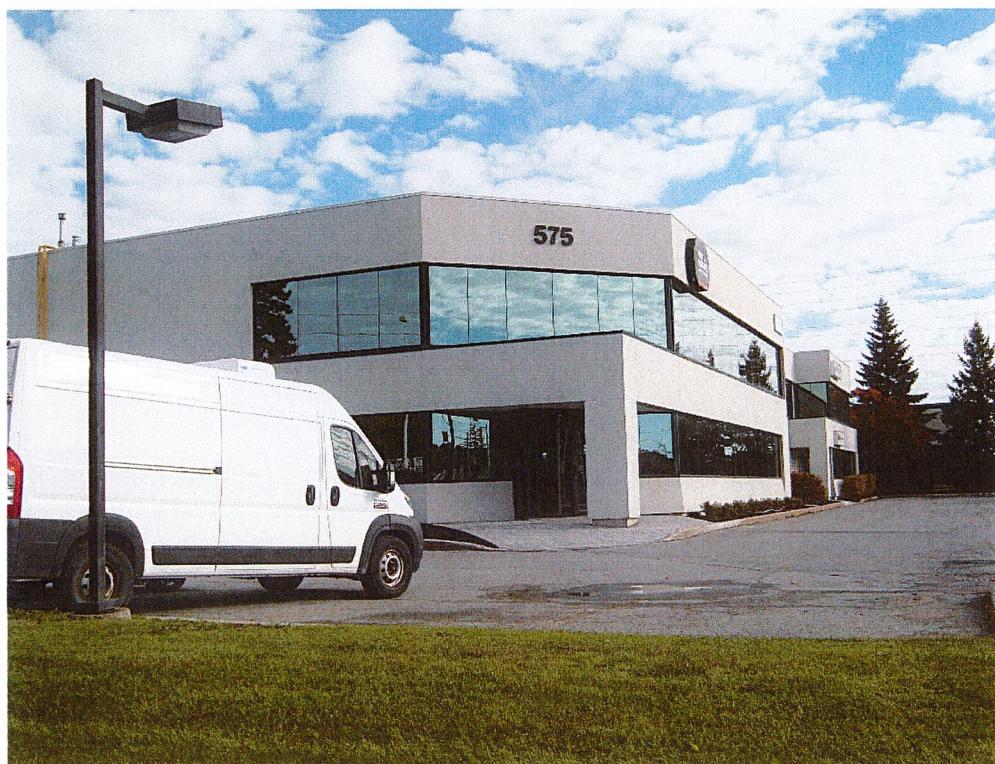
Photo 18: View facing northeast off Lancelot Drive of the adjoining commercial building located to the south at 575 West Hunt Club Road.

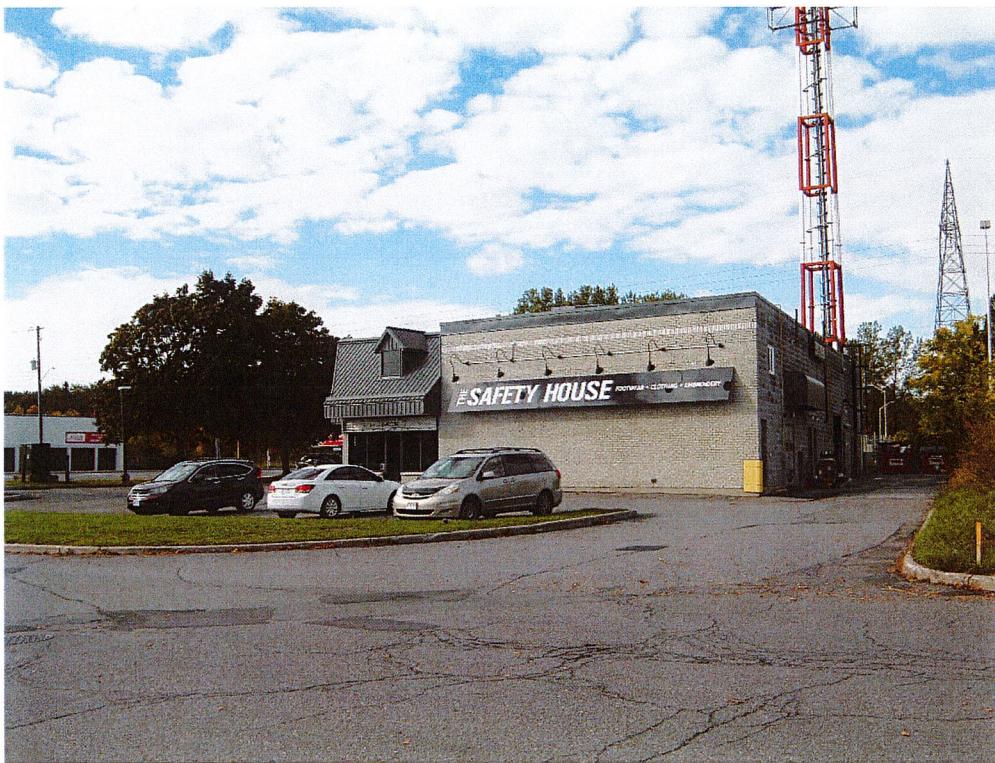
Photo 19: View facing southwest off Lancelot Drive of the neighbouring commercial building located to the southwest at 595 West Hunt Club Road.

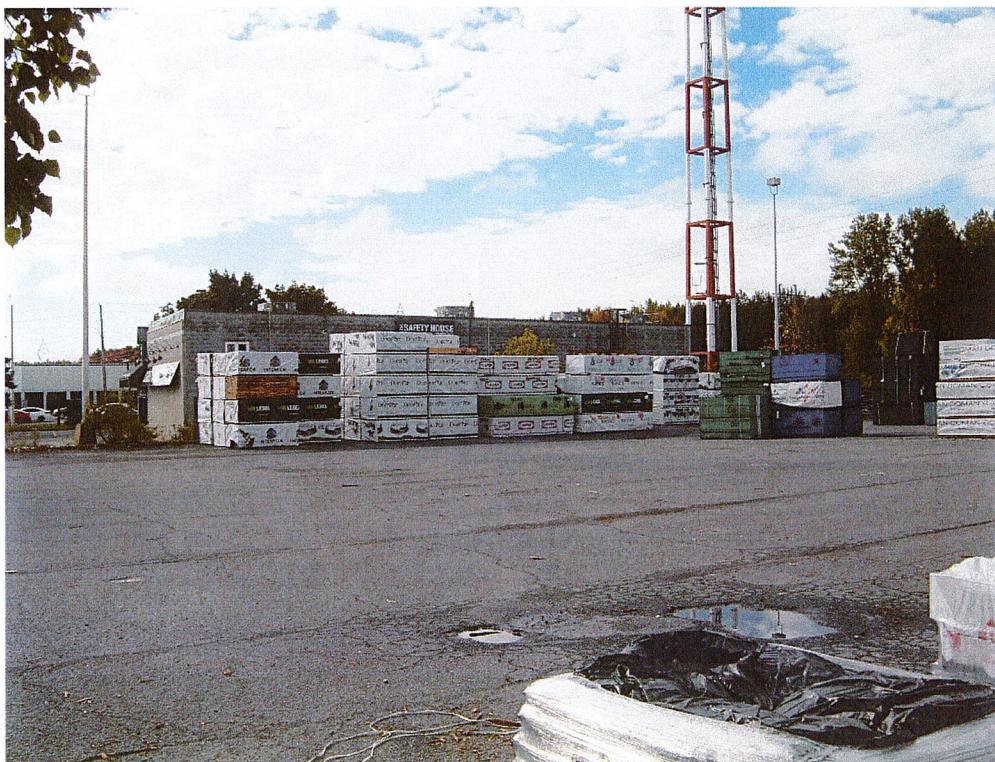
Photo 20: View facing southwest of a neighbouring exterior storage of lumber located to the west of the Site property and across Lancelot Drive.

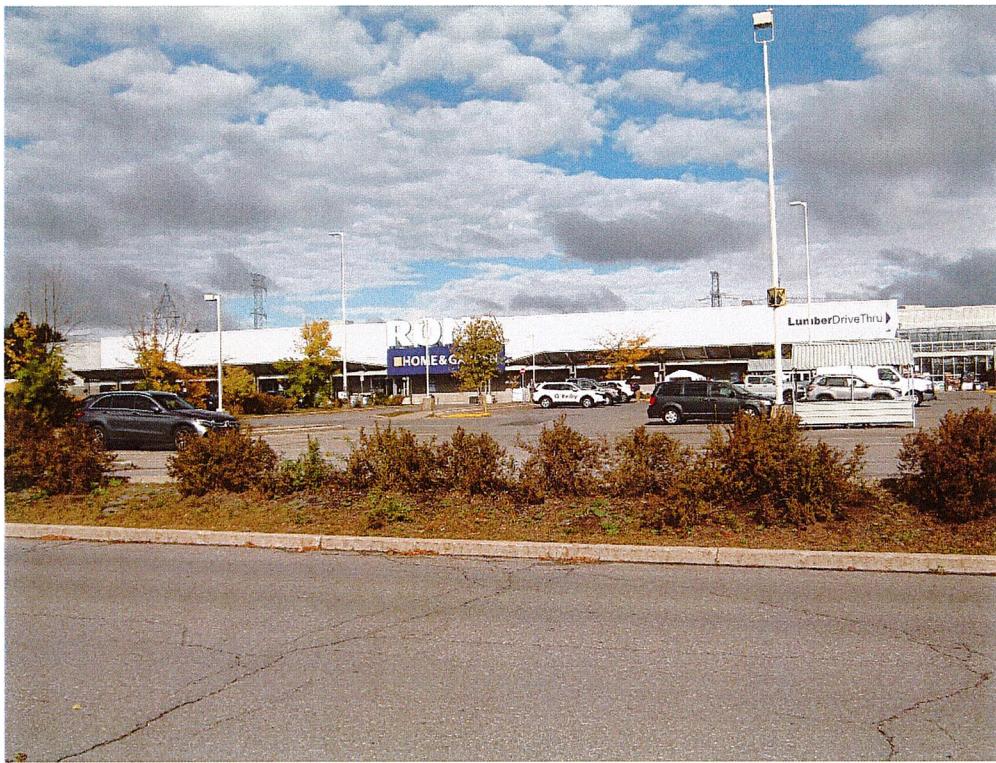
Photo 21: View facing north of the neighbouring commercial property (RONA) located to the north at 585 West Hunt Club Road and across the north roadway (in foreground).

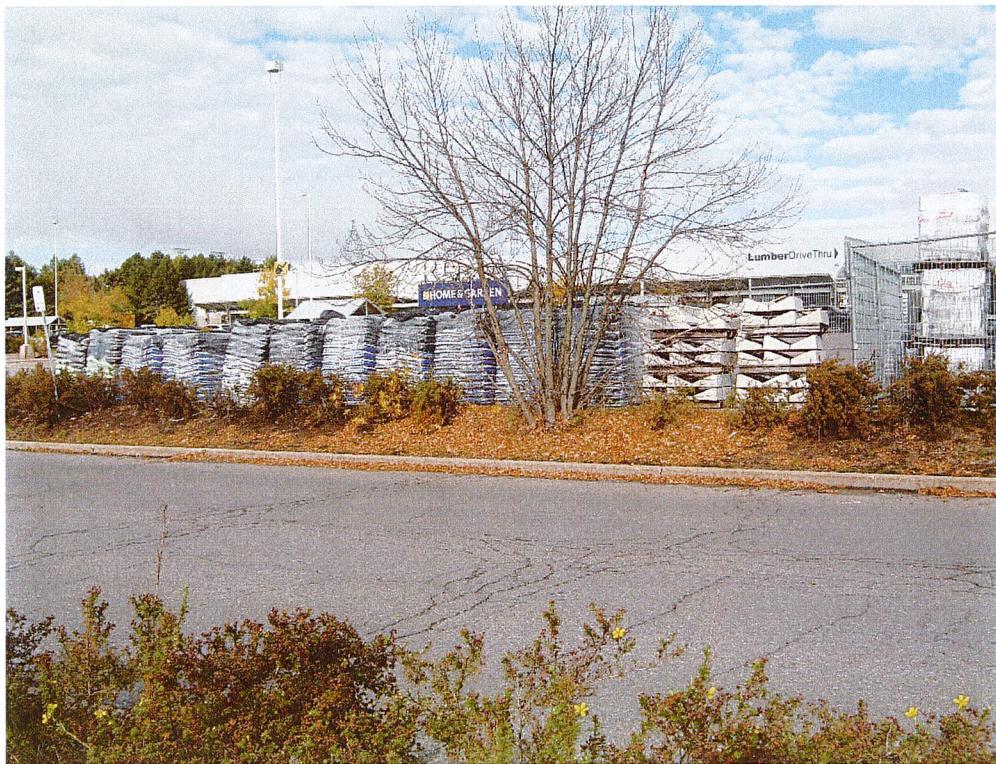
Photo 22: View facing northwest of exterior storage of soil for retail purposes located at the southside of 585 West Hunt Club Road and across the north roadway.

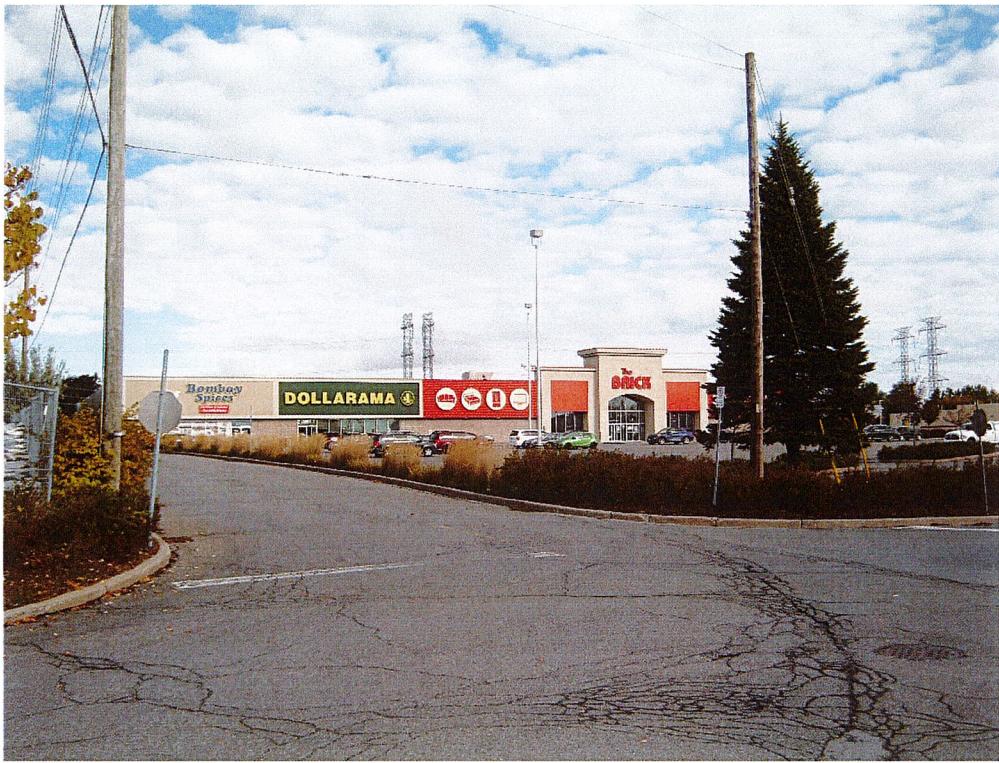
Photo 23: View facing northeast of the neighbouring commercial properties located further to the northeast at 565 West Hunt Club Road.

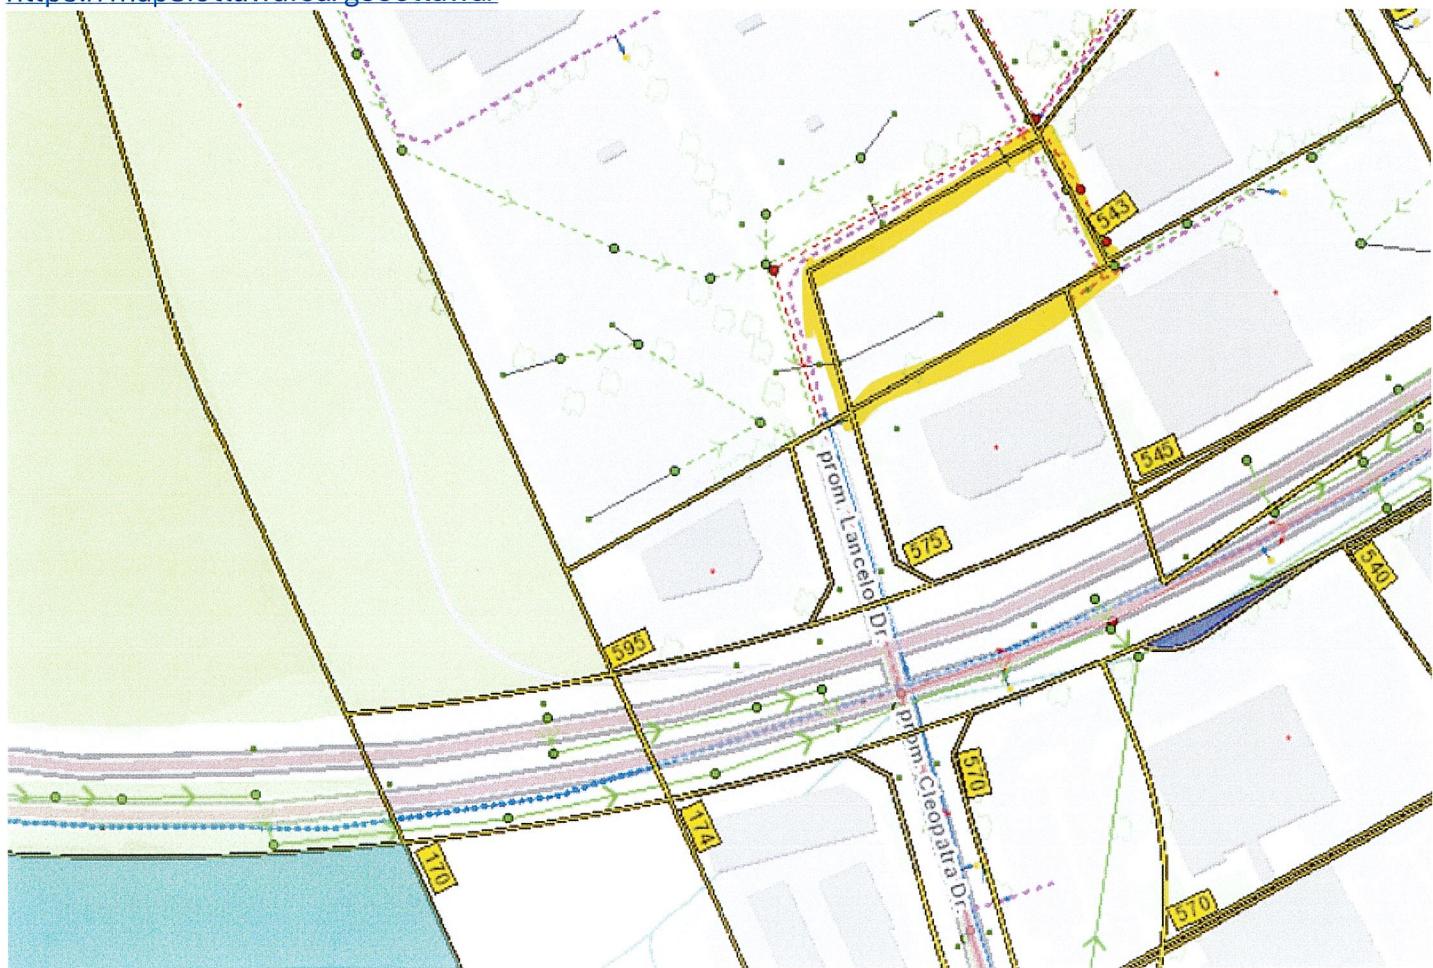
The site has direct access to private watermains, though the exact location should be confirmed through locates. LRL Engineering are preparing the Civil Design for the site, and should be able to coordinate with you on this matter.

Below is a snapshot from GeoOttawa where approximate location of existing services are shown. You may access this information by visiting
