# Tree Conservation Report

**Cisco Ottawa Campus – 2000 & 3000 Innovation Drive**

December 8, 2025

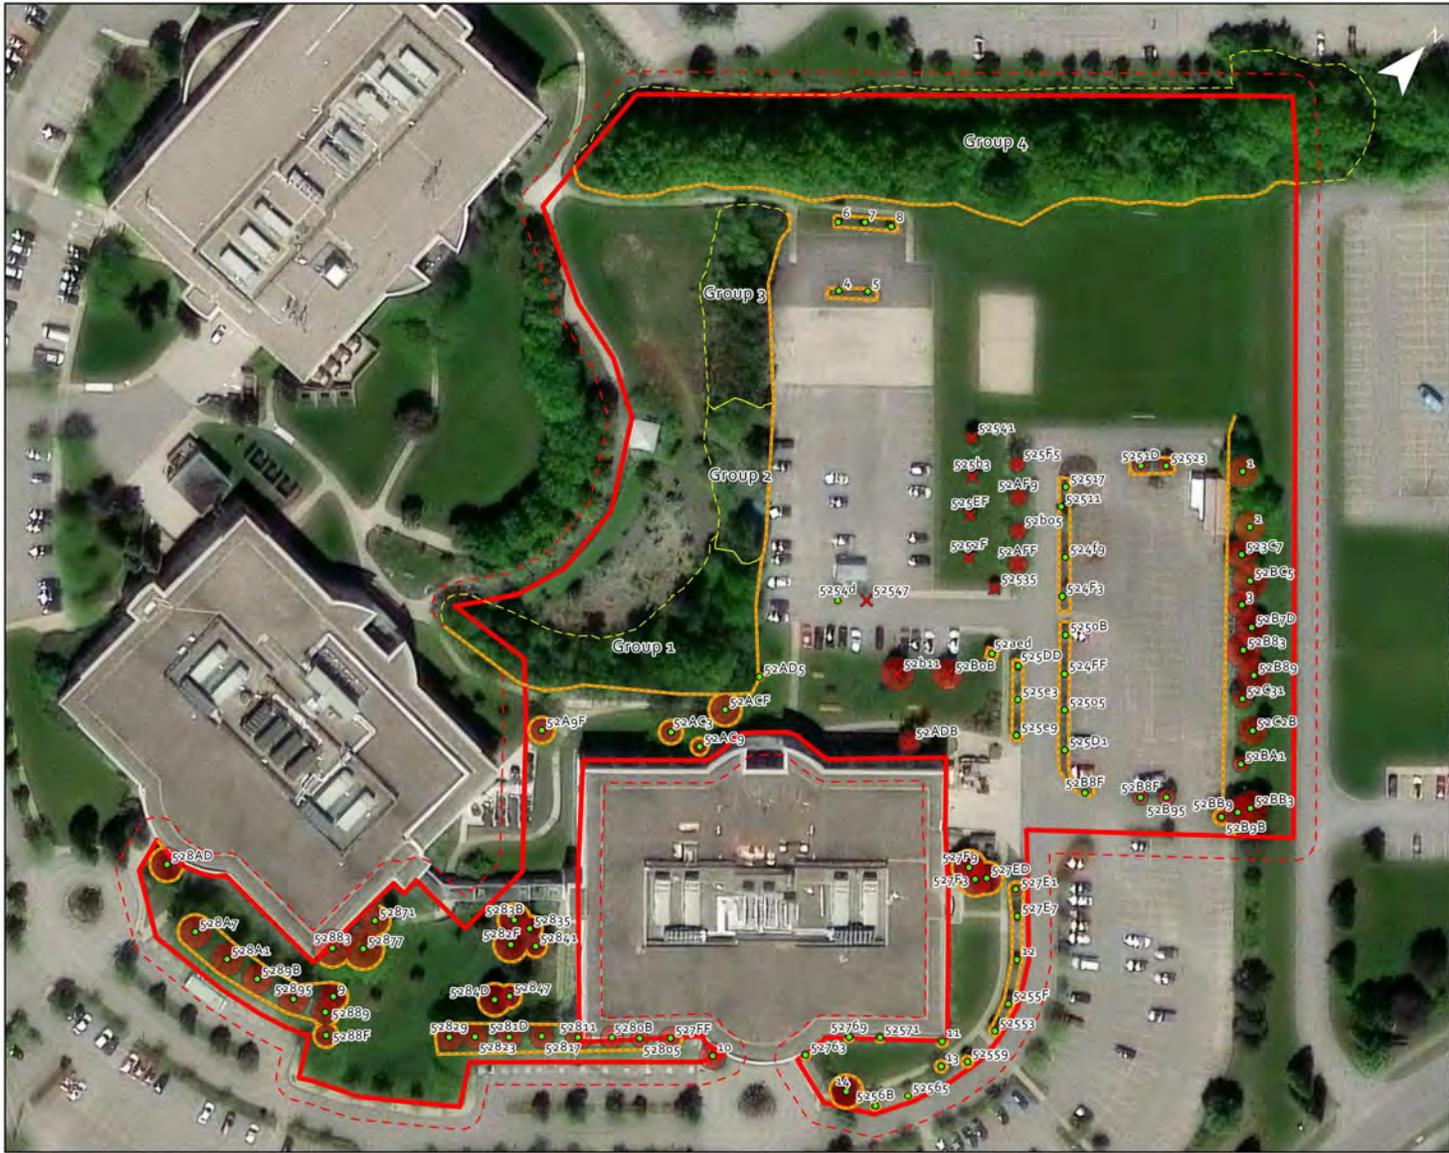
Project Name:	
<b>Cisco OTT Campus: Tree Conservation Report</b>	
Title:	
<b>Recommended Actions</b> (Map 2 as per City Guidelines)	
Prepared By:	
<b>ARCADIS</b> <small>Design &amp; Consultancy for natural and built assets</small>	
Project: 30270525	<b>Figure: 3</b>
Date: 12/8/2025

Based on the conditions of the trees and extent of the proposed construction limits, **Table 2** summarizes the impact and recommended actions of the 101 trees and four (4) tree groups assessed within the Site. It is anticipated that 13 trees >10 cm diameter at breast height (DBH) will need to be removed. These details are depicted on Mandatory Map 2 below, as per the City of Ottawa, 2021, and outlined in the Tree Inventory and Assessment Table included in **Appendix A**.

Trees to be Removed	Trees to be Retained
13	88

Based on the proposed project design and existing conditions of the trees on site, 13 trees have been recommended for removal. The following recommendations are provided:

- Retain a Certified Arborist during site layout operations to confirm recommended tree removals, pruning, and tree protection fencing in proximity to the construction limits.
