STAGE II CULTURAL HERITAGE IMPACT STATEMENT & CONSERVATION PLAN

145 Loretta Avenue & 951 Gladstone Avenue,
Ottawa, Ontario

PREPARED BY: COMMONWEALTH HISTORIC RESOURCE MANAGEMENT

Revision V5 October 2022

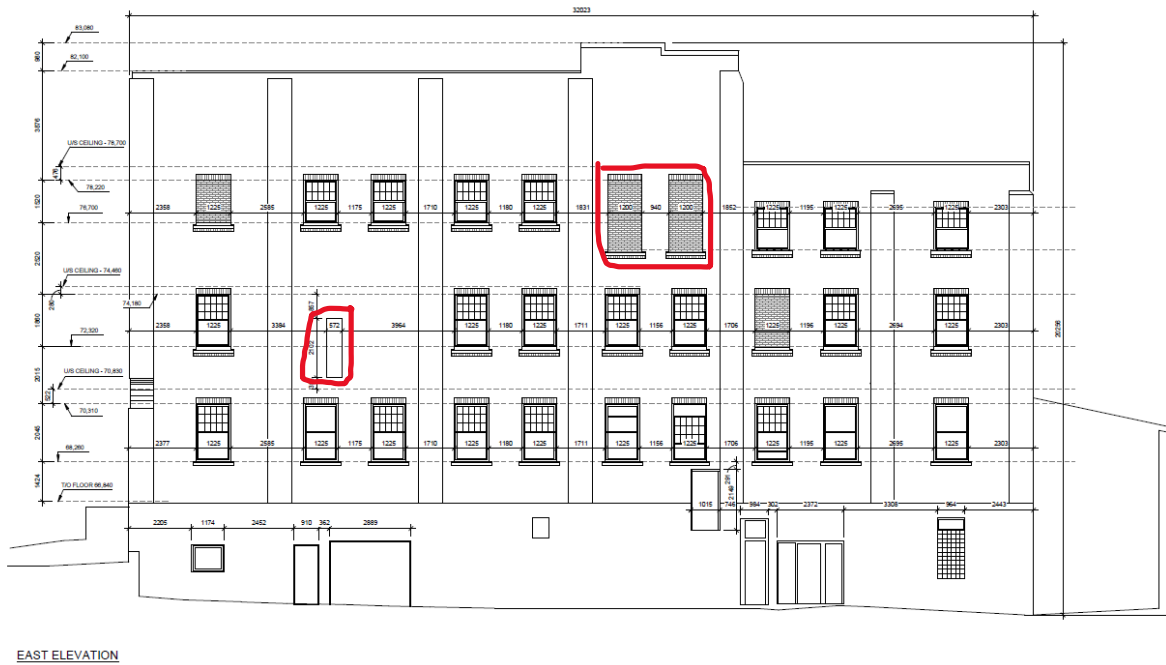
Figure 26: As-Found recording of the east and west elevation illustrating the configuration of windows and openings will provide a guide to the rehabilitation. The two areas highlighted in red are areas that the window configuration is proposed to be changed. Source: Hobin Architecture 2021.

The fenestration pattern on the east elevation overlooking the rail corridor is noted to be a character-defining feature reflecting its industrial use adjacent to a railway siding when constructed in 1924. The existing fenestration pattern will be retained including doors, and windows. At present the drawings illustrate the replacement of doors on the third floor with windows and the introduction of windows that are not original. These are noted on Figure 26.

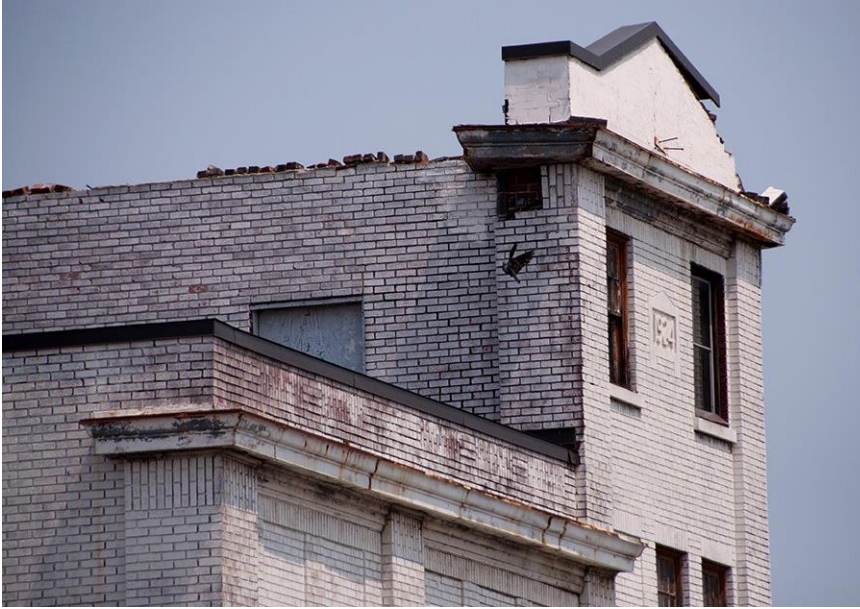
The gabled brick and metal parapets are in poor condition (figure 30) and will require restoration and for whole sections, the flashing and cornice profile details will have to be fabricated based on the photographs and remaining elements.

Figure 30: The gabled brick and metal parapets will be re-instated to their original form and design. The height of the parapet can be determined from period photos. The original colour of the brick is evident in areas where the paint has worn off. Bricked-in windows will be opened and reglazed retaining the glazing pattern.

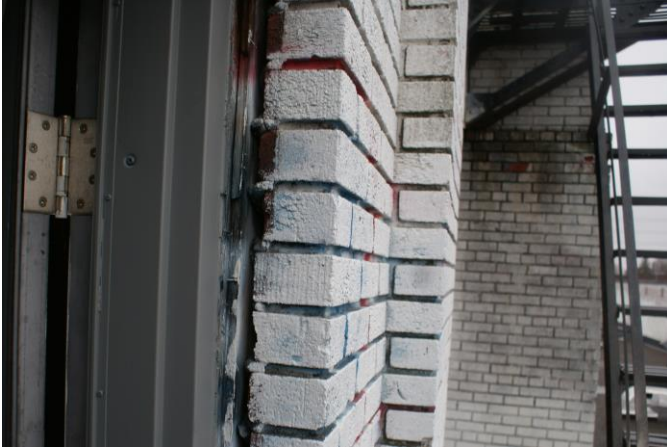
The original pointing mortar mix would appear to be a 1-part Portland, 3 parts sand with an admixture of lime to improve workability and adhesion to the masonry units. The Portland cement mortar mix was in common use when the building was completed in 1924 and is noted in manufacturers specifications for brickwork and terra-cotta tile. The joint profile is a recessed joint with a depth equal to the distance between bricks. The original mortar included a black pigment which has faded over the years where exposed. The pointing is in good condition, except for localized areas.

Figure 32: View of the exterior brickwork from a second-floor fire escape. Note the highly textured brick surfaces and recessed joint profile. Source: Commonwealth 2021.

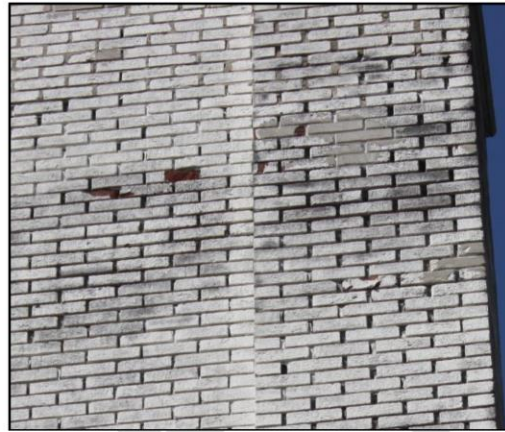
Photo 5: Typical localized area of eroded joints and face spalled bricks [JCAL 2018].

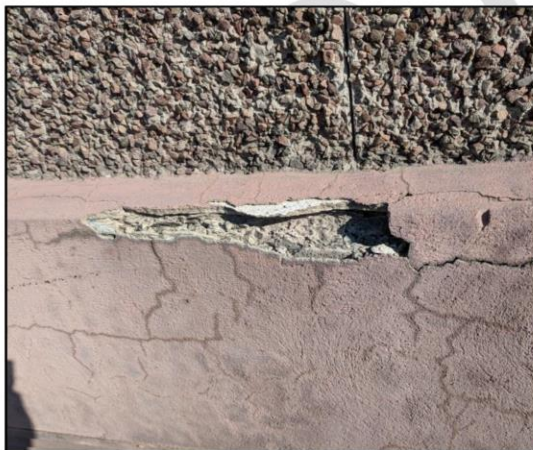
Photo 7: Debonded parging on the south elevation [JCAL 2018].

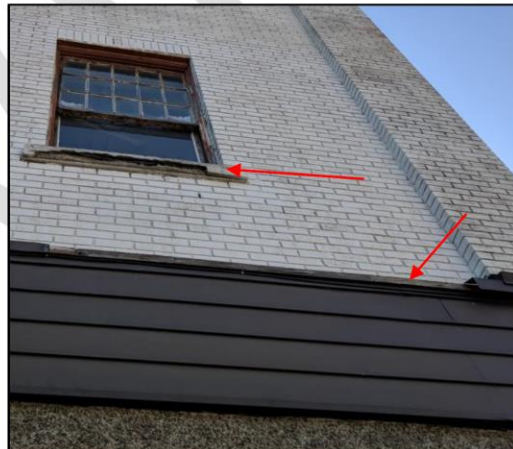
Photo 8: Deteriorated concrete window sill and damaged flashing on west elevation [JCAL 2018].
