URBAN FORESTRY & FOREST MANAGEMENT CONSULTING

March 10, 2026

**RE: TREE PROTECTION PLAN FOR 2040 ARROWSMITH DRIVE, OTTAWA**

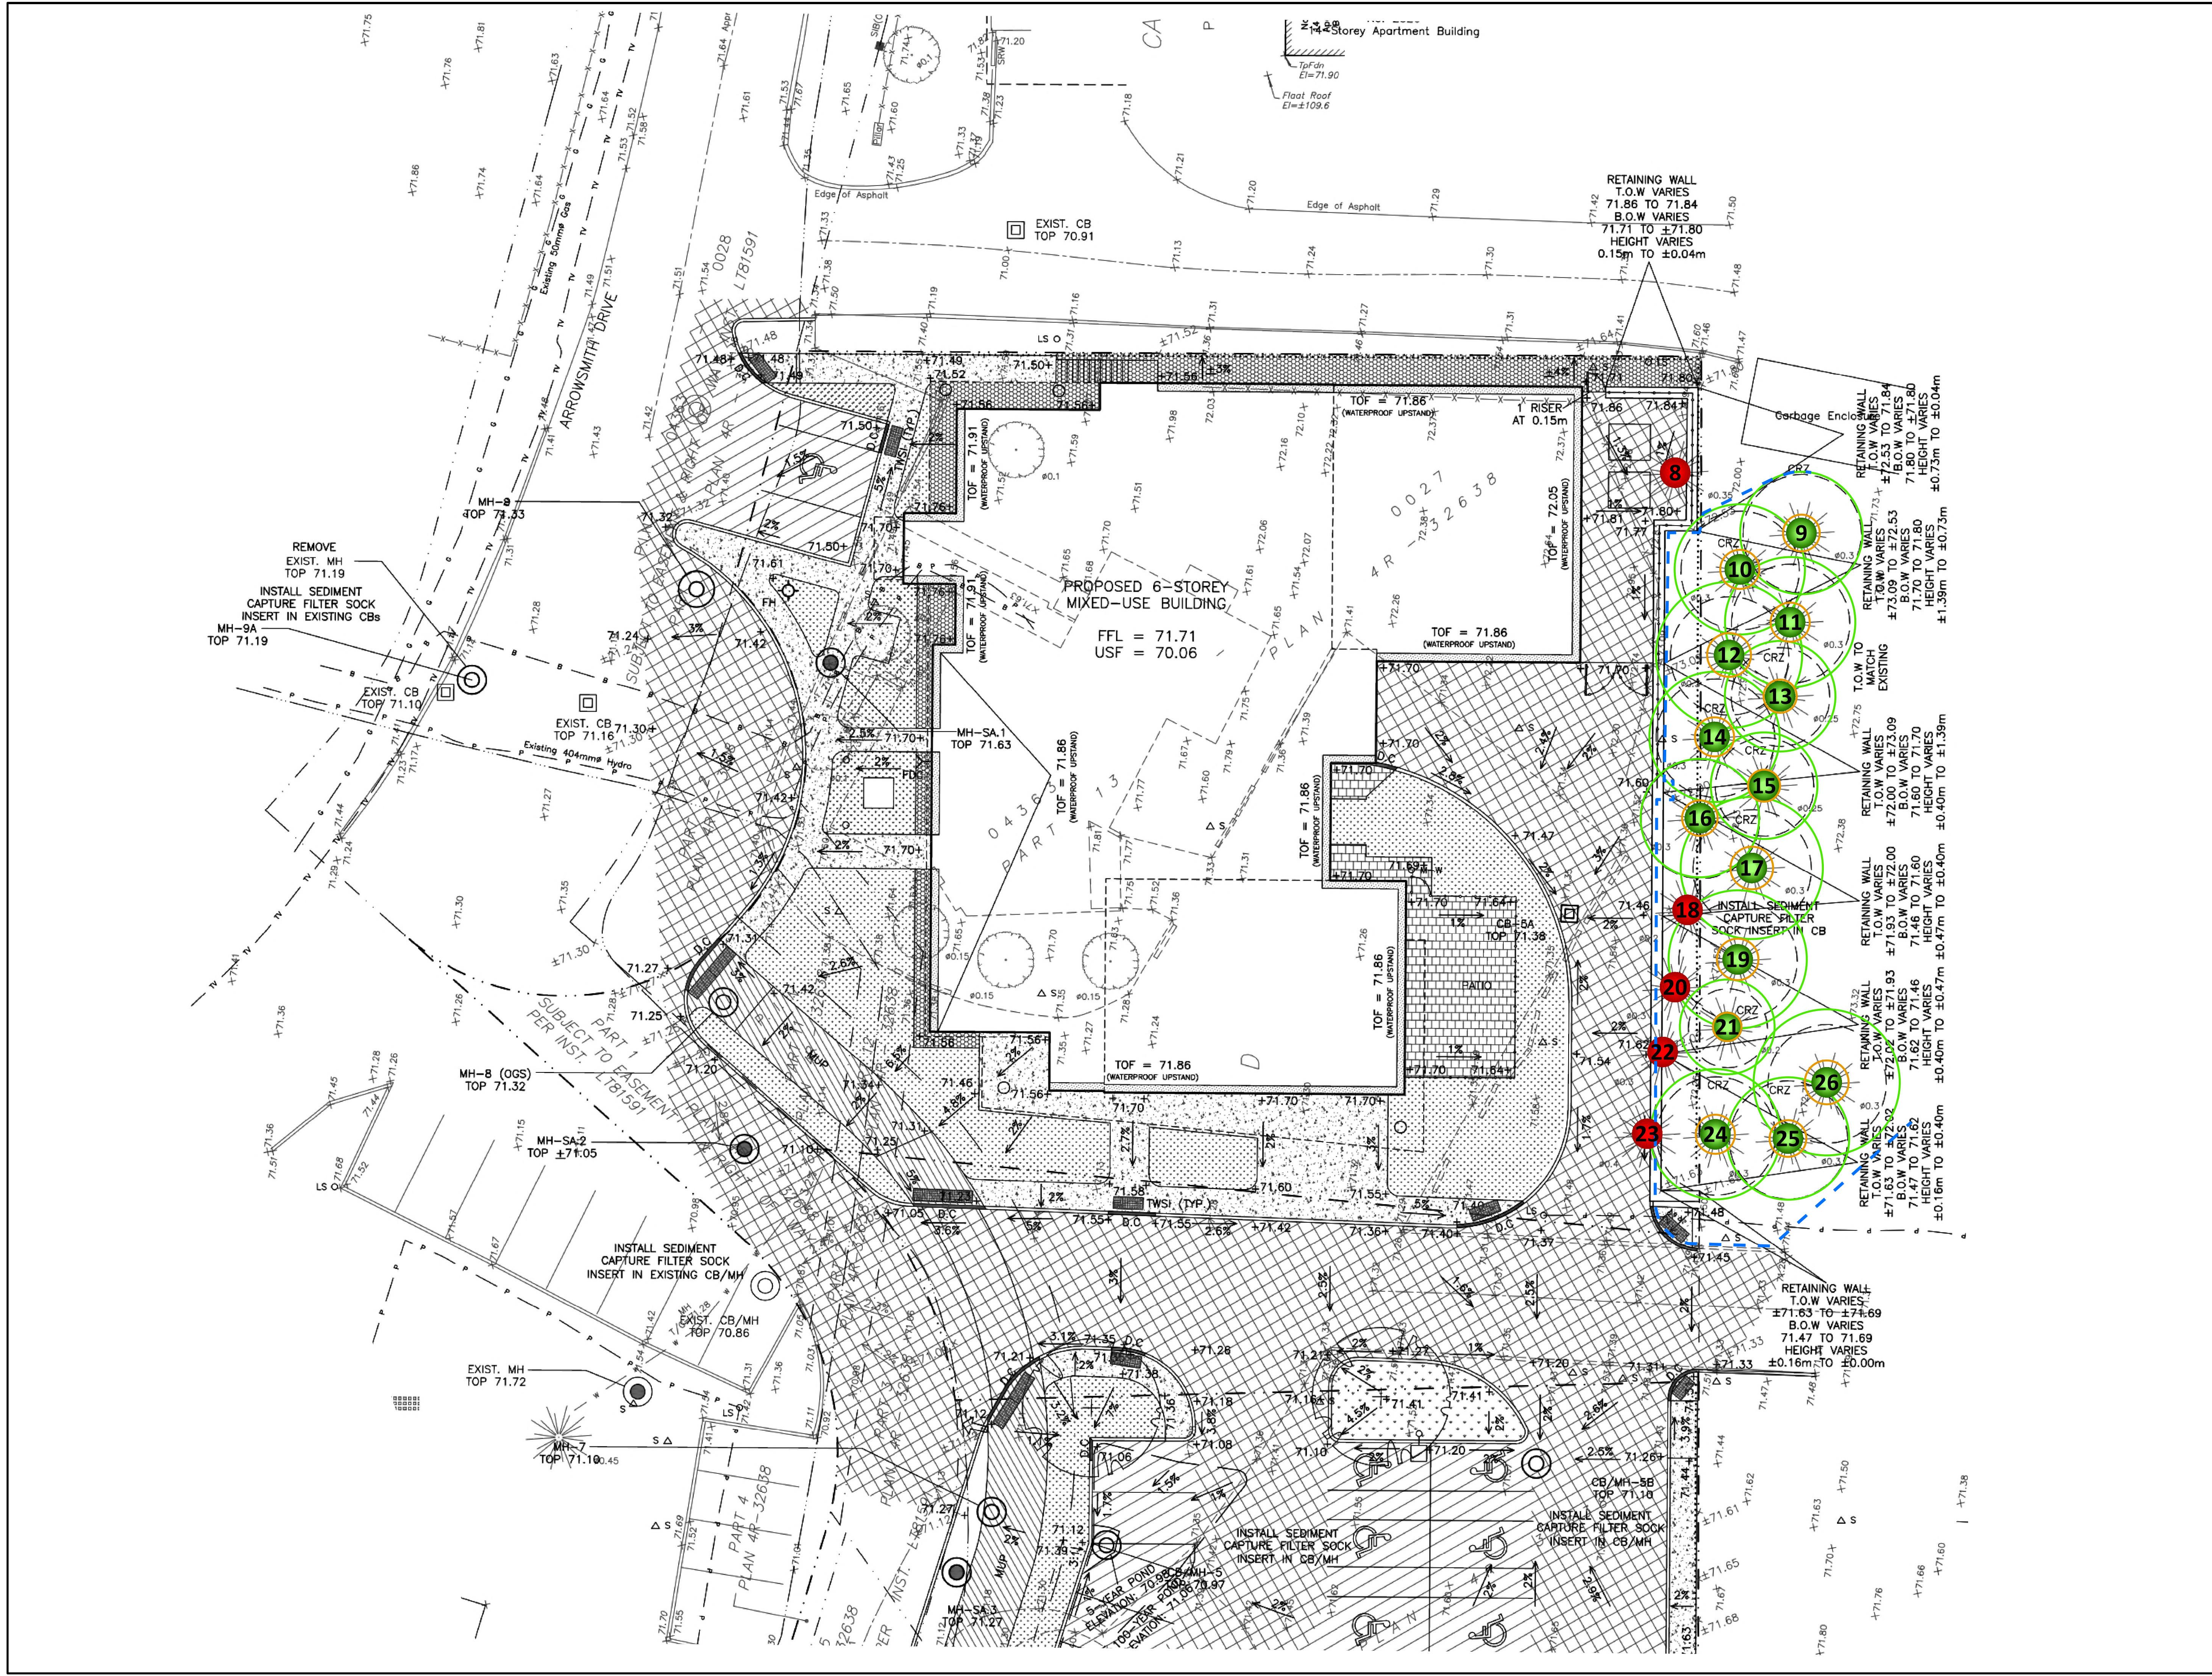
DRAWING: Tree Protection Plan

At most, 30% of one tree’s CRZ (tree #16) will be impacted by grading. This equals the maximum recommended in ISA best management practices. As shown in the plan on page 7, no static root zones will be impacted.

The consulting engineer and forester have discussed the implications of the work proposed along the eastern edge of the site. Grading behind the proposed retaining wall remains as existing. Approximately 30% of the CRZ of tree #16 will be impacted while lesser amounts of the CRZs of trees #10, 12, 14 and 24 will be impacted.

1. Erect a fence as close as possible to the critical root zone (CRZ) of trees (City of Ottawa tree protection barrier detail included on page 11). Portions of this fence will be moved as necessary (and temporarily) for access purposes when constructing the retaining wall and when completing grading.
2. Do not place any material or equipment within the CRZ of the tree.
3. Do not attach any signs, notices or posters to any tree.
4. Do not raise or lower the existing grade within the CRZ without approval.
5. Tunnel or bore when digging within the CRZ of a tree.
6. Do not damage the root system, trunk or branches of any tree.
7. Ensure that exhaust fumes from all equipment are NOT directed towards any tree's crown.

1. Hydro excavation along the edge of excavation in proximity to the tree to carefully expose roots. Exposed roots will then be cleanly cut and sealed before being reburied (see City of Ottawa root pruning detail on page 12). Excavation can then resume using traditional mechanical means. Sealing the cleanly cut root ends with a beeswax product will help prevent the loss of moisture and facilitate healing.
2. If the excavation is to be left open for any length of time a covering of at least three layers of moistened burlap is to be draped over the exposed face of excavation closet to the tree. A final covering of clear plastic will help retain moisture within the burlap. The use of burlap and plastic coverings will help reduce the loss of moisture from the soil surrounding the remaining roots.
