2510 St. Laurent Blvd – Tree Conservation Report

Claridge Homes

Prepared for Claridge Homes
by Arcadis | IBI Group

March 19, 2026

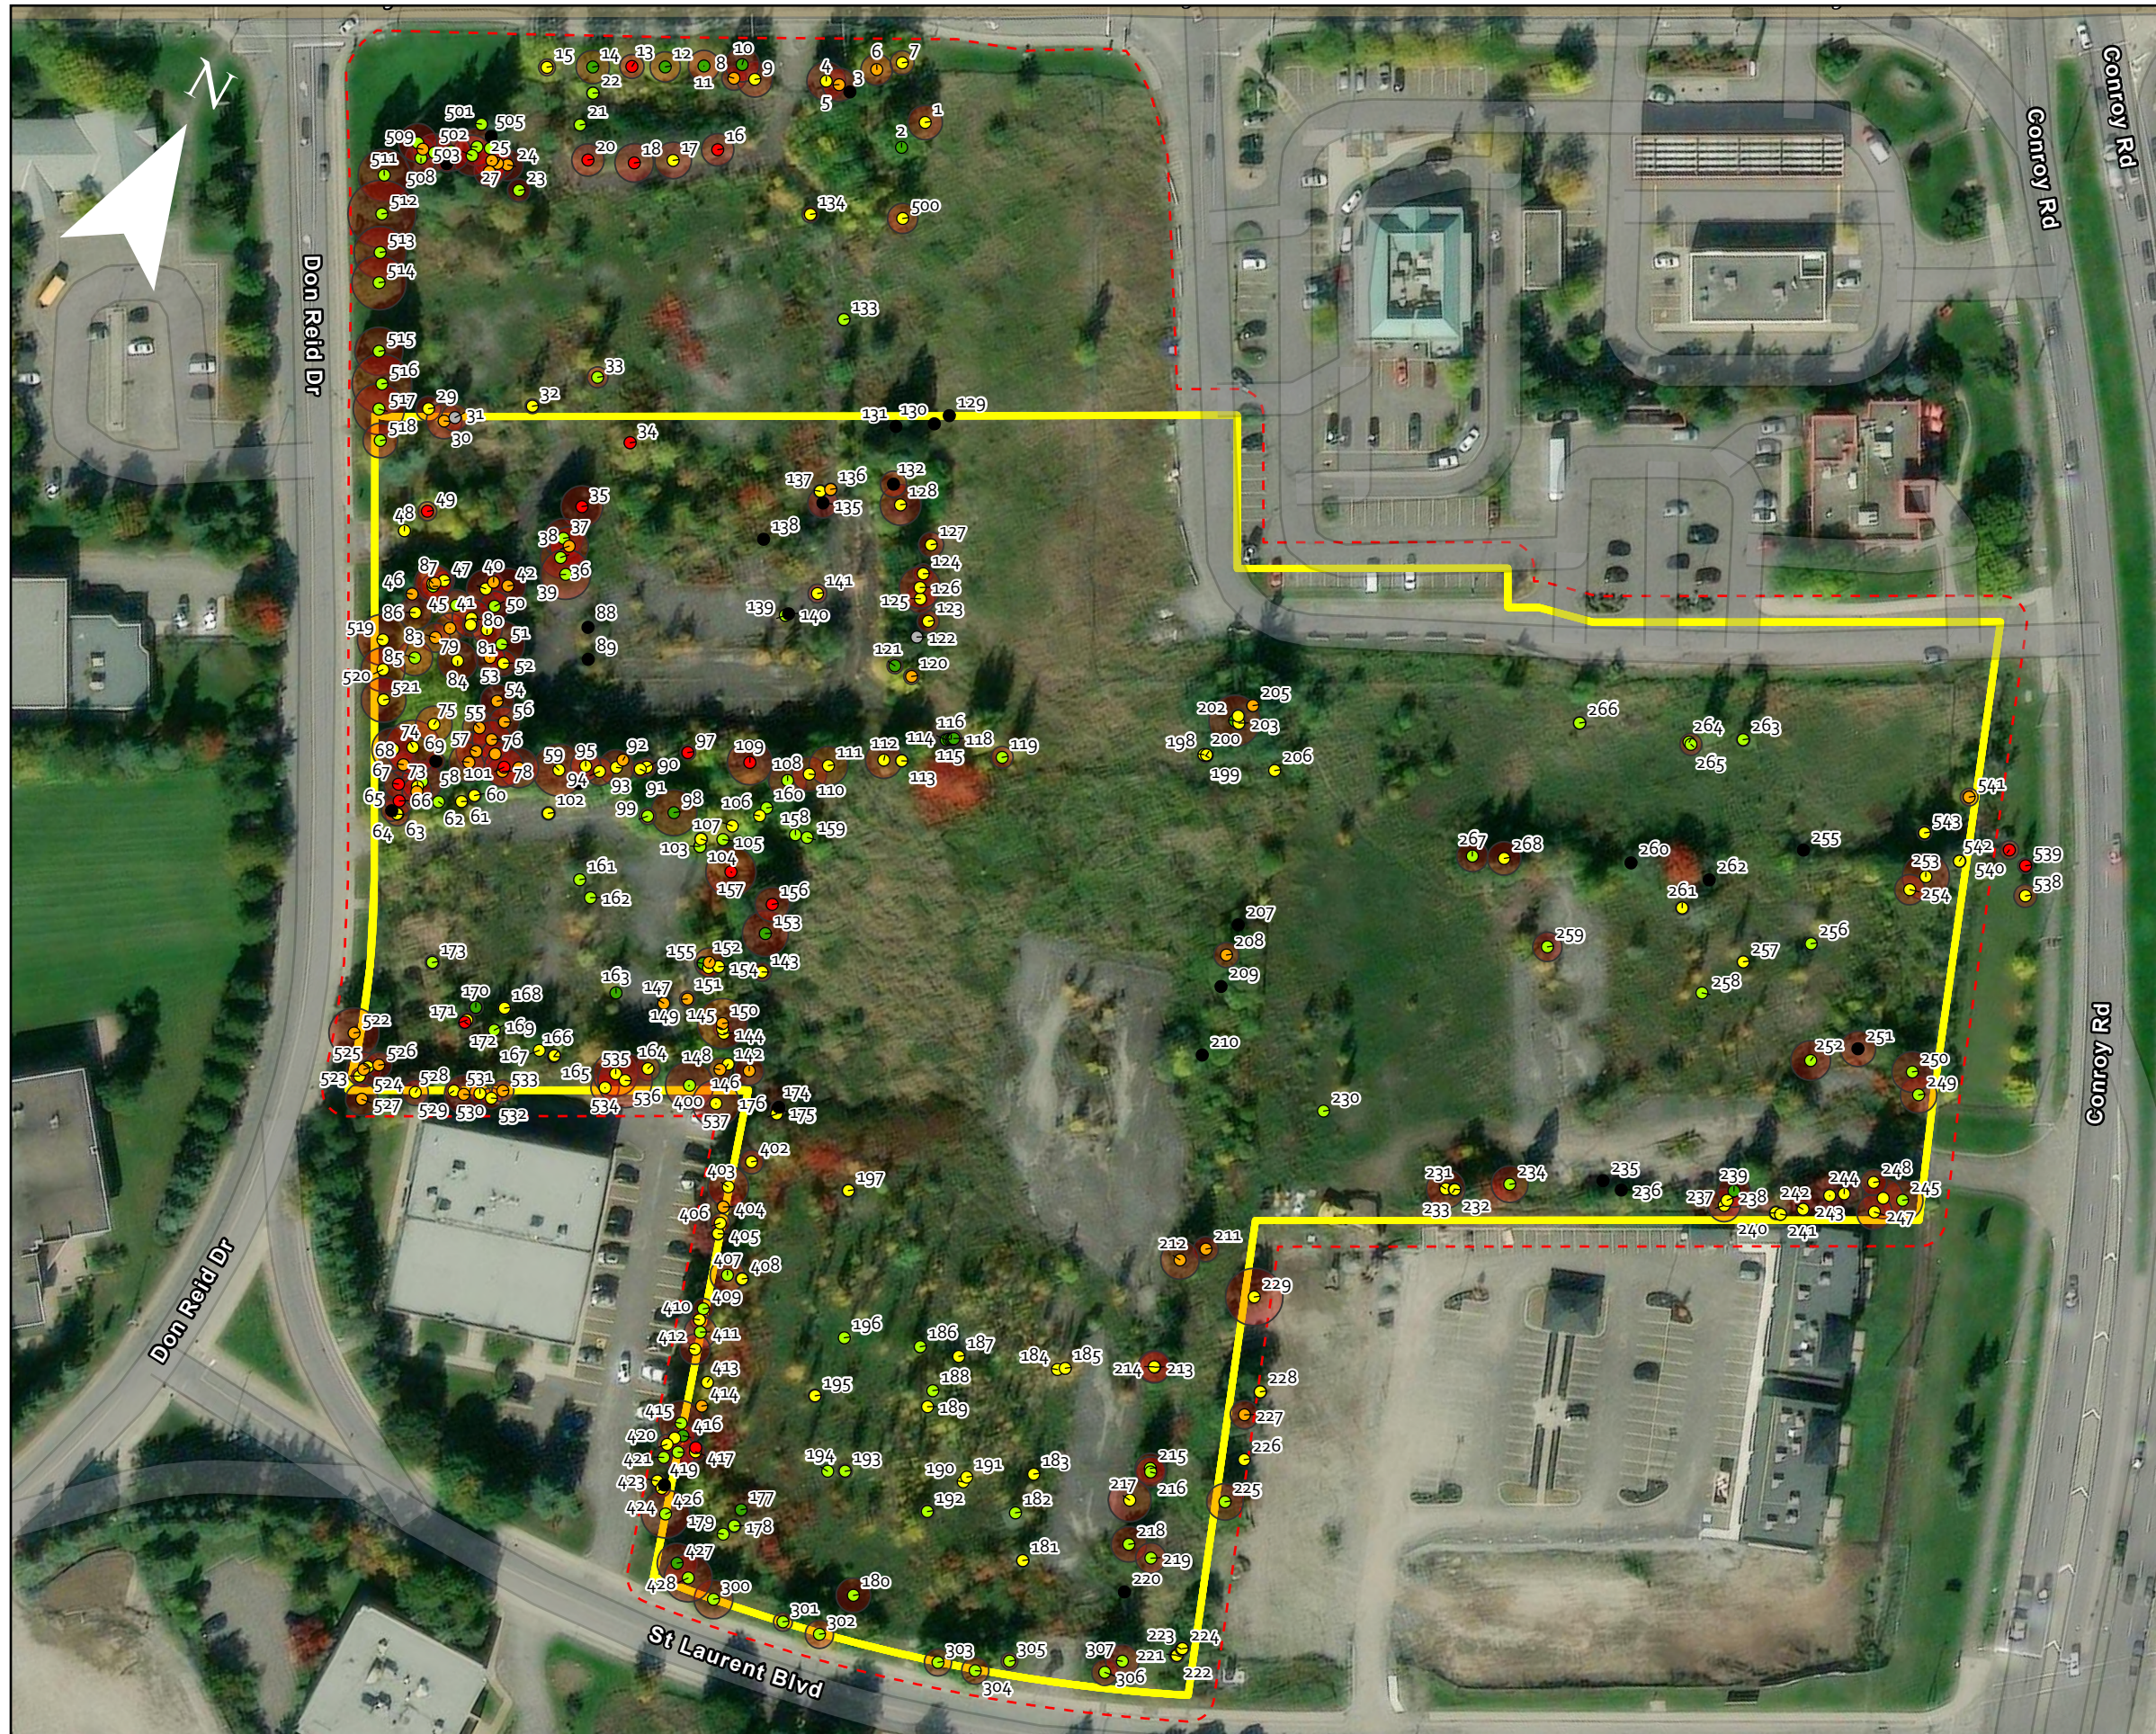
Figure: 2

The following **Table 1** provides a summary of the tree inventory results with a full Tree Inventory and Preservation Plan included in **Appendix A**. **Figure 2** below displays the tree locations and associated health conditions.

**2510 St. Laurent Blvd:
Current Vegetation
(Map 1 as per City Guidelines)**

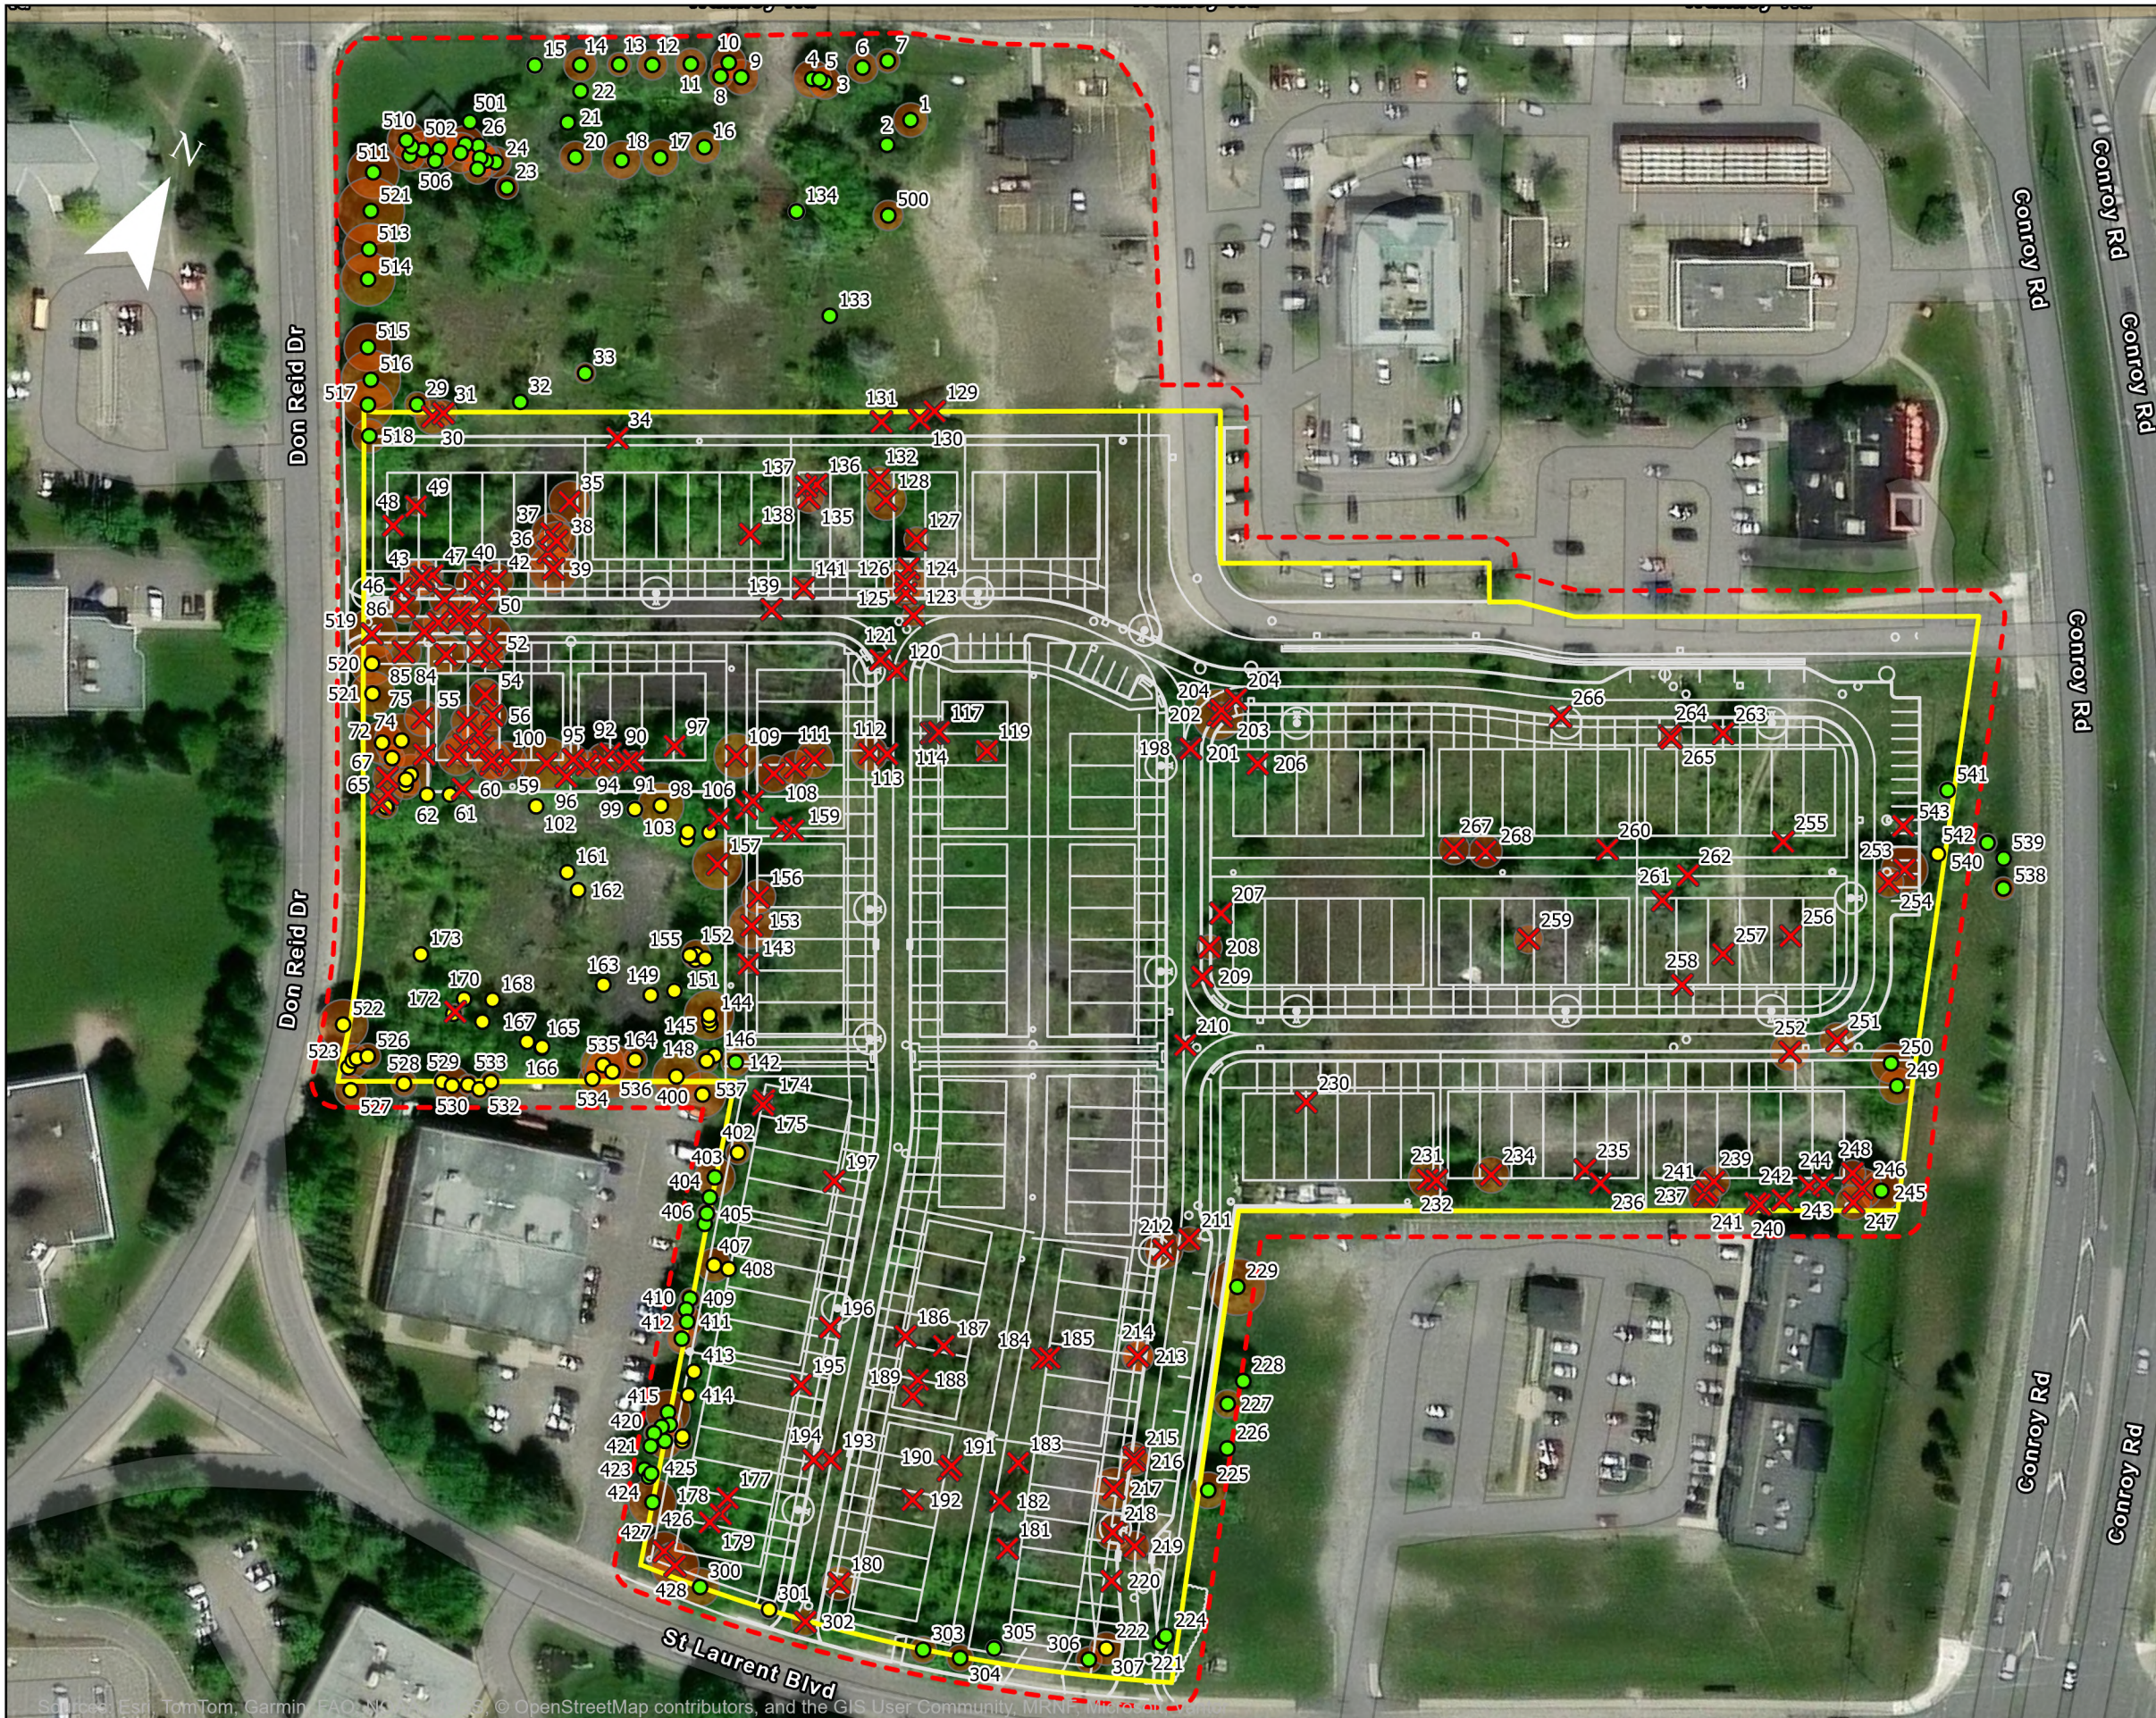
Figure: 3

Figure 3 below displays the results of the tree inventory overlaid with the current site plan. Recommendations for removal, retention, and potential for retention are included.

The Critical Root Zone (CRZ) of **190 trees are in direct conflict with the proposed site plan and or grading limits and will require removal (Appendix A). One additional tree (301) has been proposed for removal and replacement due to a trunk wound.** Physical impacts on the CRZ by construction activities rapidly deteriorates the overall health, quality, and ecological service of the tree. Therefore, tree locations that will impact majority of the CRZ have been recommended for removal.

Title: 2510 St. Laurent Blvd:
 Tree Impact Assessment
 and Recommendations
 (Map 2 as per City Guidelines)
