SEWER CCTV INSPECTION REPORT

City of Ottawa

960 Silver St Ottawa, ON

Work Order:
152188

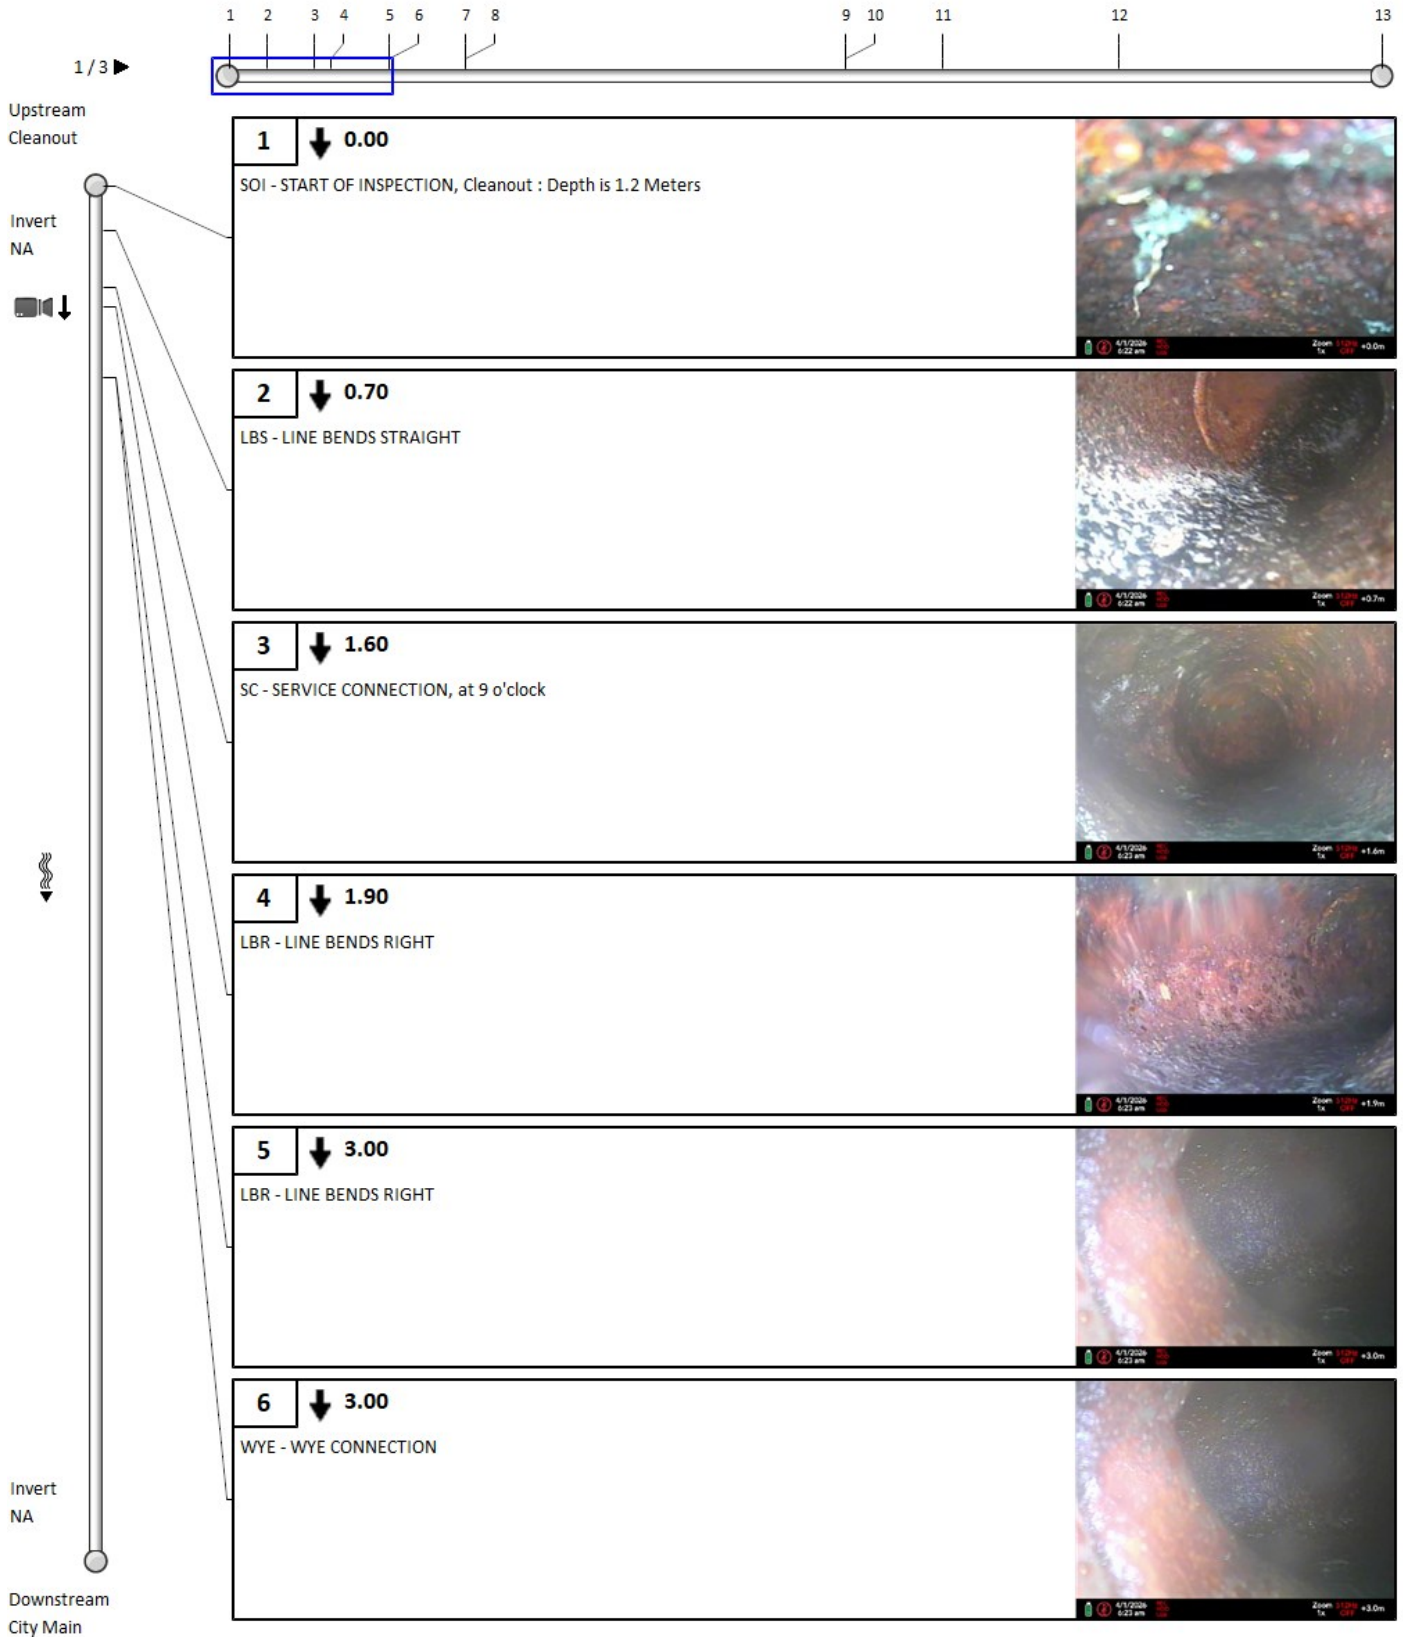
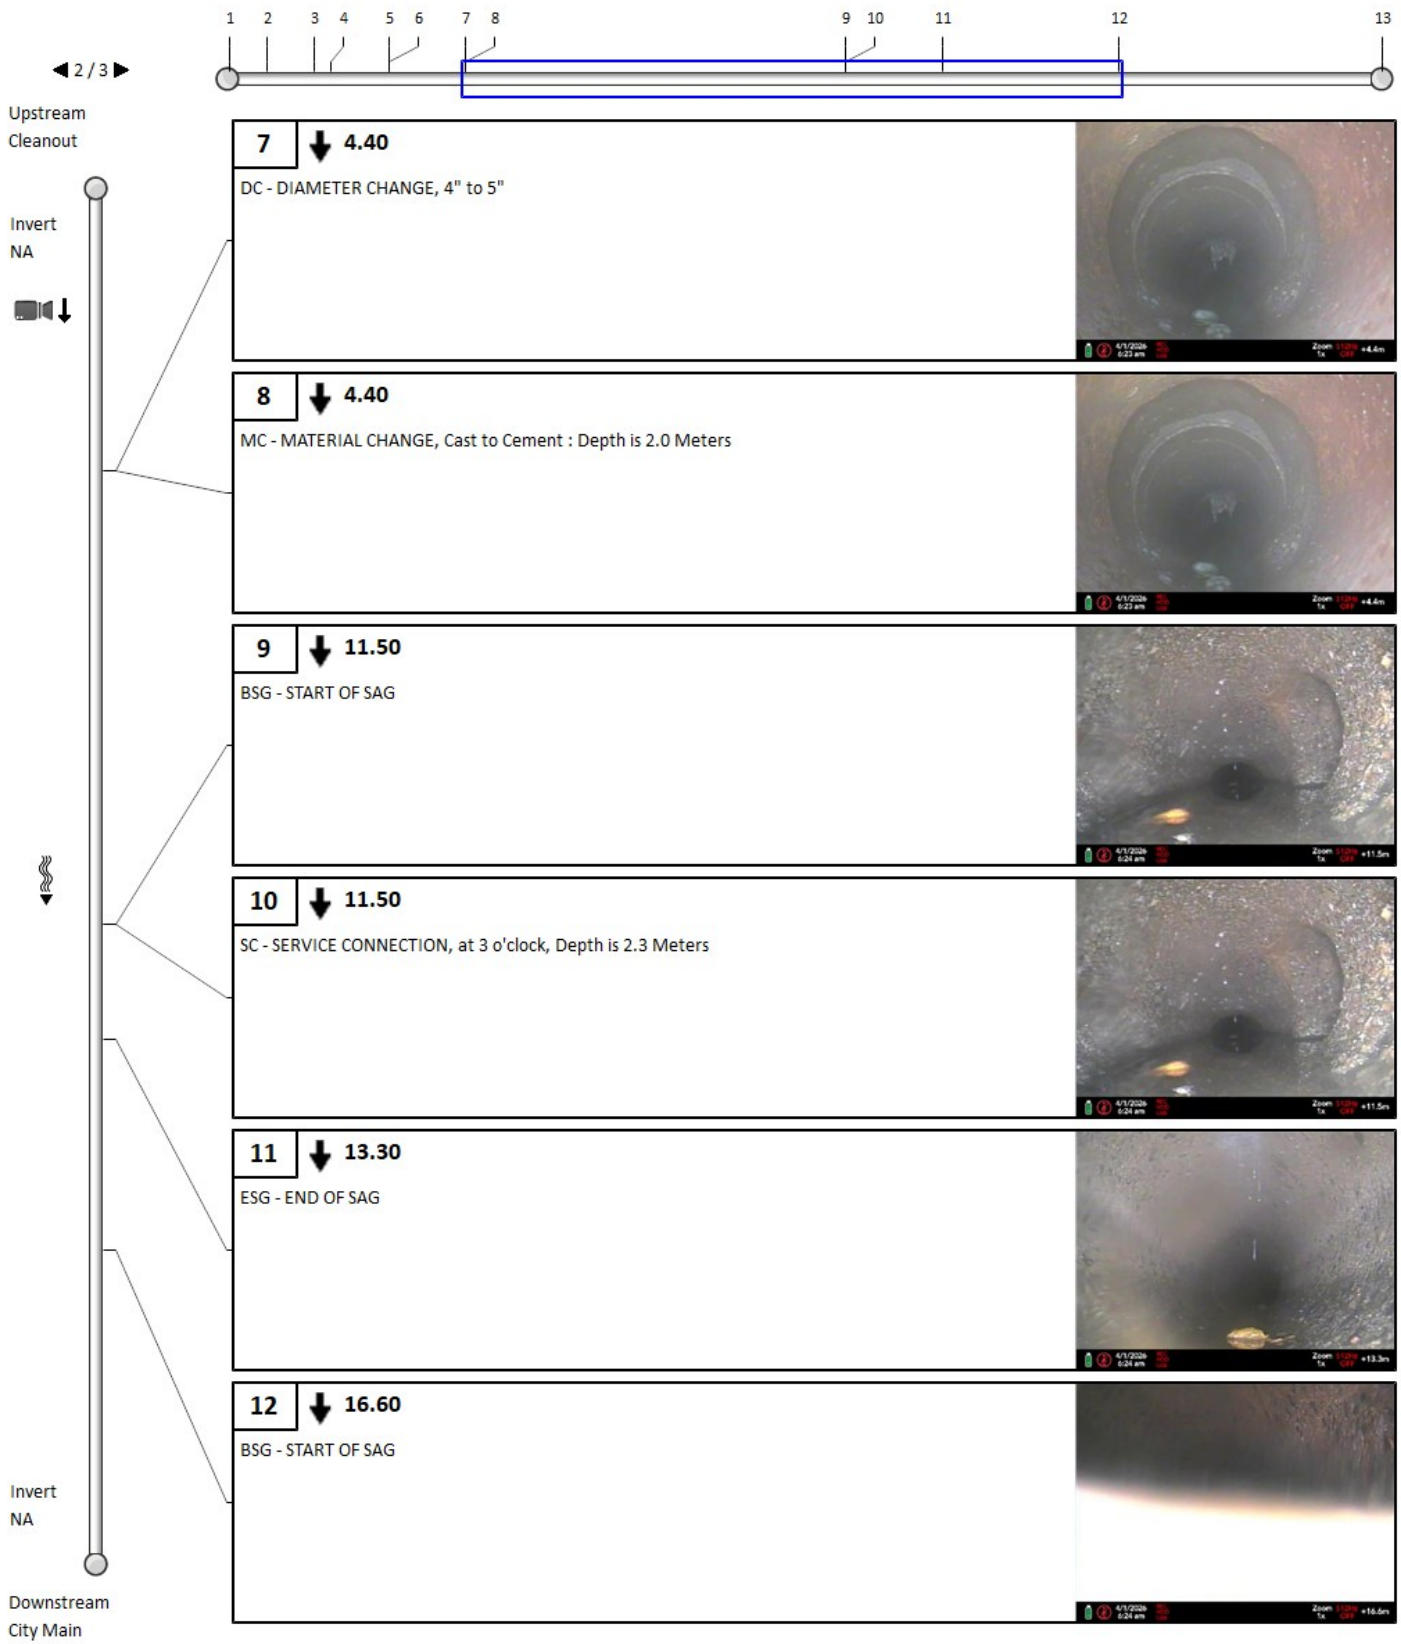
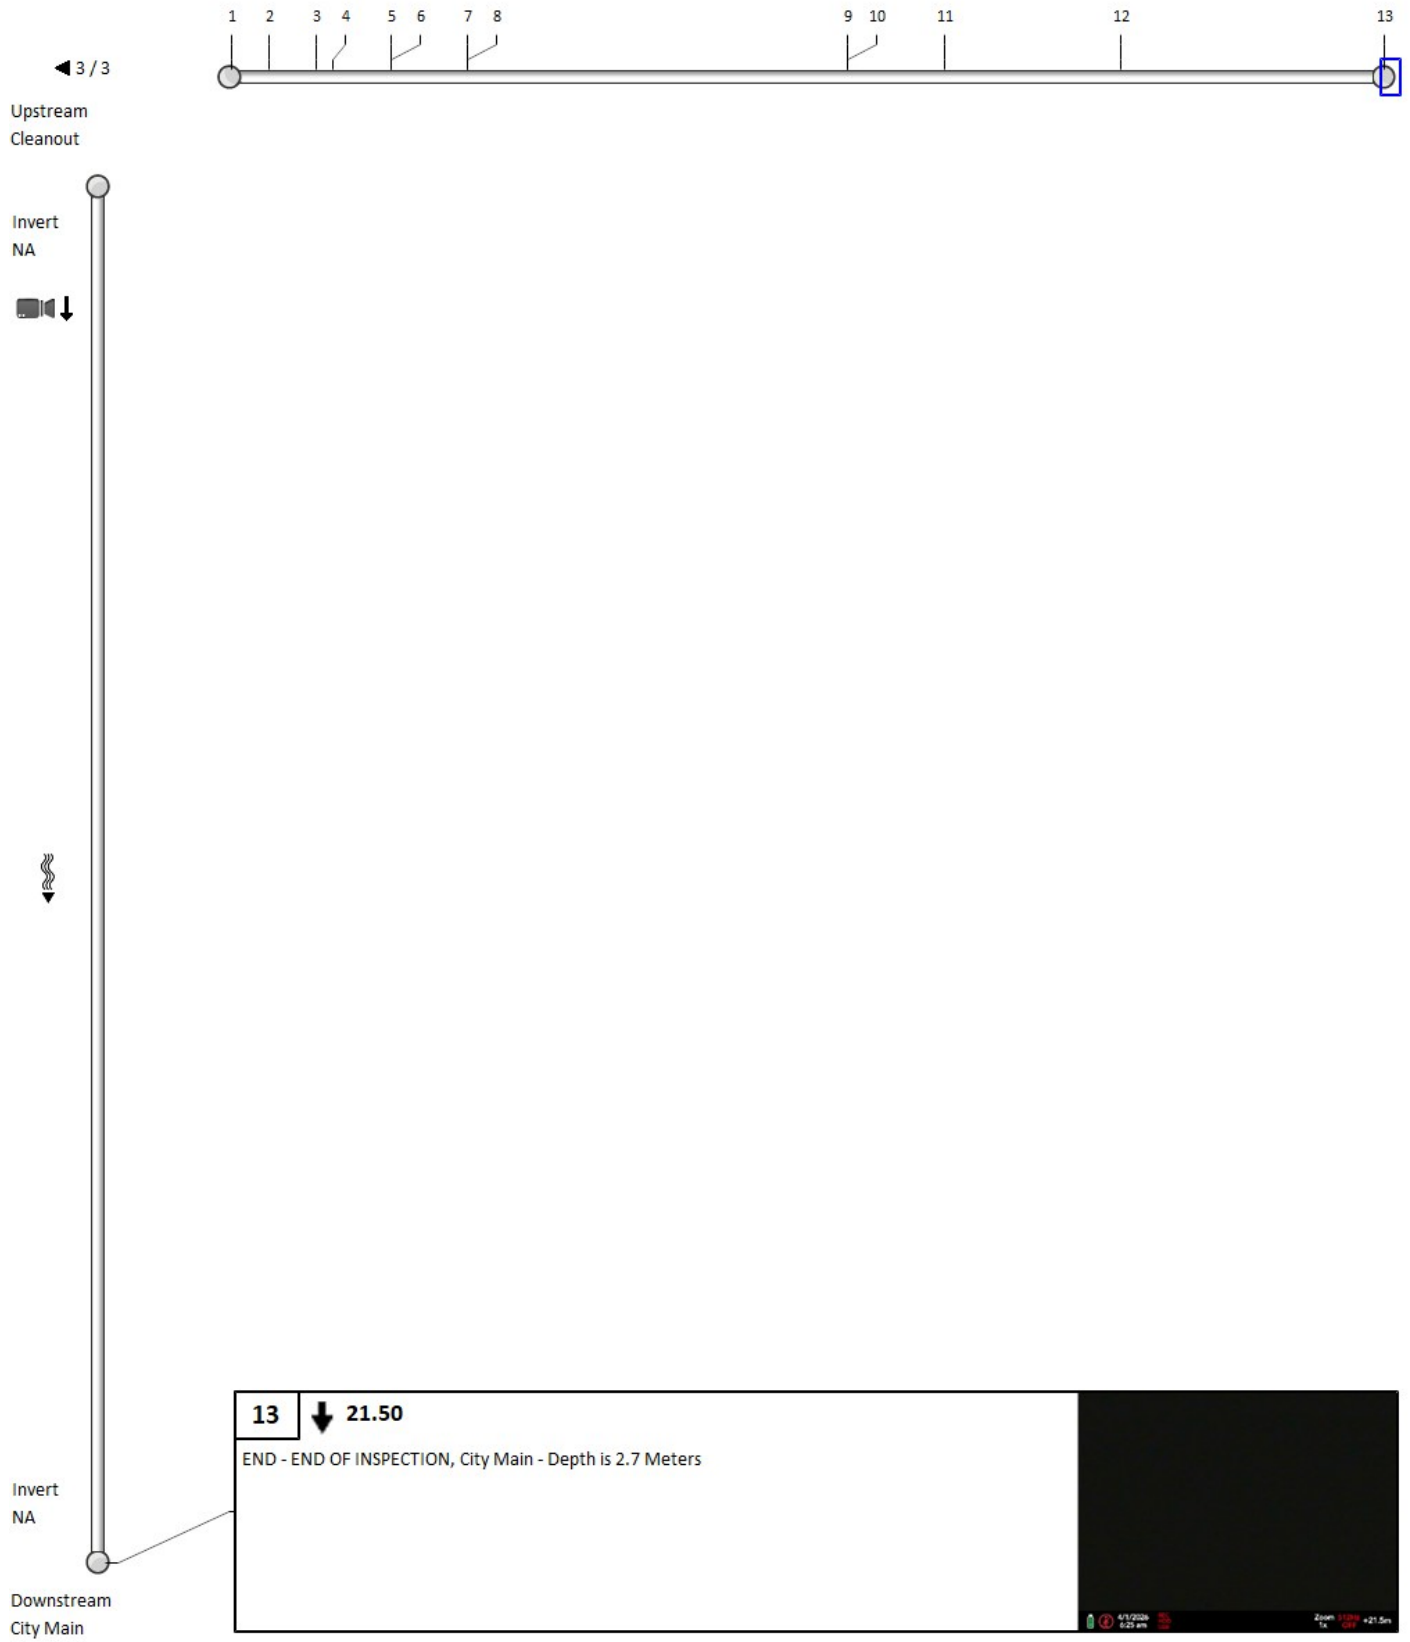
CCTV Inspection From Sanitary Cleanout to City Main

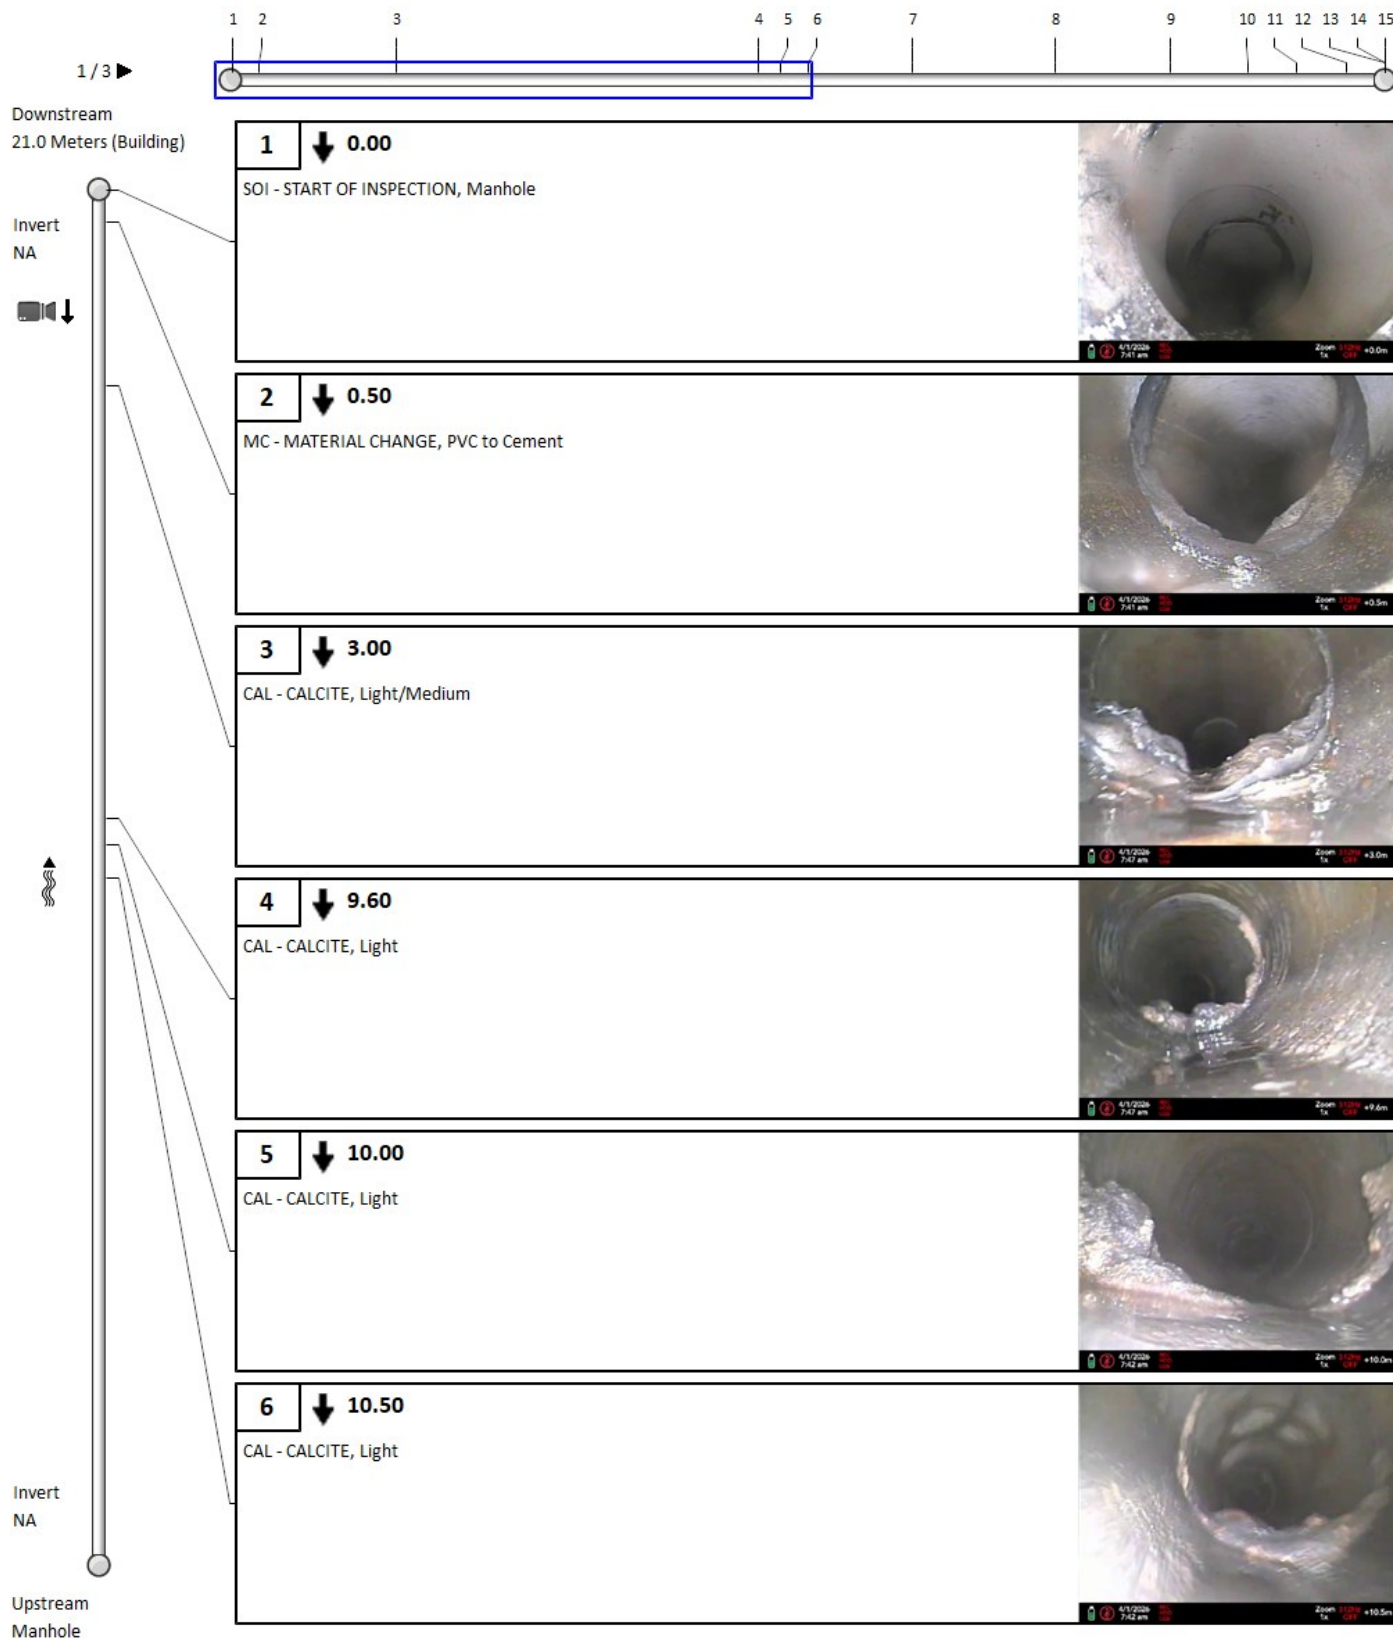
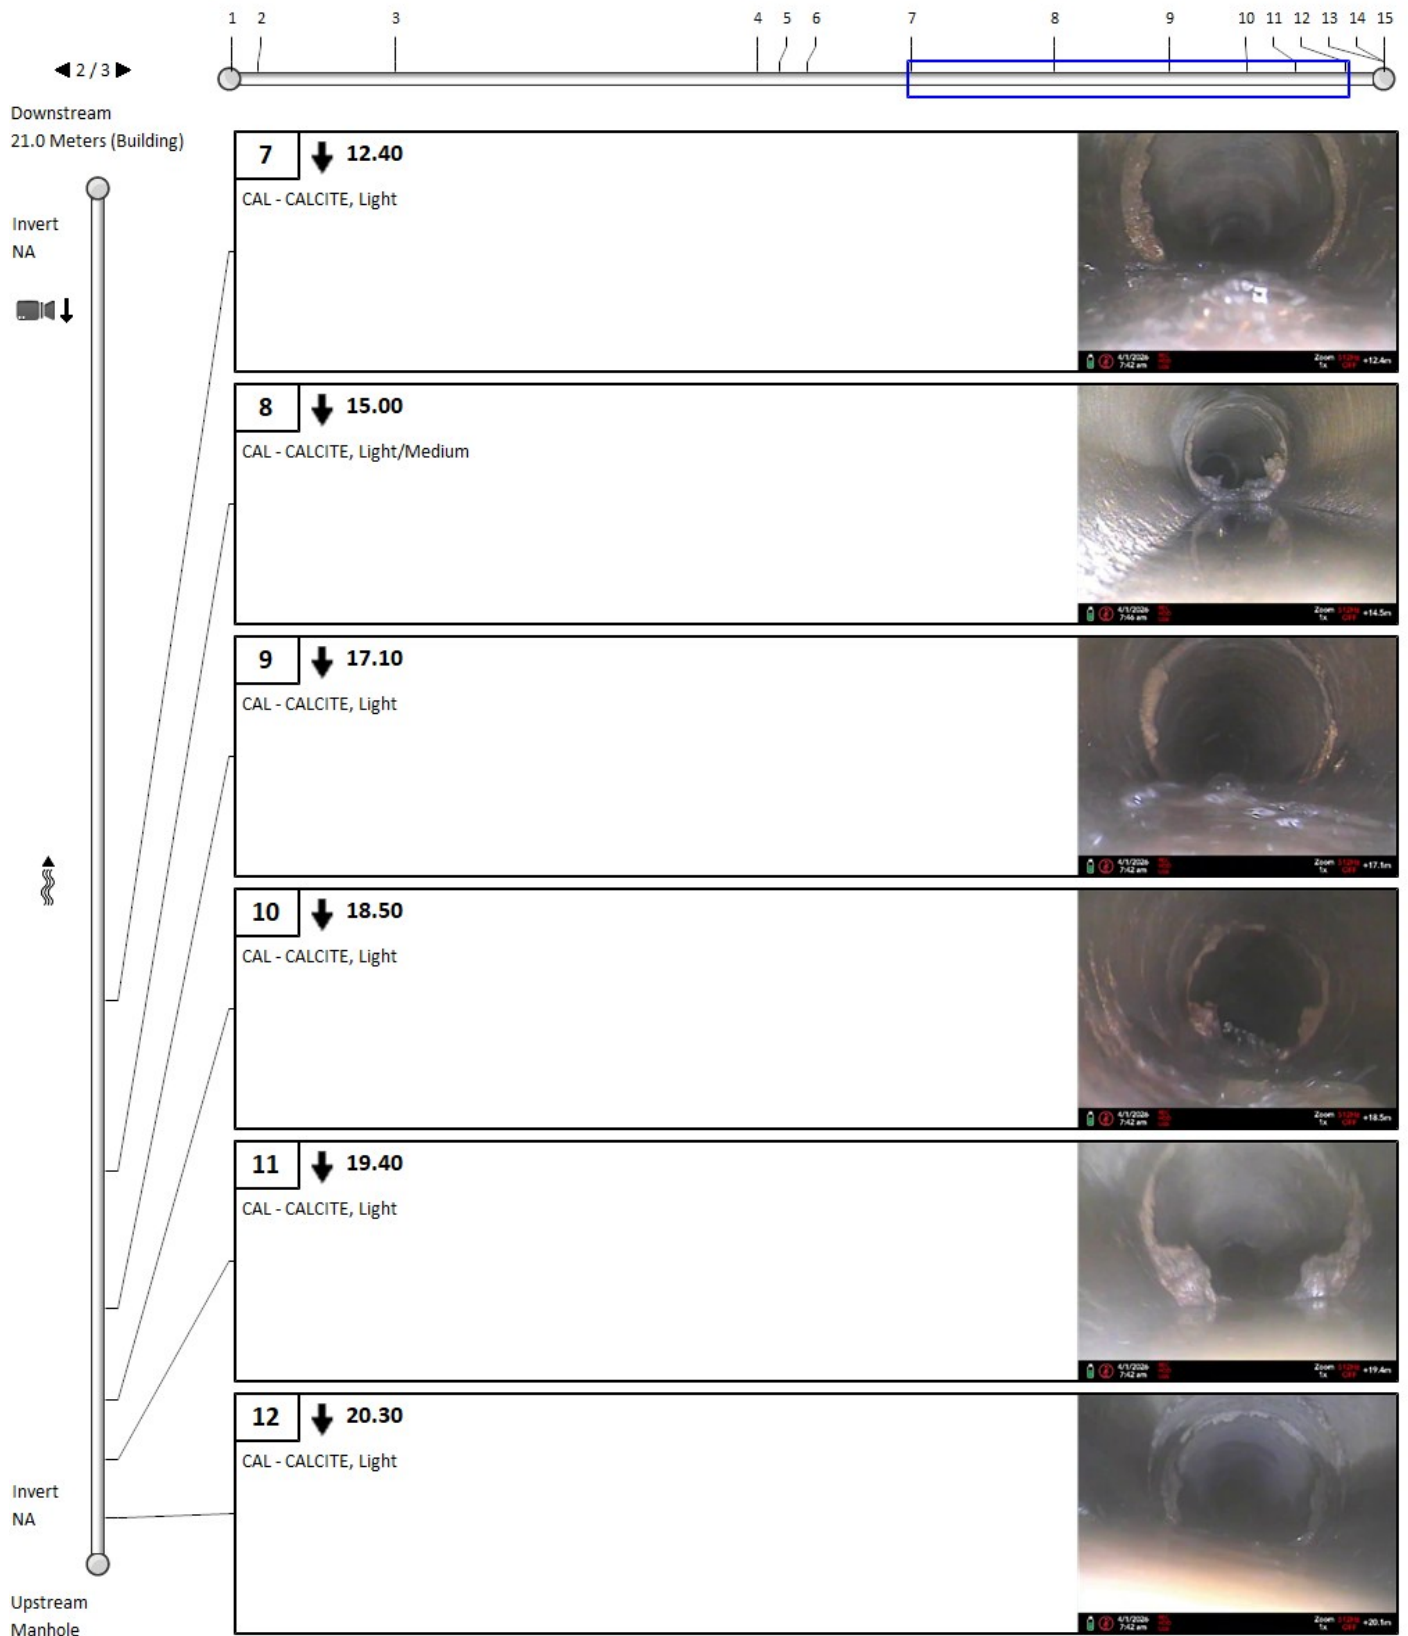
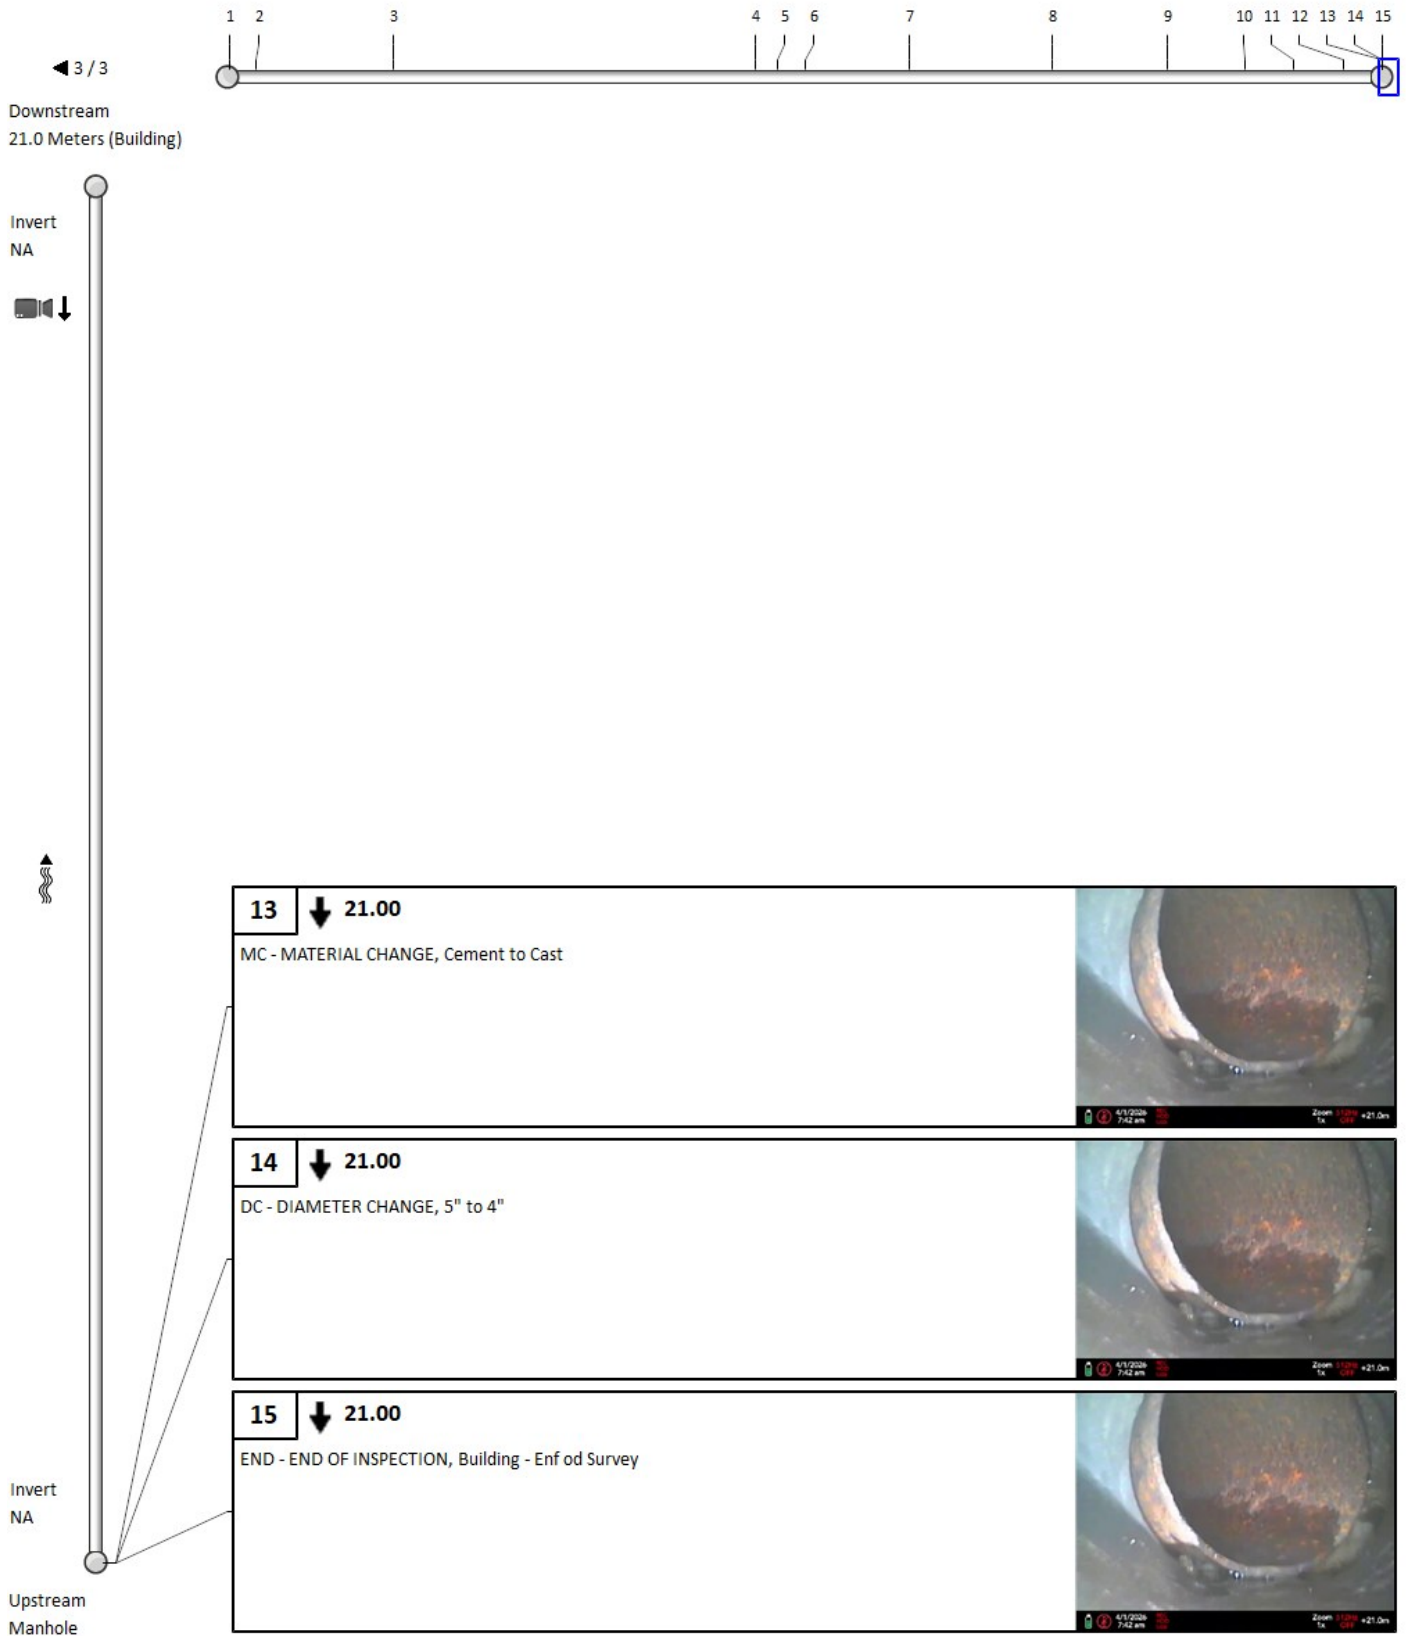
CCTV Inspection From Manhole to 21.0 Meters (Building) Light to Medium Calcite on Almost Every Joint

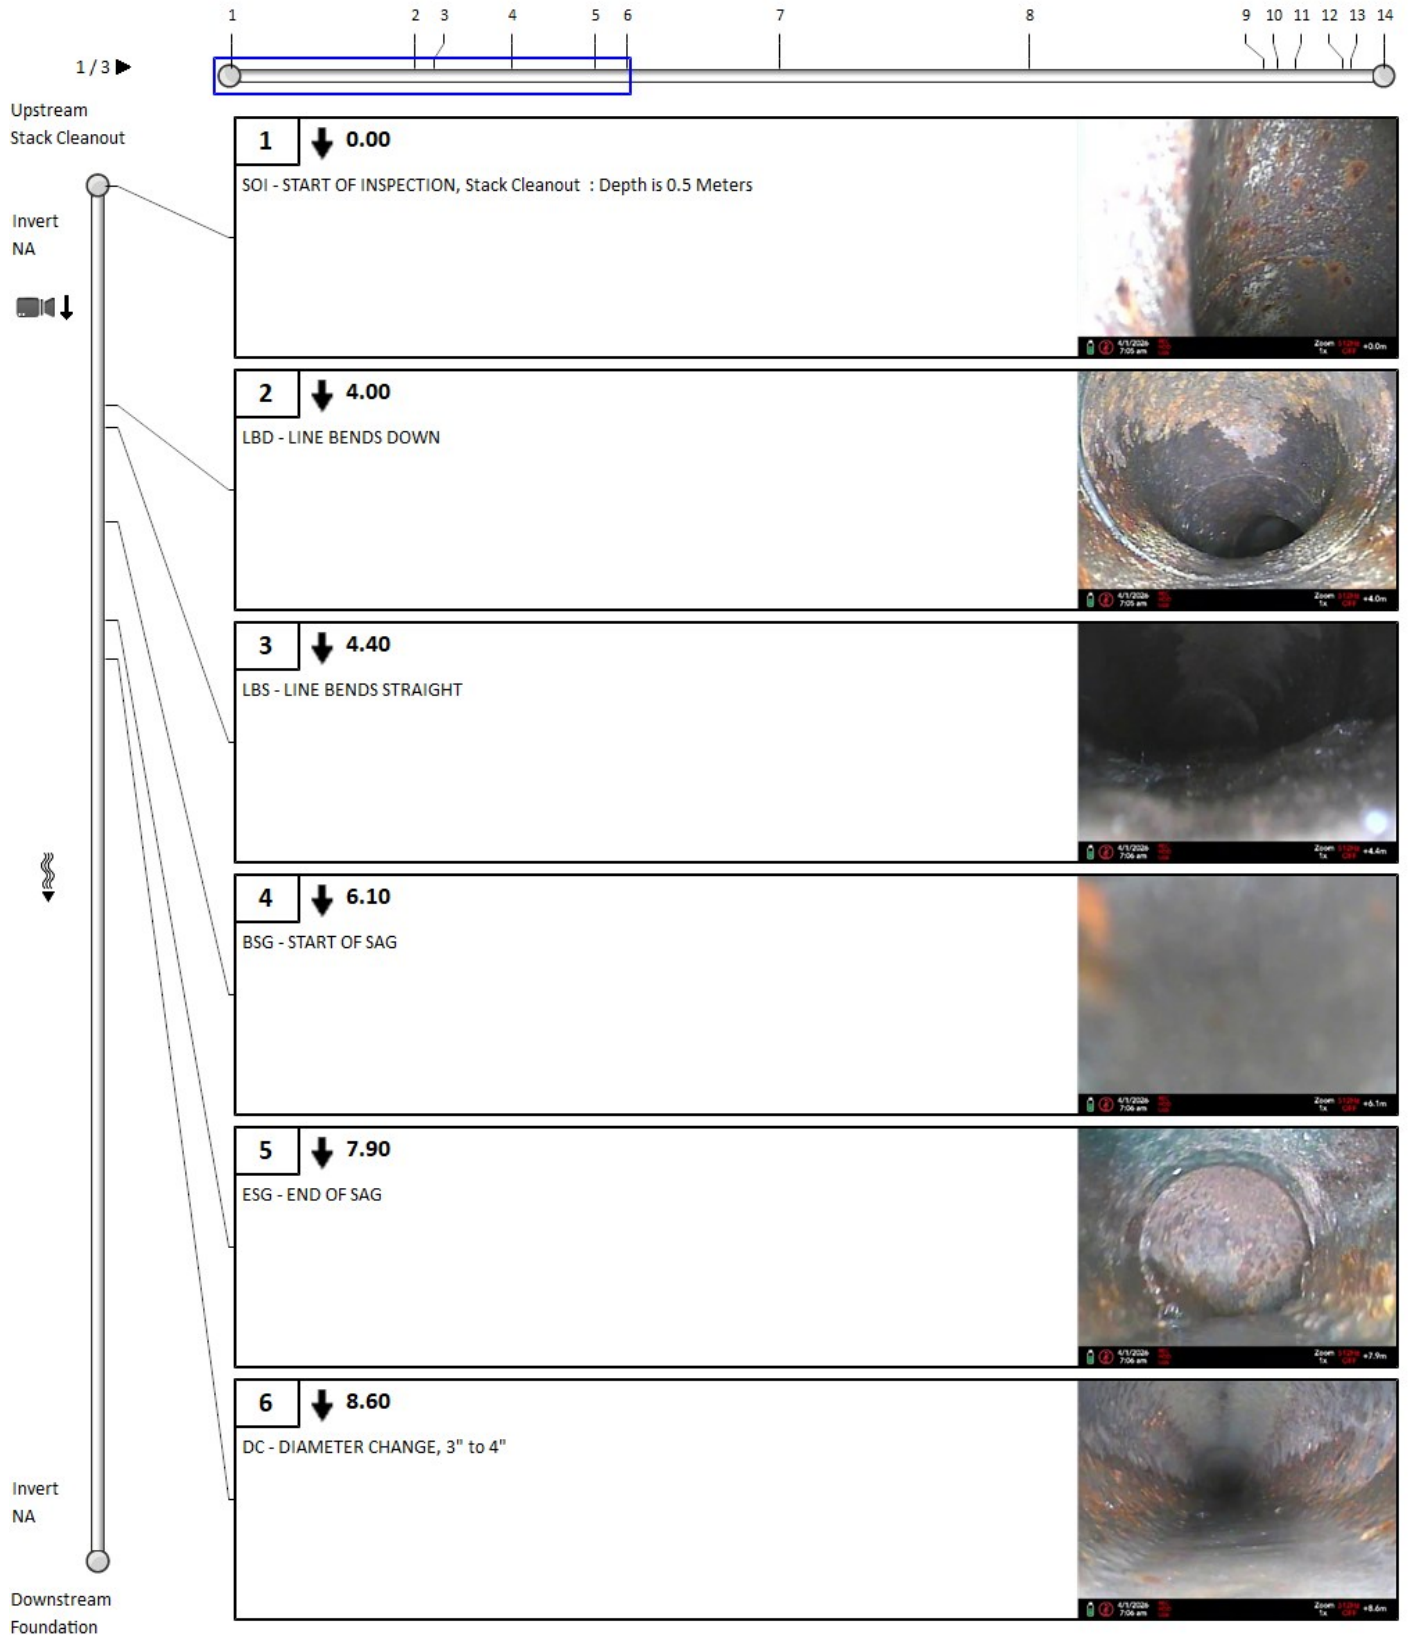
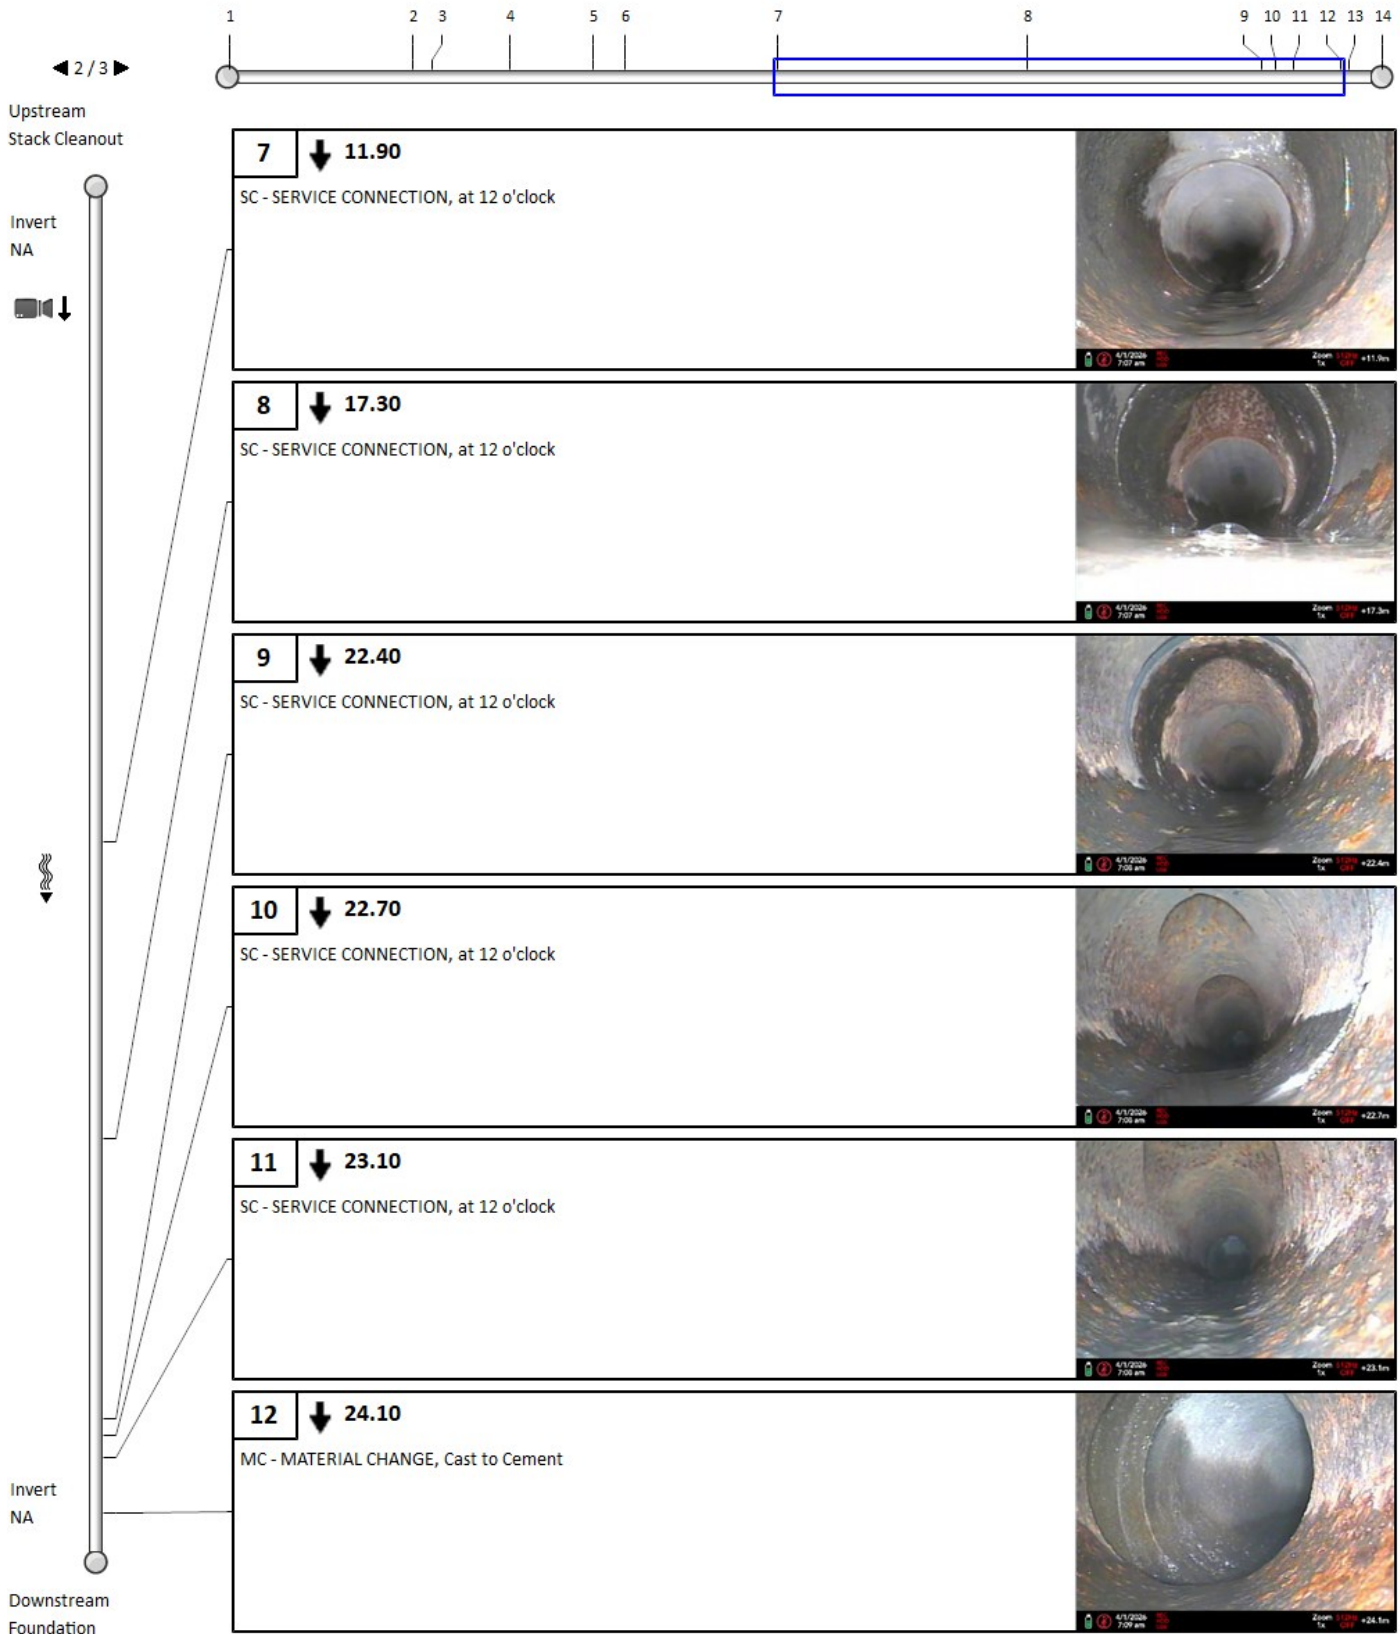
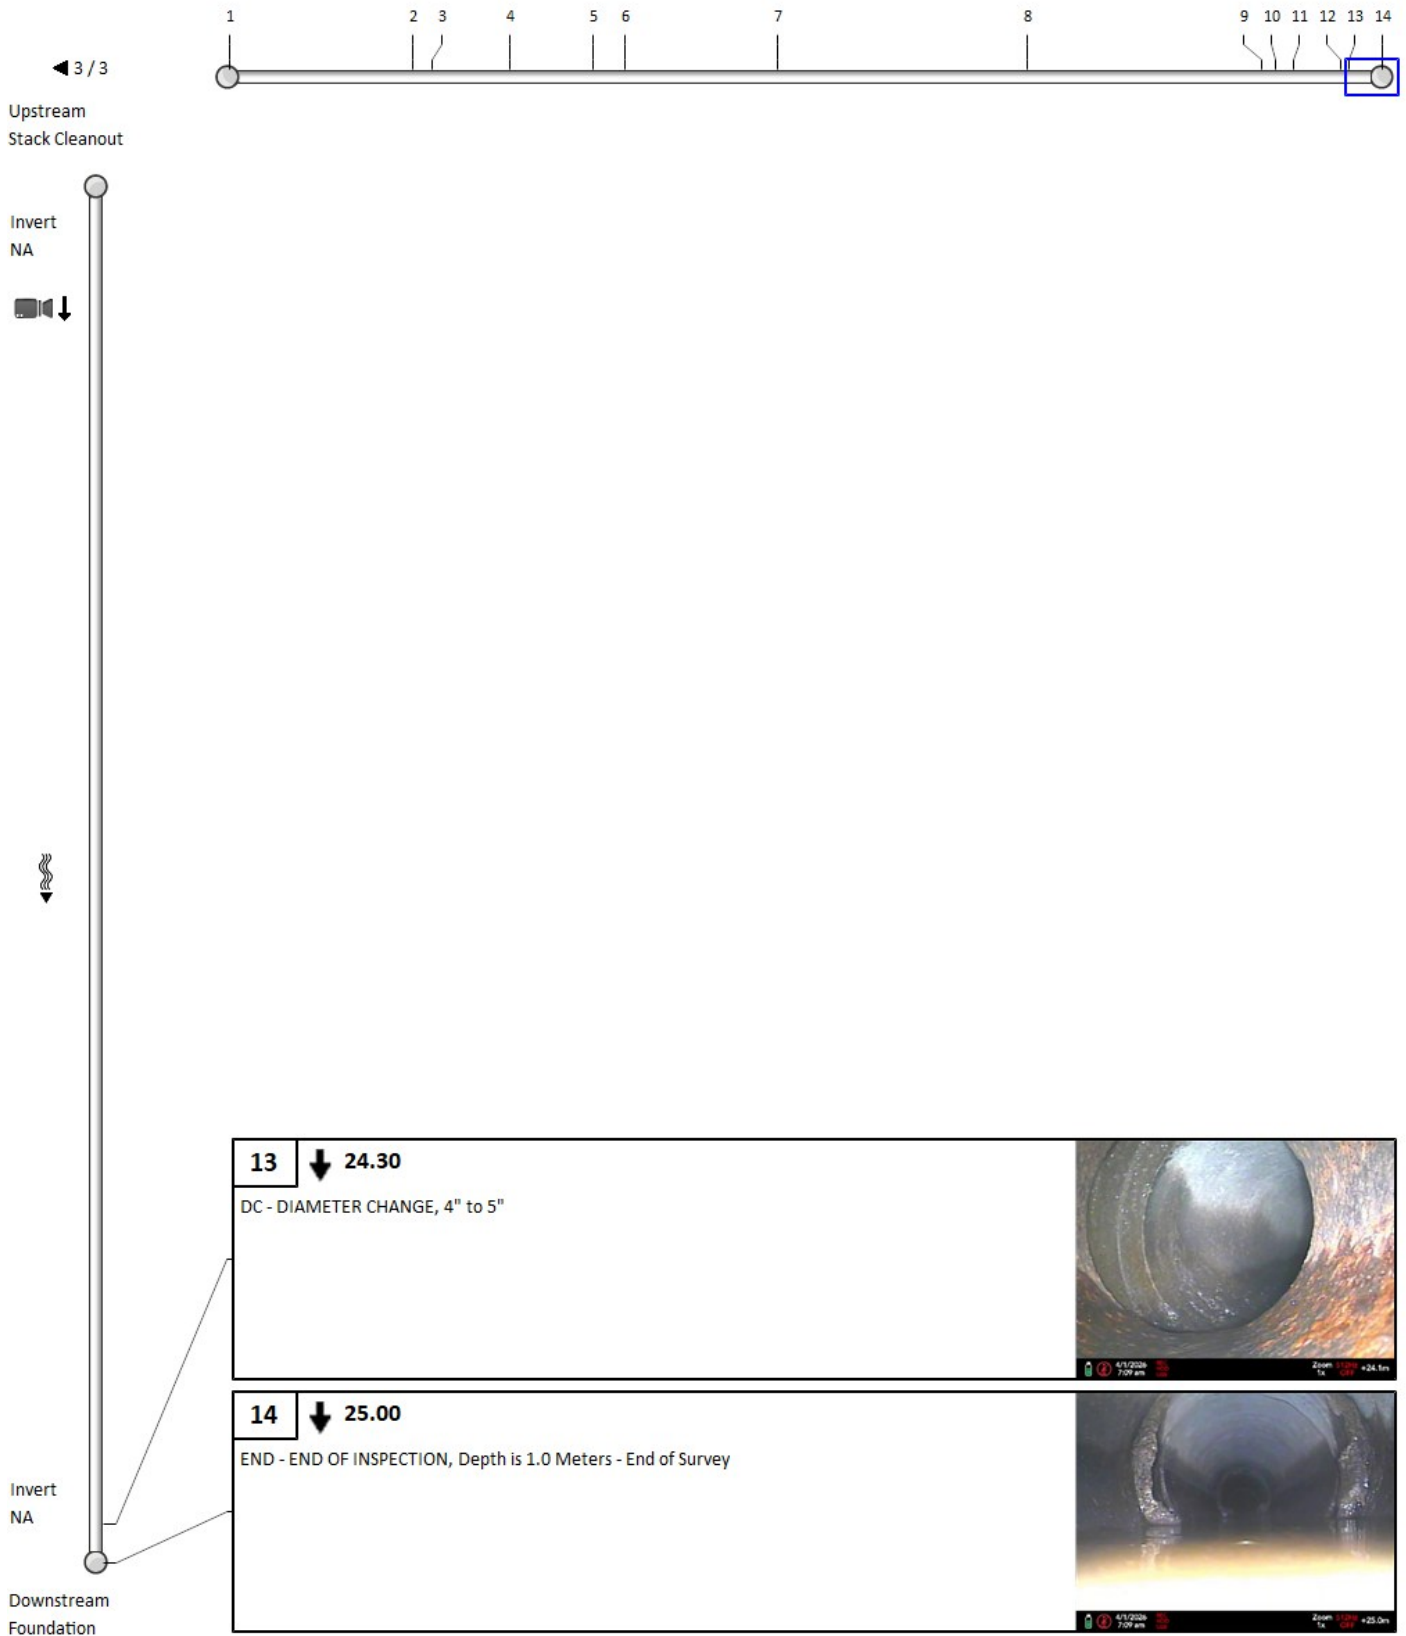
CCTV Inspection of The Storm Lateral From Stack Cleanout to Foundation
--
