VIDEO CAMERA INSPECTION REPORTS

REDLINE ARCHITECTURE INC.

**116 – 118 CARRUTHERS AVENUE
LYNDALE - STONEHURST
OTTAWA**

**SANITARY
APRIL 6, 2026
AQ-4841A**

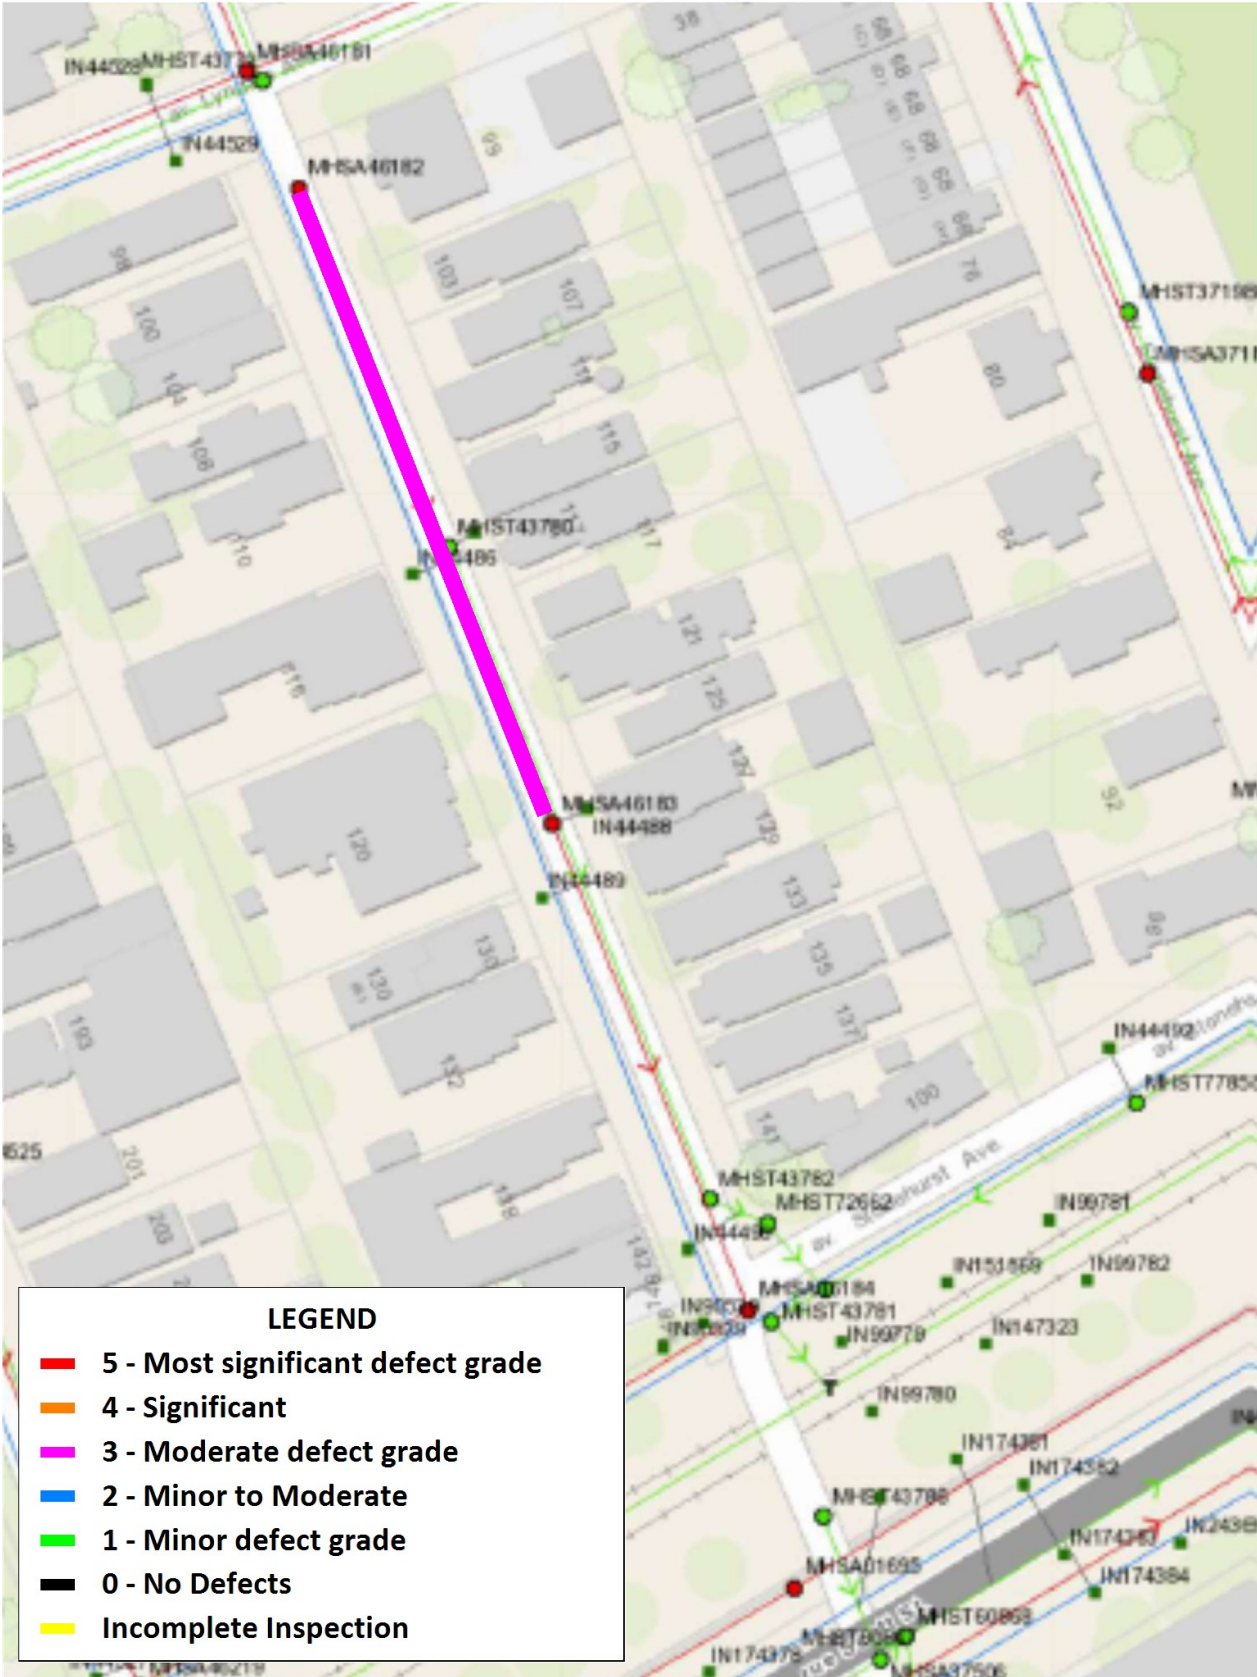
Structural rating map

3 - Moderate defect grade (1 of 1 items)

Score	Quick	Index	Pipe	Upstream	Downstream	Street	Page
3	3100	3	SAN45072	MHSA46182	MHSA46183	CARRUTHERS AVE	9

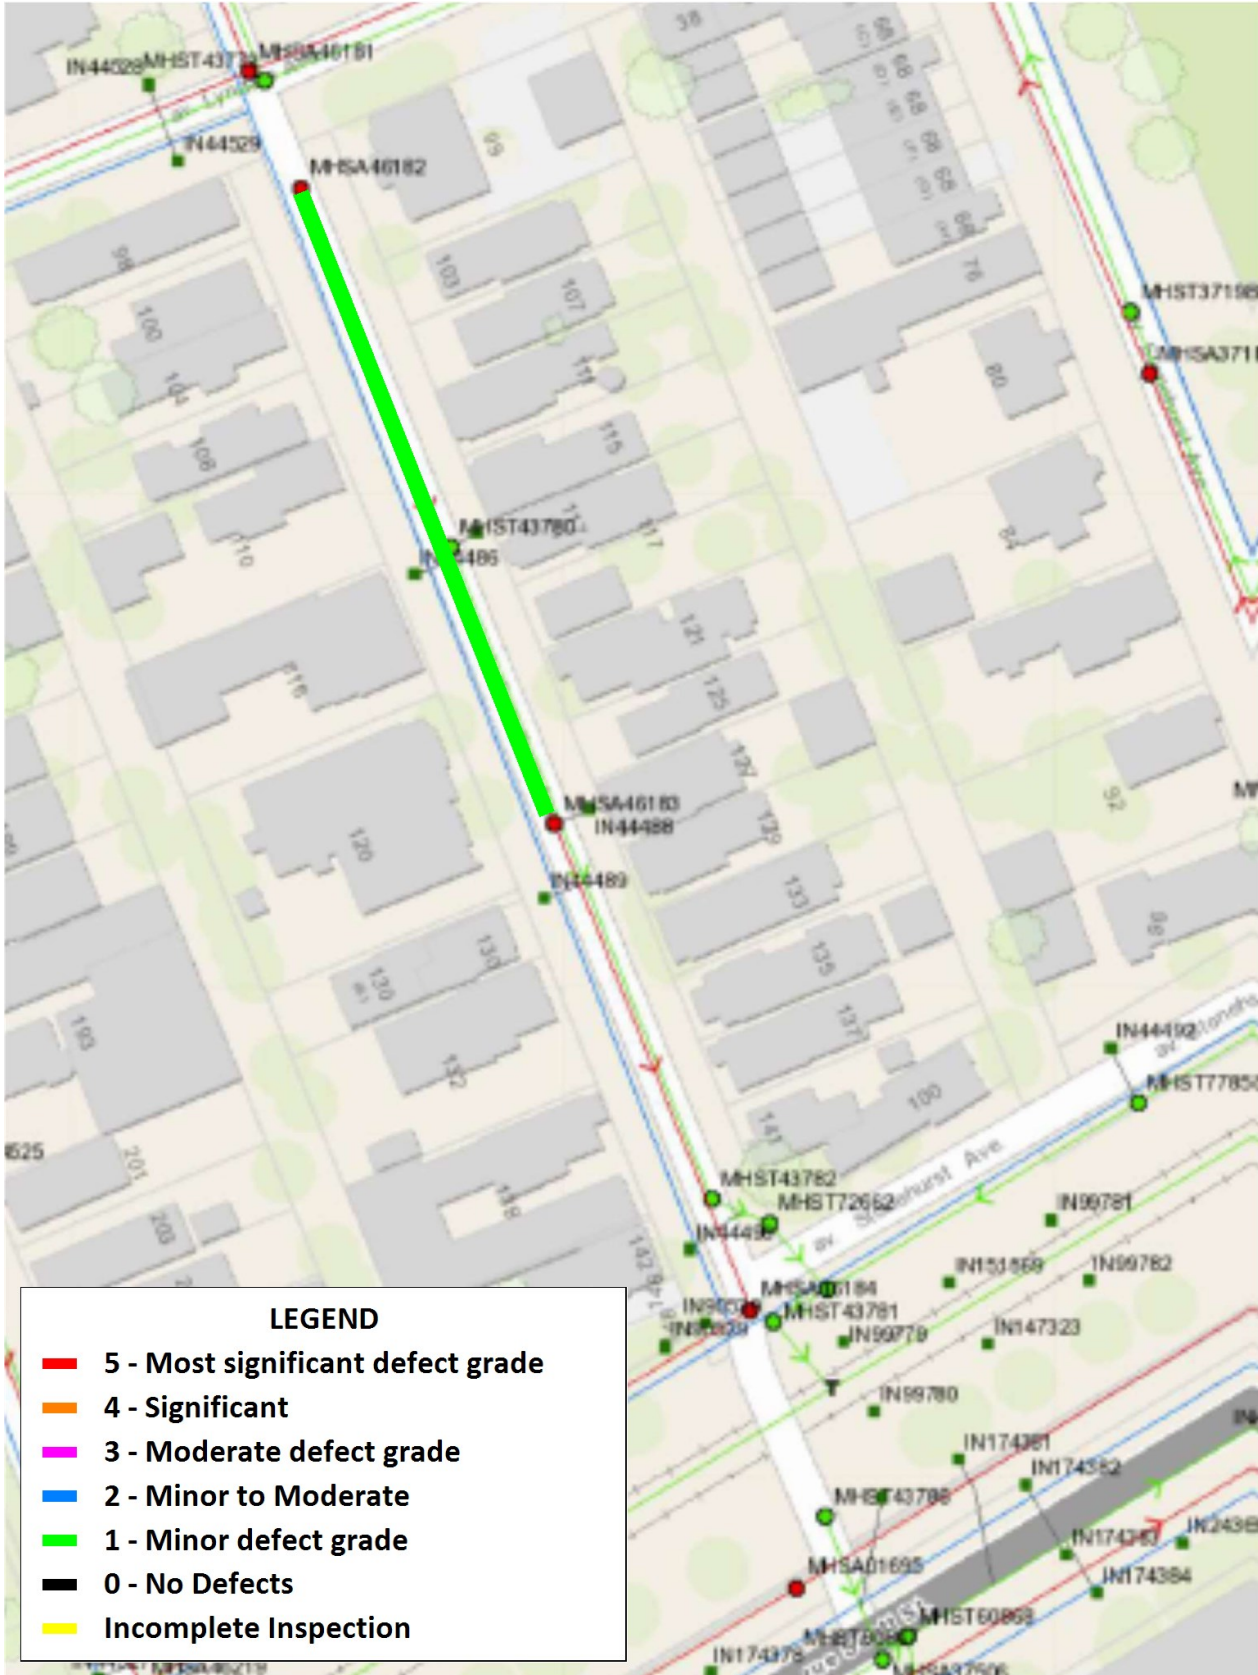
O&M rating map

1 - Minor defect grade (1 of 1 items)

Score	Quick	Index	Structural	Pipe	Upstream	Downstream	Street	Page
1	1100	1	3	SAN45072	MHSA46182	MHSA46183	CARRUTHERS AVE	9
