VIDEO CAMERA INSPECTION REPORTS

**116 – 118 CARRUTHERS AVENUE
LYNDALE - STONEHURST
OTTAWA**

PRE CONSTRUCTION

**STORM
APRIL 6, 2026
AQ-4841B**

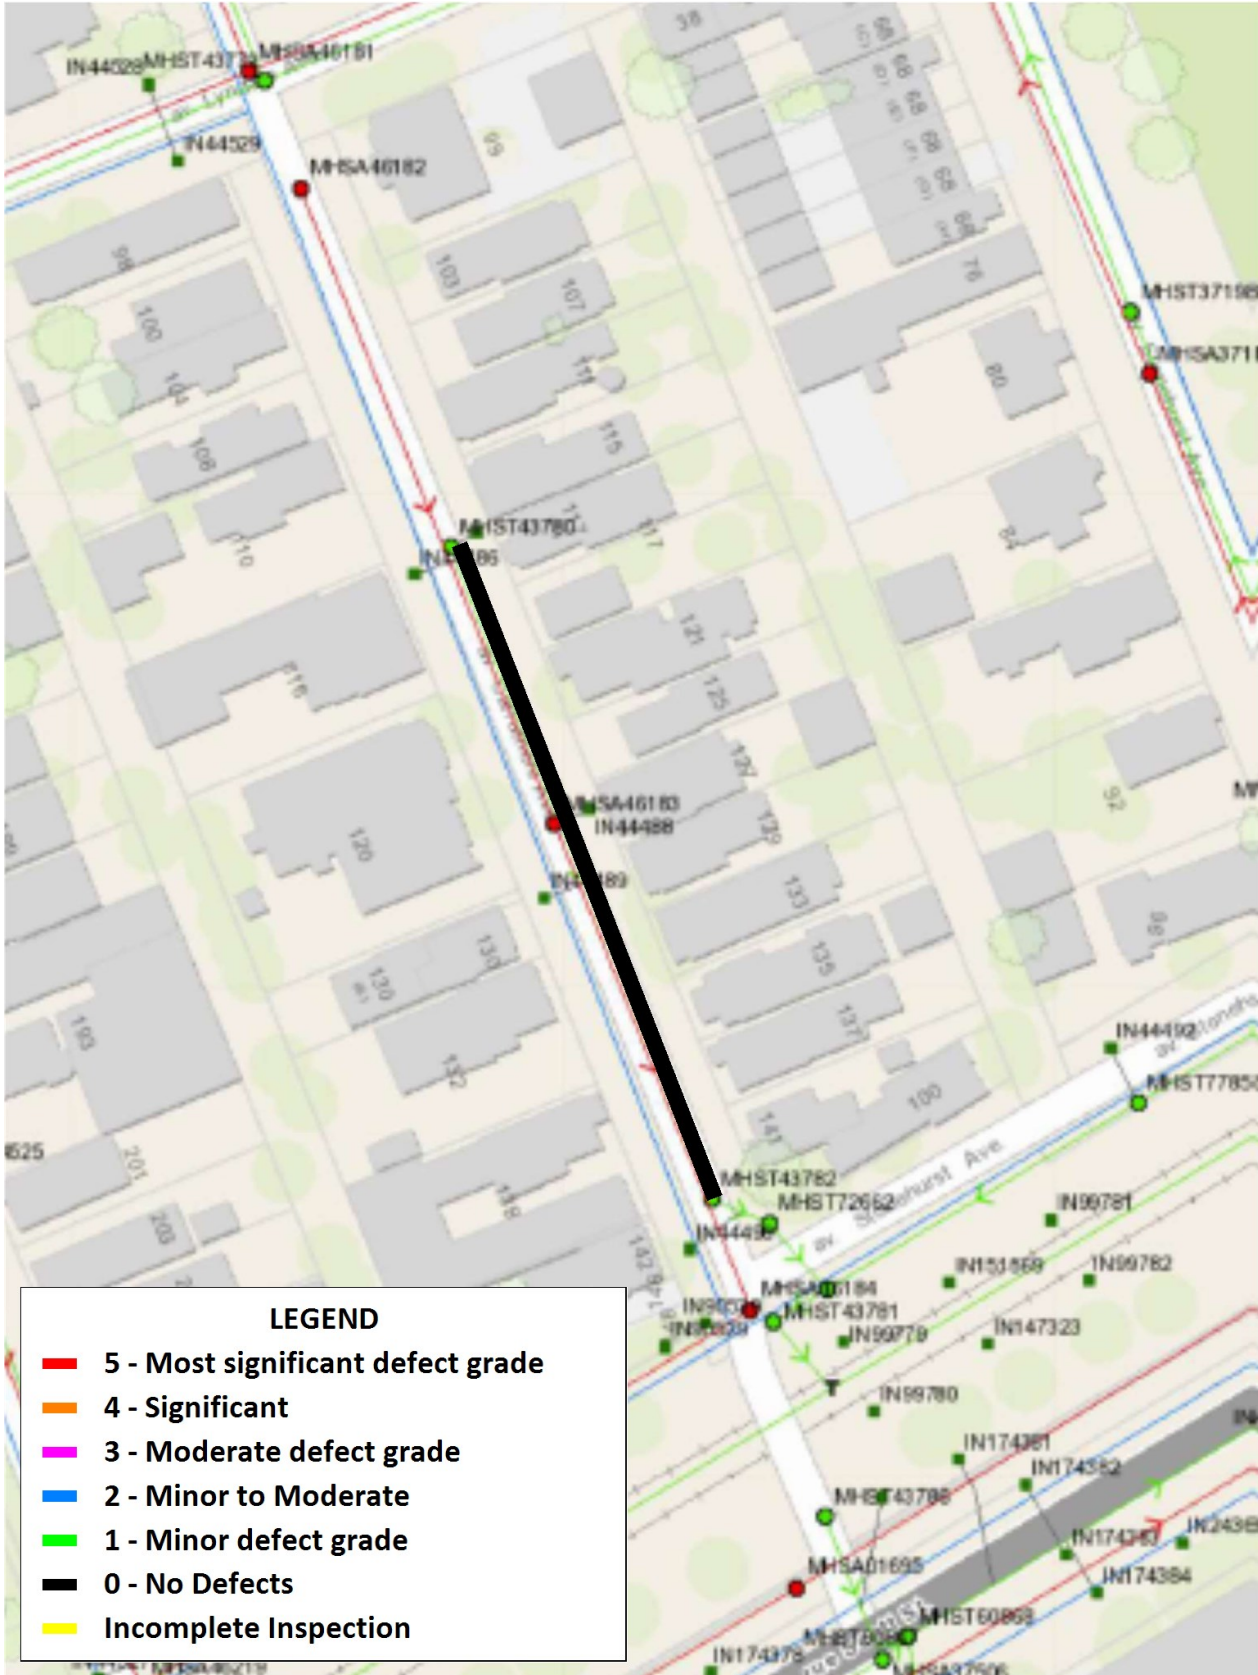
Structural rating map

0 - No Defects (1 of 1 items)

Score	Quick	Index	Pipe	Upstream	Downstream	Street	Page
0	0000	0	STM51095	MHST43780	MHST43782	CARRUTHERS AVE	9

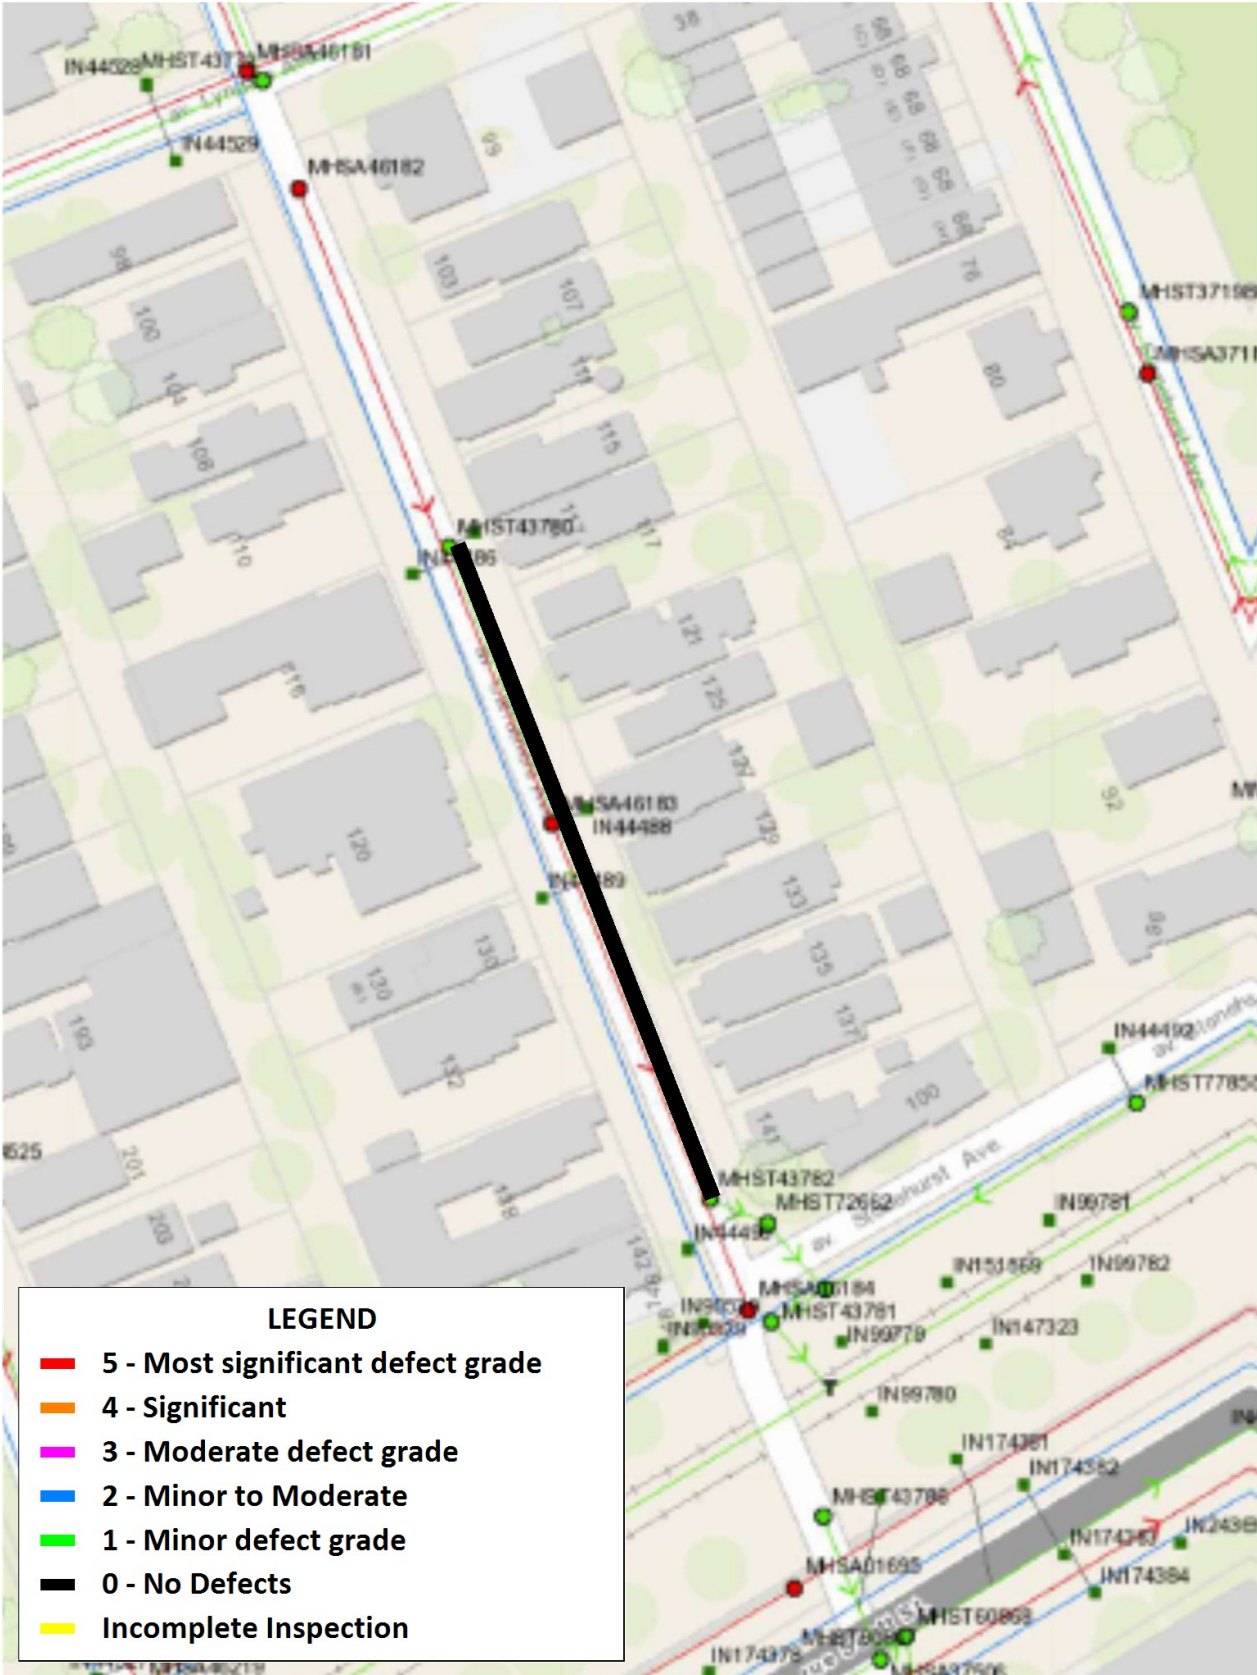
O&M rating map

0 - No Defects (1 of 1 items)

Score	Quick	Index	Structural	Pipe	Upstream	Downstream	Street	Page
0	0000	0	0	STM51095	MHST43780	MHST43782	CARRUTHERS AVE	9
