TREE CONSERVATION REPORT

Ashbury College
362 Mariposa Ave.

April 1st, 2026

Stantec Consulting Ltd.
1331 Clyde Avenue
Ottawa ON K2C 3G4
Project No. 160401942

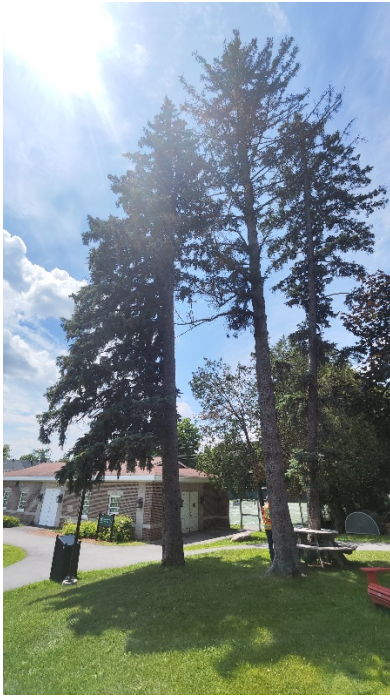
Photograph 1: Three spruce trees (trees #24-26) anticipated to require removal for construction of new pathway.

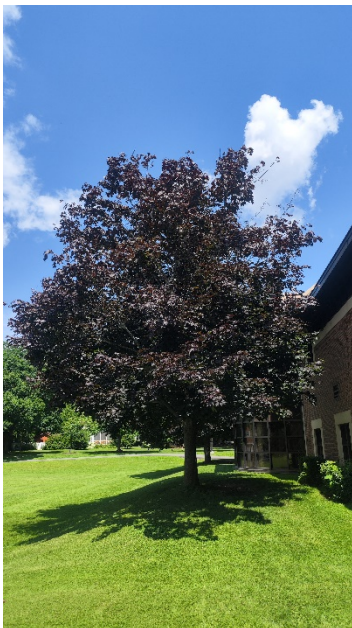
Photograph 2: One of four Norway Maples (trees #8-11) adjacent the College building anticipated to require removal for construction and grading.

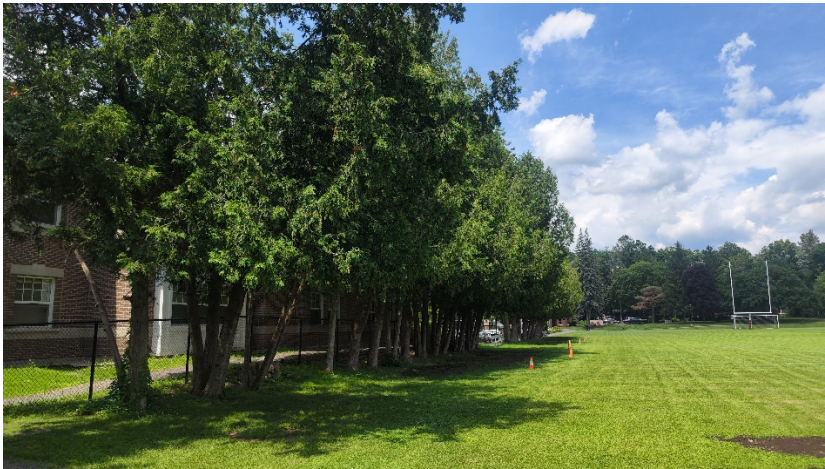
Photograph 3: Mature cedar groupings (G1 & G2) provide shade and screening along the west side of the existing sports field.

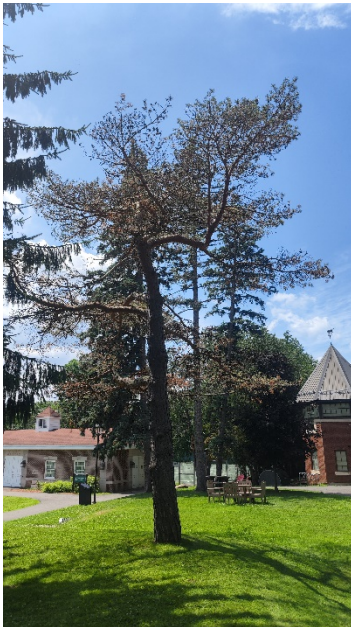
Photograph 4: Scots Pine (tree #23) in significant decline. It is recommended to remove this tree.

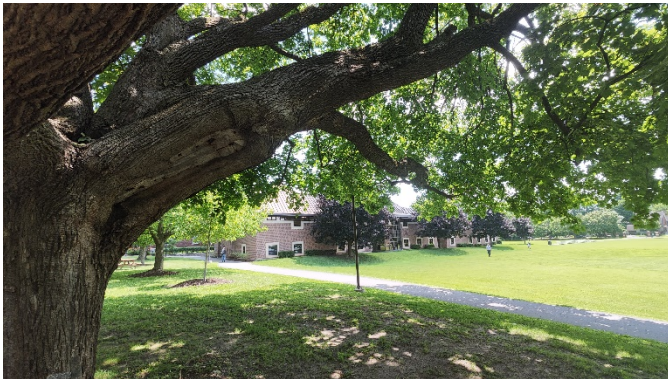
Two trees were assessed as potentially hazardous to the public. Tree #16 is a large and significant Sugar Maple next to a walkway and often used as a backdrop for class photos. It has a large branch extending

Photograph 5: Hazardous limb over pathway on a significant / distinctive Sugar Maple (tree #16).

horizontally over the pathway with significant wood decay at the junction to the trunk potentially weakening its structure and making it prone to breakage. It is recommended that this branch be considered for potential physical supporting / bracing or pruning / removal to mitigate the risk of fall hazard to pathway and campus users. Tree #18 is a large Norway Maple that has significant rot in the trunk, with a natural lean towards a nearby building. It should be considered for removal.

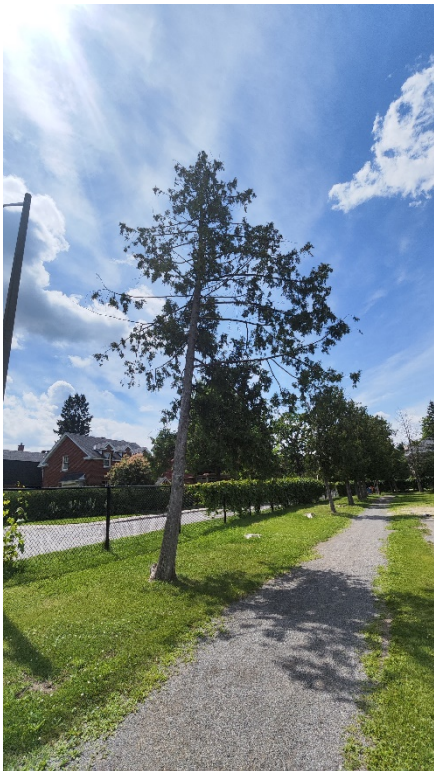
A mature stand of White Cedars (*Thuja occidentalis*) aligned in dense rows adjacent to Maple Lane and Mathews House (south and south-west side of study area) have become conical in form with dense intertwined canopies. It should be noted that although not identified on site, mature White Cedars can be susceptible to heart rot causing hollow trunks as they age. Also, several cedar trees within these groupings have canopies which are significantly suppressed by adjacent cedars and large deciduous trees.

Photograph 6: Cedar trees along the south side of the existing sports field no longer form a continuous canopy.

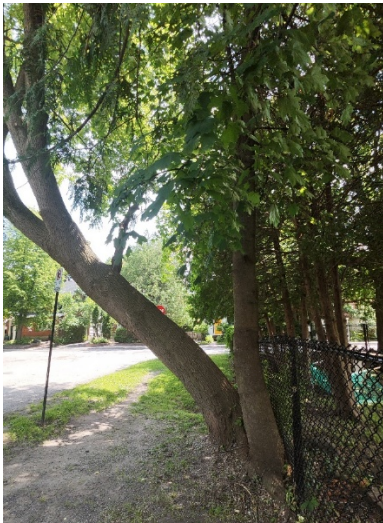
Photograph 7: Several trees located outside of private property on municipal right-of-way.

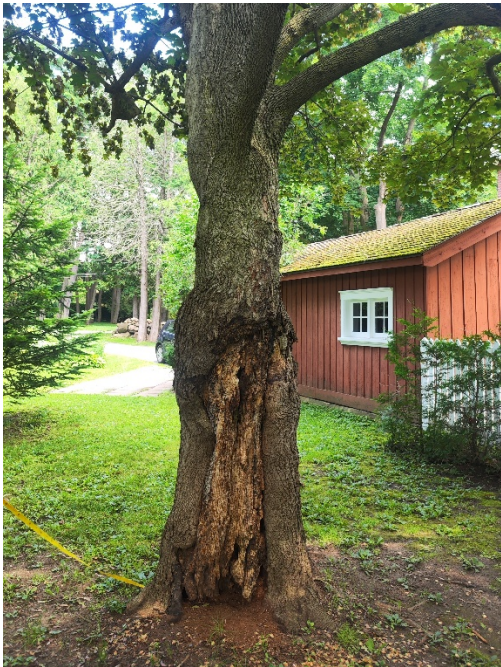
Photograph 8: Hazardous tree (#18) near Ashbury House with severe rot in base of trunk.
