RE: TREE PROTECTION PLAN FOR 2040 ARROWSMITH DRIVE, OTTAWA

This tree protection plan was prepared by IFS Associates Inc. (IFS Inc.) in support of a building permit for 2040 Arrowsmith Drive in Ottawa. The need for this report is related to trees protected under the City of Ottawa's Tree Protection By-law (By-law No. 2020-340). The work proposed includes demolishing existing buildings and construction of a six-storey mixed-use building (see plan on page 7 of this report). A driveway with retaining wall and curb is proposed for the rear of the building and is adjacent to a stand of trees on the neighbouring property at 2000 Jasmine Crescent. This plan details efforts to ensure the successful retention of these trees.

DRAWING: Tree Protection Plan

PROJECT: 2040 ARROWSMITH DRIVE
CITY OF OTTAWA

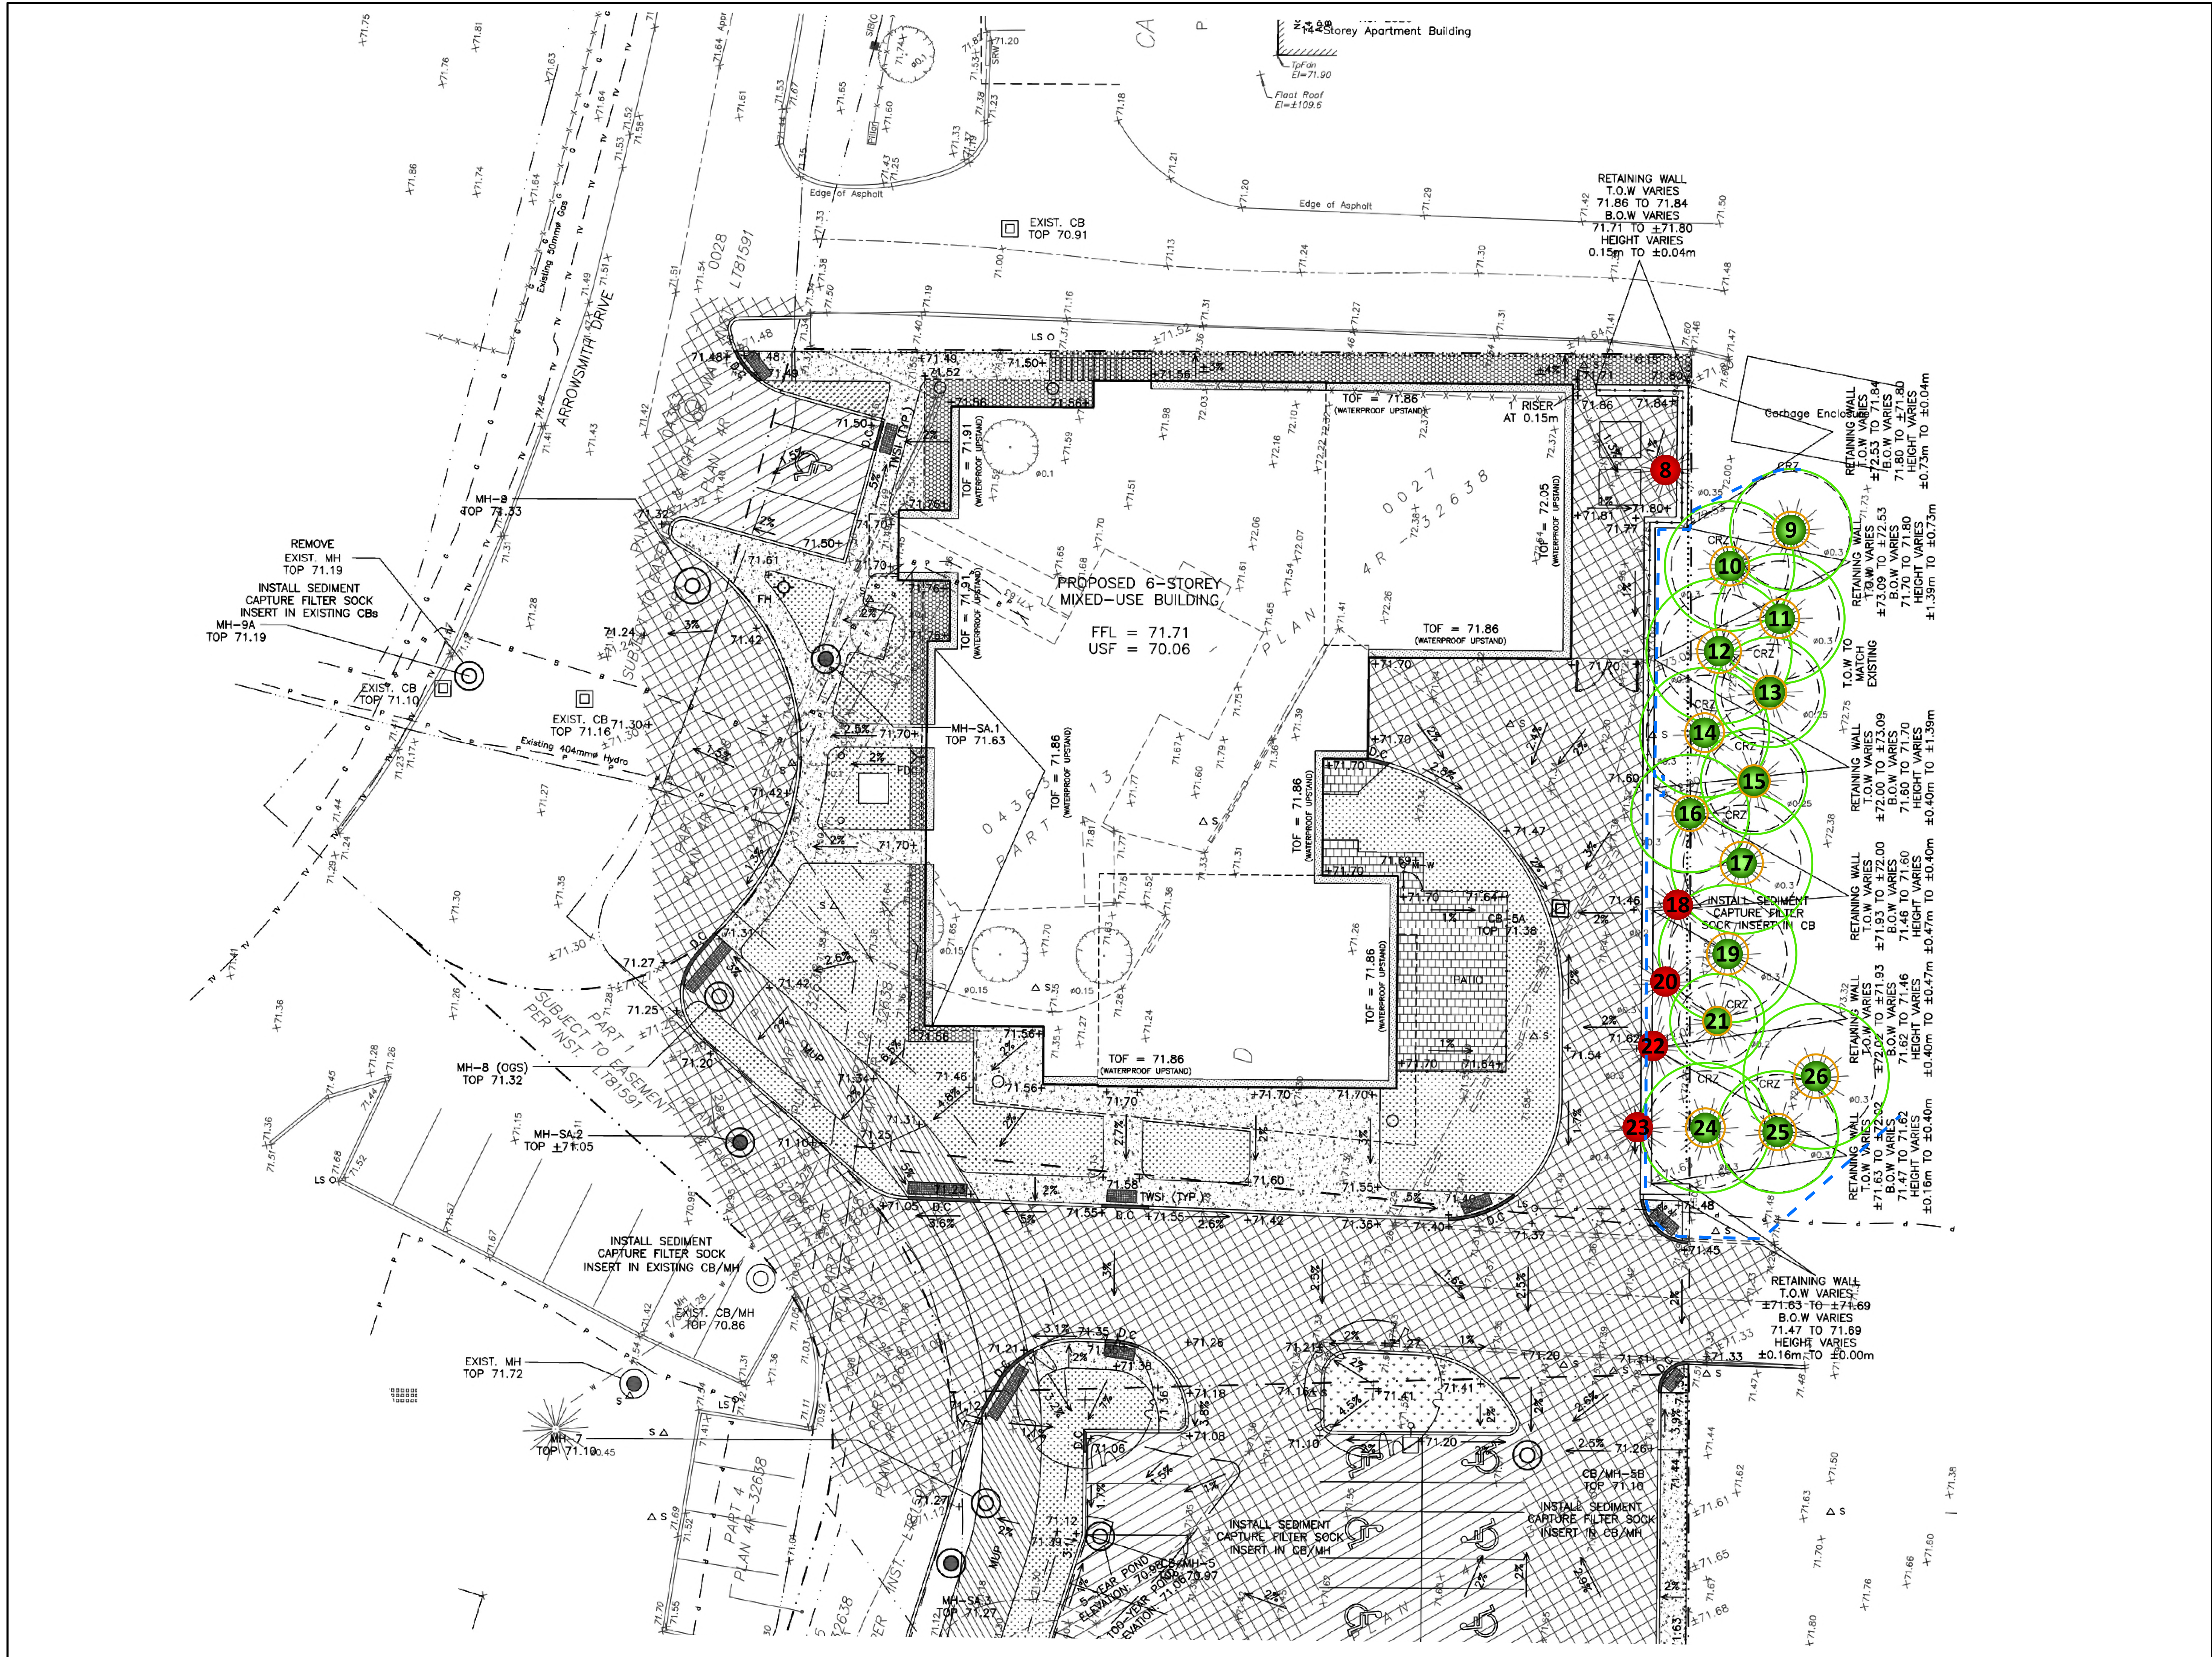
At most, 30% of one tree’s CRZ (tree #16) will be impacted by grading. This equals the maximum recommended in ISA best management practices. As shown in the plan on page 7, no static root zones will be impacted.

The consulting engineer and forester have discussed the implications of the work proposed along the eastern edge of the site. Grading behind the proposed retaining wall remains as existing. Approximately 30% of the CRZ of tree #16 will be impacted while lesser amounts of the CRZs of trees #10, 12, 14 and 24 will be impacted.

As excavation for the proposed retaining wall is proposed within the CRZs of trees #10, 12, 14, 16 and 24, the following measures will be taken:

1. Hydro excavation along the edge of excavation in proximity to the tree to carefully expose roots. Exposed roots will then be cleanly cut and sealed before being reburied (see City of Ottawa root pruning detail on page 12). Excavation can then resume using traditional mechanical means. Sealing the cleanly cut root ends with a beeswax product will help prevent the loss of moisture and facilitate healing.
2. If the excavation is to be left open for any length of time a covering of at least three layers of moistened burlap is to be draped over the exposed face of excavation closet to the tree. A final covering of clear plastic will help retain moisture within the burlap. The use of burlap and plastic coverings will help reduce the loss of moisture from the soil surrounding the remaining roots.

The stumps of trees #1 through 8 will be excavated as part of typical site preparation. No special considerations are required. It is recommended to leave stumps of trees #18 and 20 in place, cut as low as possible to the ground. This will avoid damaging roots of the trees to remain (nearby trees of the same species will fuse roots). If stump grinding is necessary then only the stumps themselves, and not surrounding root plate, should be ground down 10-15cm, the grindings removed and backfilled with topsoil. Topsoil can be added to cover any exposed surface roots within the root plate.

The stumps of trees #22 and 23 will be partially removed to install the proposed retaining wall. It is likely an excavator will be used for this work. If root pruning is completed first little damage to the roots of adjacent trees is anticipated.

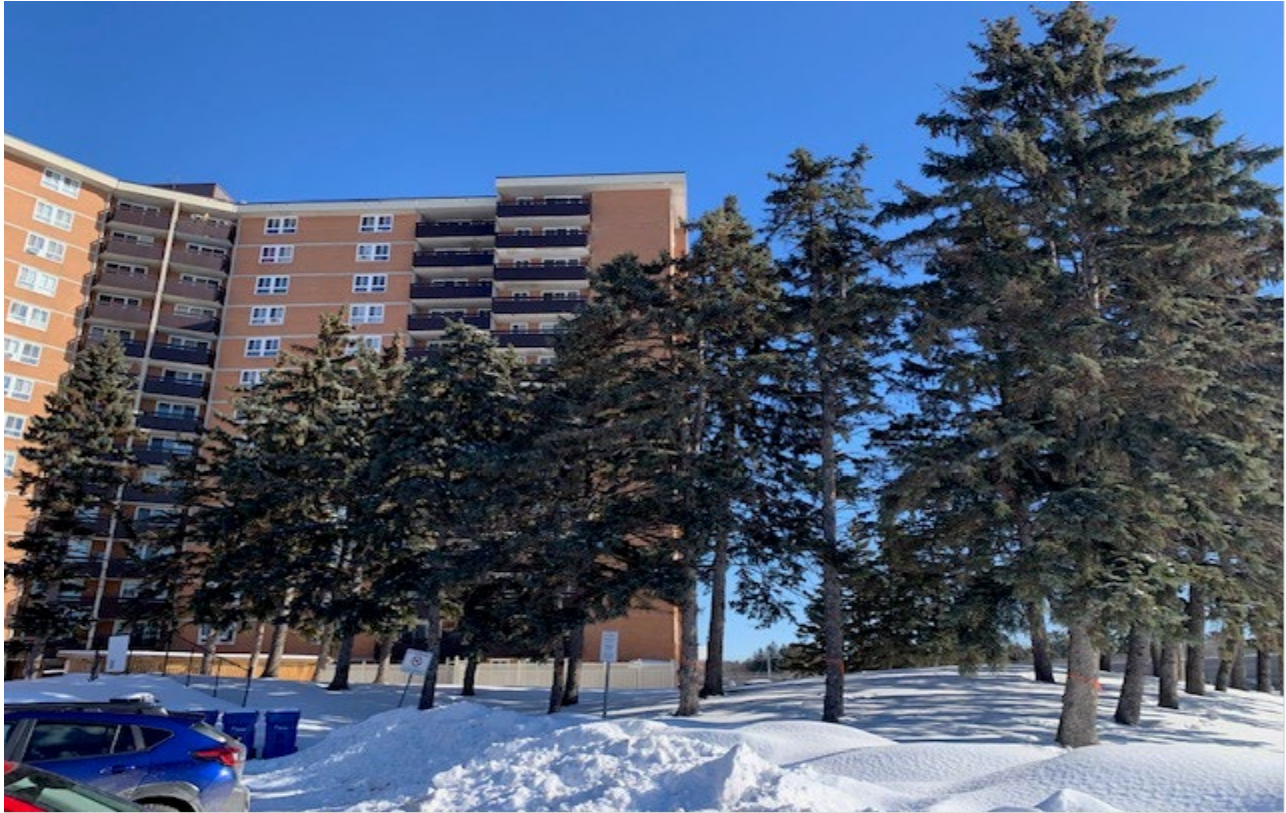
Picture 1. Trees #8 to 23 (left to right) – Colorado spruce trees on and adjacent to 2040 Arrowsmith Drive

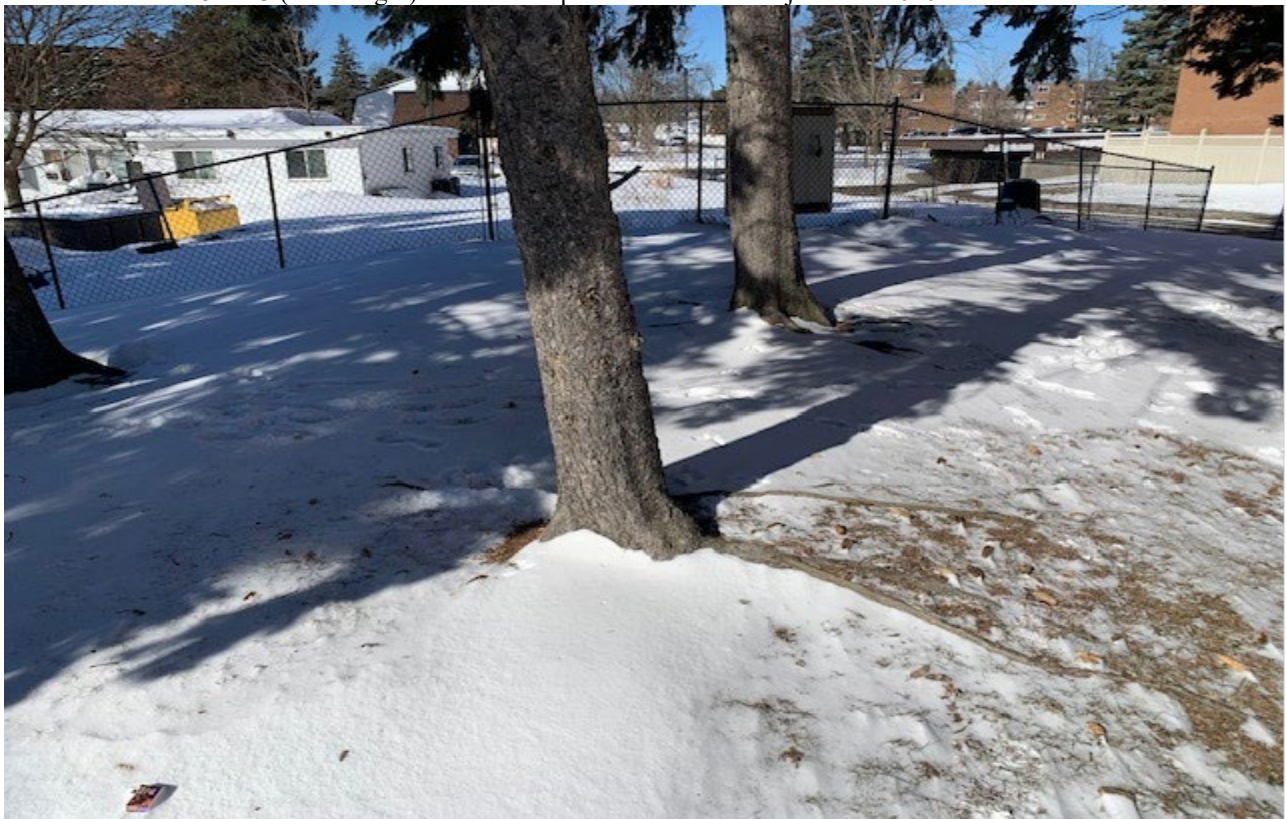
Picture 2. Rooting conditions below Colorado spruce trees on and adjacent to 2040 Arrowsmith Drive (note exposed surface roots)

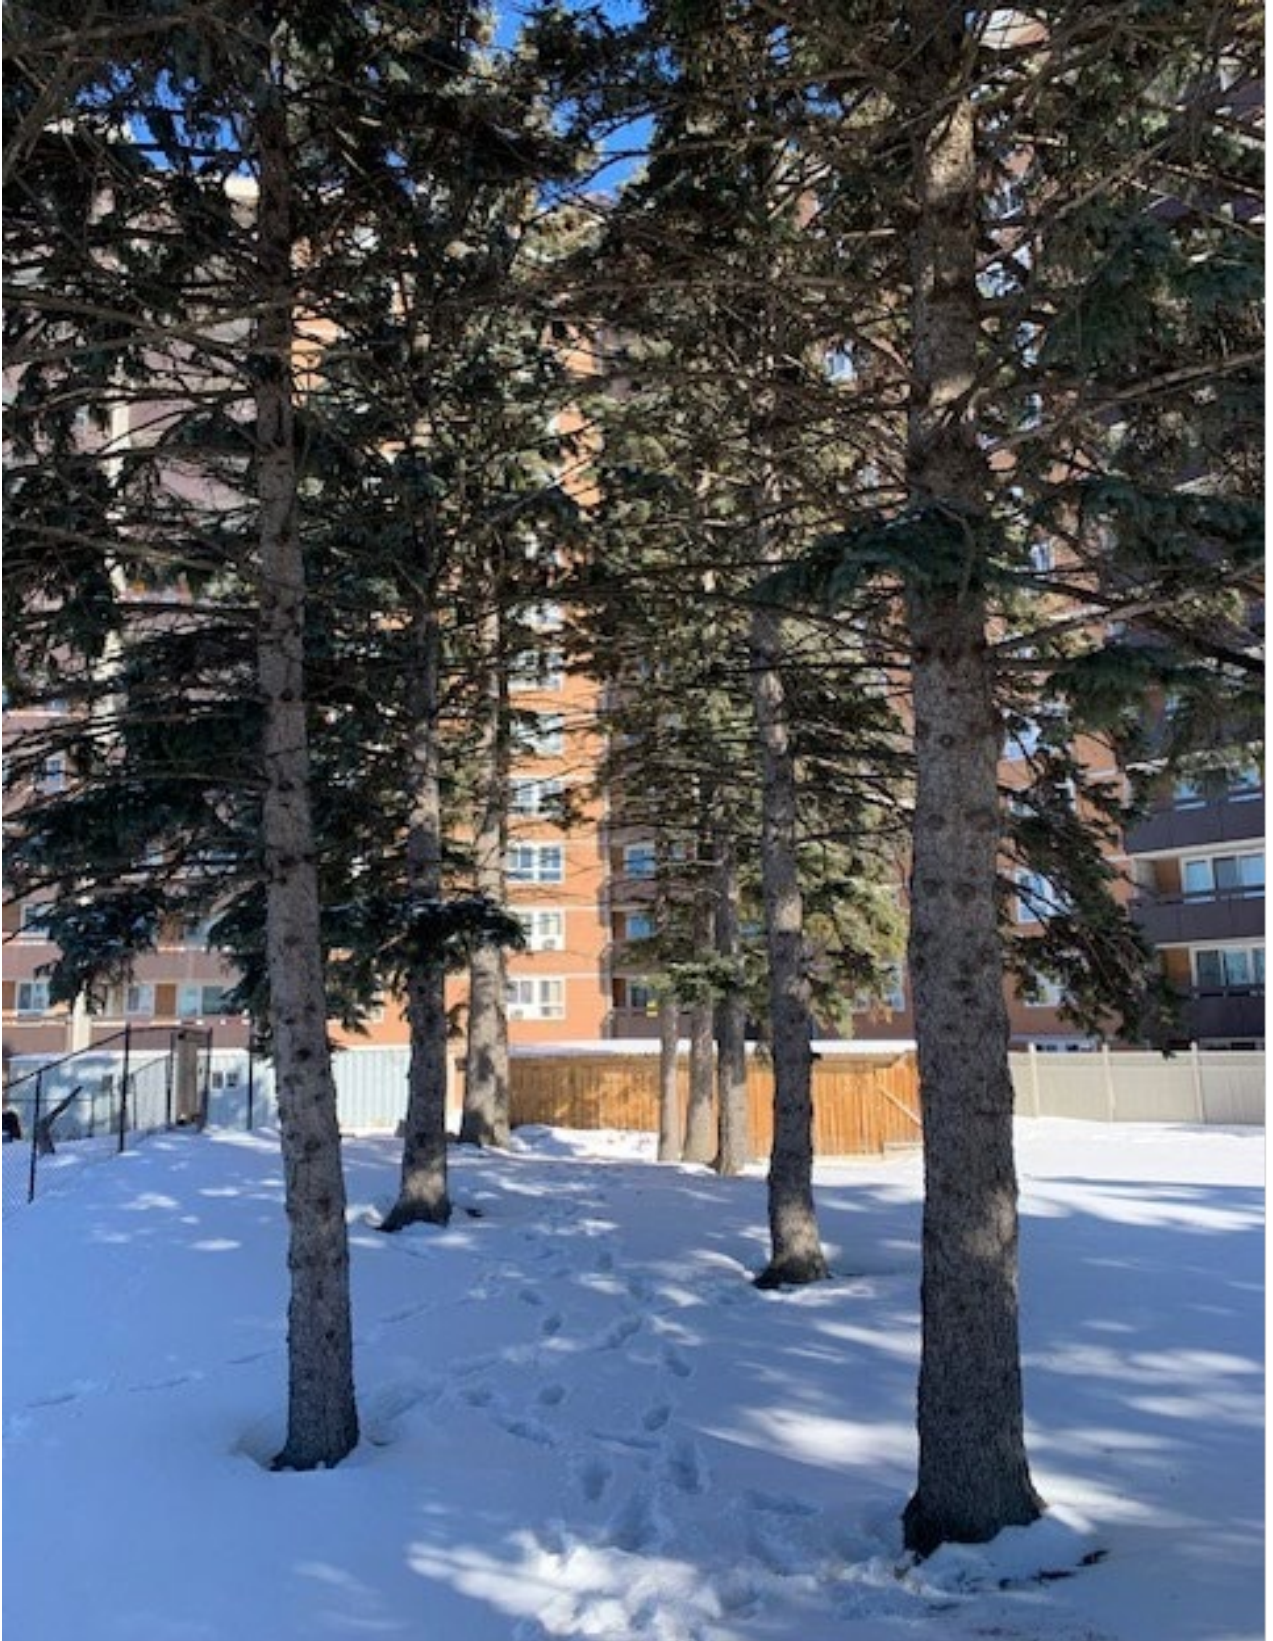
Picture 3. Lines of Colorado spruce trees adjacent to 2040 Arrowsmith Drive

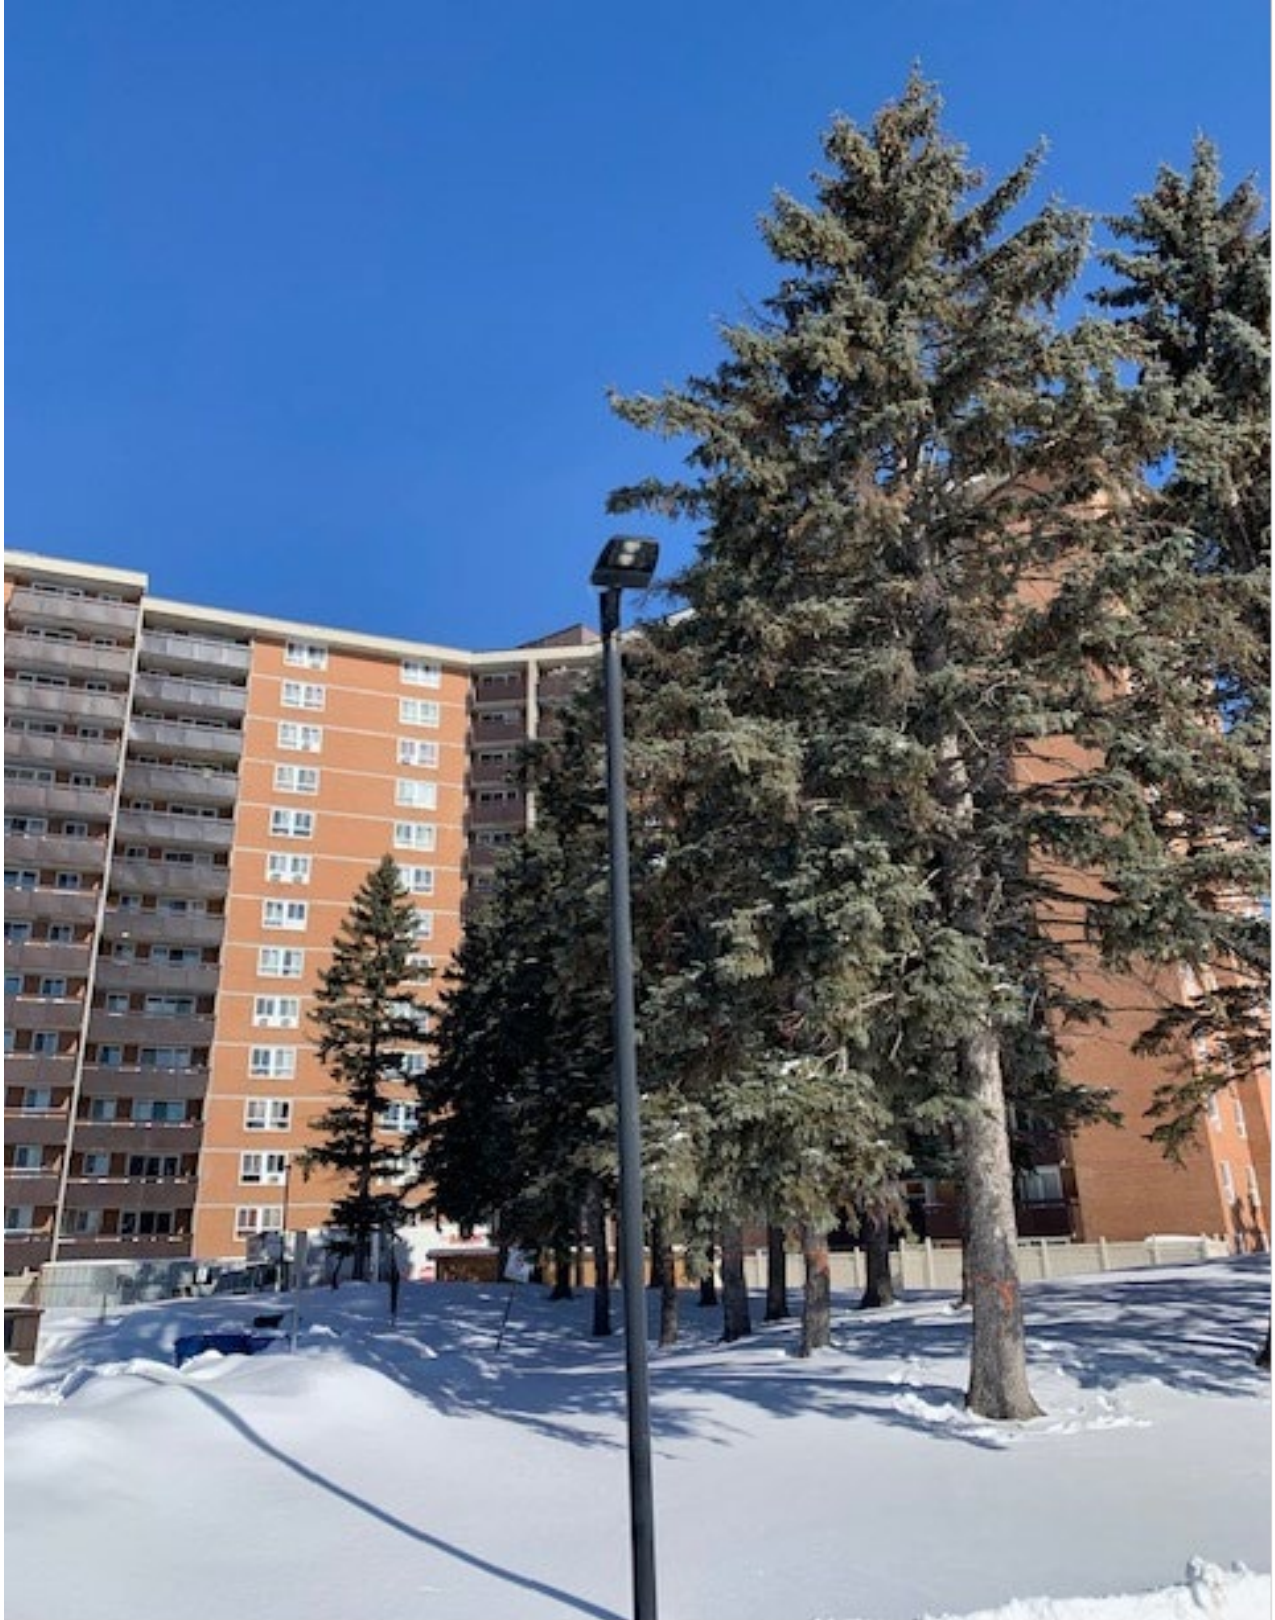
Picture 4. Colorado spruce trees on and adjacent to 2040 Arrowsmith Drive (note trees marked for removal with flagging tape)
