# TREE CONSERVATION REPORT

Tree Conservation Report submitted as Partial  
Requirements for a Site Plan Control Application  
for 1480 Richmond Rd and 2625 Carling Ave. June  
26, 2026

**Address:** 1480 Richmond Rd and 2625 Carling Ave.

**Date of Report:** June 26, 2026

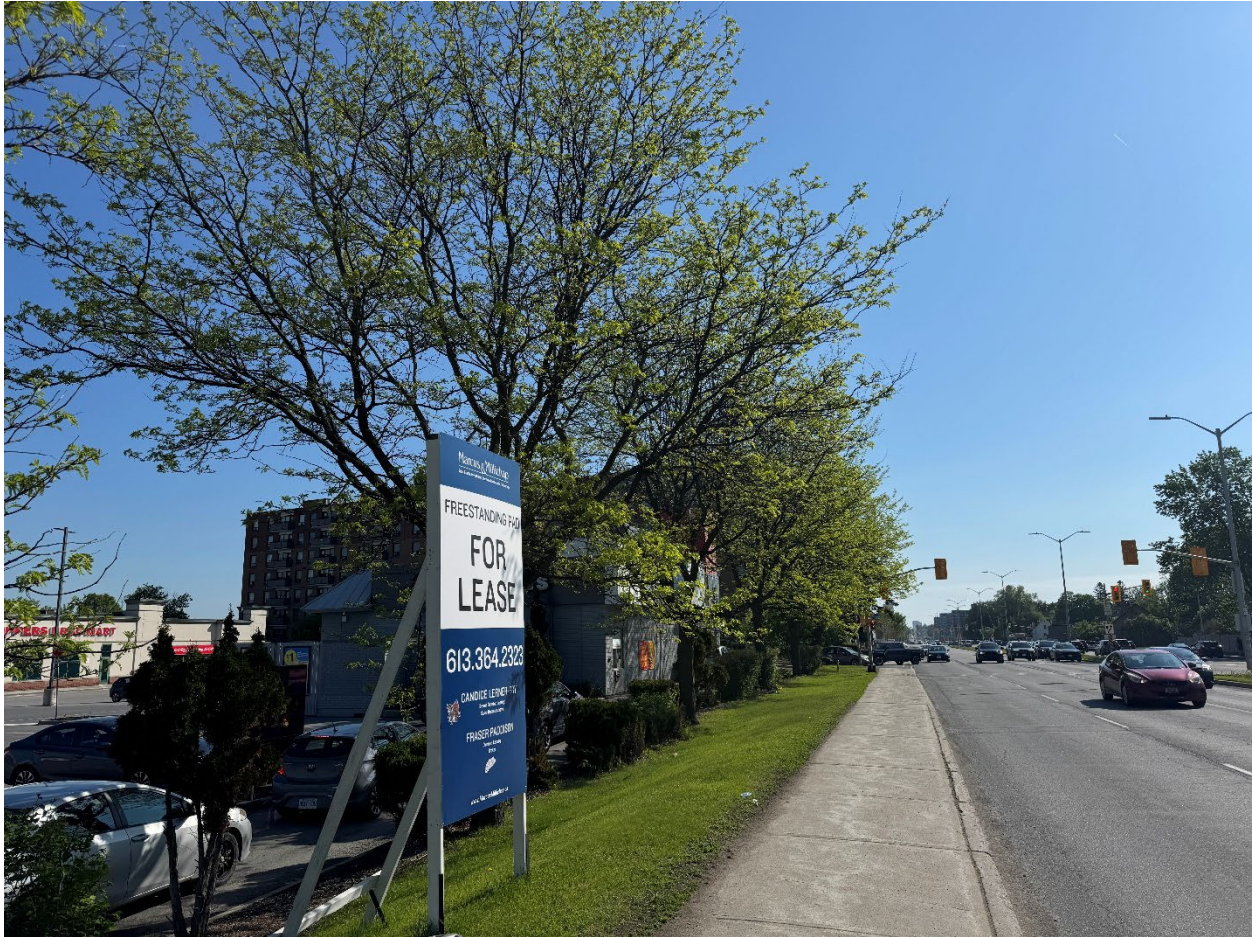
| Tree <sup>1</sup> | Species | Diameter<br>at breast<br>height (cm) | Ownership <sup>2,3</sup> | Condition | Action | Recommendations |
|---|---|---|---|---|---|---|
| 1 | Honey locust ( <i>Gleditsia triacanthos</i> ) | 37 | City | Good | Retain | No action required; far enough from proposed construction |
| 2 | Honey locust ( <i>Gleditsia triacanthos</i> ) | 38 | City | Good | Retain | No action required; far enough from proposed construction |
| 3 | Honey locust ( <i>Gleditsia triacanthos</i> ) | 40 | City | Good | Retain | No action required; far enough from proposed construction |
| 4 | Honey locust ( <i>Gleditsia triacanthos</i> ) | 36 | City | Good | Retain | No action required; far enough from proposed construction |
| 5 | Honey locust ( <i>Gleditsia triacanthos</i> ) | 38 | City | Fair | Retain | No action required; far enough from proposed construction |
| 6 | Honey locust ( <i>Gleditsia triacanthos</i> ) | 35 | City | Fair; 30 cm long injury on trunk | Retain | No action required; far enough from proposed construction |

Photo 1: Honey locusts along Carling Avenue

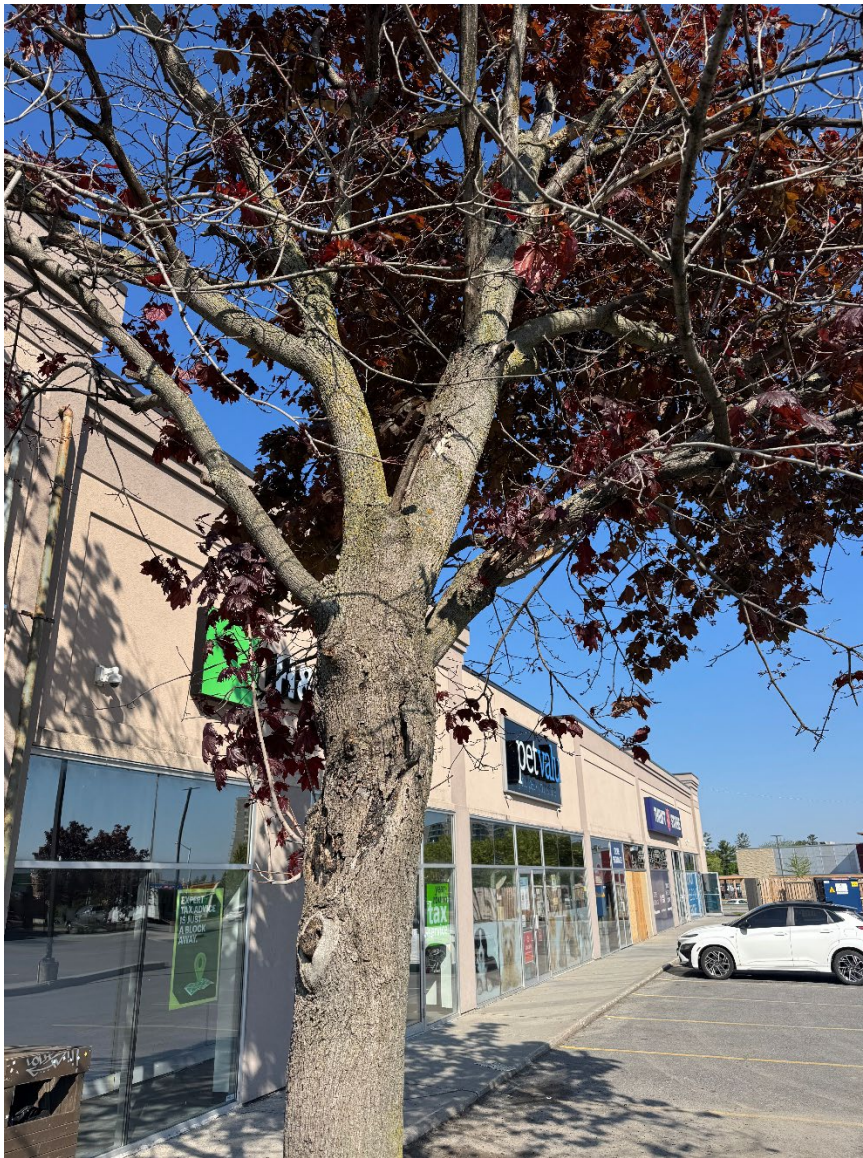
| Tree <sup>1</sup> | Species | Diameter<br>at breast<br>height (cm) | Ownership <sup>2,3</sup> | Condition | Action | Recommendations |
|---|---|---|---|---|---|---|
| 7 | Norway (Crimson King) maple ( <i>Acer platanoides</i> ) | 30 | Subject property | Poor; large canker at 2 m above grade, at junction of crown | Remove | Remove and replace based on poor health |

Photo 2: Tree 7, Norway maple to be removed. Note large canker on trunk.

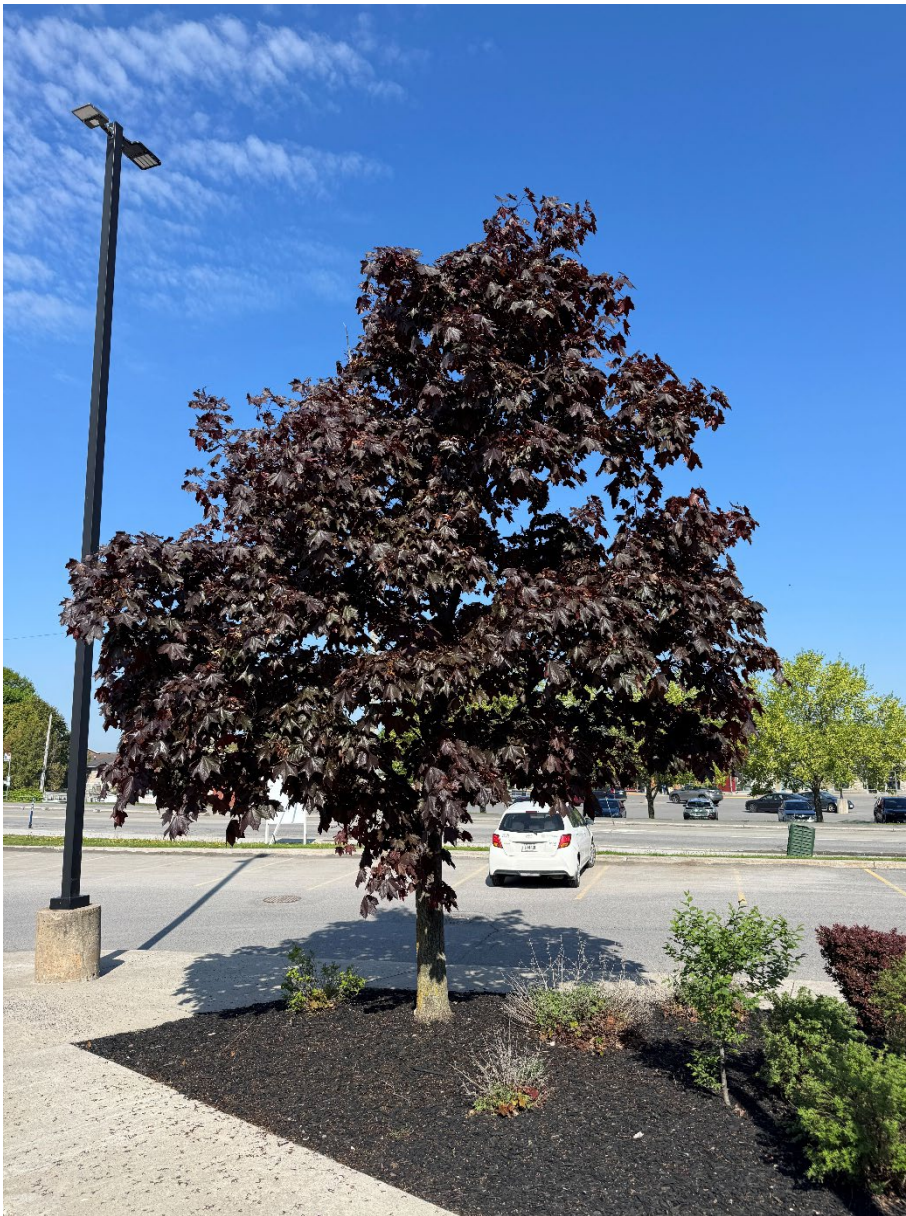
The only tree on the property that will be removed due to the proposed construction is tree 11, a privately owned Norway maple. Three Norway maples on the site are proposed for removal and replacement due to their poor health. Two are city-owned (trees 12 and 13) and one is private (tree 7). Additional trees along the eastern property line (trees 14, 15, 28 and 28) are proposed for removal and replacement. These are all Manitoba maples that have seeded in naturally, and this project is an opportunity to replace them with a longer lived, non-invasive species more suitable for the site.

| Tree <sup>1</sup> | Species | Diameter<br>at breast<br>height (cm) | Ownership <sup>2,3</sup> | Condition | Action | Recommendations |
|---|---|---|---|---|---|---|
| 11 | Norway (Crimson King) maple ( <i>Acer platanoides</i> ) | 18 | Subject property | Fair/good; light crown dieback, low vigour | Remove | Remove due to realignment of drive through |

Photo 3: Tree 11, Norway maple to be removed due to drive thru realignment

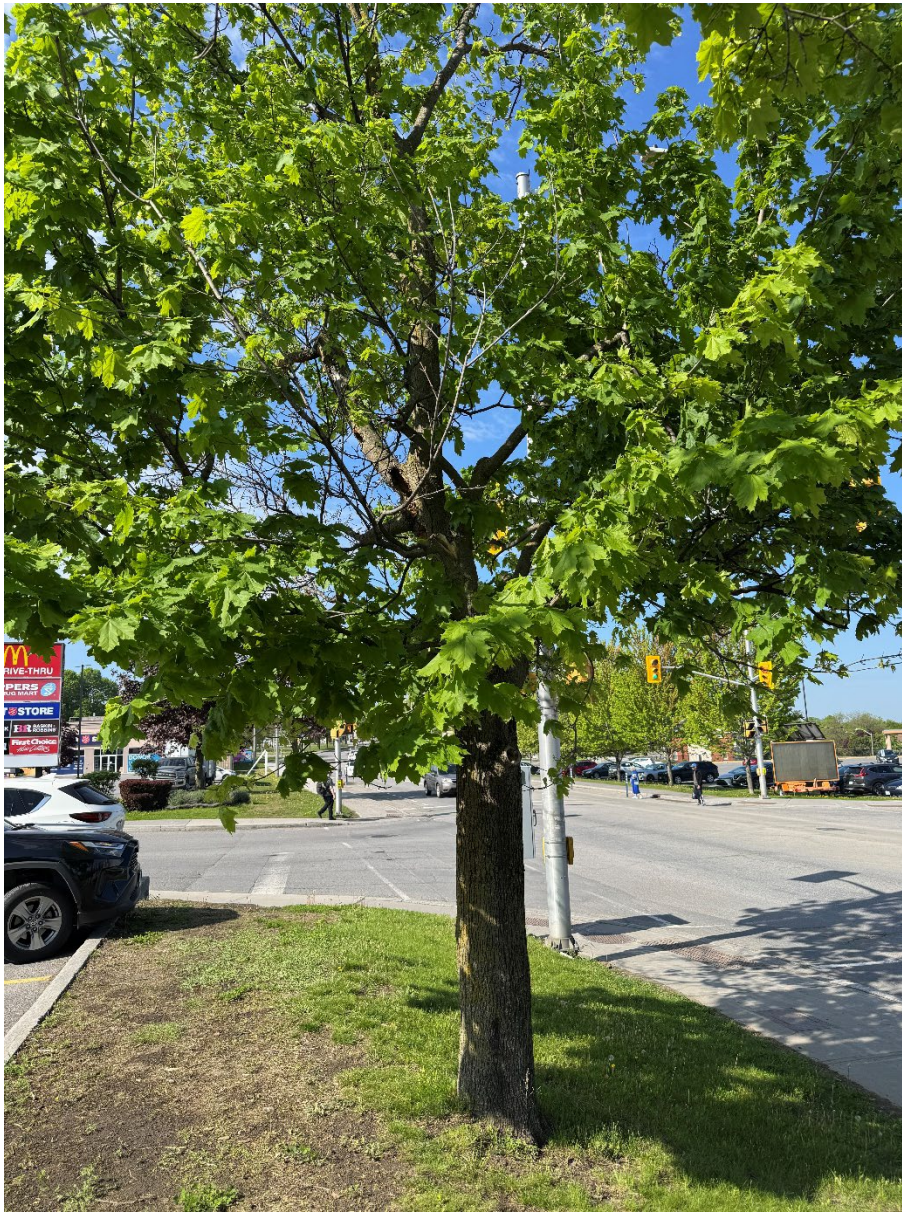
| 12 | Norway (Crimson King) maple ( <i>Acer platanoides</i> ) | 32 | City | Poor/fair; advanced crown dieback, possibly root girdling, middle codominant stem with multiple pileated woodpecker feeding cavities | Remove | Remove and replace due to poor health |

Photo 4: Tree 12, city-owned Norway maple to be removed due to poor health

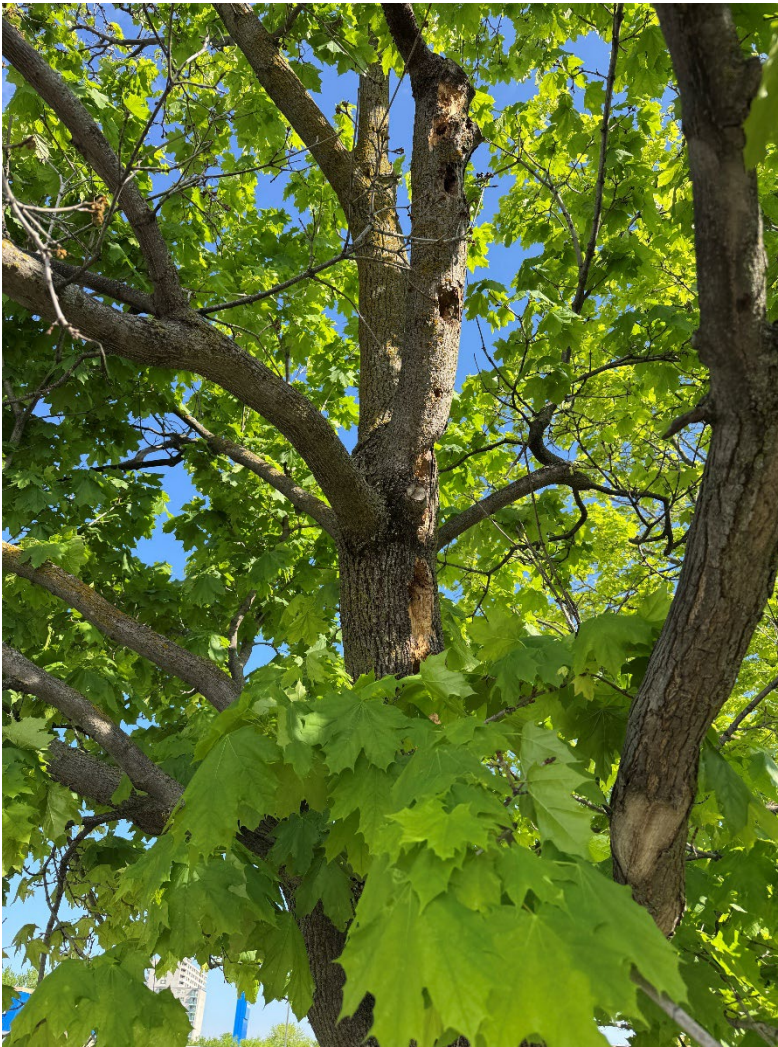
Photo 5; Crown of tree 12, note multiple pileated woodpecker feeding holes

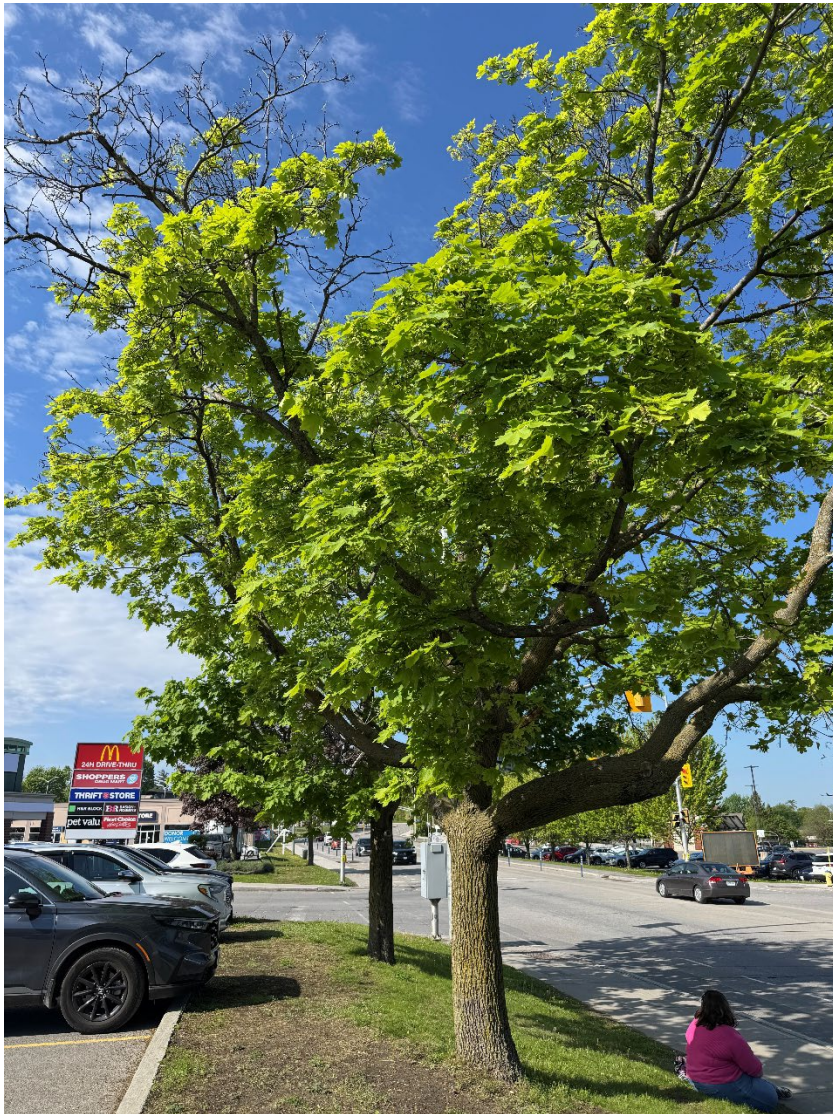
| 13 | Norway (Crimson King) maple ( <i>Acer platanoides</i> ) | 38 | City | Fair/poor; crown dieback (possible girdling roots) | Remove | Remove and replace due to poor health |

Photo 6: Tree 13, city owned Norway maple to be removed and replaced due to poor health

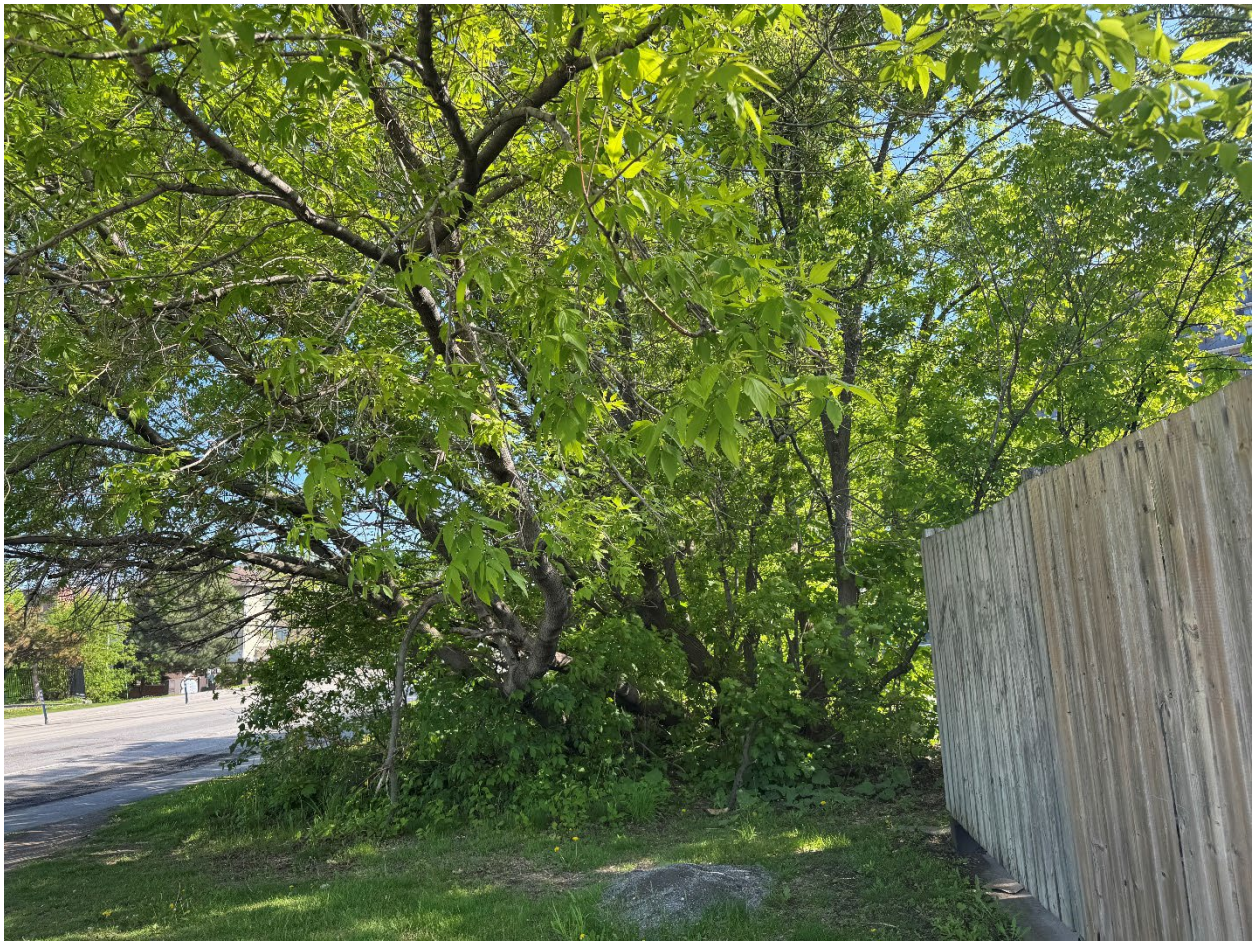
| 14 | Manitoba maple ( <i>Acer negundo</i> ) | 18 stems ranging 10-26 cm; average +/- 15 cm | Subject property | Fair; heavy leans with light dieback | Remove | Remove and replace; opportunity for beautification |

**Photo 7: Tree 14, Manitoba maple to be replaced for beautification**
