TREE CONSERVATION REPORT  
ADDENDUM 3.0  
71 Russell Ave

Tree Conservation Report Addendum submitted as  
Partial Requirements for a Site Plan Control  
Application, July 12, 2026

## Tree Conservation Report Addendum 3.0

**Address:** 71 Russell Ave  
**Date of Report:** July 12, 2026  
**Date of Site Visit:** April 9, 2026 and July 2, 2026  
**Prepared by:** Astrid Nielsen, RPF, ISA Certified Arborist ®  
101- 45 Spencer Ave, K1Y 2P5  
[Astrid.nielsen@dendronforestry.ca](mailto:Astrid.nielsen@dendronforestry.ca)  
**Client:** Colin Miller, [Colin@pinehillbuilders.ca](mailto:Colin@pinehillbuilders.ca)

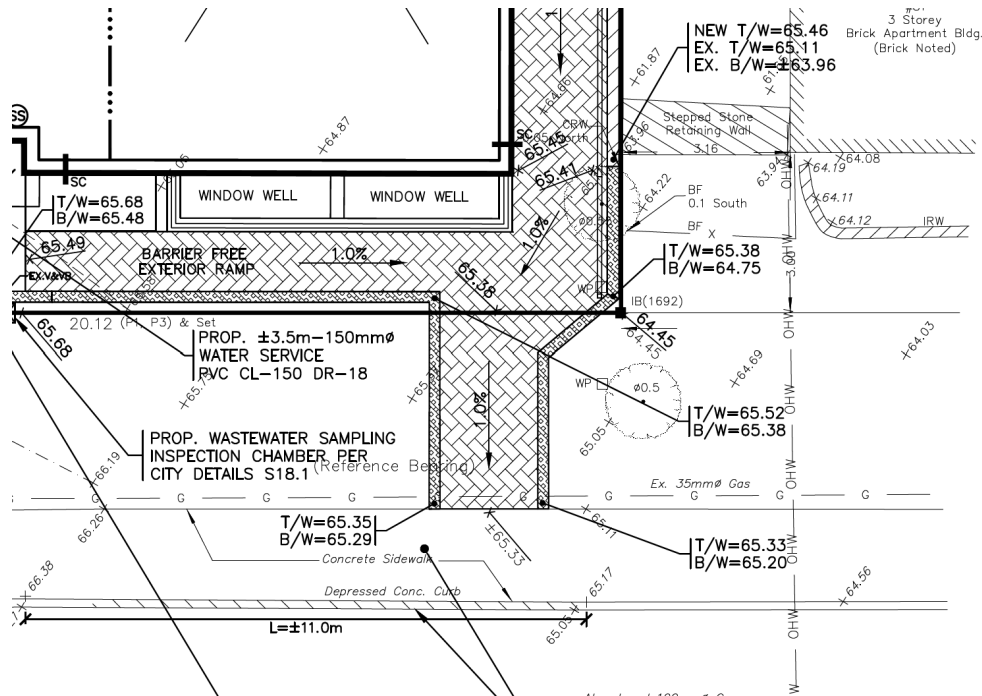
**Tree 1:** This updated report reflects changes that were made to the grading plan for the walkway to curve around the tree. The new walkway and retaining wall will be approximately 1.5 m from the edge

of the tree trunk which should avoid impacting the structural integrity of the tree. The tree roots are to be pruned in advance of any excavation for the walkway and retaining wall and be completed by a certified arborist and/or city forestry staff. The same applies to the removal of any branches for the clearance of equipment on site – clearance pruning will likely be required for site access.

Figure 1: Image clip from updated grading plan prepared by TL Mak dated May 27, 2026 showing the walkway curving around tree 1, city owned Norway maple. The distance from the edge of the tree trunk to the edge of the retaining wall is approximately 1.5 m.

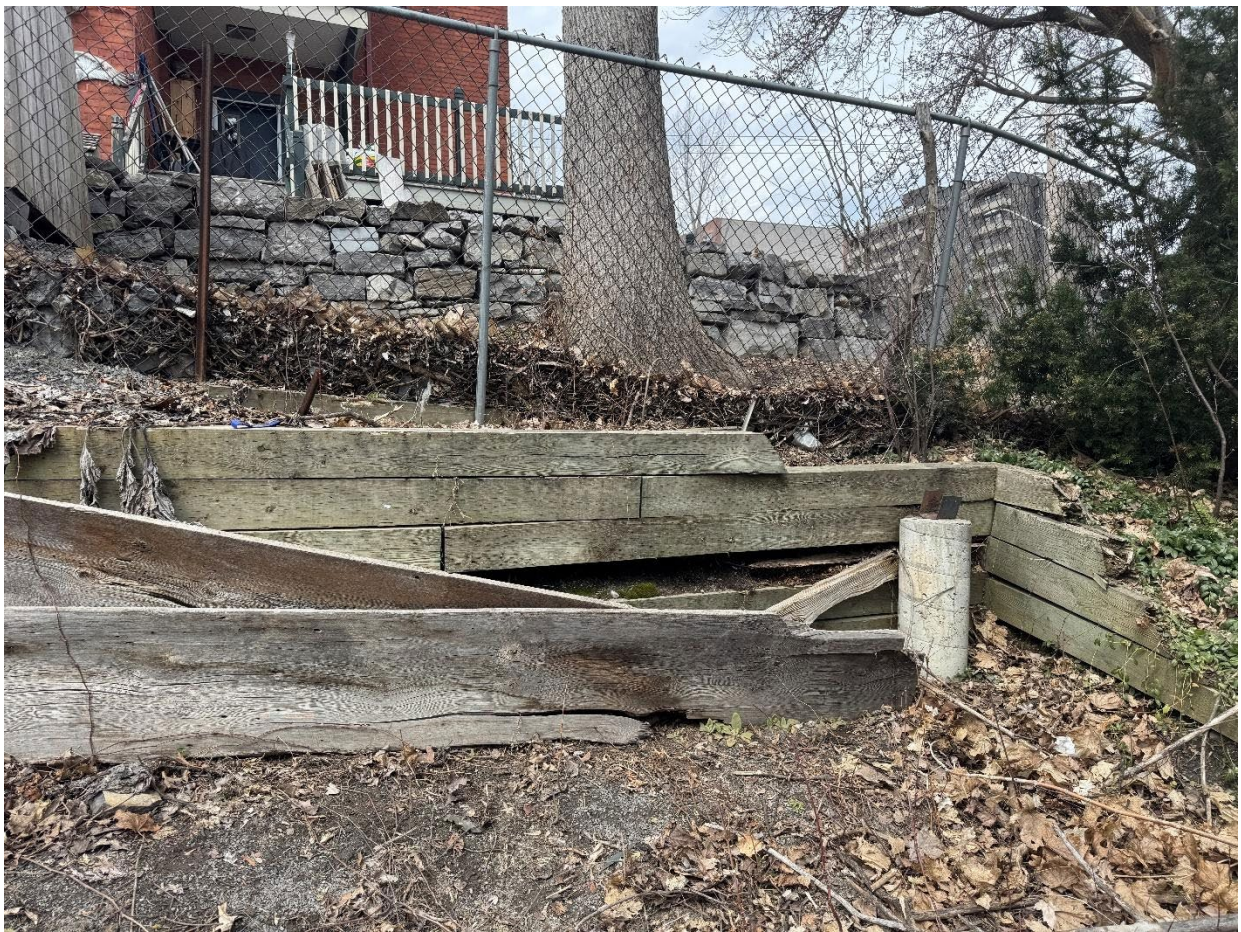
**Photo 1:** Existing wall by Tree 10, American elm on adjacent property. The new retaining wall will be over 4 m in depth and flush against the property line which is close to the existing fence

The existing wall is estimated to be 20 years old based on the condition of the wood. The team onsite noted that the wall was not functioning as a retaining wall and would likely have failed if it were supporting the soil. It was also noted that there was a French drain installed on the adjacent property which extends below the existing fence and onto the subject property.

The existing wall will be replaced with shoring set approximately 20 cm closer to the tree. Soil in this area will be removed, and pruned back by a certified Arborist, concurrent with the shoring installation. The required 20 cm of root pruning to accommodate the shoring system must be executed with clean cuts using sharp, sanitized arborist tools to minimize further stress and pathogen entry. Note that there is additional soil past the L bend of the wall that was not included in this assessment that will be excavated. It is anticipated this area will be beyond the area where structural roots will be located.

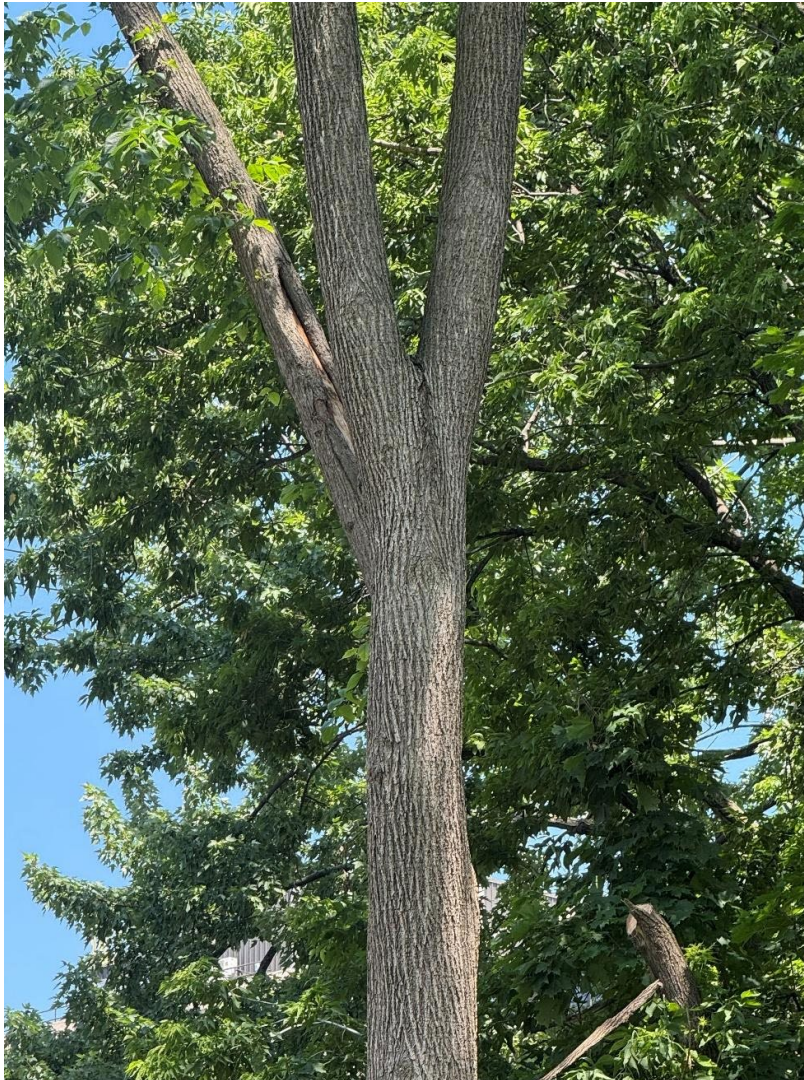
- Fair to declining canopy structure: canopy is slightly unbalanced, weighted mostly over the adjacent property
  - One major branch which extends over the adjacent property's roof has a large injury near its union with the trunk. Injury has limited wound wood growth.

Photo 2: Wound on the branch overhanging the adjacent property at 69 Russell. An aerial assessment is recommended.

Finally, we advise the neighbour to secure an independent Level 3 Advanced (aerial) Assessment from a TRAQ-certified arborist to fully evaluate the structural integrity of the potentially decayed root collar and the injured branch overhanging their roof structure.

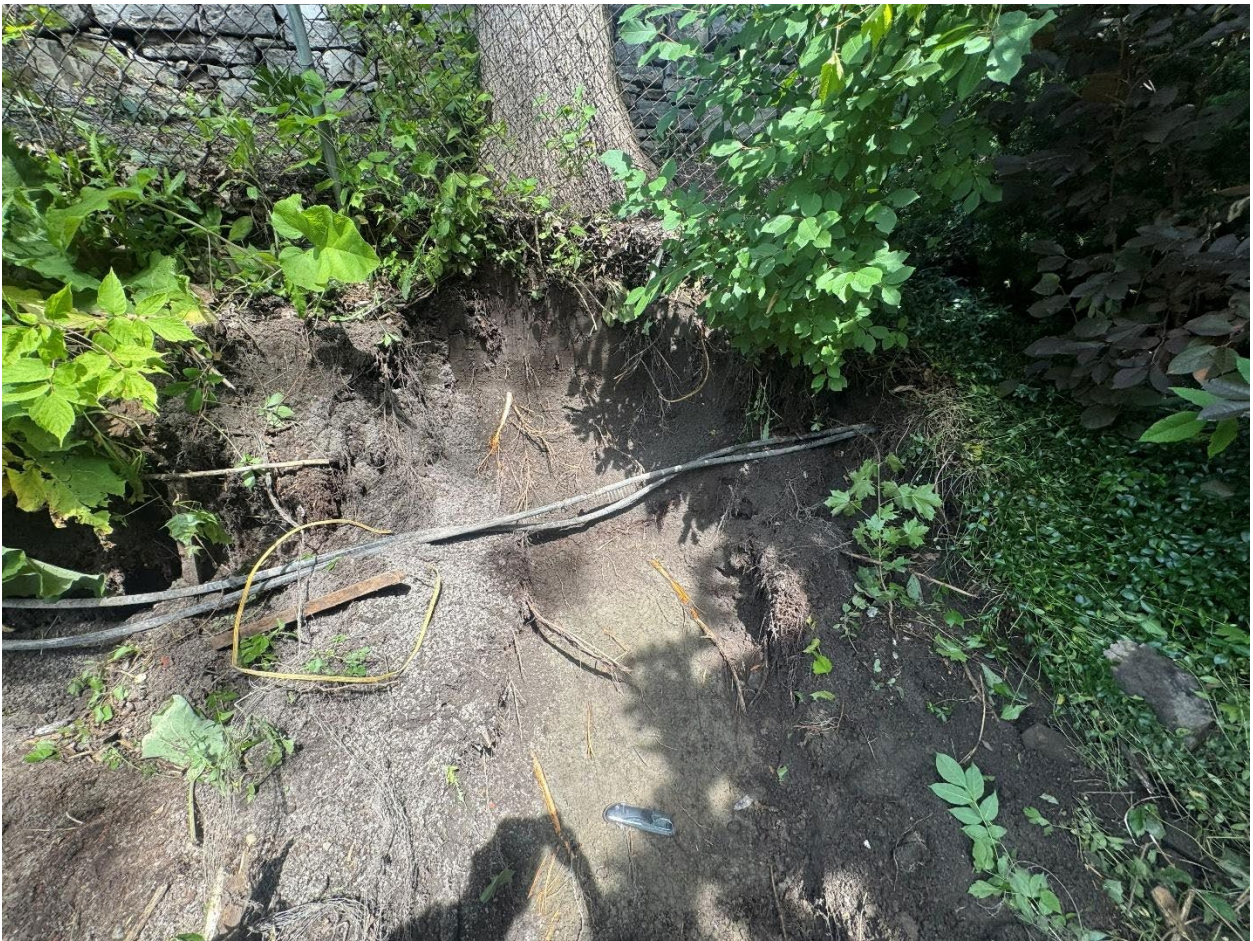
- Roots present in section of wall excavated:
  - 6 roots measuring 1.5 cm - 5 cm
    - 1 @ 5 cm
    - 1 @ 4.5 cm
    - 1 @ 3.5 cm
    - 1 @ 2 cm
    - 2 @ 1.5 cm
  - 9 roots measuring <1cm, >0.3cm
  - Fine roots
- There were two areas where some decayed wood was present that may have been roots at one point
- Roots extended the full depth of the wall, and are expected to continue deeper into the substrate on the subject property

**Photo 3: Soil and roots visible after the removal of the wall**

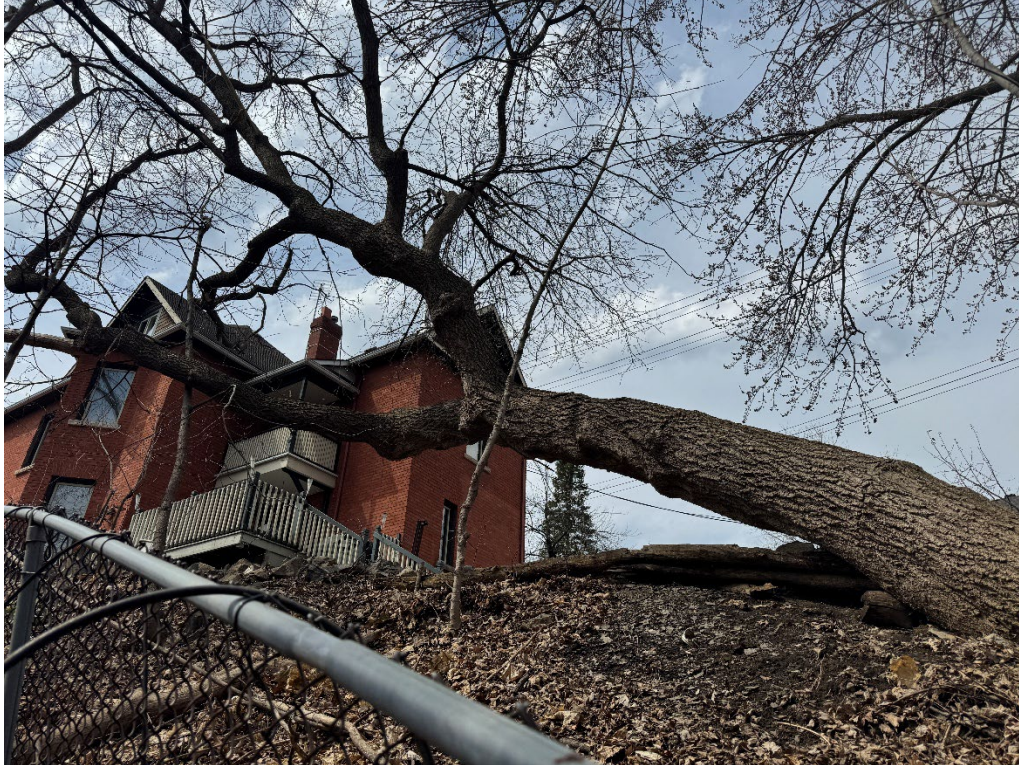
**Tree 11:** This tree is located on the adjacent property and exhibits a severe structural defect, growing at a nearly horizontal lean. Given its poor condition, the tree may be susceptible to failure triggered by construction-related vibrations. While its removal is not mandatory for the project, it is recommended that the applicant consult with the neighbor to explore this option. At a minimum, any large branches encroaching over the subject property that pose a risk of failure should be pruned.

**Photo 4:** Tree 11, Manitoba maple with very heavy lean on adjacent property

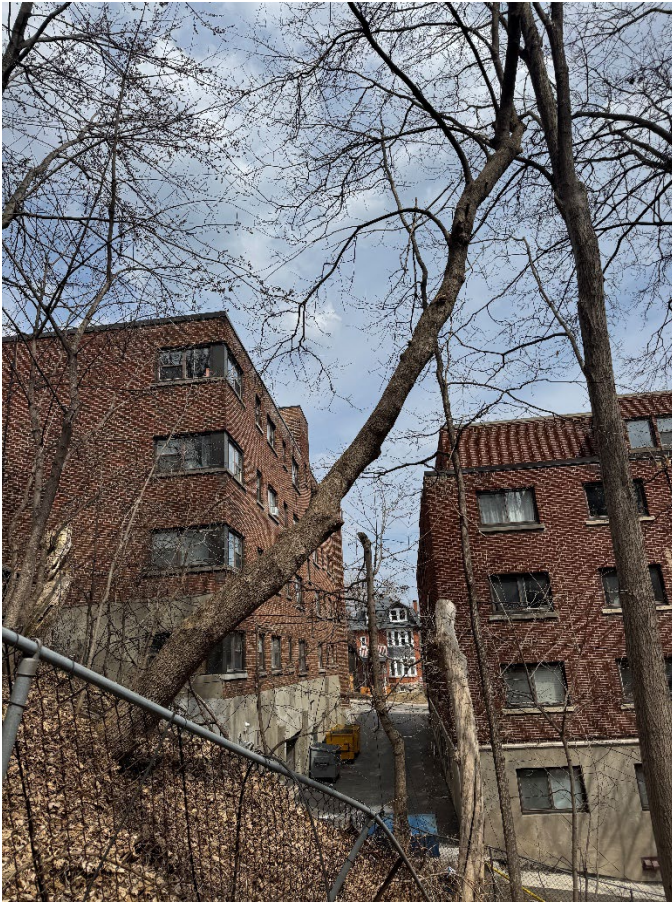
**Tree 27:** This tree is situated on an adjacent property on a steep slope experiencing active soil creep. Evidence of this movement is visible in the accumulation of soil and organic debris against the boundary fence, which has mostly collapsed under the pressure near the base of the slope.

The tree currently exhibits a significant lean toward the subject property, presenting an existing safety hazard. While a full assessment was limited by property access, visual inspection from the property line suggests potential girdling roots on the upslope side of the root flare. Furthermore, the proposed building presents a direct conflict with the tree's crown.

It is critical to note that the risk of whole-tree failure will increase once the trees on the subject site are removed, as Tree 27 will suddenly be subjected to increased wind exposure. Concurrently, the subject site will become an active construction zone, increasing the number of targets (workers, equipment, and structures) within the fall zone.

Manitoba maples are fast-growing, opportunistic trees characterized by weak wood and shallow, fibrous root systems that grow irregularly toward light, making them prone to storm failure. Furthermore, they tend to uproot more frequently than other maple species on similar sites (Ontario, 2024). From a failure potential perspective, the downhill lean increases the overturning moment on the shallow root plate. Should this tree fail, it is most likely to involve a full tree failure that includes the entire rooting mass. This root plate failure would remove a large volume of soil, exacerbating current erosion issues on the slope.

Photo 1: Tree 27, Manitoba maple on adjacent property that should be removed due to the potential for failure on subject property

Because of the degree of lean, there are no effective or practical mitigation measures available to reduce this risk to an acceptable level. Given the lack of viable alternatives, removing (most of) the tree is the only recommended option to ensure site safety. Furthermore, the massive above-ground weight of the tree is likely contributing to the downward soil creep. Removing the tree while leaving the stump and entire root network intact may actually reduce ongoing erosion and improve the overall stability of the slope.

To optimize slope stability while mitigating the overhead hazard, it is recommended that the crown and stem be removed, but the trunk and root system be left intact. Because Manitoba maple is a prolific stump sprouter, leaving the stump untreated will trigger the immediate production of epicormic shoots, ensuring the root system remains alive and continues functioning as it did prior to removal. To establish permanent structural anchoring, a succession planting strategy combining native trees, shrubs, and herbs is recommended. Shrubs will provide for immediate, shallow soil cohesion, whereas structural trees, such as oak, will establish deep taproots.

If the adjacent property owner does not support removal of this tree, an option would be to remove the portion of the tree extending over the subject property line to reduce the weight and reassess. Although this may not be an accepted arboricultural practice, it may reduce the risk to an acceptable level which is a higher priority. It is recommended that a risk assessment be completed after the pruning has been completed.

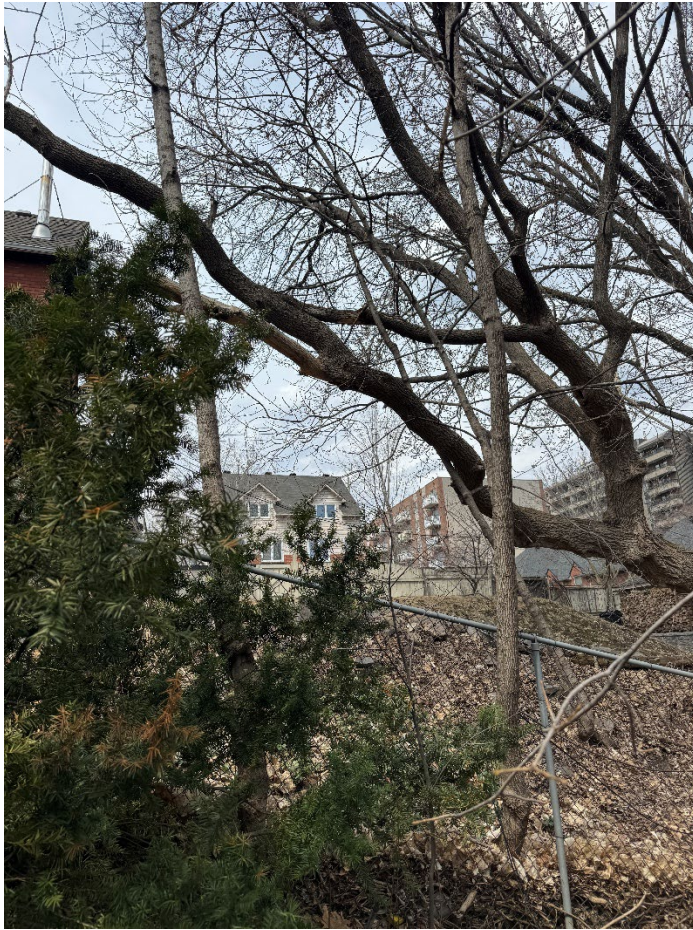
***Additional two small Manitoba maple along the fence line:*** There are two small Manitoba maple along the fence line, intertwined with the existing metal fence, that will also require removal. These trees measure 11 cm in diameter and are in poor health due to their weak bases.

Photo 2: Small Manitoba maples along the fence long, intertwined with the fence
