# Tree Conservation Report

**Cisco Ottawa Campus – 2000 & 3000 Innovation Drive**

July 24, 2026

Arcadis Canada Inc.  
333 Preston Street, Suite 500  
Ottawa, Ontario K1S 5N4  
Canada

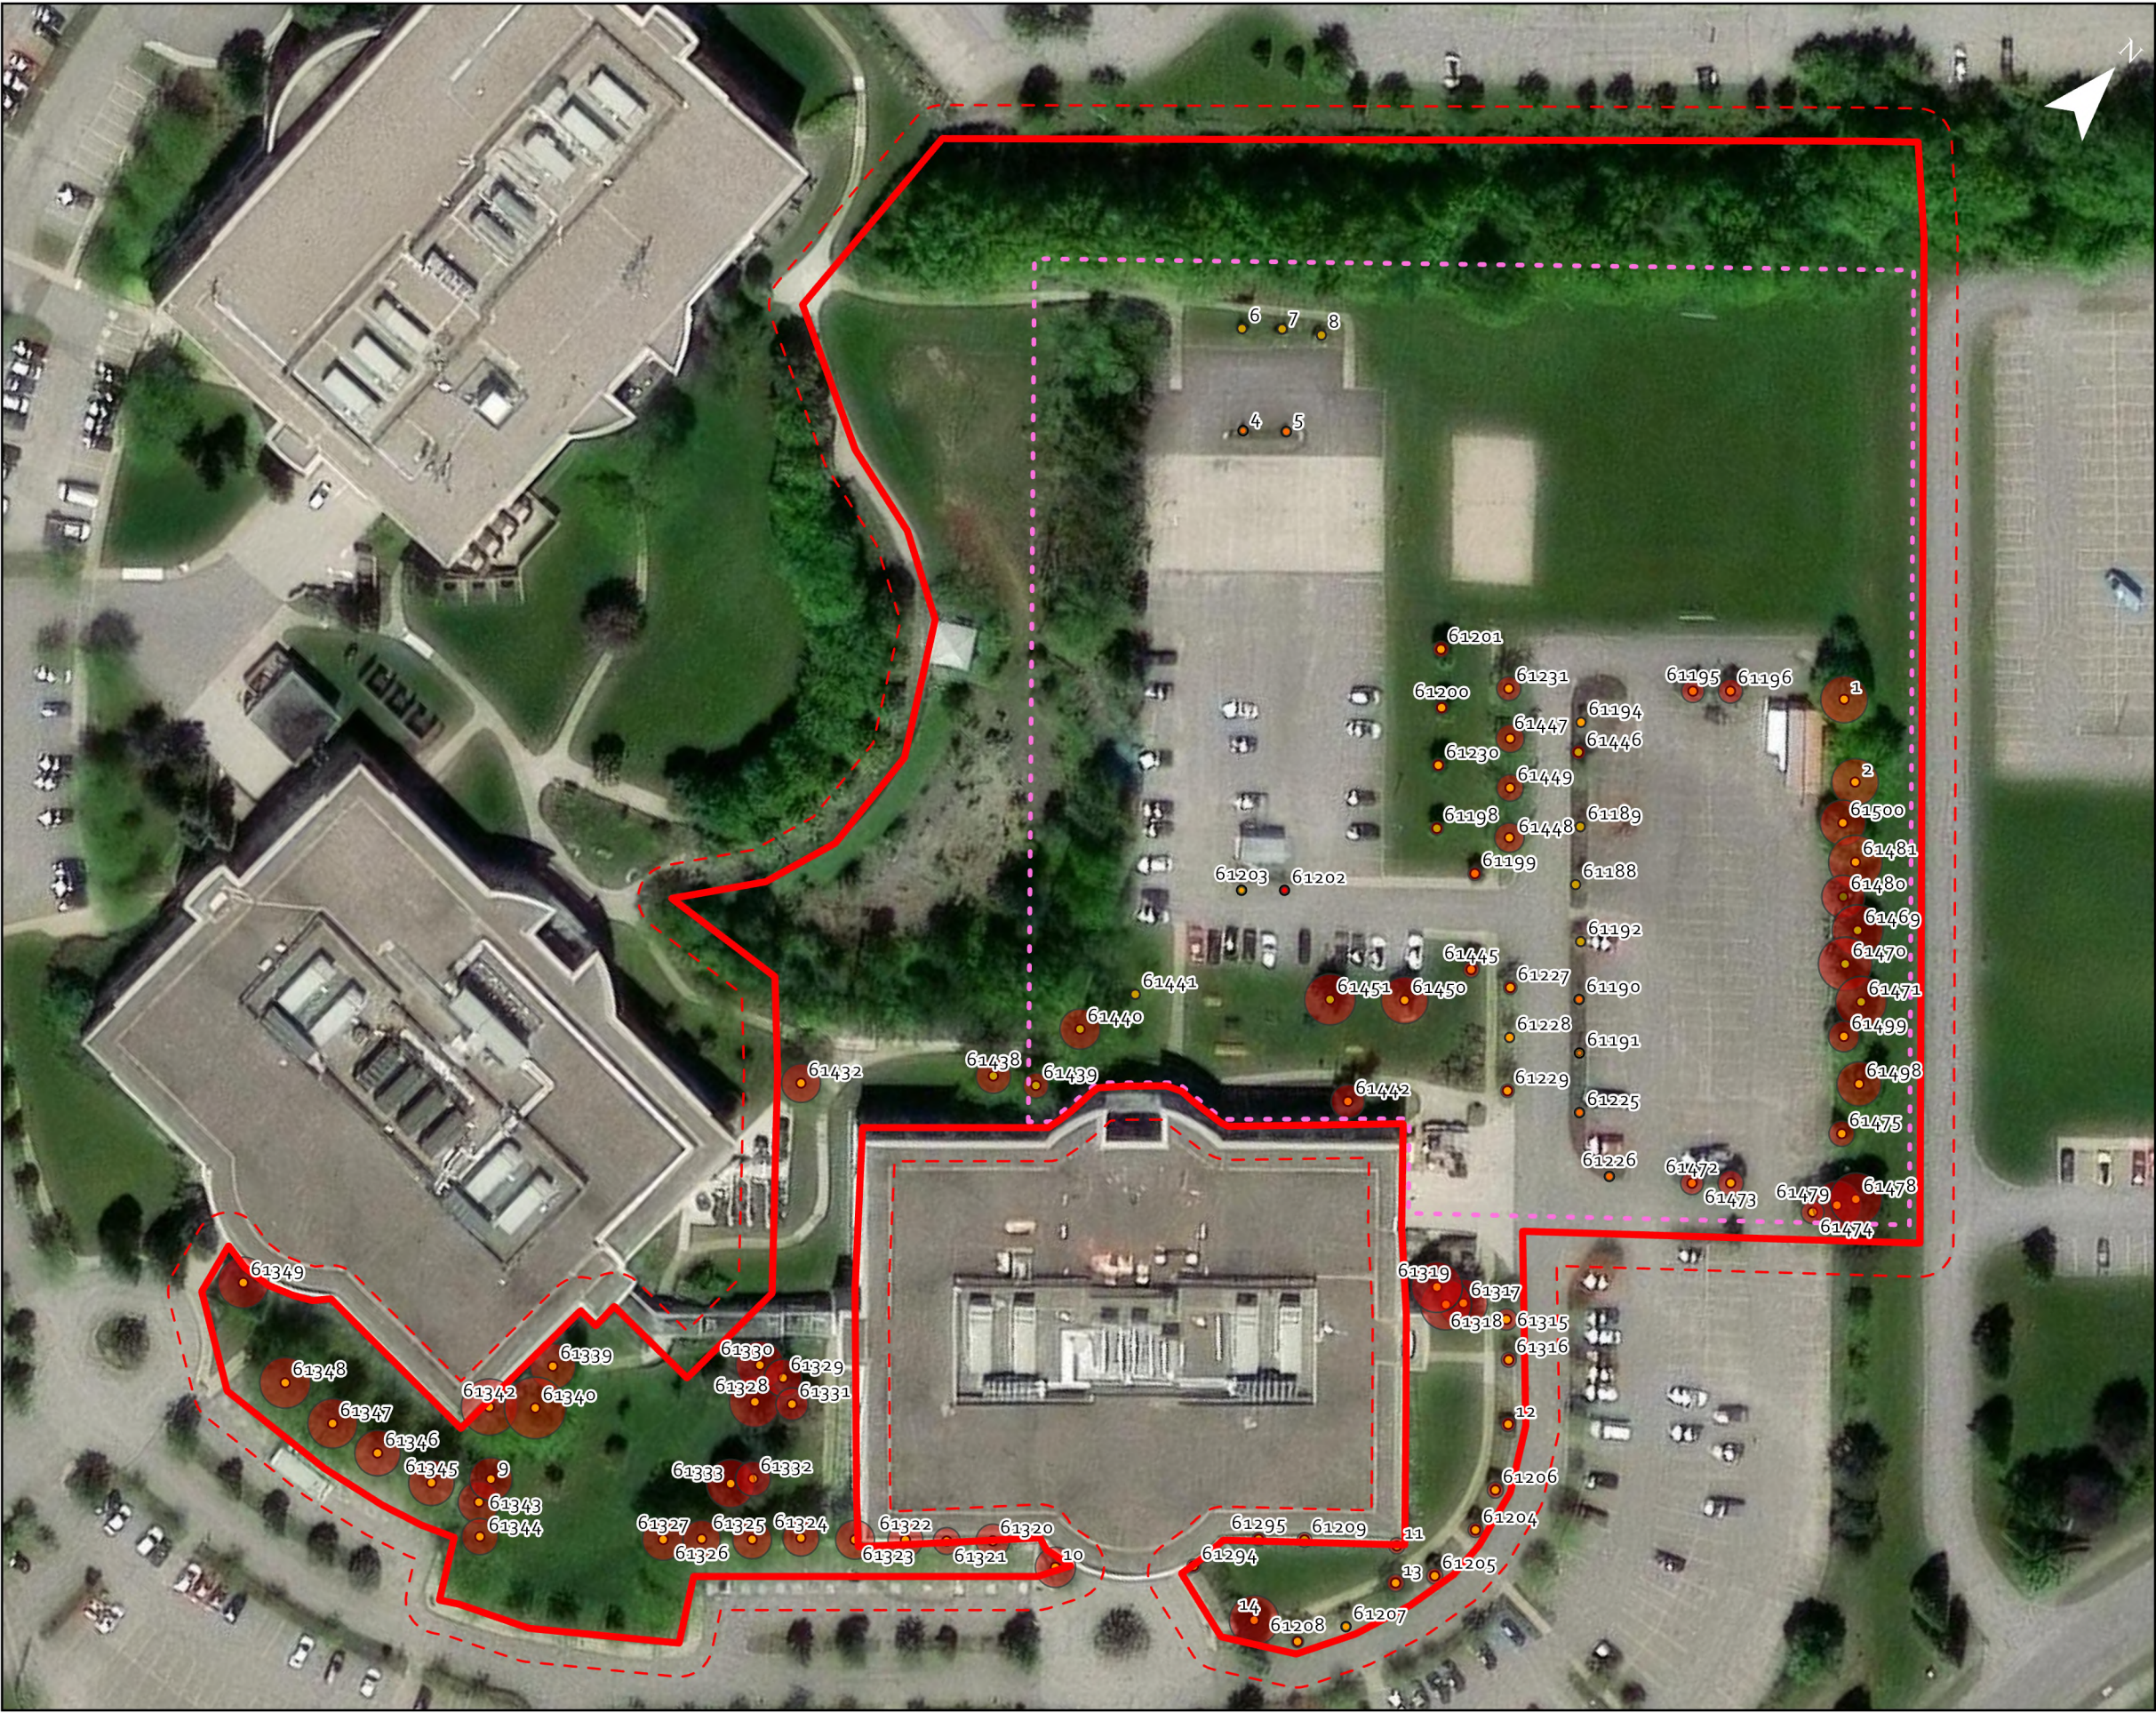
**Figure: 2**

Each tree was given an overall health condition rating of: Excellent, Good, Fair, Poor, or Dead. A map showing the determined health condition of the trees on the Site can be seen on Mandatory Map 1 as per City of Ottawa, 2021 (**Figure 2**). The following is a summary of how the ratings are determined:

A total of 101 individual trees and four groups were assessed as part of this inventory. The condition of the trees on Site ranged from Very Good to Poor, approximately 85% of which were in Very Good to Good condition. The

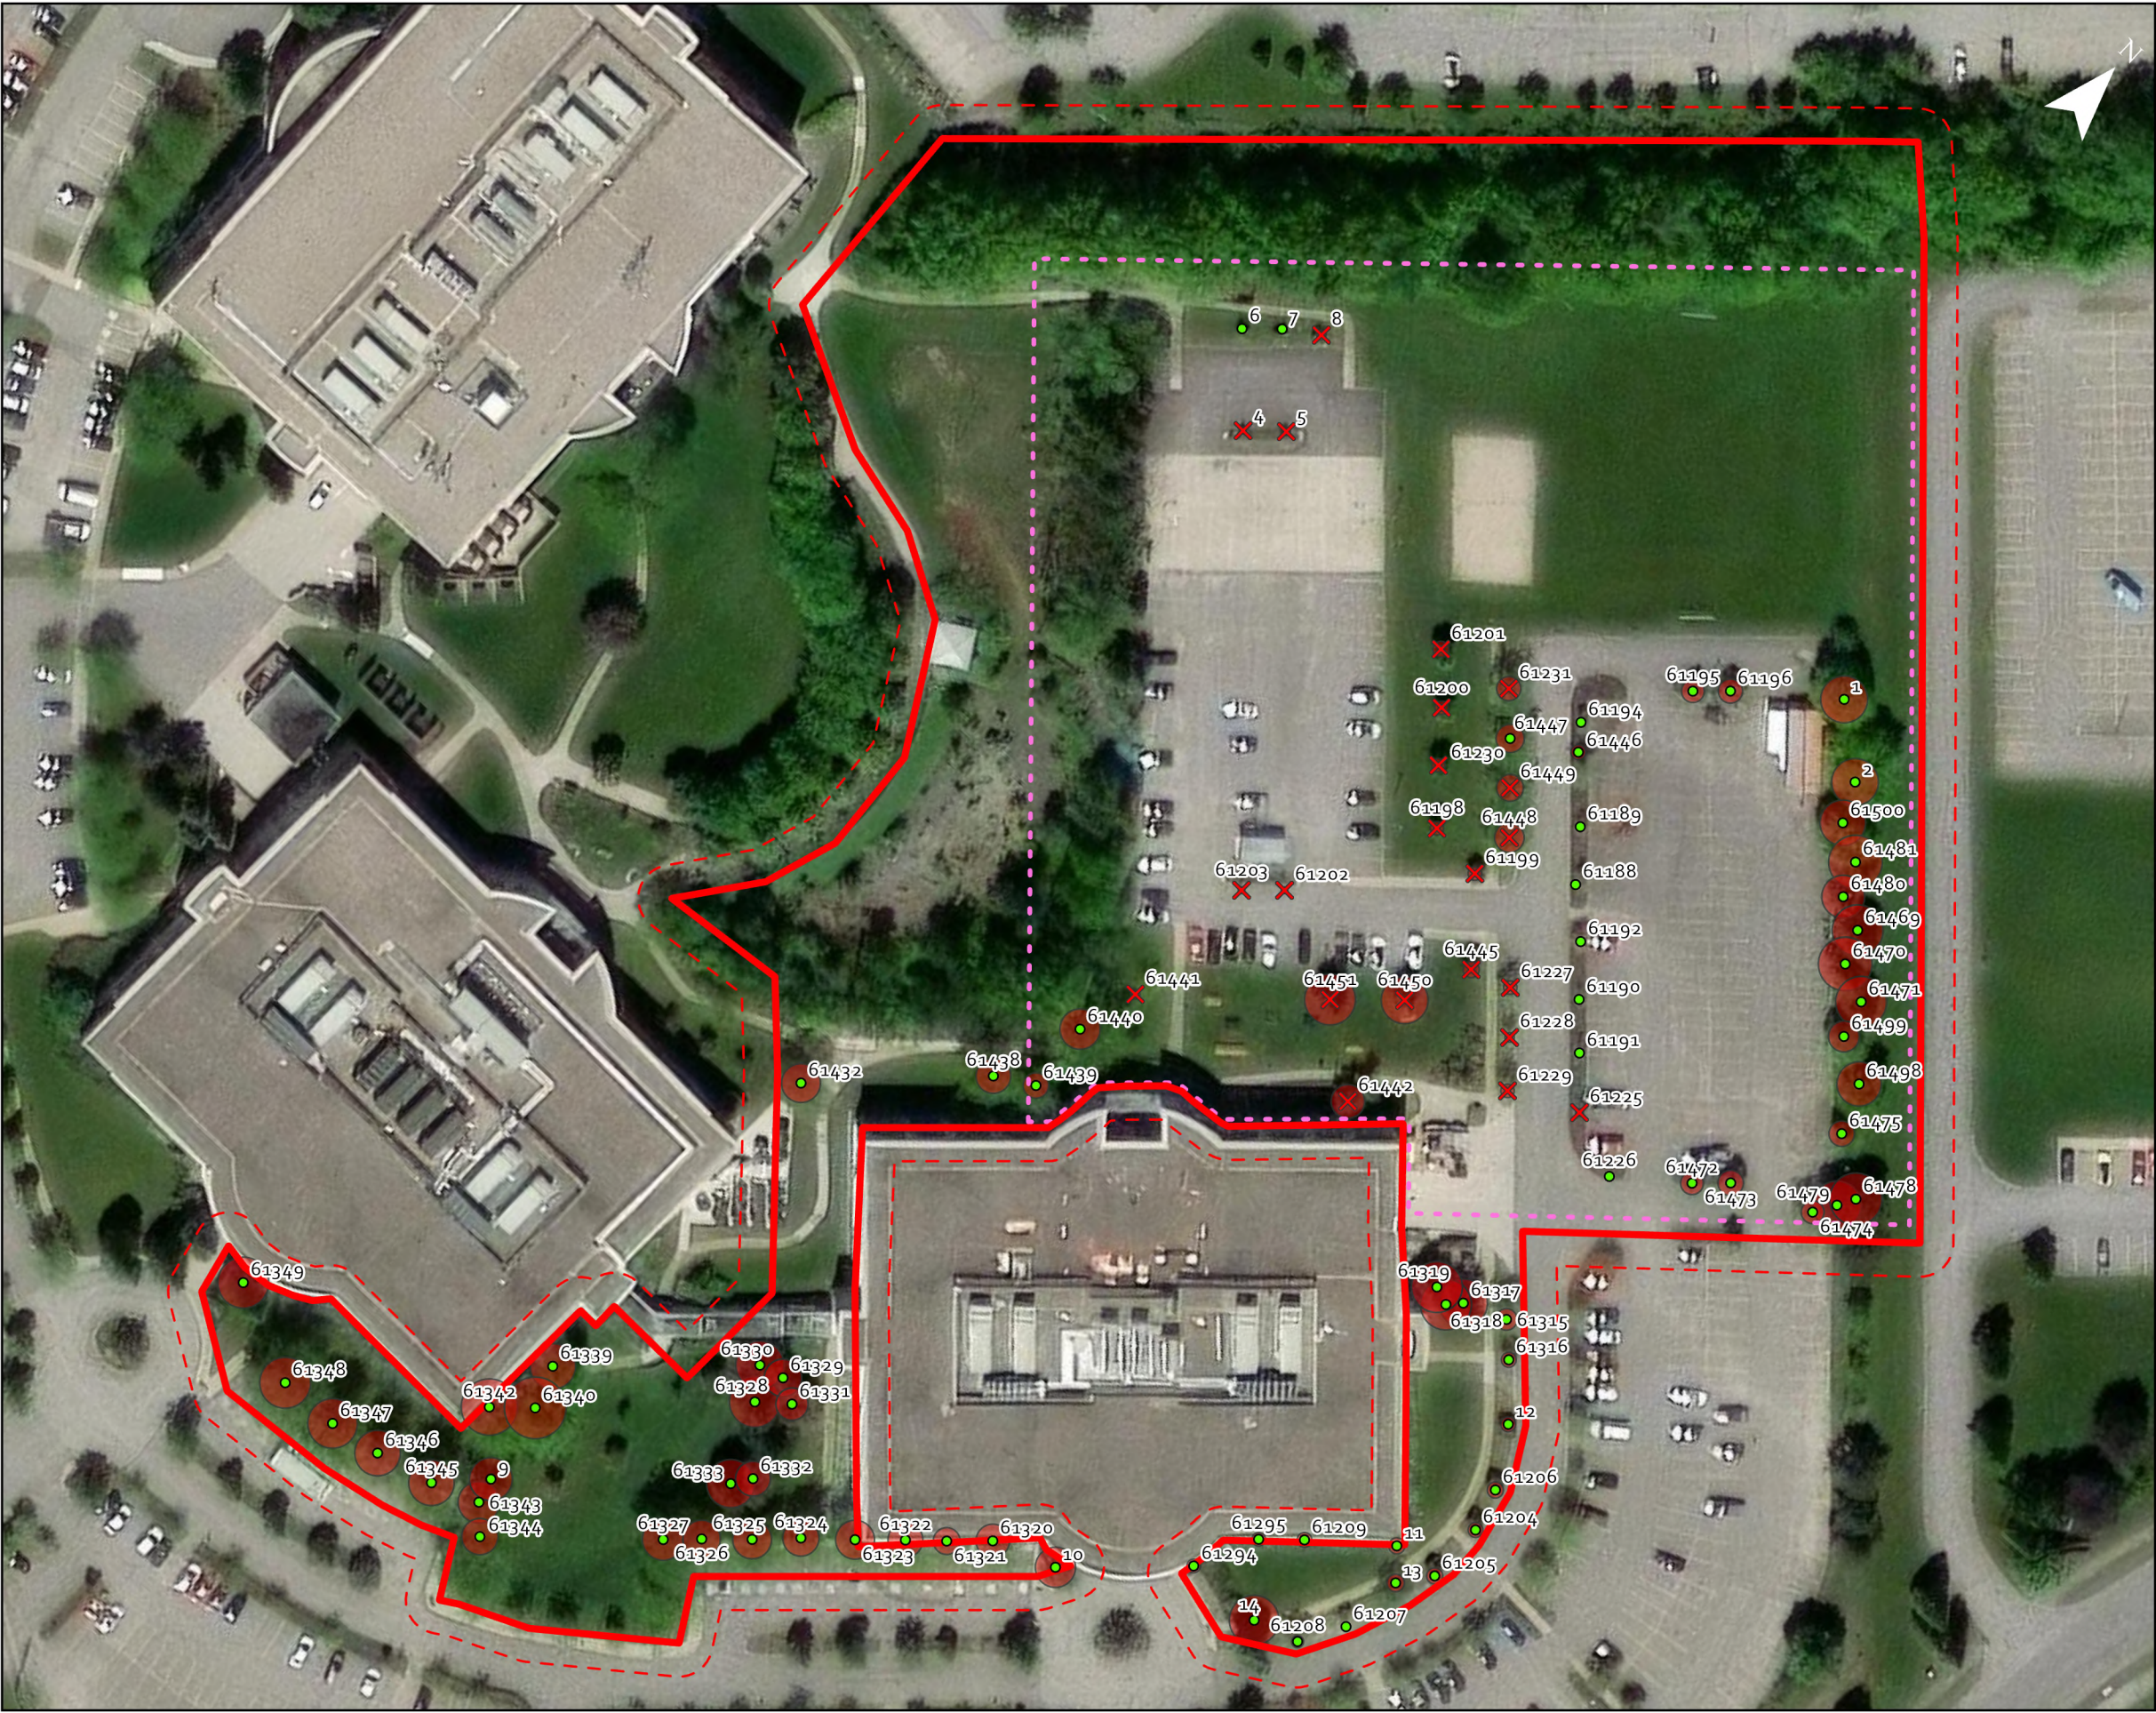
# Figure: 3

Based on the conditions of the trees and extent of the proposed construction limits, **Table 2** summarizes the impact and recommended actions of the 101 trees and four (4) tree groups assessed within the Site. It is anticipated that 21 trees will need to be removed within the construction limits. 8 of these are 5 to 9 cm diameter at breast height (DBH) and 13 are >10 cm diameter at breast height (DBH). 80 trees four (4) tree groups on the Site will be retained. These details are depicted on Mandatory Map 2 below (**Figure 3**), as per the City of Ottawa, 2021, and outlined in the Tree Inventory and Assessment Table included in **Appendix A**. Based on the proposed project design no work is anticipated within the critical root zone of any of the retained trees. The new pathway and amenities proposed for areas adjacent the existing tree groupings will be designed and installed as to not require excavation and not impact any existing trees.

Based on the proposed project design and existing conditions of the trees on site, 22 trees have been recommended for removal in order to accommodate the construction. The following recommendations are provided:

- Retain a Certified Arborist during site layout operations to confirm recommended tree removals, pruning, and tree protection fencing in proximity to the construction limits.
