TREE CONSERVATION REPORT ADDENDUM 4.0

71 Russell Ave

**Address:** 71 Russell Ave

**Date of Report:** August 25, 2026

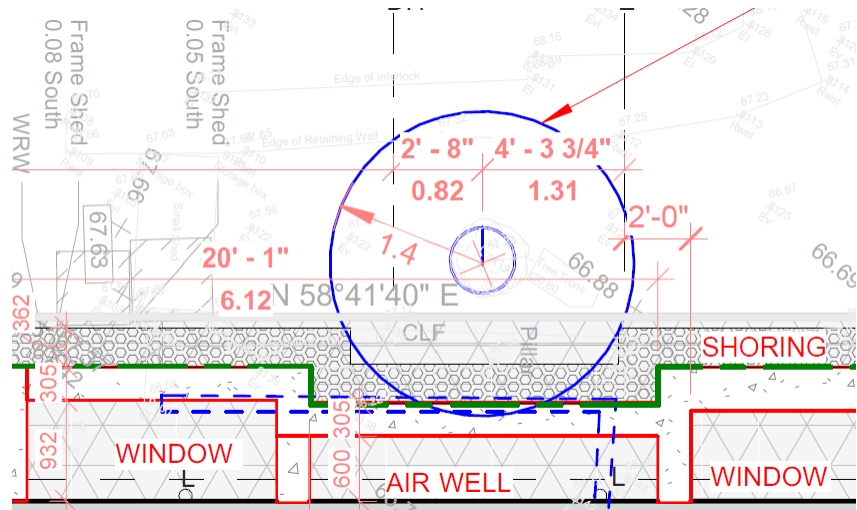
The project team has redesigned the wall to include a notch around the tree that relocated the shoring and proposed retaining wall to follow the path of the previous wooden wall, which followed the extent of the roots on the subject property immediately adjacent to the tree. The image below shows the updated site plan that includes the surveyed location of the tree and the location of the old wooden wall (extent of roots) as the dashed blue line. The green line represents the extent of excavation via shoring. This notching also demonstrates how the roots beyond the elbow of the old wall that will be severed as part of the shoring installation are outside of the static root zone, which is defined as three times the diameter of the tree. Although the diagram shows the measurement of the static root zone from the centre of the tree, the excavation is still outside of the static root zone if measured from the edge of the tree (an additional 23 cm).

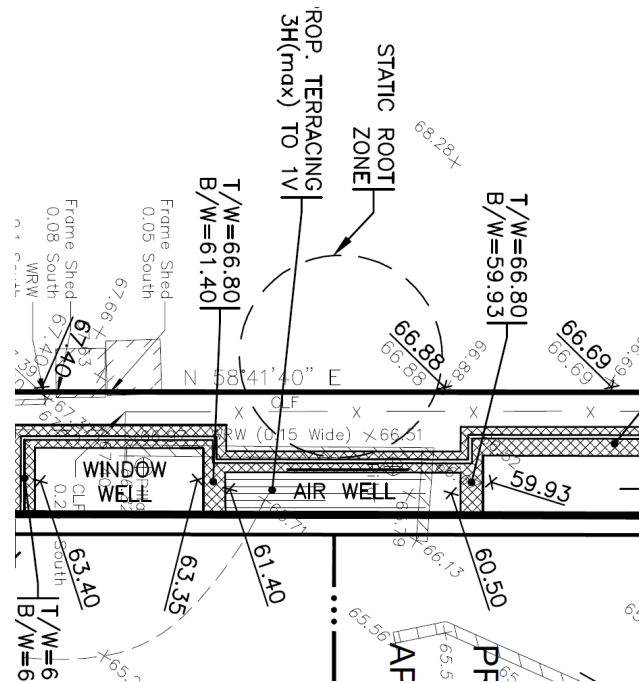
The grading plan prepared by TL Mak was also updated on August 24, 2026, to reflect the addition of this notch. Below is a snapshot of this plan that includes the static root zone of the tree:

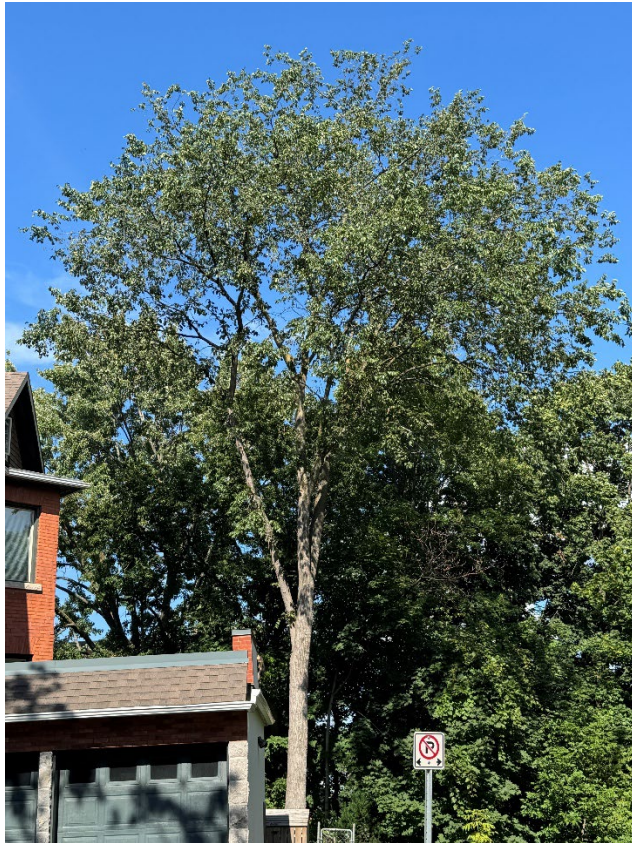
Figure 3: Photo of tree 10 taken on August 18, 2026

**Note:** During the site assessment on August 18, slight foliar wilting was observed within the elm's canopy. While wilting is frequently a symptom of summer drought, the record rainfall experienced this season indicates a possible vascular issue rather than a lack of soil moisture. This wilting *may* be a very early indicator of Dutch Elm Disease (DED), which obstructs the tree's vascular system and prevents the upward transport of water. To confirm or rule out the pathogen, it is recommended that the arborist performing the planned canopy pruning inspect symptomatic branches for vascular staining—specifically looking for brown streaks or a solid brown ring in the outer sapwood (xylem) beneath the bark.

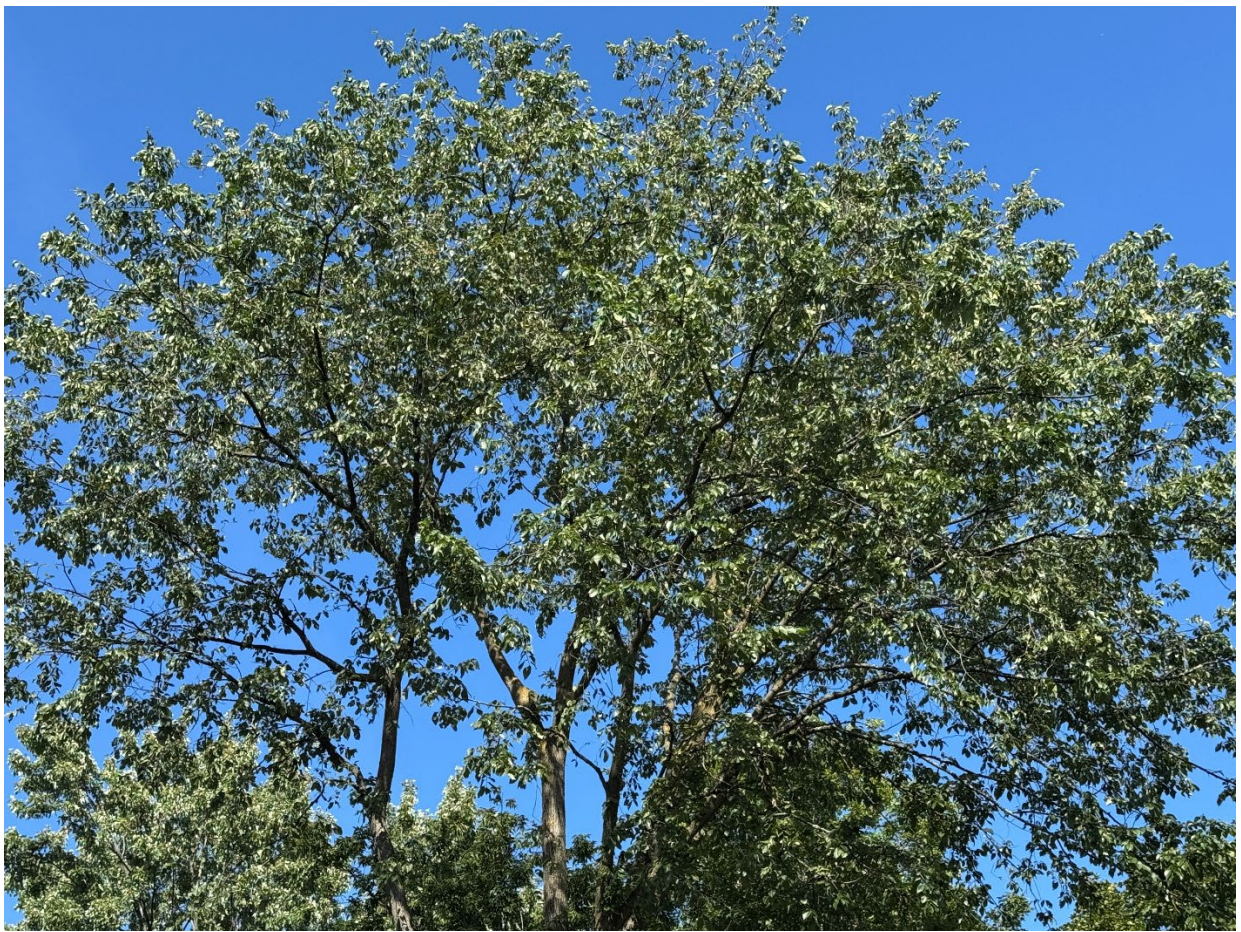
**Figure 4: Close up of canopy. Note the thin canopy and slightly wilted leaves**
