**970 SILVER ST  
Ottawa, Ontario**

## **SEWER CCTV INSPECTION REPORT**

**Report Id**  
153924SA1

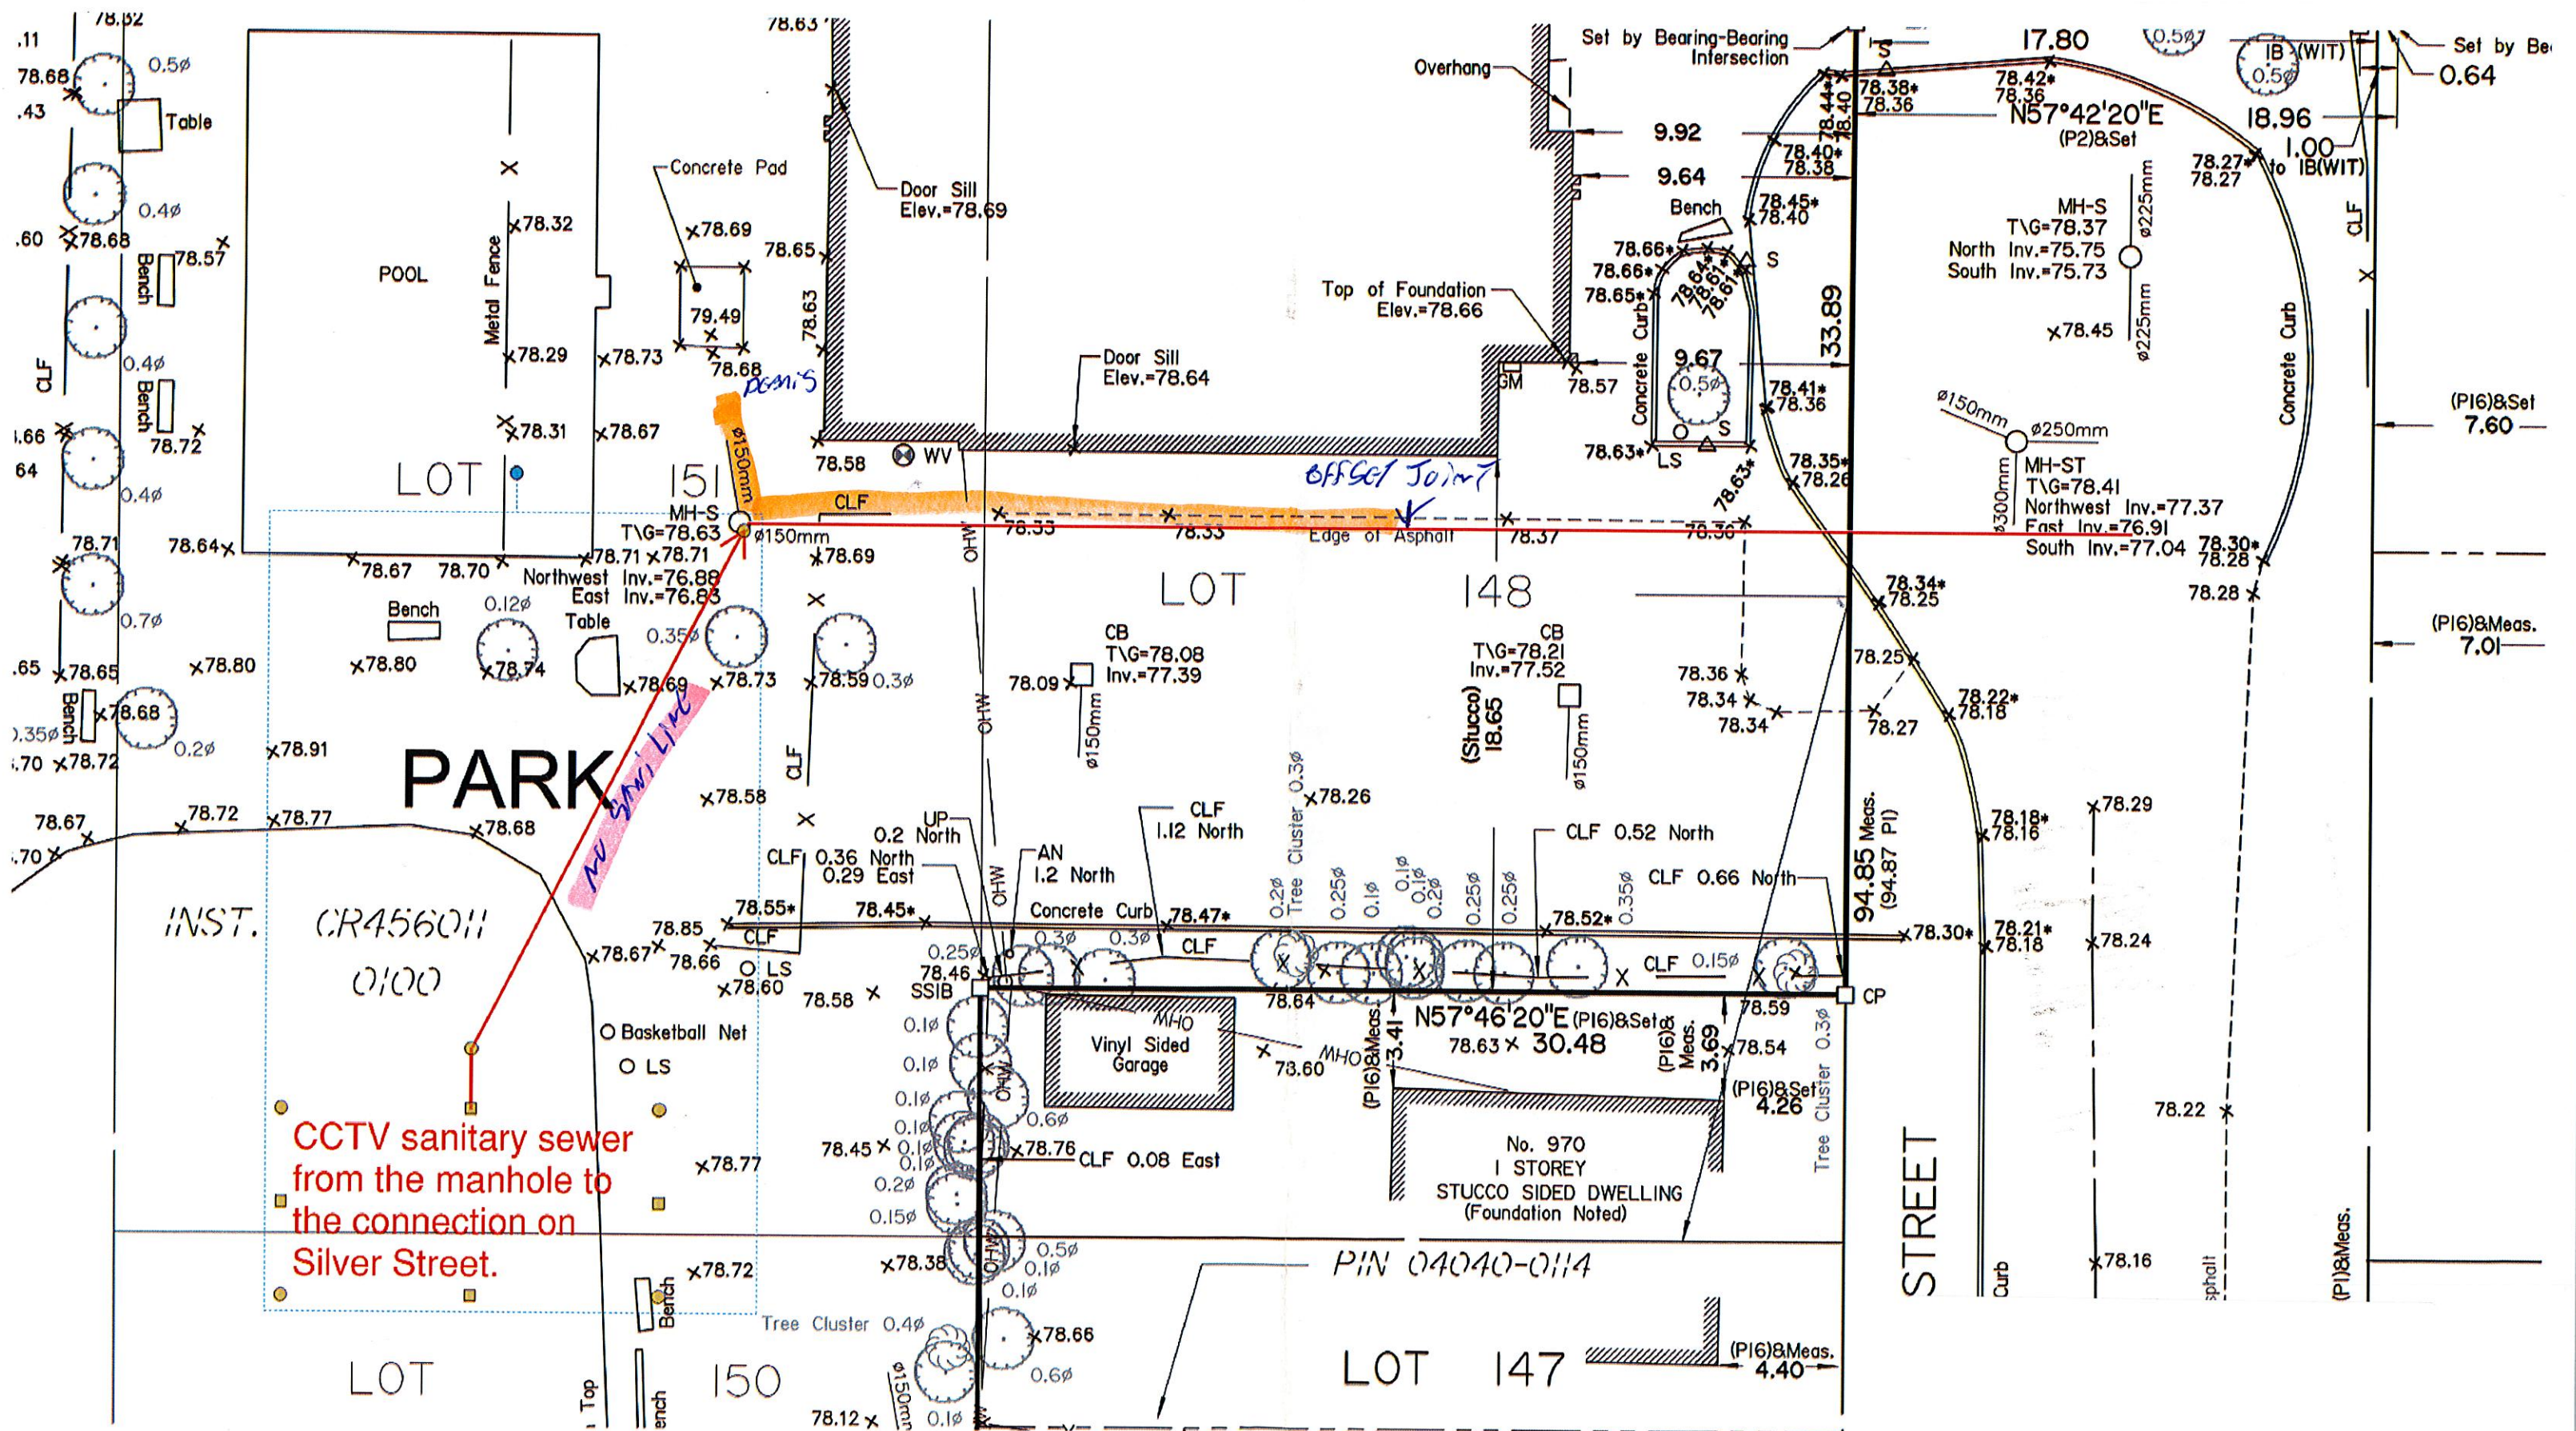
| Peak: | 3 | Peak: | 0 | Peak: | 3 |
| Quick rating: | 3611 | Quick rating: | 0000 | Quick rating: | 3611 |

| OFFSET JOINT |
