**TREE CONSERVATION REPORT**

Ashbury College  
362 Mariposa Ave.

August 14<sup>th</sup>, 2026

Stantec Consulting Ltd.  
1331 Clyde Avenue  
Ottawa ON K2C 3G4  
Project No. 116501019

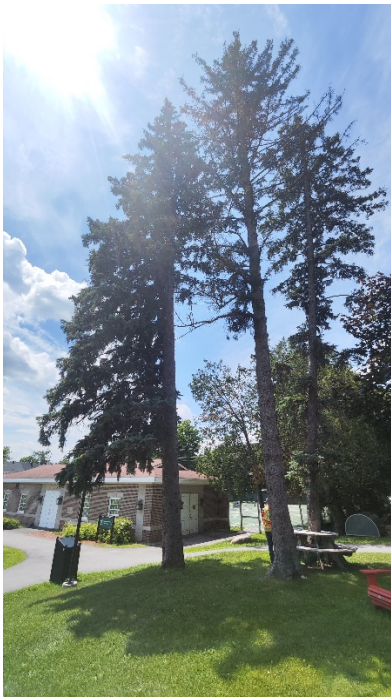
| A photograph showing three tall, slender spruce trees standing in a grassy yard. In the background, a brick building with a white roof and a paved driveway are visible under a bright blue sky with scattered clouds. | <p><b>Photograph 1: Three spruce trees (trees #24-26) anticipated to require removal for construction of new pathway.</b></p> |

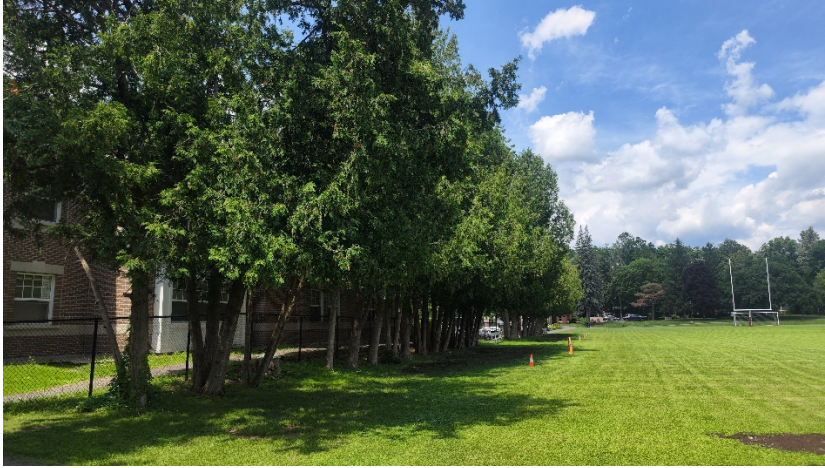
**Photograph 3: Mature cedar groupings (G1 & G2) provide shade and screening along the west side of the existing sports field.**

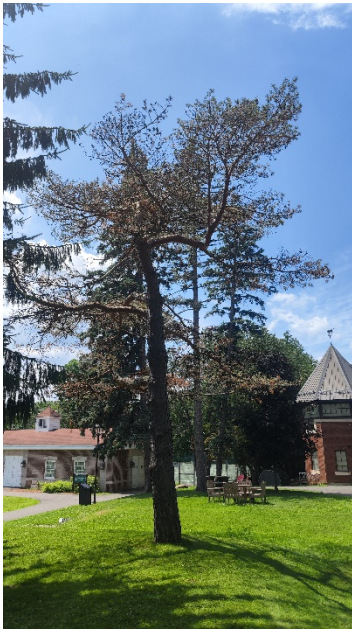
**Photograph 4: Scots Pine (tree #23) in significant decline. It is recommended to remove this tree.**

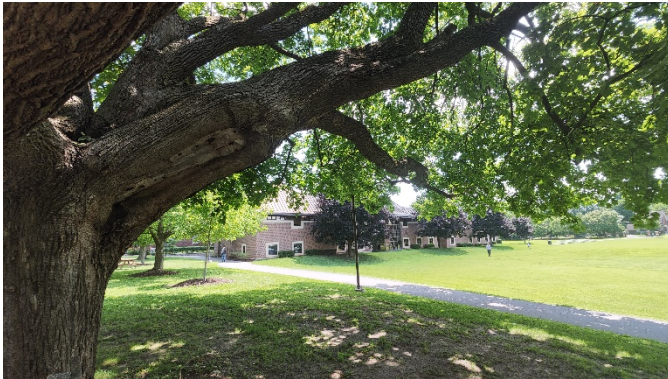
Three trees were identified as requiring further attention because of condition or potential public safety concerns. Tree #16 is a large and significant Sugar Maple located next to a walkway that is often used as a backdrop for class photographs. A large branch extends horizontally over the pathway and exhibits significant wood decay at the junction with the trunk, which may weaken the branch structure and increase the potential for failure. It is recommended that a Certified Arborist assess this branch for mitigation, which may include physical support, bracing, pruning, or removal. Tree #18 is a large Norway Maple with significant trunk rot and a natural lean toward a nearby building. This tree should be considered for removal. Tree #23 is a Scots Pine in significant decline and is recommended for removal, as noted in Appendix B.

| ID # | Botanical Name | Common Name | Total Count | DBH (cm) | Tree Count (by DBH Range) | | | Condition | | | Remarks | | Rationale for Removals | Ownership | Construction Requirement |
|---|---|---|---|---|---|---|---|---|---|---|---|---|---|---|---|
| 16 | <i>Acer saccharum</i> | Sugar Maple | 1 | 82 | 0 | 0 | 1 | F | F | F | branch tip dieback, exposed roots, trunk cavity, wood decay | large cavity on large horizontal branch extending over pathway. *potential hazard: consider pruning | To be protected | Private | Retain / *Prune |

**Photograph 5: Hazardous limb over pathway on a significant/distinctive Sugar Maple (tree #16).**

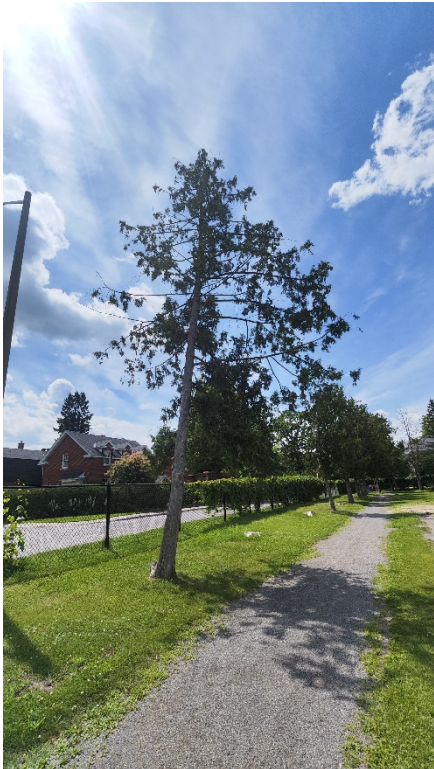
A mature stand of White Cedars (*Thuja occidentalis*) aligned in dense rows adjacent to Maple Lane and Mathews House on the south and southwest sides of the study area has developed a conical form with dense, intertwined canopies. Although heart rot was not identified during the field assessment, mature White Cedars can be susceptible to heart rot and hollow trunks as they age. Several cedar trees within these groupings also have canopies that are significantly suppressed by adjacent cedars and large deciduous trees.

**Photograph 6: Cedar trees along the south side of the existing sports field that no longer form a continuous canopy.**

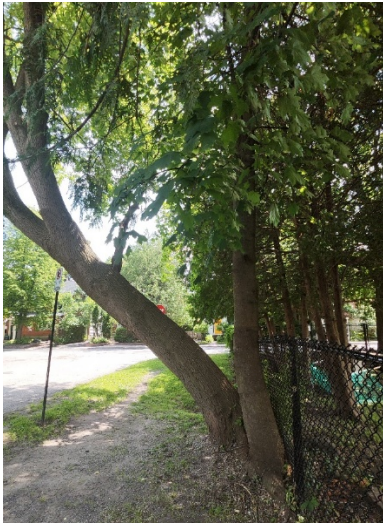
**Photograph 7: Several trees located outside of private property on municipal right-of-way.**

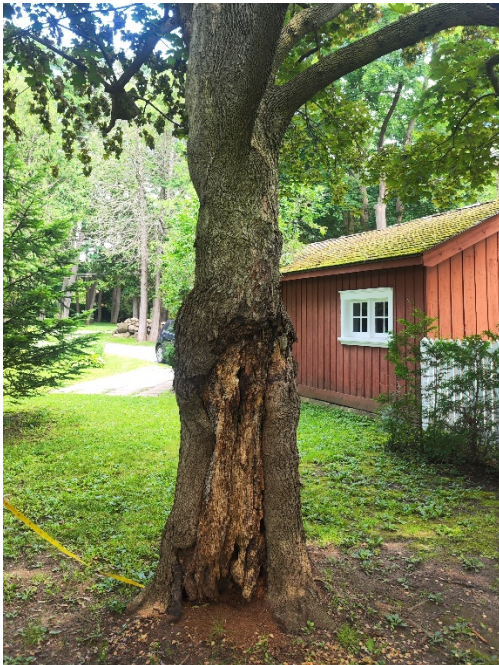
| ID # | Botanical Name | Common Name | Total Count | DBH (cm) | Tree Count (by DBH Range) | | | Condition | | | Remarks | | Rationale for Removals | Ownership | Construction Requirement |
|---|---|---|---|---|---|---|---|---|---|---|---|---|---|---|---|
| 18 | <i>Acer platanoides</i> | Norway Maple | 1 | 64 | 0 | 0 | 1 | P | P | F | trunk cavity, wood decay, natural lean, suppressed canopy vigor, crossing branches | *hazardous tree, significant damage / decay<br>consider removal | To be protected | Private | Retain* |

**Photograph 8: Hazardous tree (#18) near Ashbury House with severe rot in base of trunk.**
