## Phase I - Environmental Site Assessment

Residential Property  
1003 Prince of Wales Drive  
Ottawa , Ontario

September 20, 2013

Report: PE3118-1

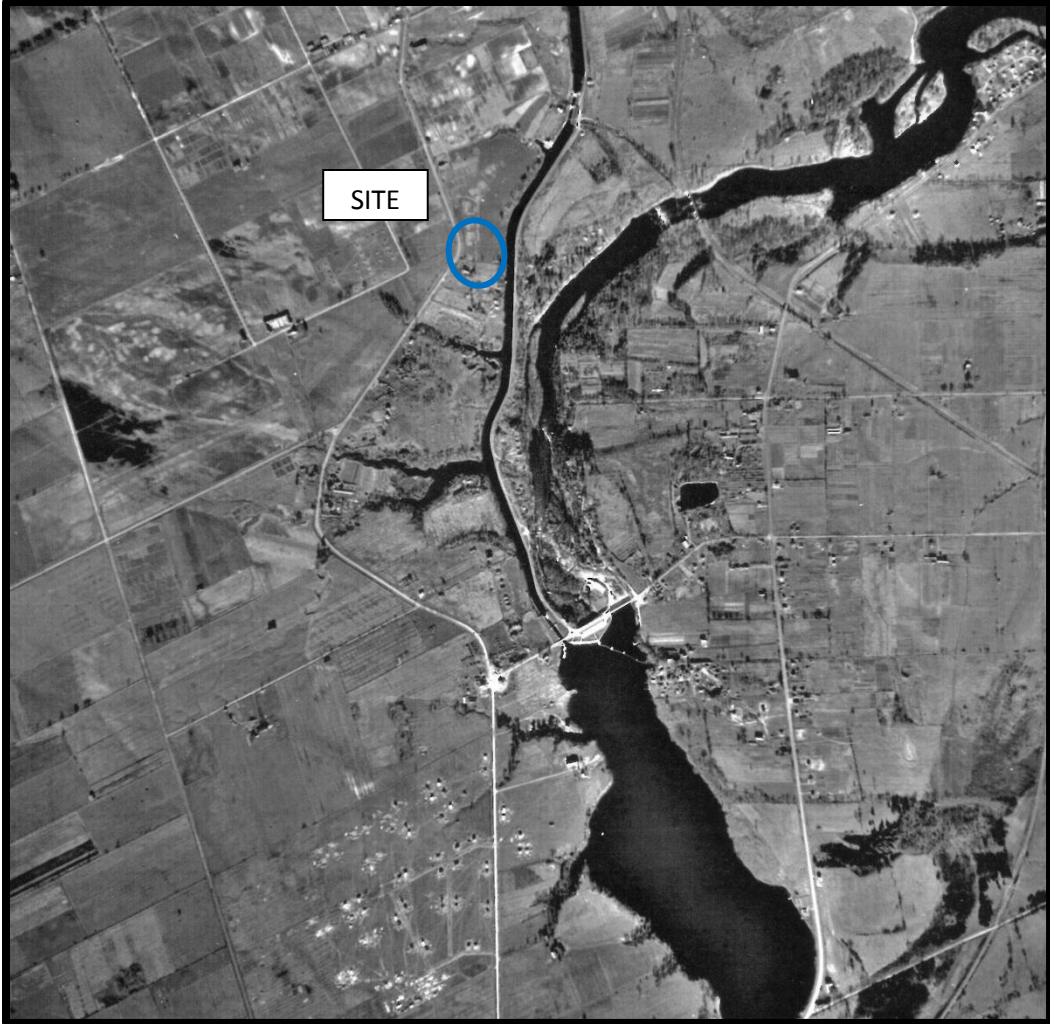
AERIAL PHOTOGRAPH  
1945

| 1945 | The subject site appears to be vacant while the adjacent property to the south is occupied by a residential dwelling. Surrounding lands appear to be vacant or used for agricultural purposes. |

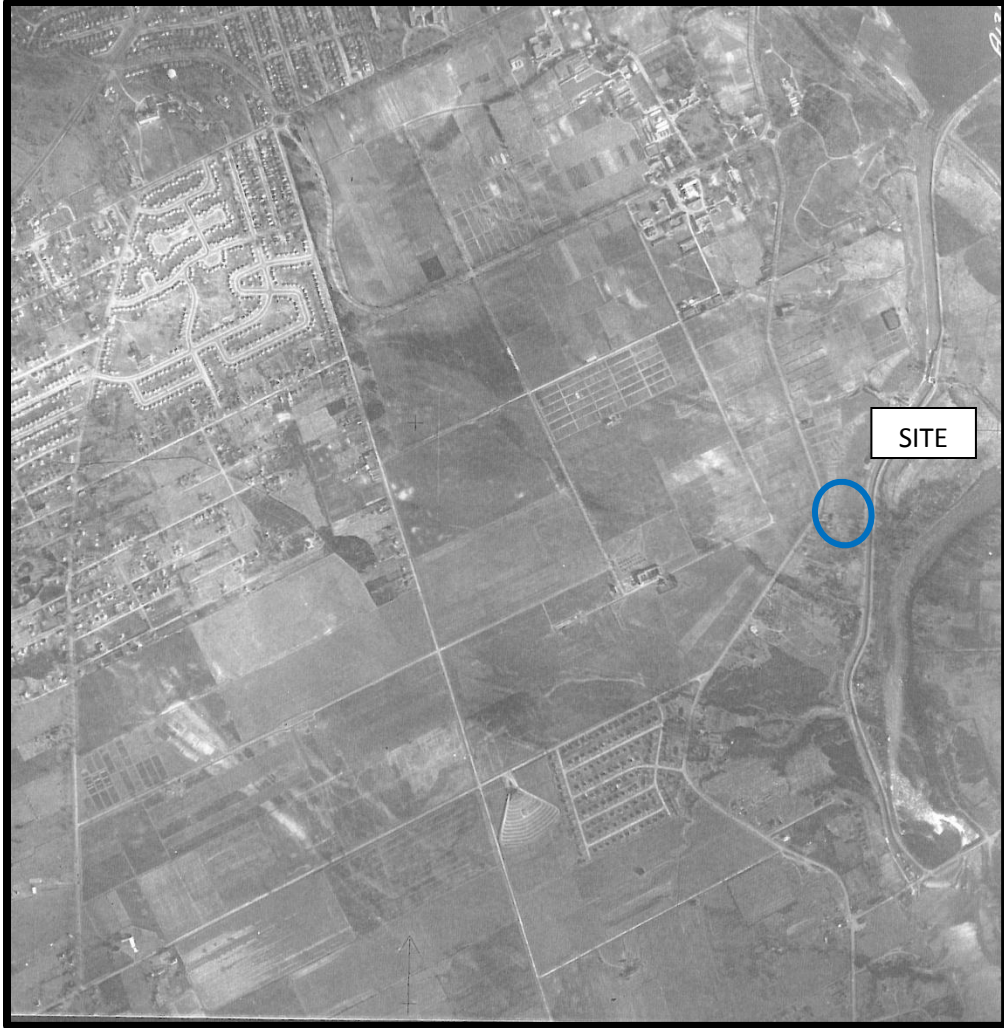
AERIAL PHOTOGRAPH  
1953

| 1953 | The subject site appears to be occupied by a single structure. The surrounding lands appear to be vacant or used for agricultural purposes. |

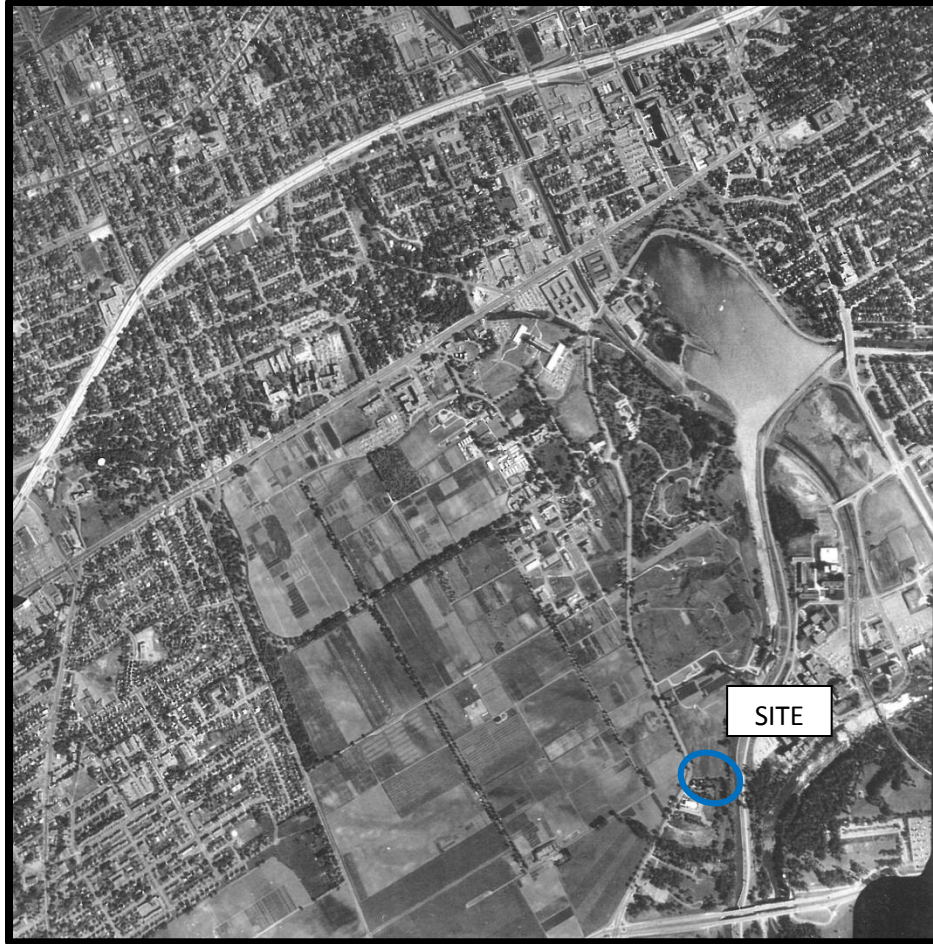
AERIAL PHOTOGRAPH  
1970

| 1970 | The subject site is obscured by trees. Carleton University and the Church of Jesus Christ of Latter-Day Saints can be seen to the northeast and south, respectively. |

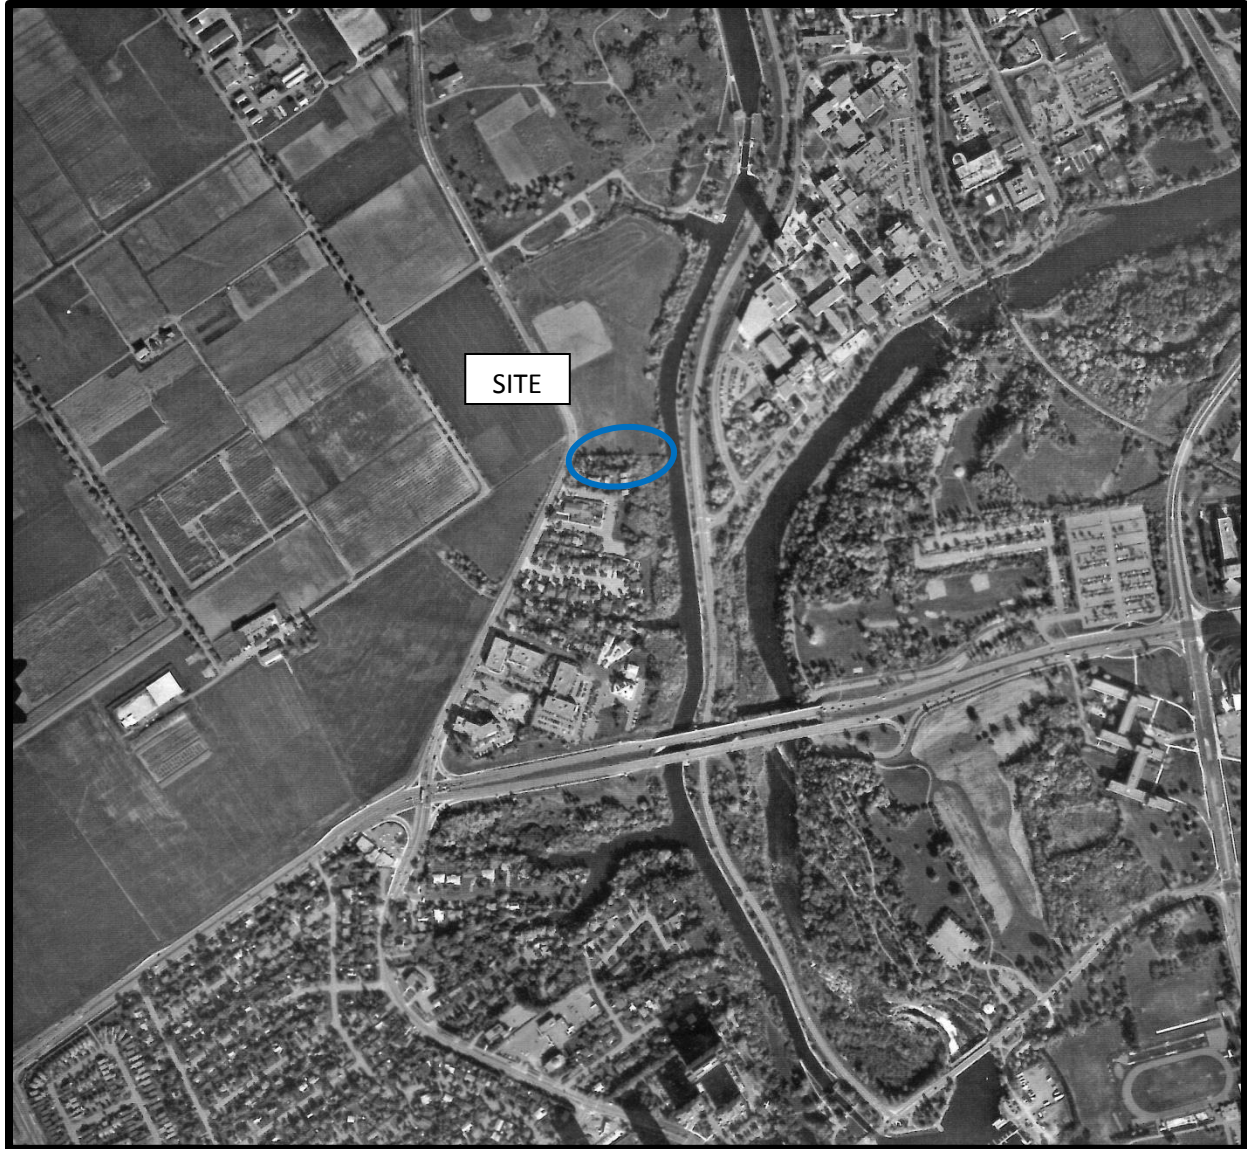
AERIAL PHOTOGRAPH  
1994

| 1994 | The subject site is obscured by trees. A small residential development is visible on the adjacent property to the south. |

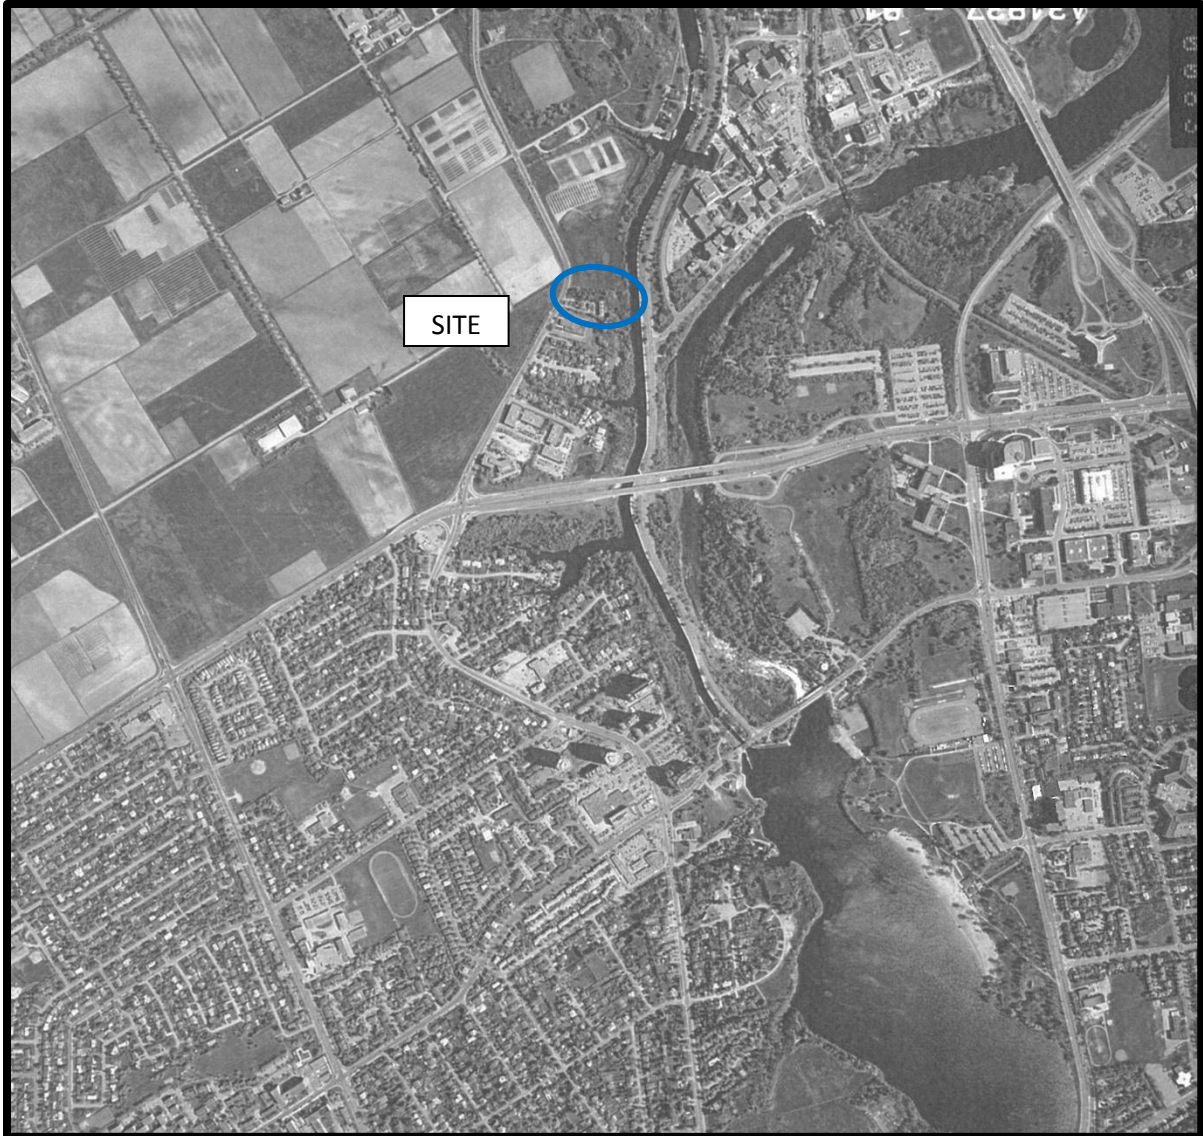
AERIAL PHOTOGRAPH  
2002

| 2002 | There are no significant changes to the subject or neighbouring properties. |

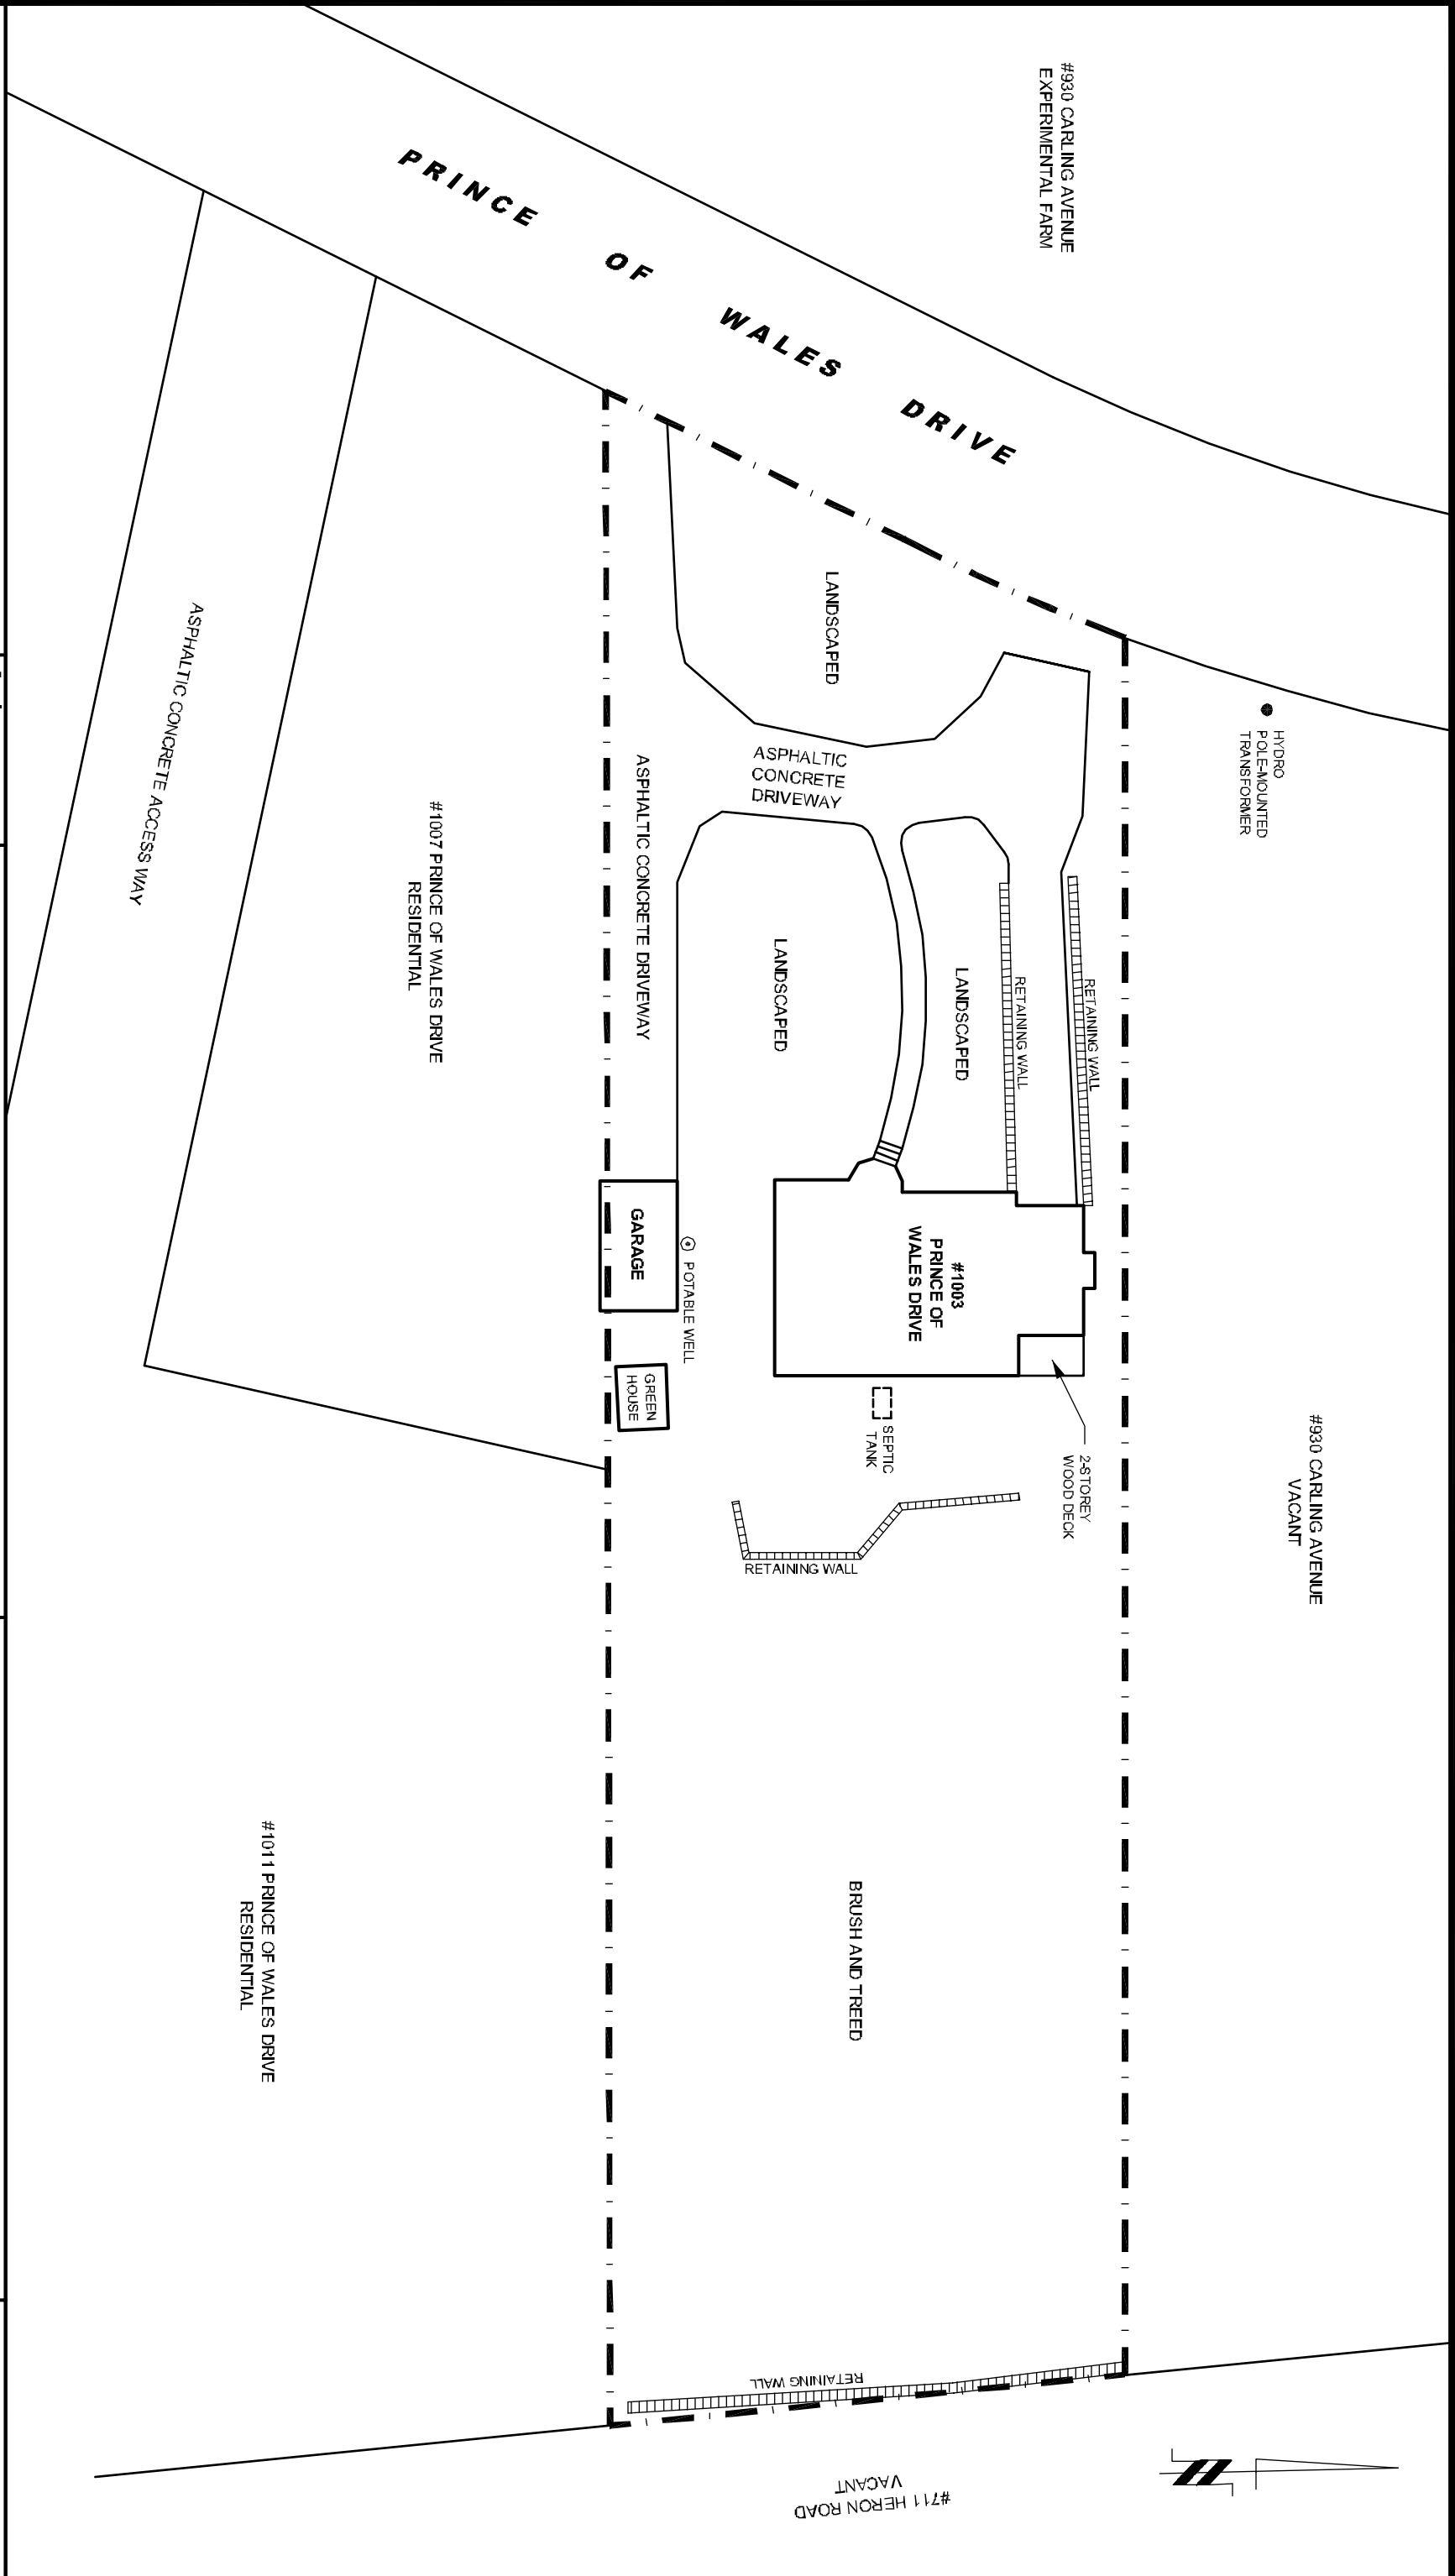
# SITE PLAN

- North - Vacant land that is part of the Experimental Farm;
- South - Residential buildings followed by the Church of Jesus Christ of Latter-Day Saints;
- East - Rideau Canal and Rideau River;
- West - Prince of Wales Drive followed by the Experimental Farm.

The environmental impact from the current use of the neighbouring properties upon the subject site is considered to be low. Land use adjacent to the subject site is illustrated on Drawing No. PE3118-1 - Site Plan in the Appendix.
