**Re: Tree Conservation Report – 192 Bronson Ave., Ottawa**

This report details a pre-construction Tree Conservation Report (TCR) for the above-noted property in Ottawa. The need for this report is related to trees protected under the Urban Tree Conservation By-law 2009-200 and the Municipal Trees and Natural Areas Protection By-law 2006-279. Tree conservation reports are required for all site plan control applications on properties where there is a tree of 10 centimetres in diameter or greater. The approval of this TCR by the City of Ottawa and the issuing of a permit by them authorize the removal of approved trees. **Importantly, although this report may be used to support the application for a City tree removal permit, it does not by itself constitute permission to remove trees or begin site clearing activities. No such work should occur before a tree removal permit is issued by the City of Ottawa. In particular, permission to remove private trees adjacent to the subject property will be required before a tree removal permit is issued.**

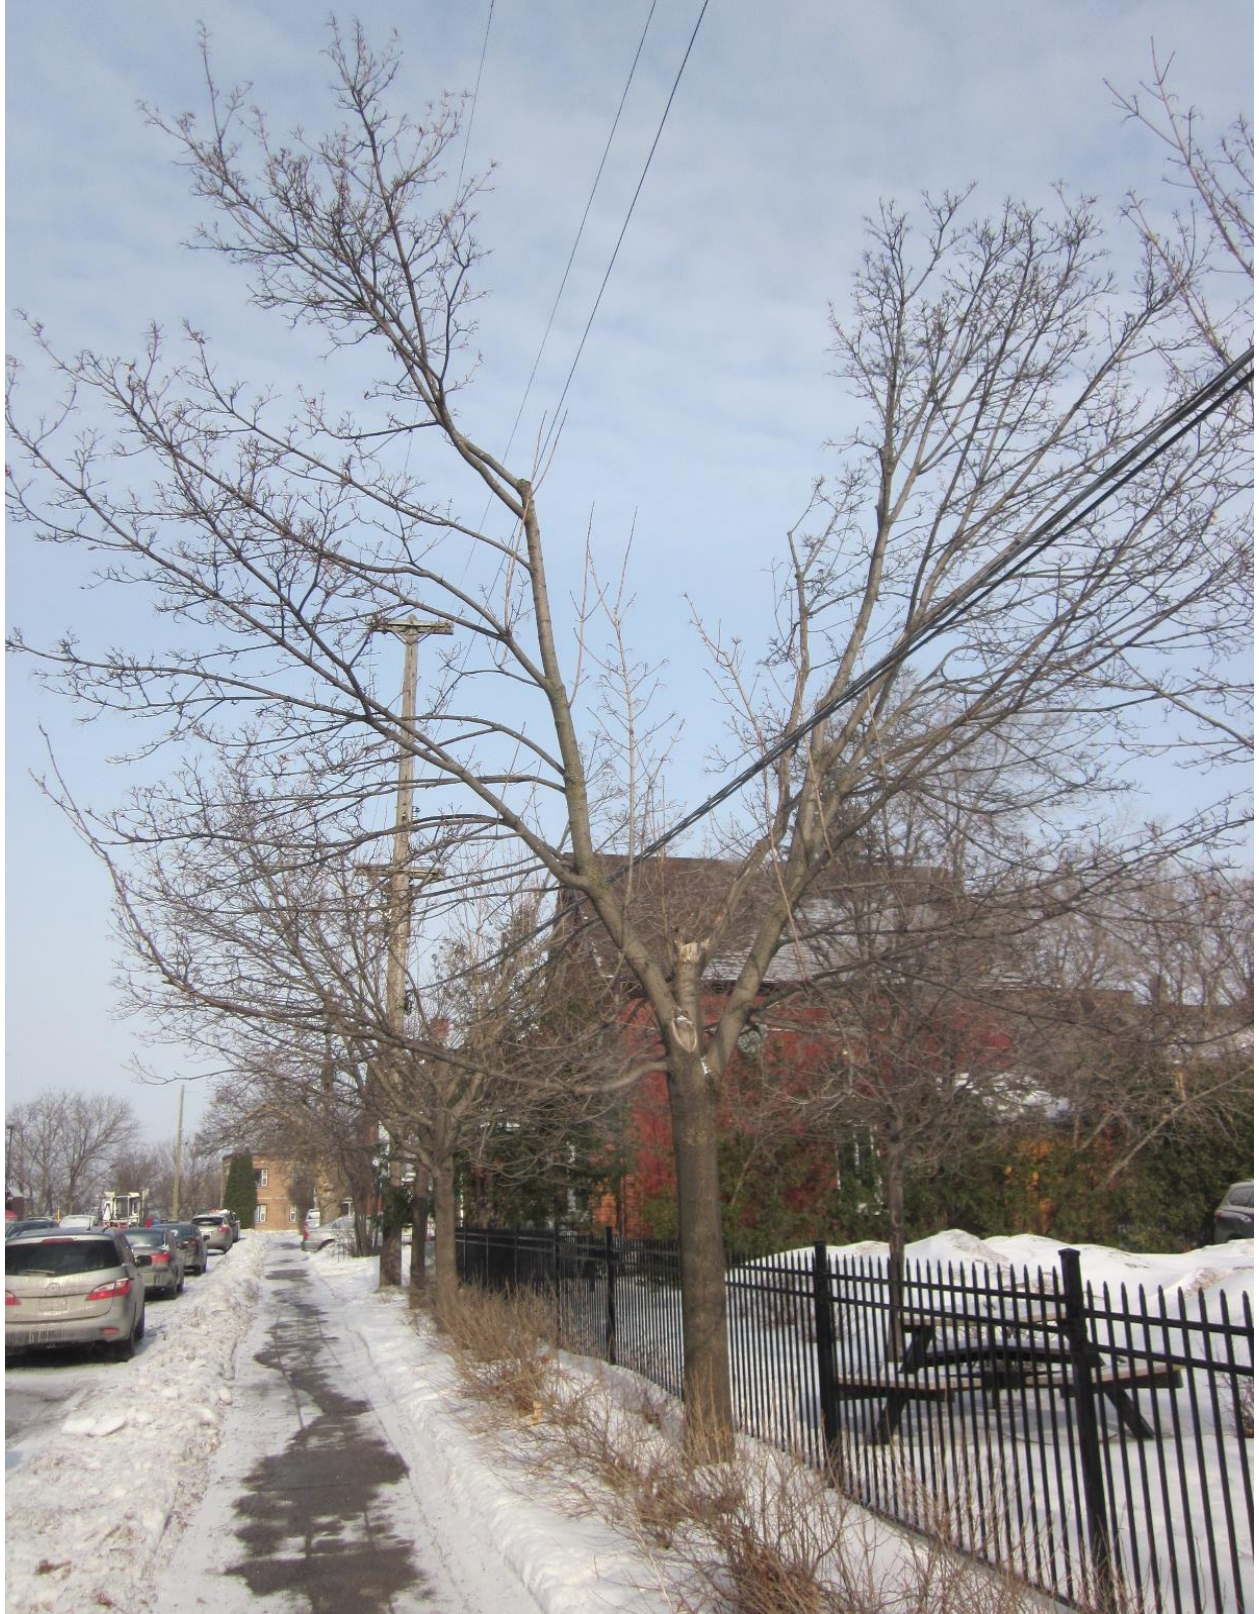
| Tree No. | Tree Species | Condition (VP→E) | D.B.H (cm) | Tree Condition Notes & Status ( <b>to be removed or retained</b> ) |
|---|---|---|---|---|
| 8 | Norway maple | Poor | 24 | Located on City property; heavily pruned by Hydro; invasive, undesirable species; <b>to be retained</b> |
| 10 | Norway maple | Poor | 22 | Located on City property; heavily pruned by Hydro; invasive, undesirable species; <b>to be retained</b> |
| 12 | Norway maple | Poor | 19 | Located on City property; heavily pruned by Hydro; invasive, undesirable species; <b>to be retained</b> |

Picture 1. Trees #8, 10 and 12 adjacent to 192 Bronson Ave.

Preservation and protection measures intended to mitigate damage during construction will be applied for the trees to be retained adjacent to the subject property. The following measures are the minimum required by the City of Ottawa to ensure tree survival during and following construction:

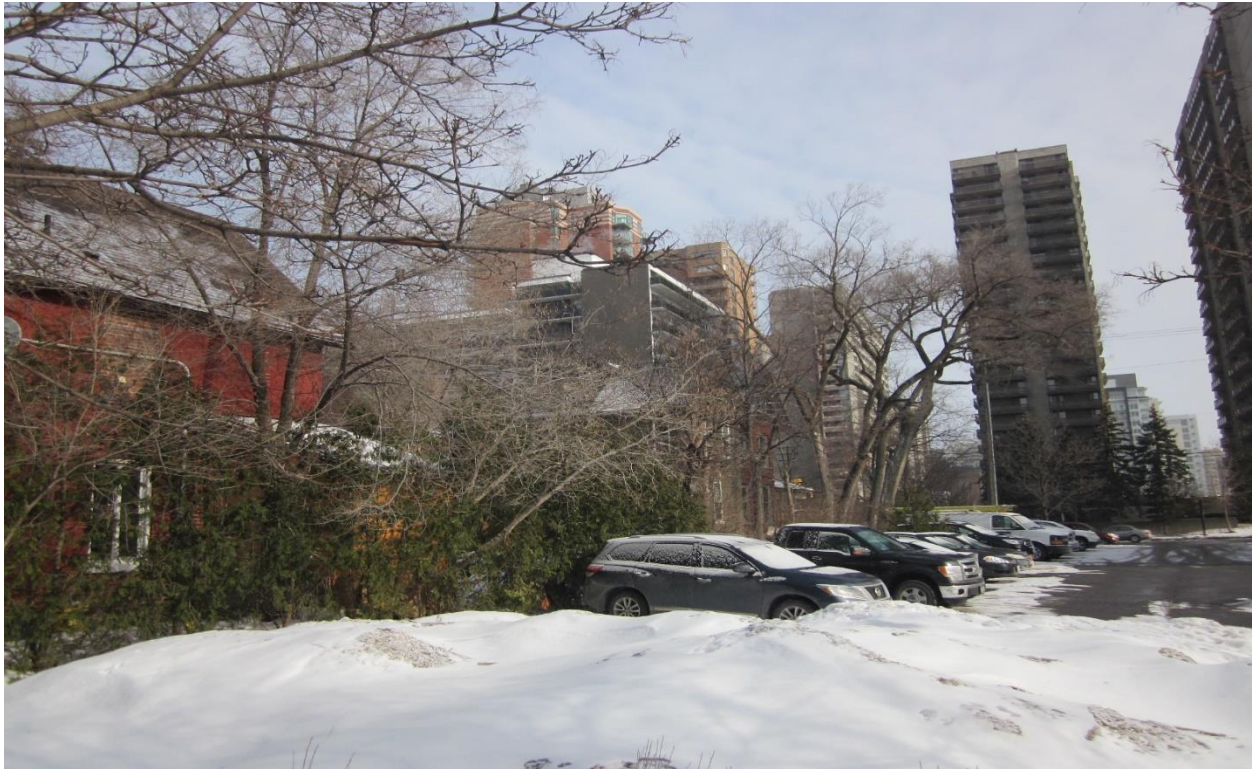
| Tree No. | Tree Species | Condition (VP→E) | D.B.H (cm) | Tree Condition Notes & Status ( <b>to be removed or retained</b> ) |
|---|---|---|---|---|
| 15 | Siberian elm<br>( <i>Ulmus pumila</i> ) | Good | 25 | On neighbouring private property; maturing tree; generally good growth form; invasive, undesirable species/ <b>to be retained</b> |
| 16 | Mountain-ash<br>( <i>Sorbus</i> spp.) | Poor | 33 | Over-mature tree; major deadwood in crown-in advanced decline; trees #23-26 all with lilac underneath; <b>to be removed</b> |
| 17 | Ash<br>( <i>Fraxinus</i> spp.) | Very poor | 18 | Dead due to Emerald ash borer ( <i>Agrilus planipennis</i> ) infestation; <b>to be removed</b> |

Picture 2. Trees #15, 16 and 17 on and adjacent to 192 Bronson Ave.

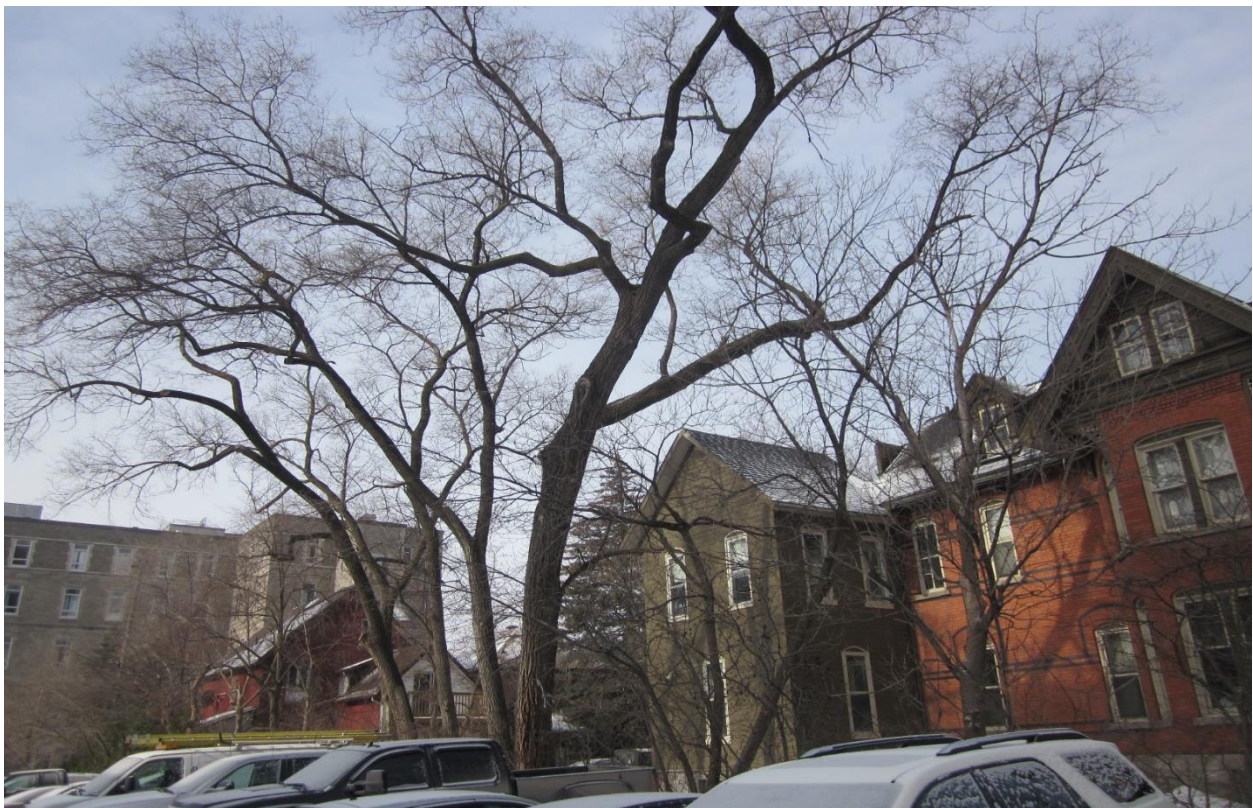
| Tree No. | Tree Species | Condition (VP→E) | D.B.H (cm) | Tree Condition Notes & Status ( <b>to be removed or retained</b> ) |
|---|---|---|---|---|
| 20 | Siberian elm | Fair | 41 | Shared tree (will require neighbour's permission to remove); mature tree; growing on mild angle; slime flux apparent in mid-crown; trees #20-24 each an invasive, undesirable species with chokecherry underneath; <b>to be removed</b> |
| 21 | Siberian elm | Fair | 40 | Mature tree; growing on moderate angle due to intercompetition for sunlight; <b>to be removed</b> |
| 22 | Siberian elm | Fair | 31 | On neighbouring private property; mature tree; growing on mild angle; slime flux apparent in mid-crown; <b>to be retained</b> |
| 23 | Siberian elm | Fair | 53 | On neighbouring private property; mature tree; growing on mild angle; <b>to be retained</b> |
| 24 | Siberian elm | Fair | 59 | On neighbouring private property; mature tree; growing on moderate angle due to intercompetition for light; <b>to be retained</b> |
| 25 | Manitoba maple | Poor | 14 avg. | On neighbouring private property; five-stemmed from grade-all divergent; <b>to be retained</b> |
| 26 | Manitoba maple | Fair | 23 | On neighbouring private property; growing on mild lean; <b>to be retained</b> |

Picture 3. Trees #20 through 26 on and adjacent to 192 Bronson Ave.

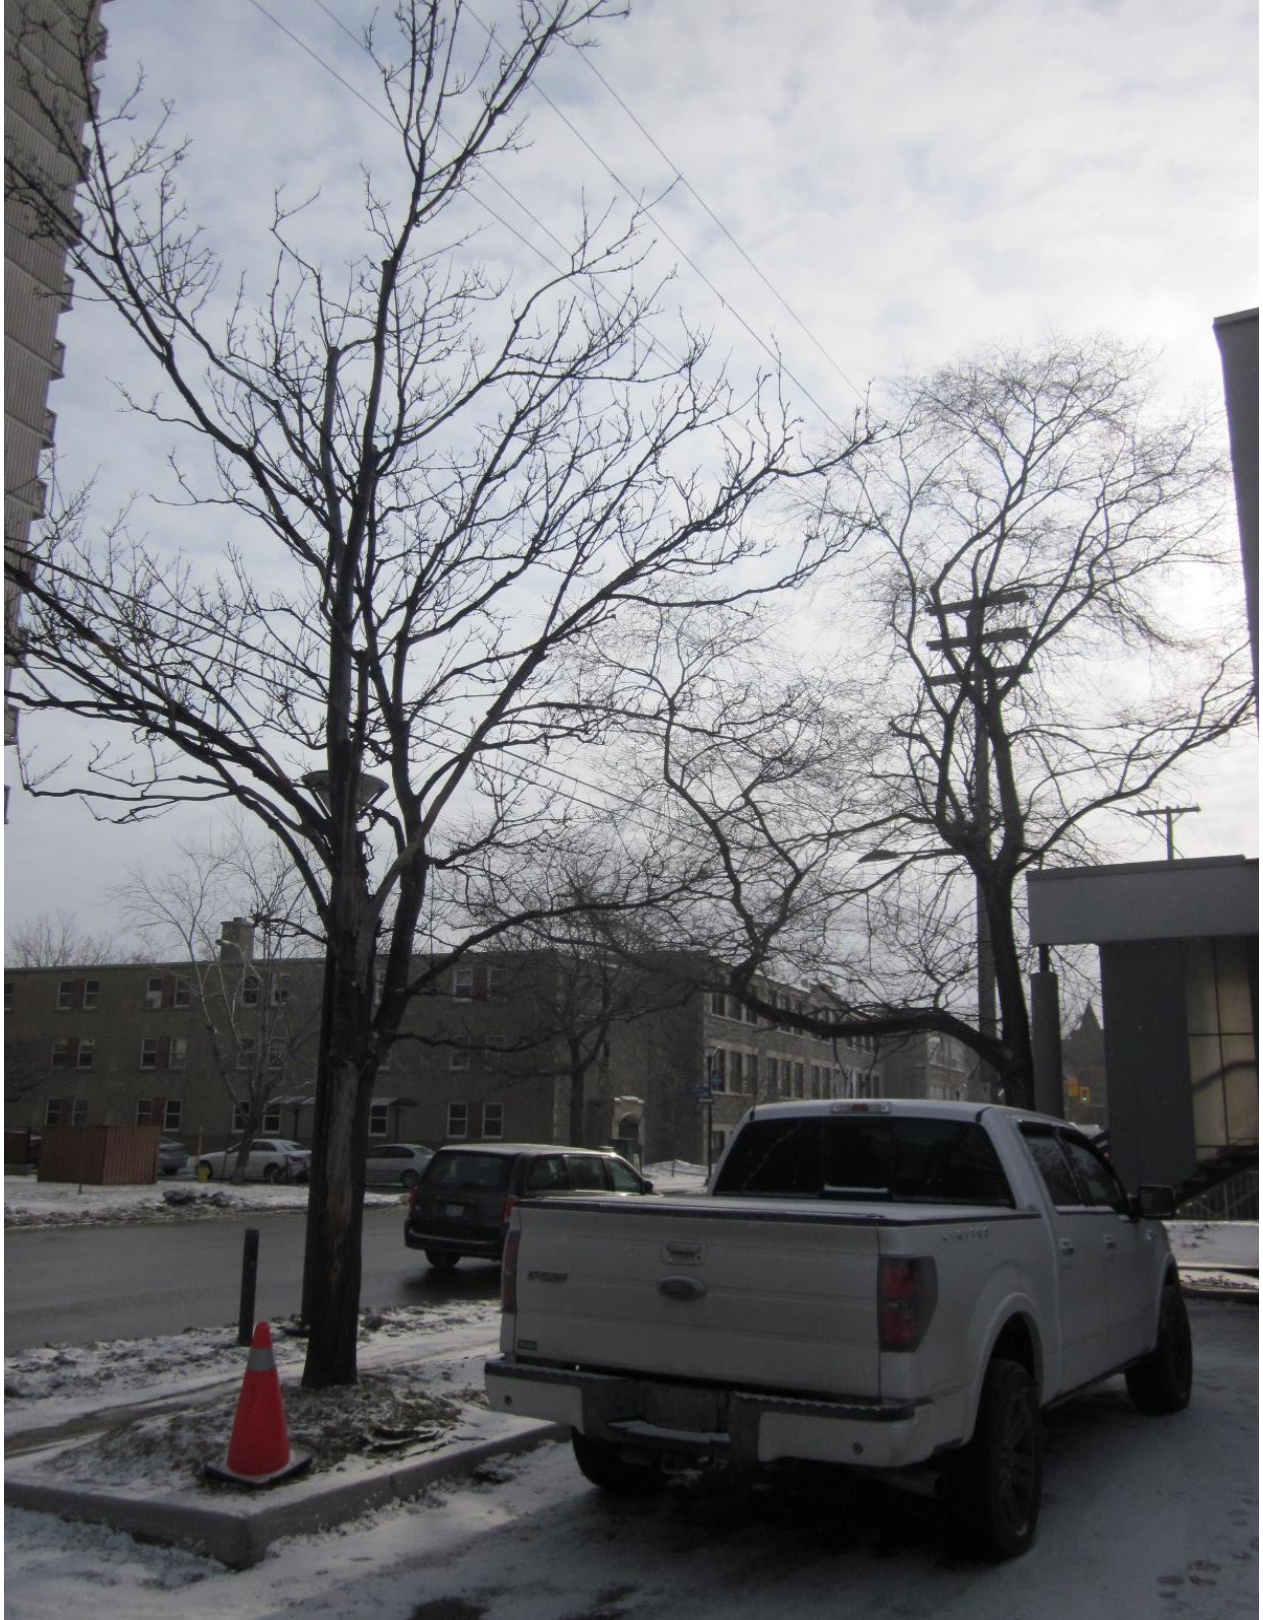
| Tree No. | Tree Species | Condition (VP→E) | D.B.H (cm) | Tree Condition Notes & Status ( <b>to be removed or retained</b> ) |
|---|---|---|---|---|
| 28 | Norway maple | Very poor | 23 | Dead due to very restricted rooting area; <b>to be removed</b> |

| Tree No. | Tree Species | Condition (VP→E) | D.B.H (cm) | Tree Condition Notes & Status ( <b>to be removed or retained</b> ) |
|---|---|---|---|---|
| 29 | Siberian elm | Fair | 42 | Crown asymmetrical due to proximity of building; invasive, undesirable species; <b>to be removed</b> |

Picture 4. Trees #28 and 29 at 192 Bronson Ave.
