# TREE INSPECTION REPORT

239 Craig Henry Drive

This assessment is based on a ground inspection of the trees conducted on September 10th, 2013.

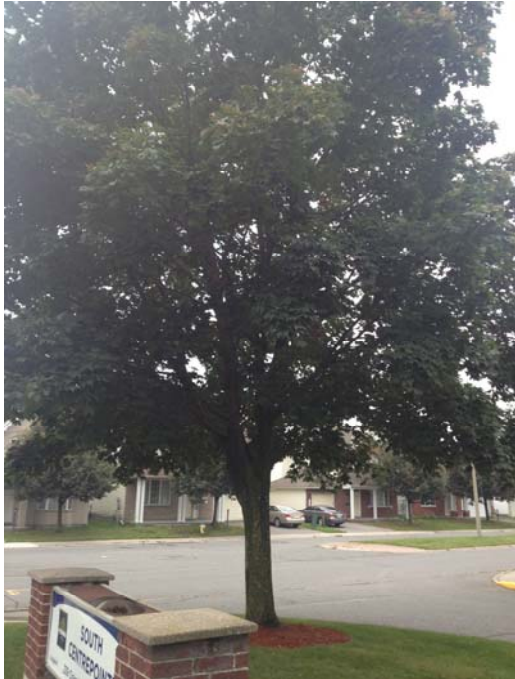
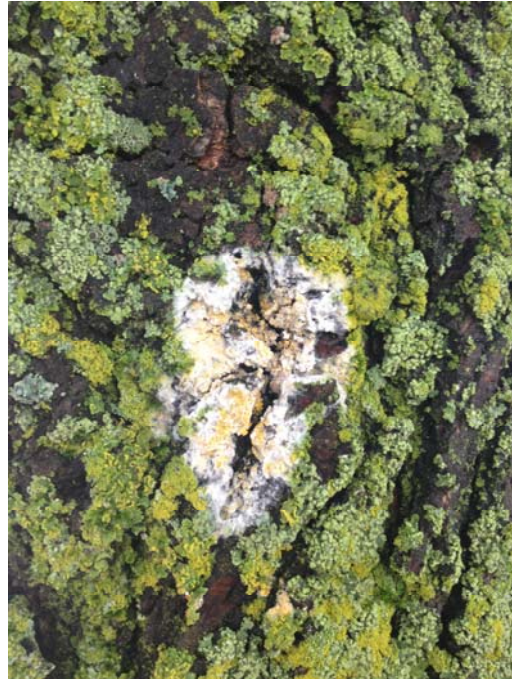
MODERATE: The tree is well-formed and has good vigour and a full canopy; however the trunk is densely inhabited by lichens, and has multiple sites of infection of a lichenicolous fungus which is a symptom of rot. The lichens and fungus are very moist and are shedding profusely, making an accurate measurement of the tree difficult. The presence of the fungus could represent internal decay, though the tree appears healthy – See Figure 1 & 2

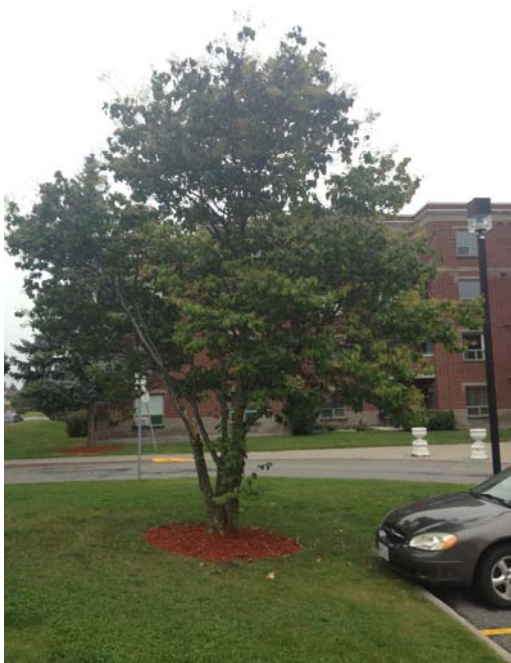
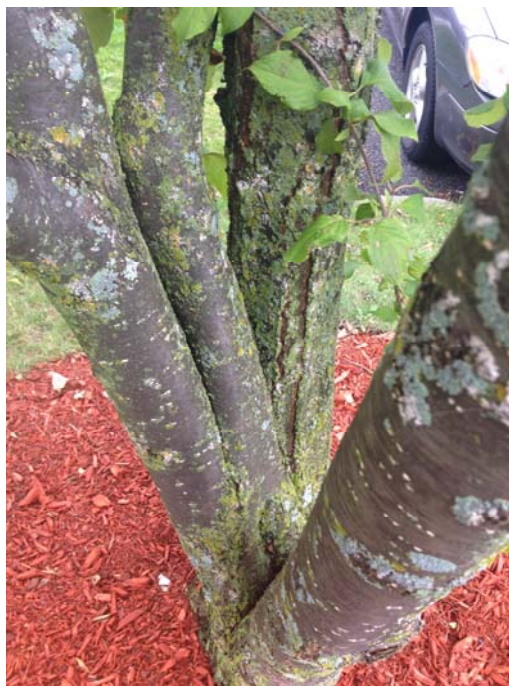
POOR: The multiple stems are very weakly joined at the base of the tree, with severely included bark and evidence of decay. The vigour of the tree is poor, with 10% dead minor branches and chlorotic leaves throughout (beyond seasonal coloration). There is evidence of a recent failure of one of two codominant stems, diverging from one of the tree's main stems at approximately 1.5m above grade. Further failure is likely, however the tree's small size and the absence of targets represent little hazard - See Figure 3 & 4

It is our understanding that this area of the site is to be redeveloped, and that all of the existing trees listed above are to be removed for this purpose. Trees # 2, 5 and 9 ought to or may be removed in any case, due to poor health and potential risk. The remaining 7 trees on site are all in reasonably good condition, however the extent of development and site re-grading would make their retention impossible. Trees # 3 and 8 could potentially be transplanted, though due to the existing injuries to their trunks, their survival is unlikely and this is not recommended as a course of action.

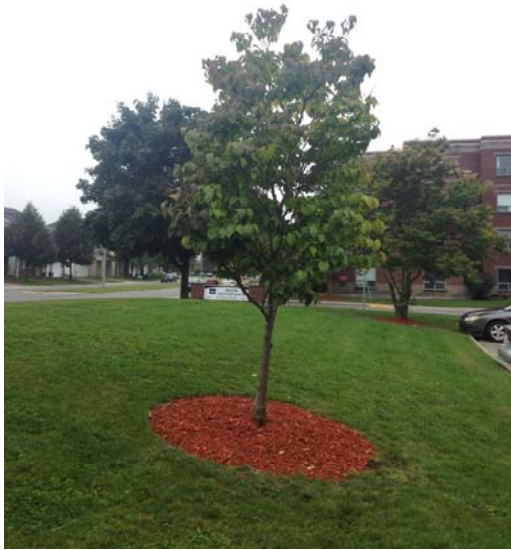
MODERATE: The tree is in good condition, however it has been severely girdled at the base, possibly from maintenance activities. This may contribute to long-term decline - See Figure 5

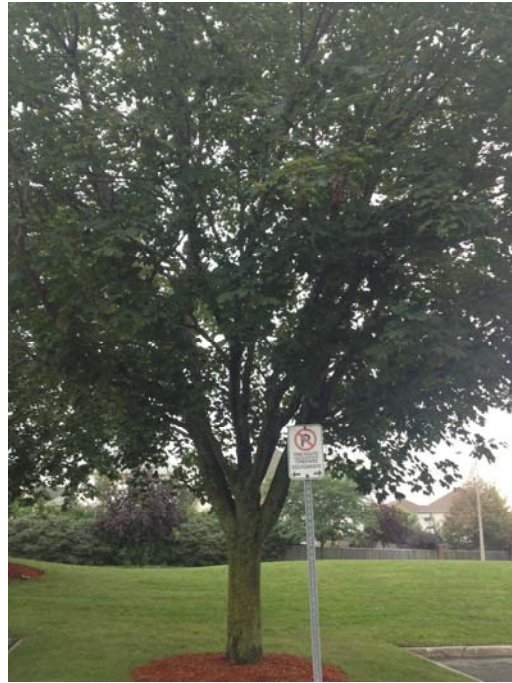
GOOD: The tree is in good health, and has good form. There is one minor broken branch, and one branch union with included bark at approximately 3m above grade - See Figure 6

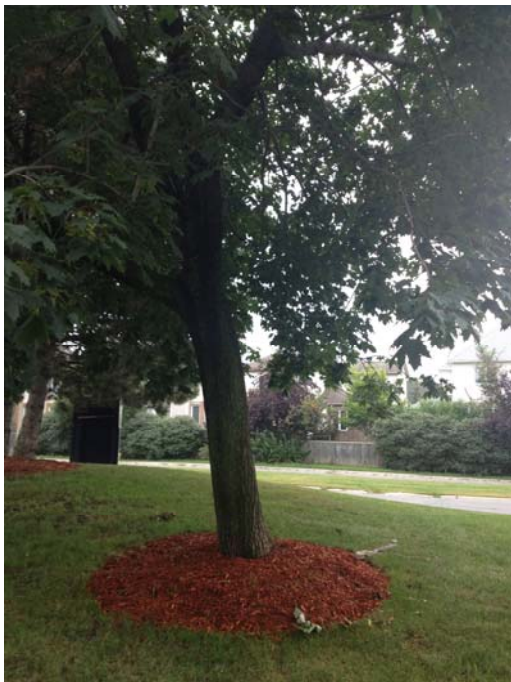
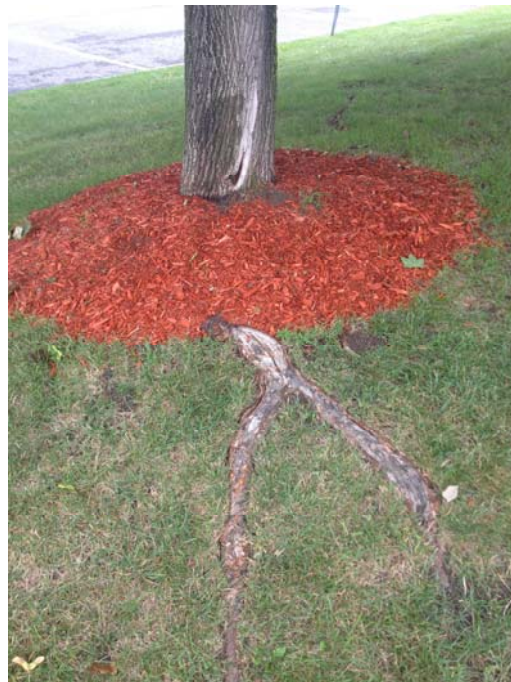
POOR - HAZARDOUS: The tree has a moderate to severe lean, at approximately 75° North. There are surface roots on the upper side of the lean, and some evidence of loose soil and disturbance to the mulch around the base of the tree indicating possible heaving. There is an injury at the base of the trunk on the upper side of the lean, potential indication of injury to the root collar below grade or potential site of the introduction of butt rot. There is no growth correction in the stem or canopy of the tree to indicate that the lean is established. The tree is otherwise healthy and well formed, but potentially hazardous due to instability - See Figure 7 & 8

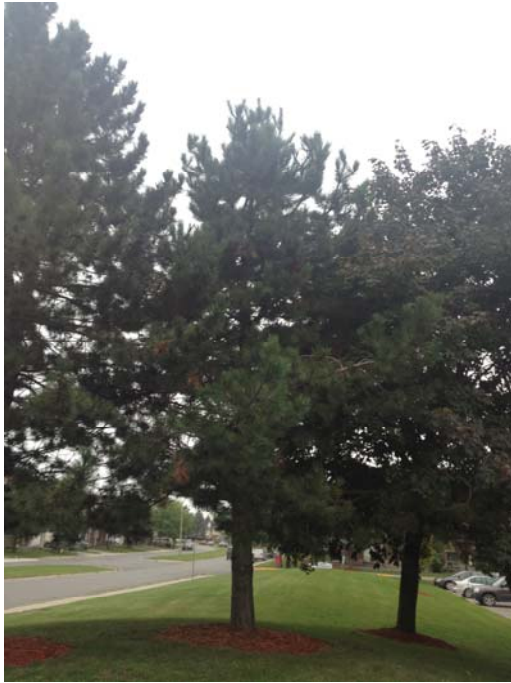
MODERATE: The tree has some dying needles throughout, and has moderate vigour. There is a significant amount of sap dripping from specific areas higher in the canopy, which were not visible from a ground inspection. The form of the tree is good - See Figure 9

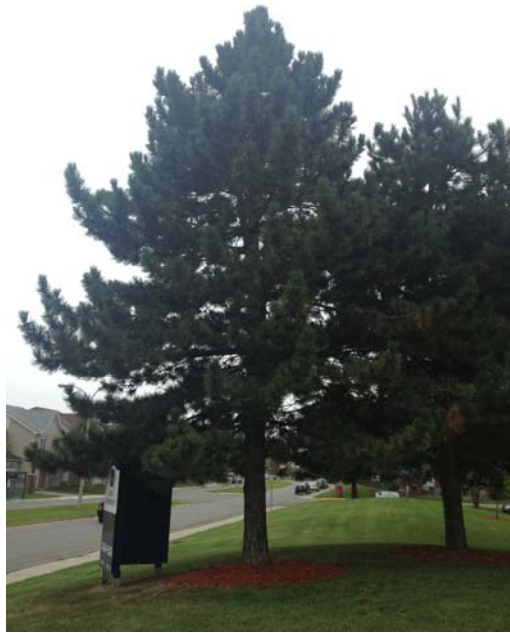
MODERATE: The tree is healthy, but the form is poor, with codominant stems separating at approximately 2.5m above grade. The western stem divides again into codominants at approximately 3.5m above grade - See Figure 10

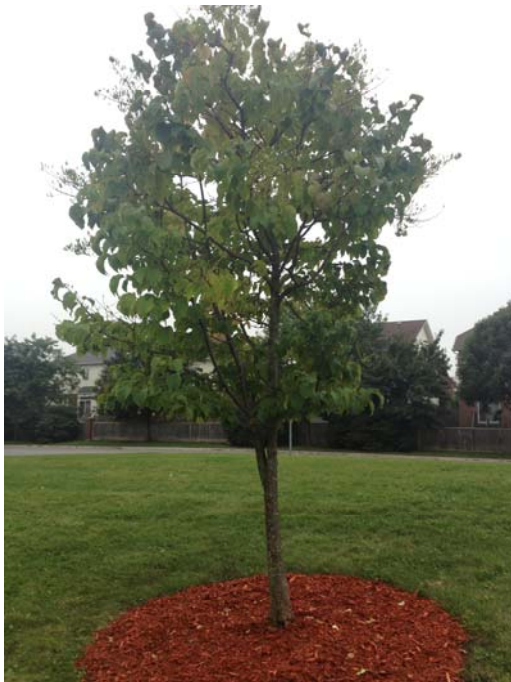
MODERATE: The tree is in good condition, however it has been severely girdled at the base, possibly from maintenance activities. This may contribute to long-term decline – See Figure 11

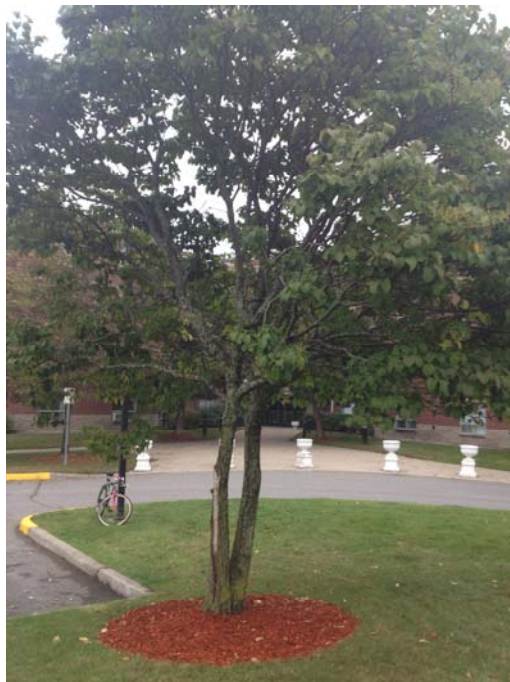
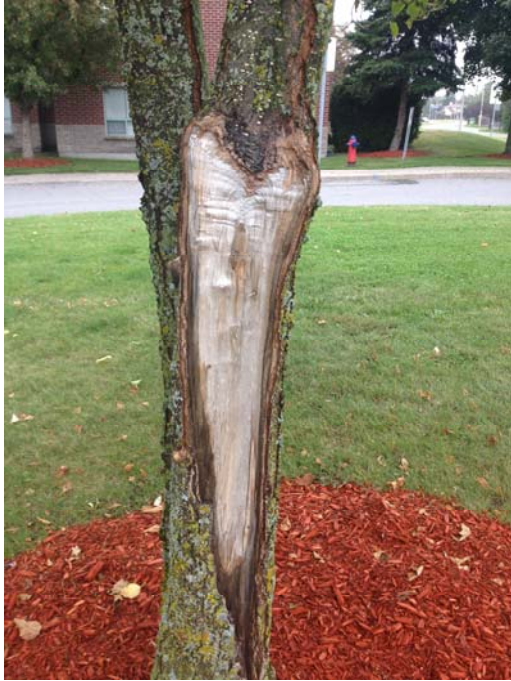
POOR: The tree has codominant stems, diverging at the base, with included bark and evidence of decay. The western stem is severely injured, from what appears to be the failure of codominant stems at a height of 1.5m. The health and vigour of the tree is moderate– See Figure 12 & 13

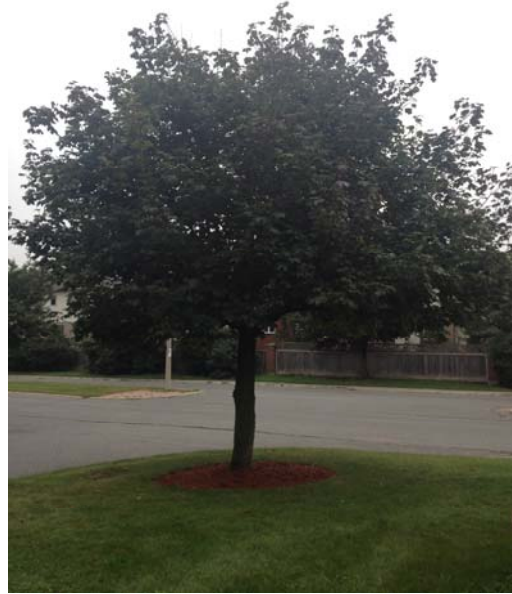
MODERATE: The tree has a healthy, dense canopy, with some tangled branches growing in close contact with each other. There is a large dead branch, pruned off at approximately 1.2 m above grade on the main trunk, which has healed somewhat poorly, though there is no immediate evidence of decay. The tree appears otherwise healthy – See Figure 14

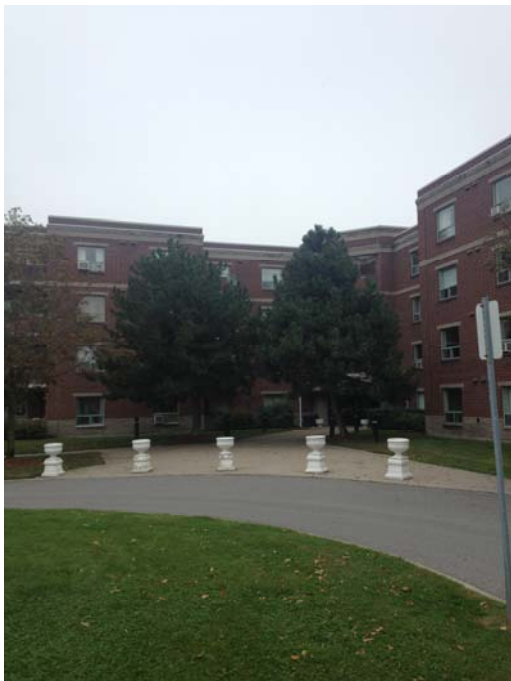
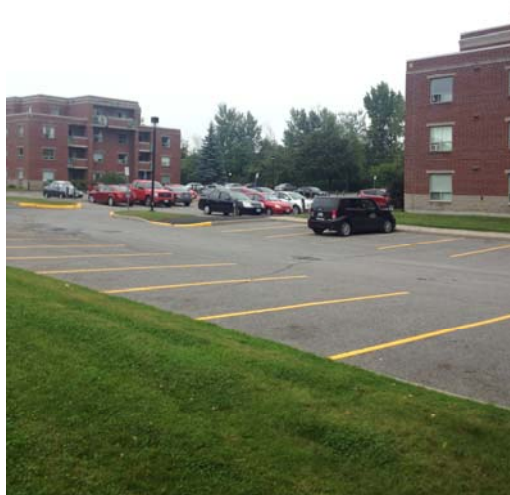
There are other trees on the property, though they are located on the other side of the drive aisle and parking areas and are unlikely to be within the zone of impact from construction. If any construction activity, including traffic and hoarding, should take place near these areas, tree protection fencing should be installed to protect the Critical Root Zones of these trees.
