Urban Forestry & Forest Management Consulting

March 28, 2016

Re: Tree Conservation Report – 559 Riverdale Ave.

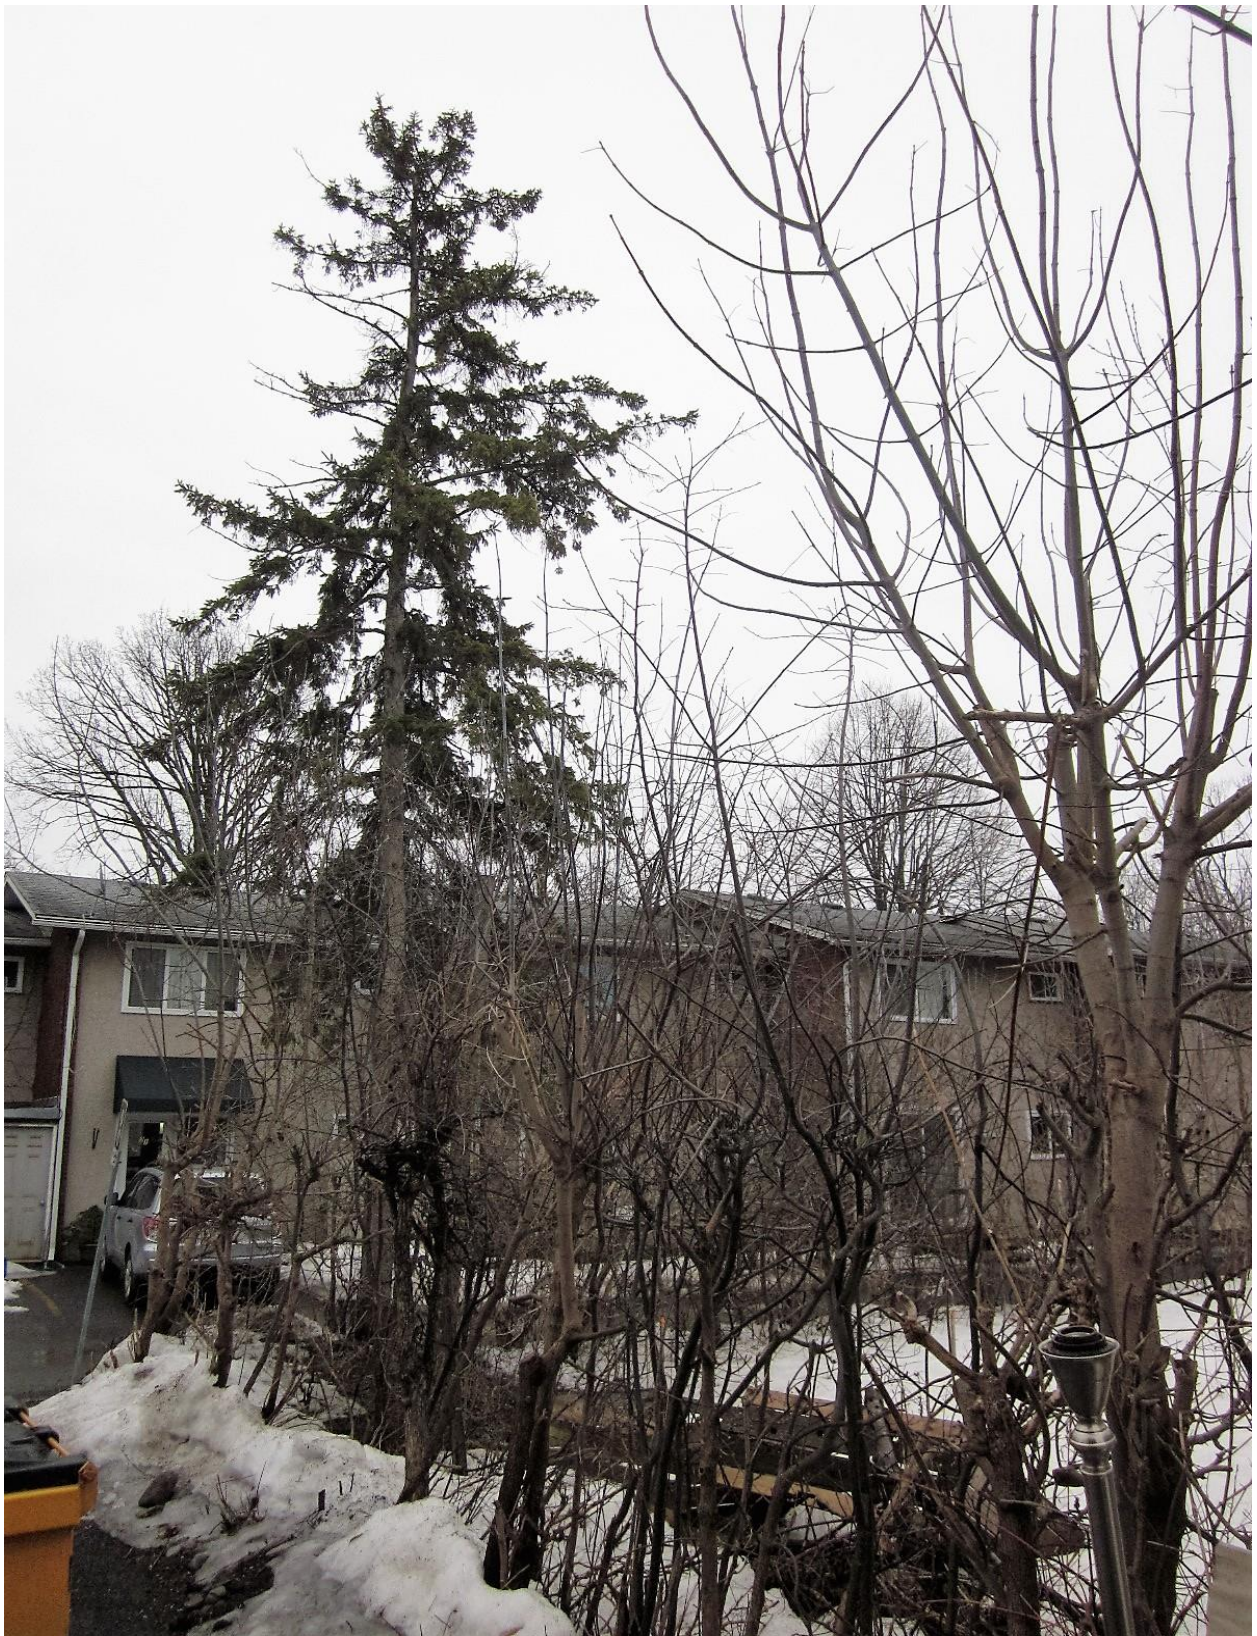
Tree No.	Tree Species	Condition (VP→E)	D.B.H (cm)	Tree Condition Notes & <b>Preservation Status</b> (to be removed or retained)
1	White spruce ( <i>Picea glauca</i> )	Poor	29.8	Mature; crown thin, poor growth increment-in decline; <b>to be removed</b>
2	Mountain-ash ( <i>Sorbus</i> spp.)	Poor	20 avg.	Mature; multi-stemmed from 0.4m; one stem dead others in advanced decline; <b>to be removed</b>

A deciduous hedge surrounds three sides of the property. The majority of trees within the hedge are either undesirable and/or invasive species: Manitoba maple (*Acer negundo*), buckthorn (*Rhamnus* spp.) and Siberian elm (*Ulmus pumila*). The only native desirable species present are ash (*Fraxinus* spp.) and white elm (*Ulmus americana*), both of which are very prone to disease and insects. All vegetation within the hedges likely originated from seed. Attempts at hedging these trees have been made in the past, leaving them all in poor condition. These hedges are to be removed but since all stems are under 10cm in diameter they are not subject to permit requirements.

Picture 1. White spruce and portion of deciduous hedge surrounding 559 Riverdale Ave.

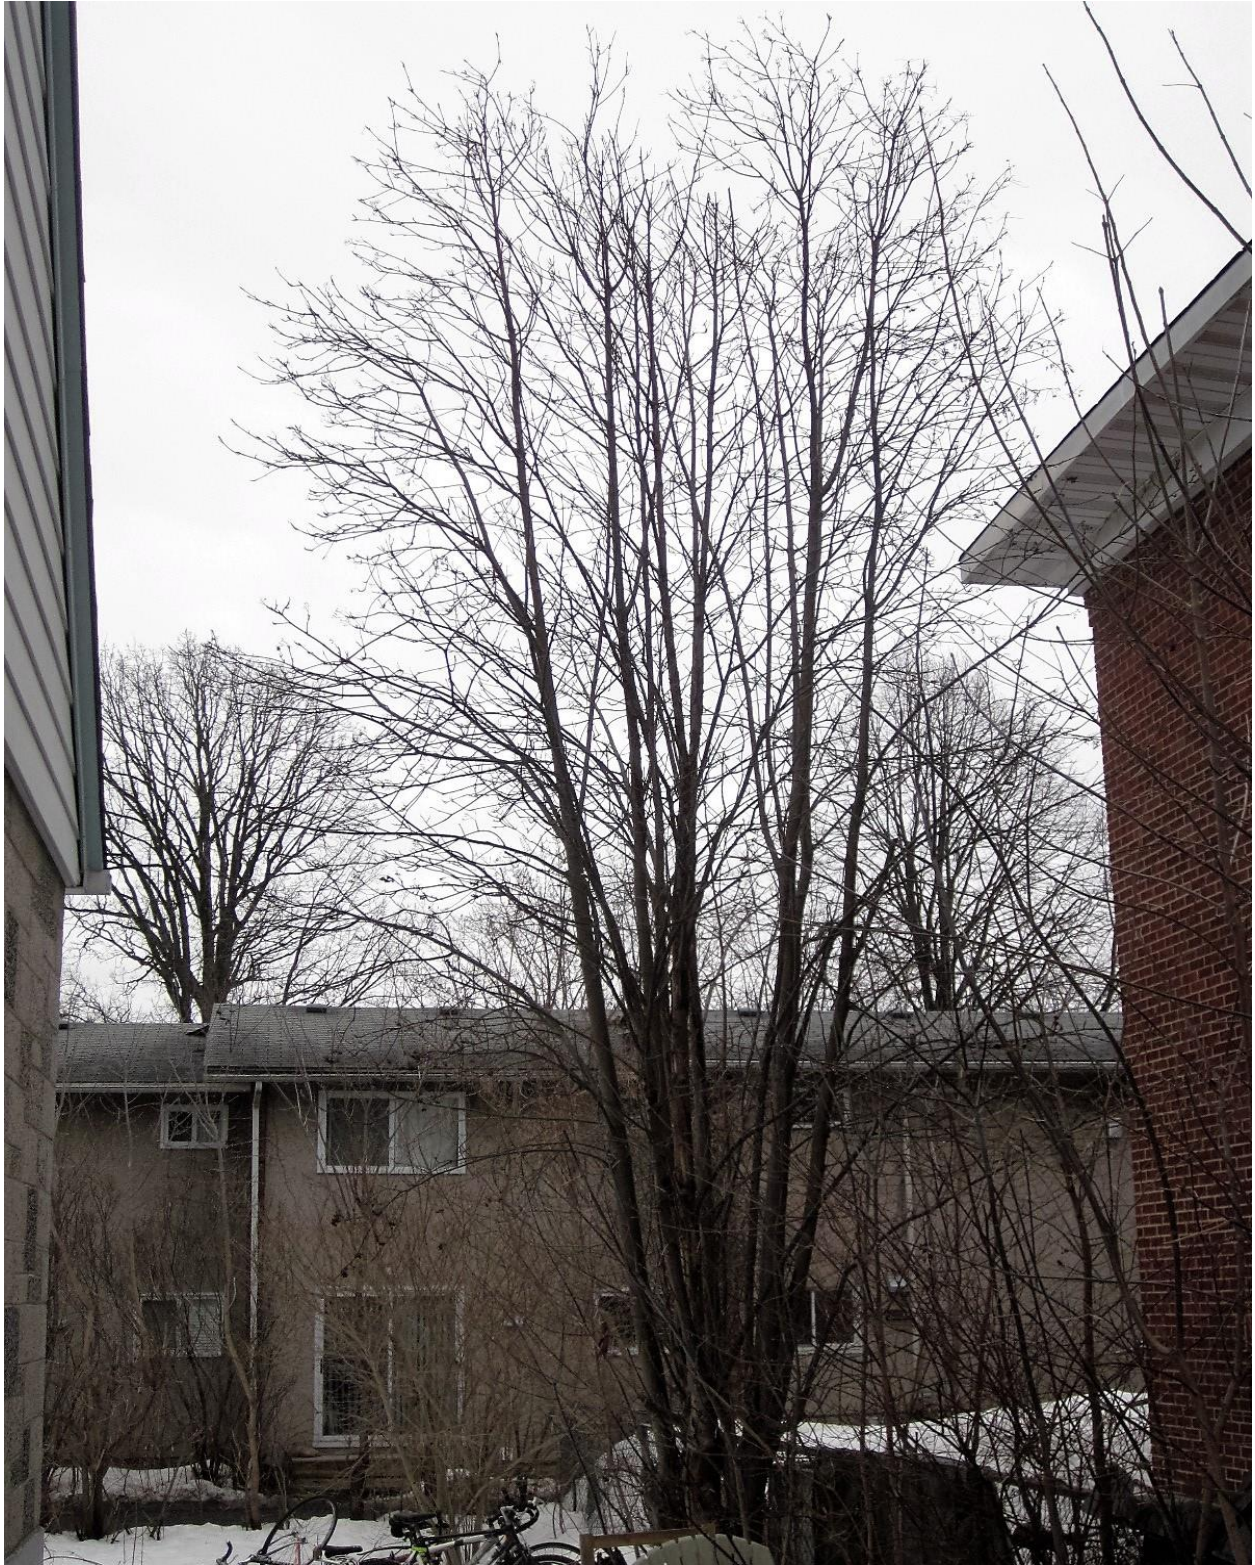
Picture 2. Mountain-ash at rear of 559 Riverdale Ave.
