## **Geotechnical Investigation and Slope Stability Assessment**

Final (3rd Revision)

Proposed Humanics Sanctuary and Sculpture Park  
3400 Old Montreal Road  
Part of Lot 7, Concession 1, Old Survey  
Ottawa (Formerly Township of Cumberland), Ontario

OTT-00229886-A0

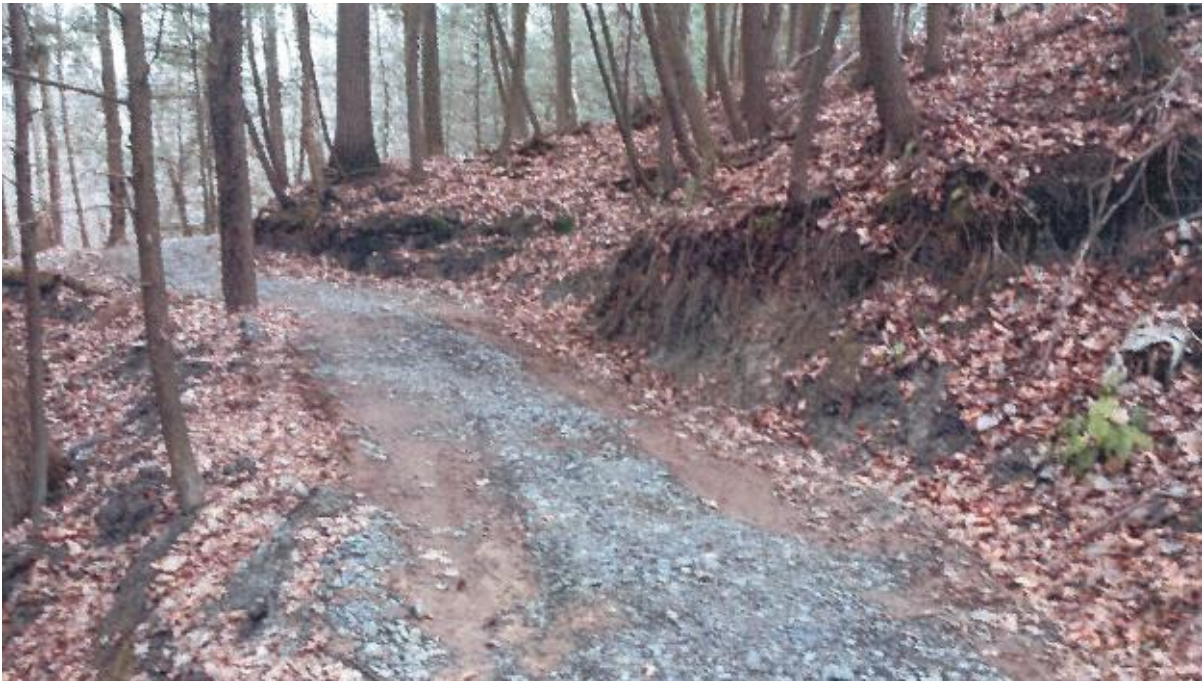
**Photo No. 6 – Erosion of cut uphill of pathway.  
Cut approximately 16 m long x 0.5 m to 1 m high.**

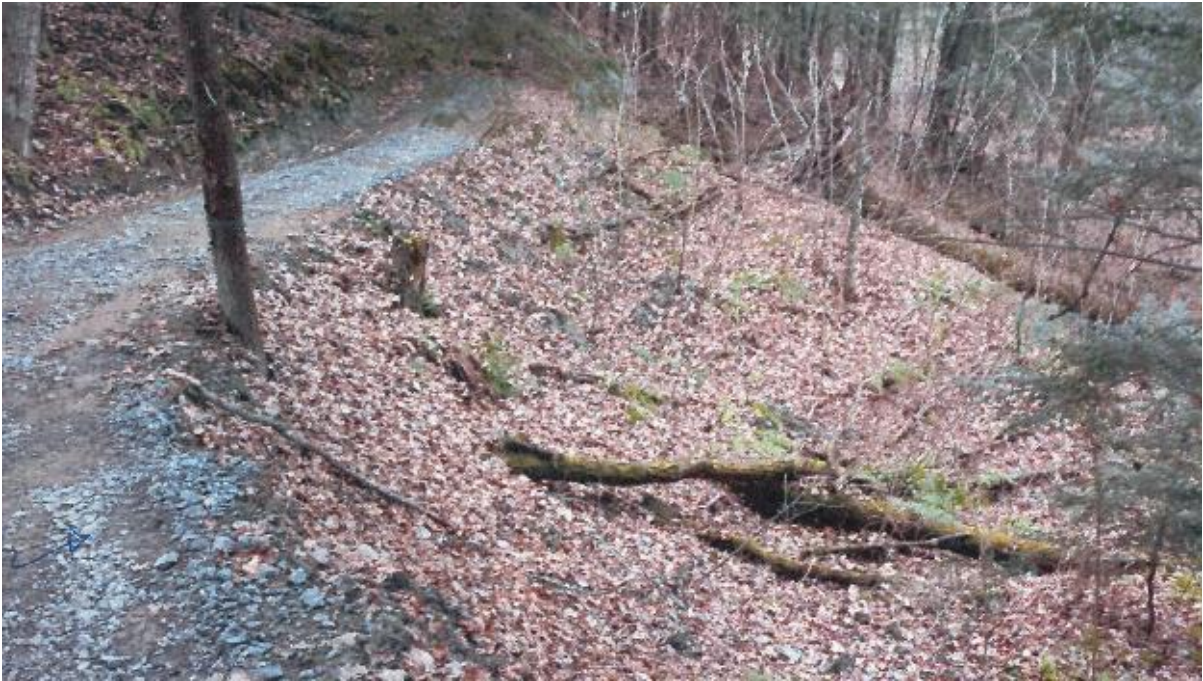
**Photo No. 7 – Erosion of slope downhill of pathway.  
Area approximately 30 m long x 1 m to 3 m high.**

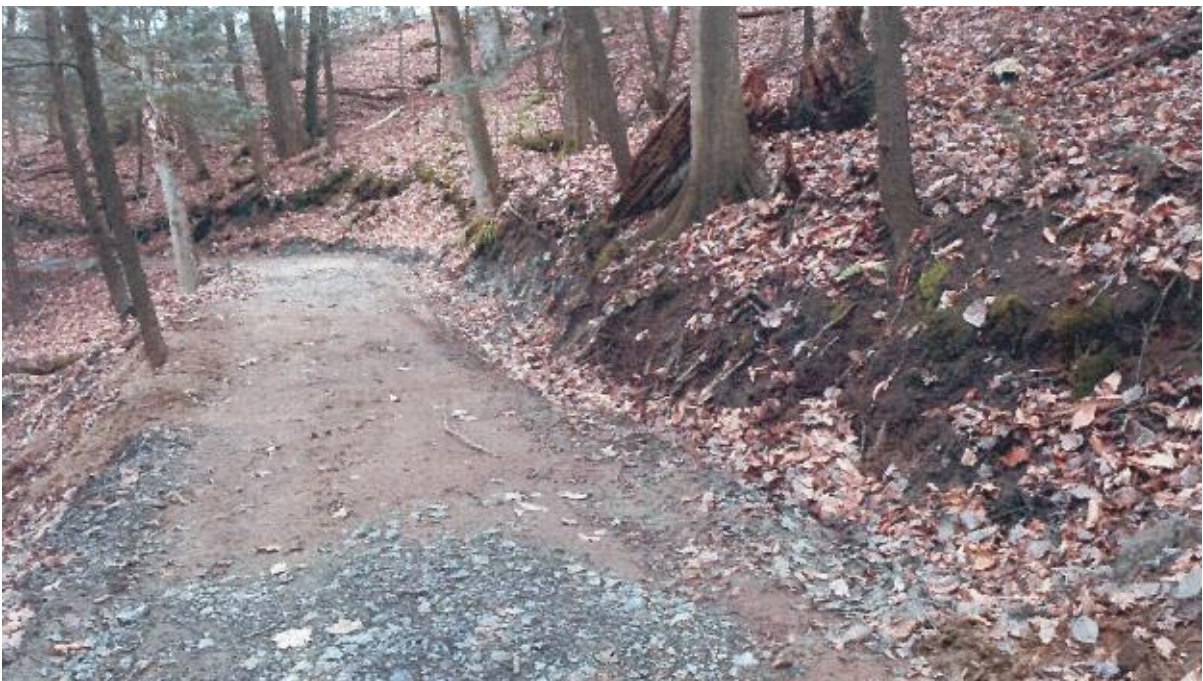
**Photo No. 8 – Erosion of cut uphill of pathway.  
Cut approximately 42 m long x 0.5 m to 1.3 m high.**

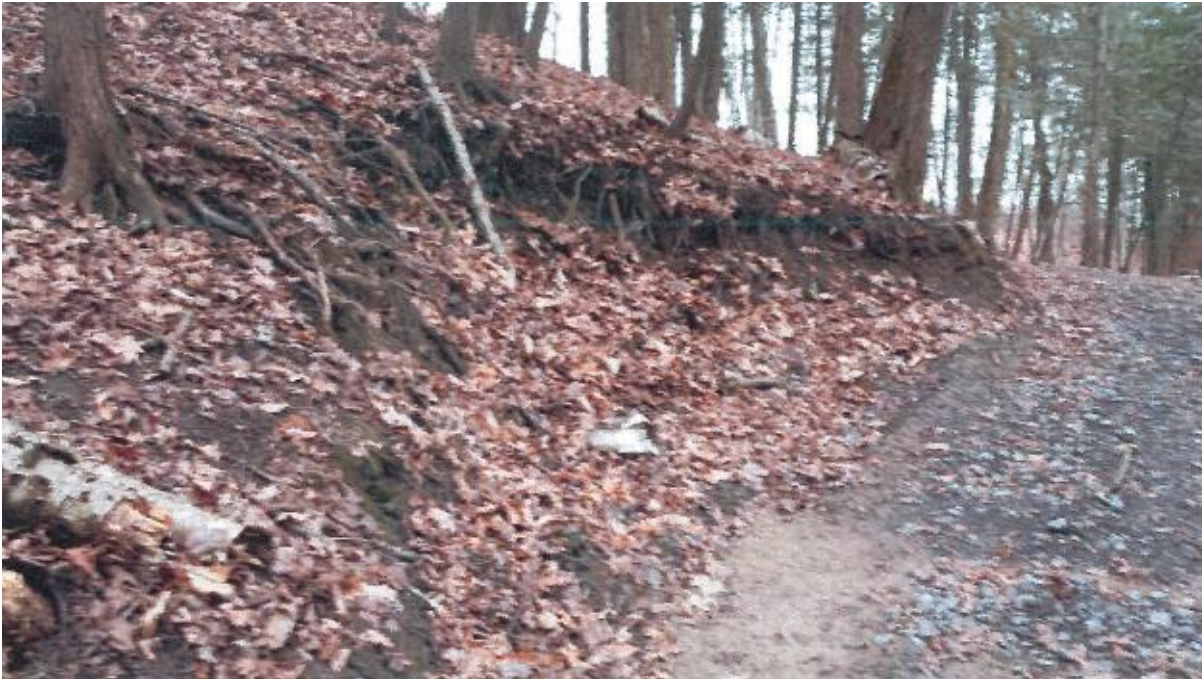
**Photo No. 13 – Erosion of slope uphill of pathway.  
Area approximately 5 m long and 1 m to 1.5 m high.**

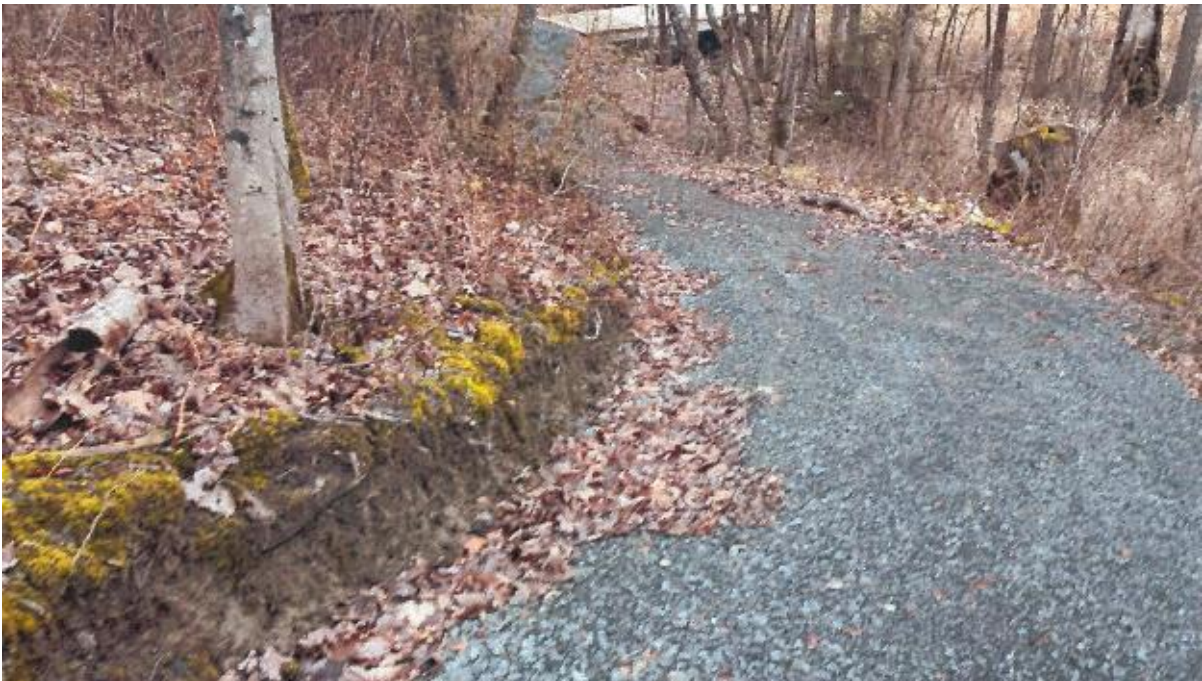
**Photo No. 17 – Erosion of cut downhill of pathway.  
Cut approximately 30 m long x 0.3 m high.**

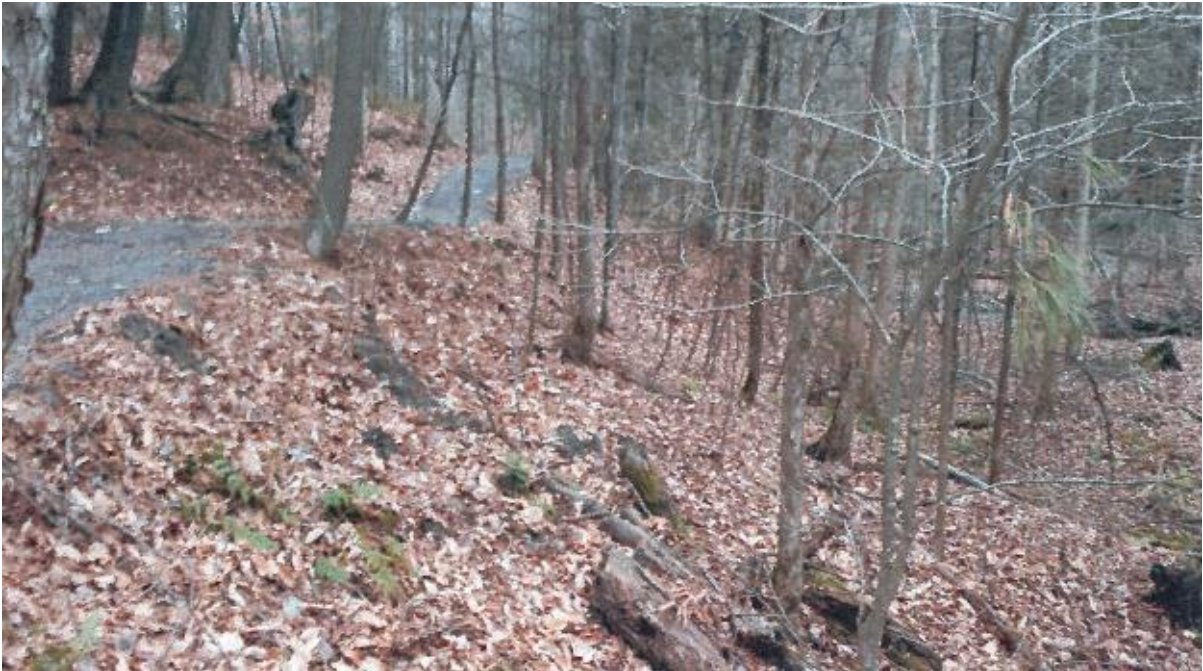
**Photo No. 22 – Erosion below pathway. Cut approximately 30 m long x 0.5 to 2 m high.**

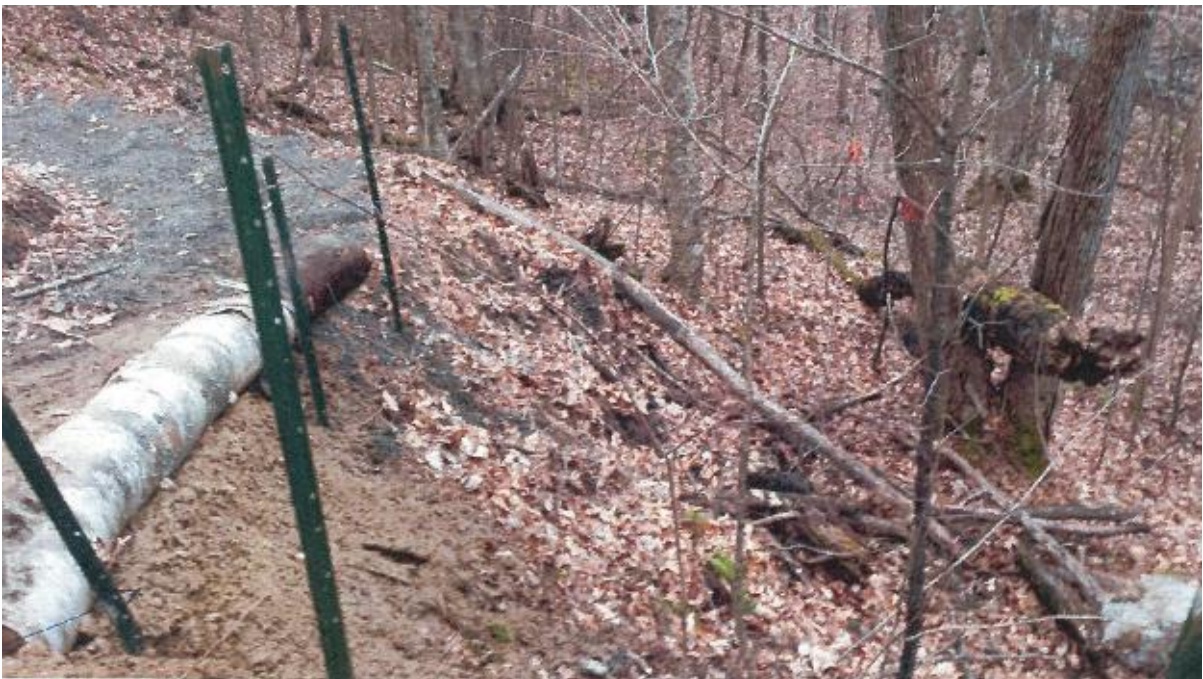
**Photo No. 23 – Erosion of slope downhill of pathway.  
Area approximately 12 m long x 1.5 m to 2 m high.**
