January 9, 20202

Version 2.0  
Matrix 28063-788

**Subject: 788 March Road – Shirley's Brook Meander Belt Width**

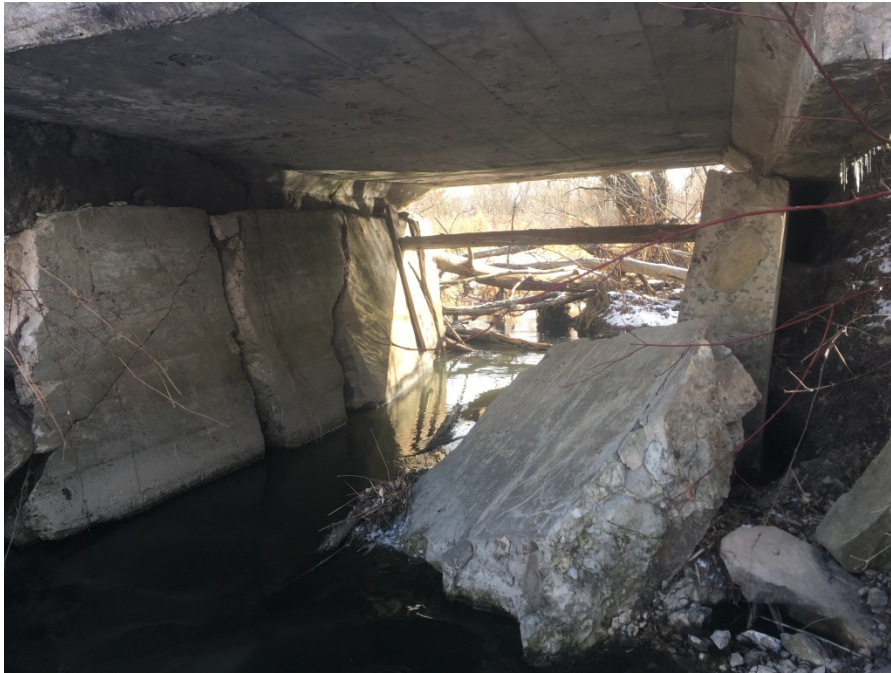
1. Open bottom concrete box culvert marking the upstream extent of the site. The culvert is undersized and in very poor condition as a result of outflanking.

As stated in the Matrix (2018) report for 762 March Road, the removal of the upstream box culvert would prevent the further collapse of the structure into the channel which could obstruct flows, which could result in flooding and significant channel adjustment. Future culverts should provide a span with consideration for fluvial geomorphic processes which account for future channel evolution.

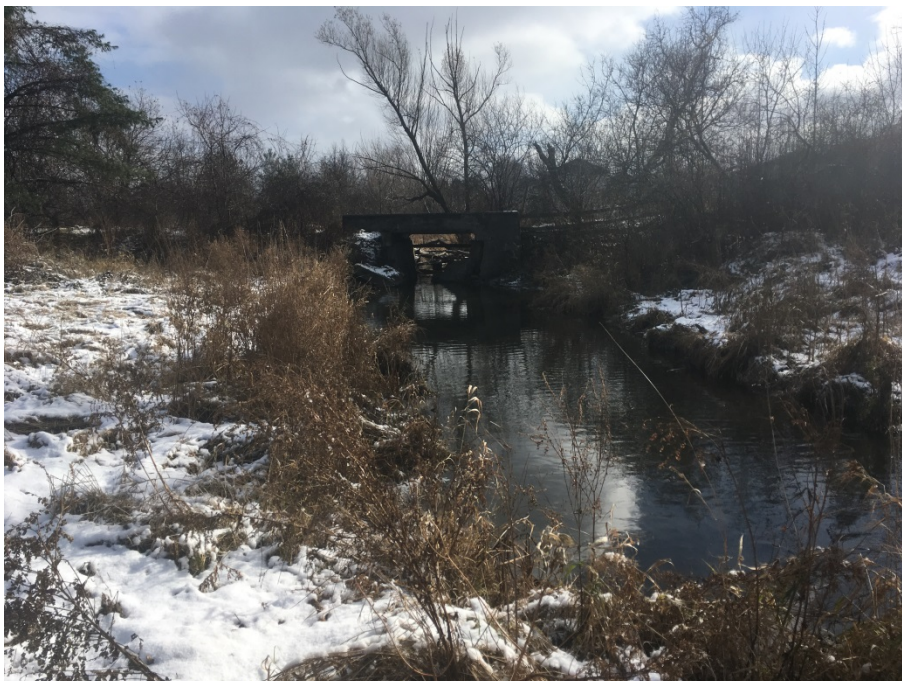
2. Looking upstream towards culvert in Photograph 1. This section of historically straightened channel is partially backwatered from downstream woody debris obstruction.

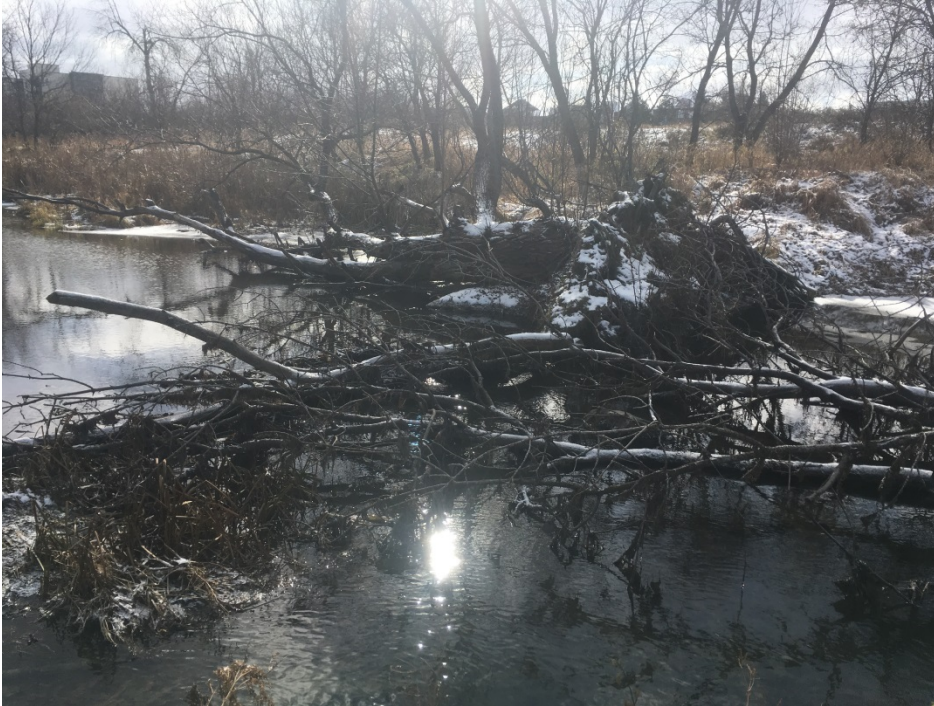
3. Large woody debris causing backwatered conditions to upstream extent of study area.

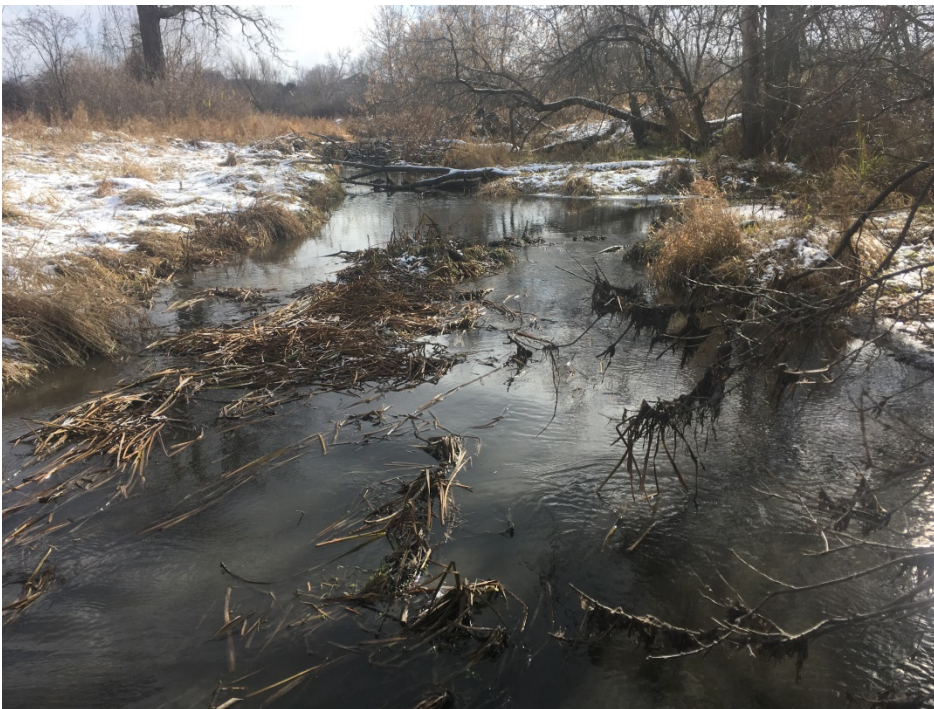
4. More in-stream vegetation causing further backwatering through the site.

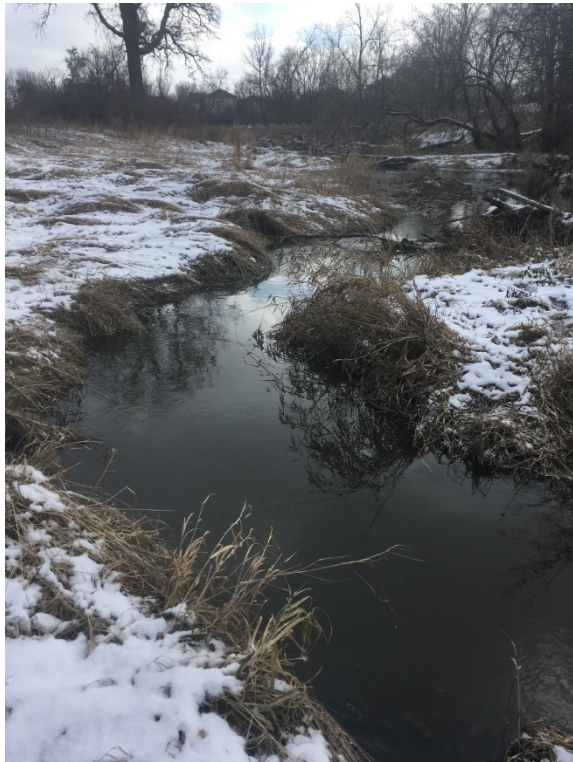
5. Channel between major woody debris and downstream culvert and ponding area.

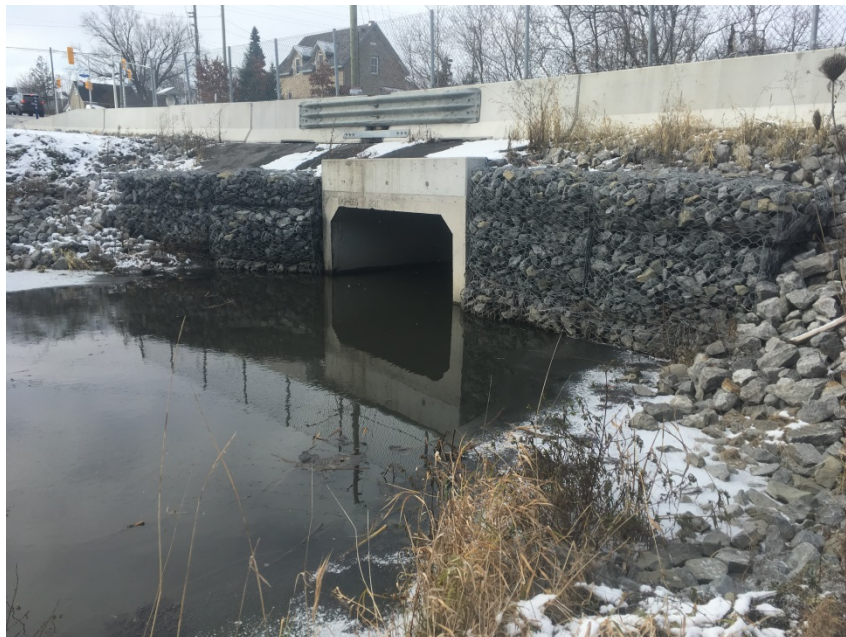
The box culvert at Klondike Road at the downstream extent of the study area is in good condition and appears to be a relatively new structure; however, its width is only 3.0 m (the approximate bankfull width of the watercourse). The culvert is significantly armoured with rip rap and gabion baskets and a ponded area has been formed upstream, likely to achieve the desired grade for the recent culvert extension works and to dissipate water velocities at the inlet. Given local changes in the channel bed material observed in the immediate vicinity of the Klondike Road culvert, monitoring of the culvert is recommended to ensure capacity is maintained. Unconfined heavily organic fines were observed within the pool, followed by exposed underlying coarse material at the foot of the inlet and within the culvert for a distance before transitioning to deposited gravels near the culvert outlet. These observations could be indicative of a hydraulic thrust resulting from high water conditions in which the ponded water upstream of the culvert creates a pressure head, flushing fines and gravels out of the culvert and channel bed. The culvert spans only the bankfull width of the channel (3.0 m), which does not allow any degree of natural channel adjustment to occur.

6. Open bottom concrete box culvert marking the downstream extent of the site. Culvert extension resulting in the creation of a ponded area upstream of crossing within the study area.
