Jock River, Barrhaven Conservancy

Erosion Hazard Assessment and Erosion Threshold Analysis

Prepared for:
David Schaeffer Engineering Ltd.
120 Iber Road, Unit 103
Stittsville, ON
K2S 1E9

January 11, 2018
PN17071

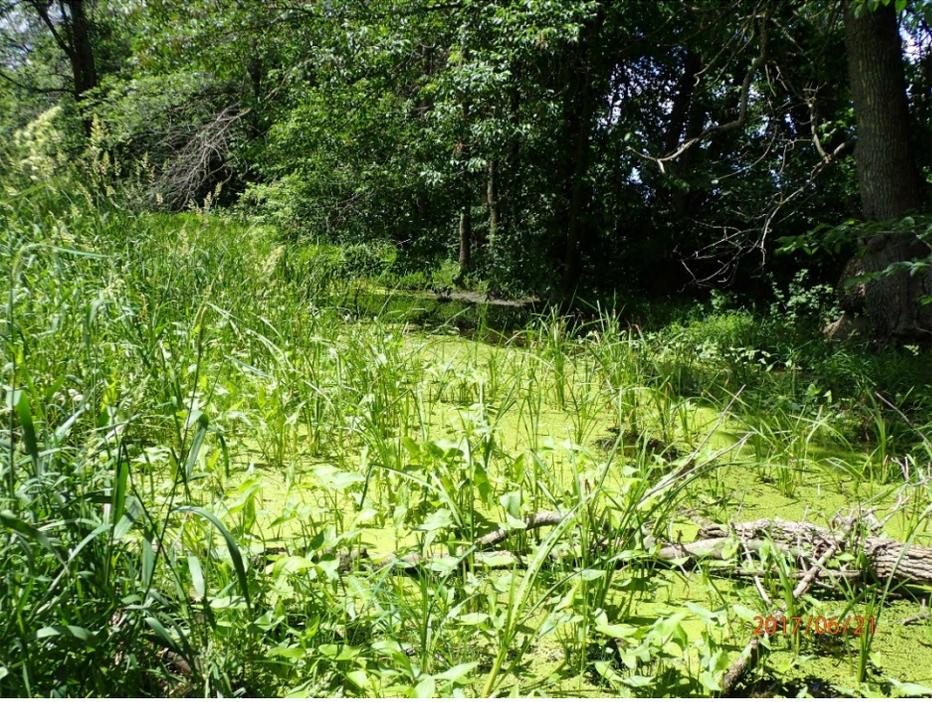
<p>Photo 1 Reach FCD2</p>

<p>Photograph taken facing west. Bed material was 30 to 40cm deep consisted of fines and organics.</p>	
<p>Photo 2 Reach FCD2</p>

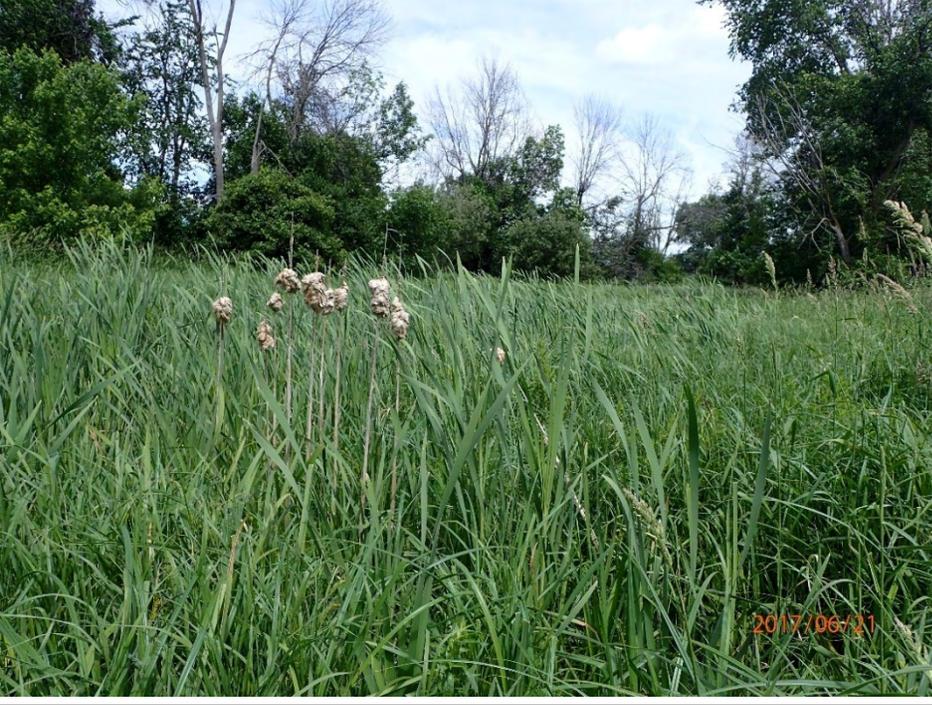
<p>Photograph taken facing east. Wetland feature fully encroached with reeds.</p>

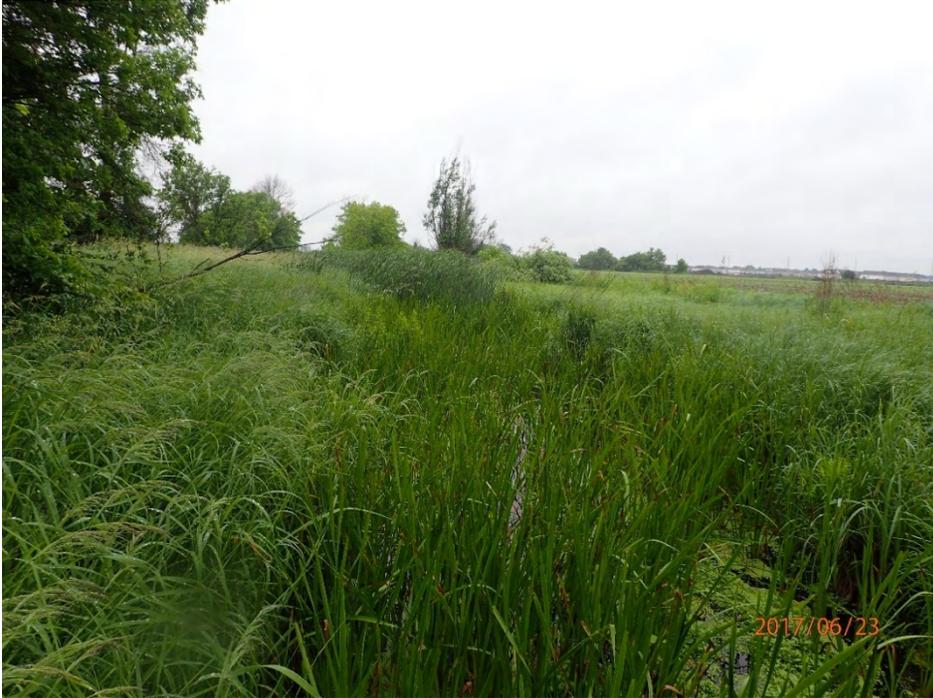
<p>Photo 3</p> <p>Reach FCD3</p>

<p>Photograph taken facing east. Heavily encroaching reeds in the wetland feature was observed.</p>	
<p>Photo 4</p> <p>Reach FCD3</p>

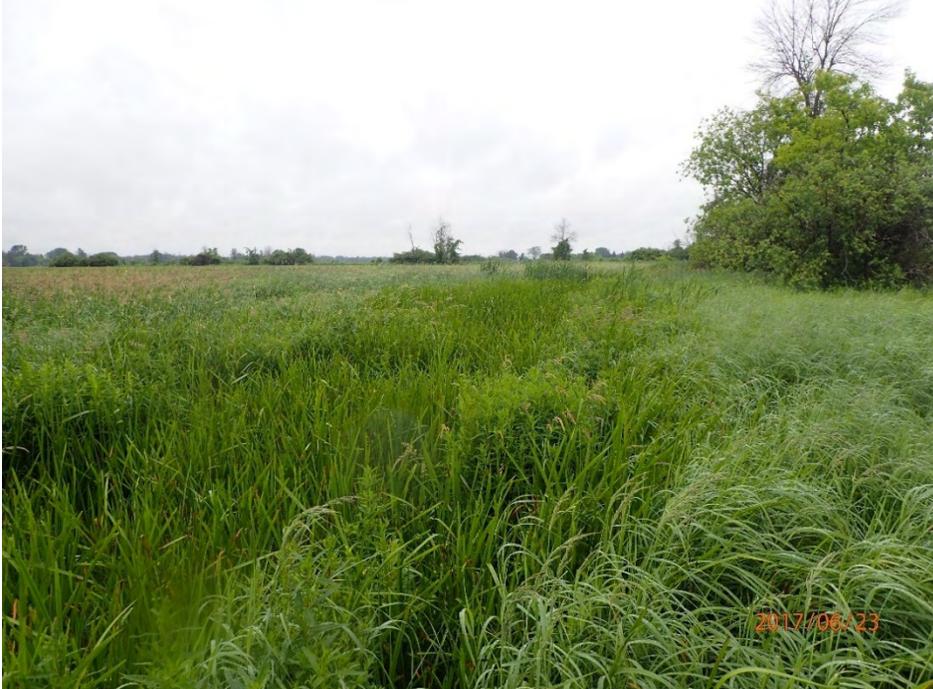
<p>Photograph taken facing east. Fragmented riparian buffer was dominated by grass.</p>

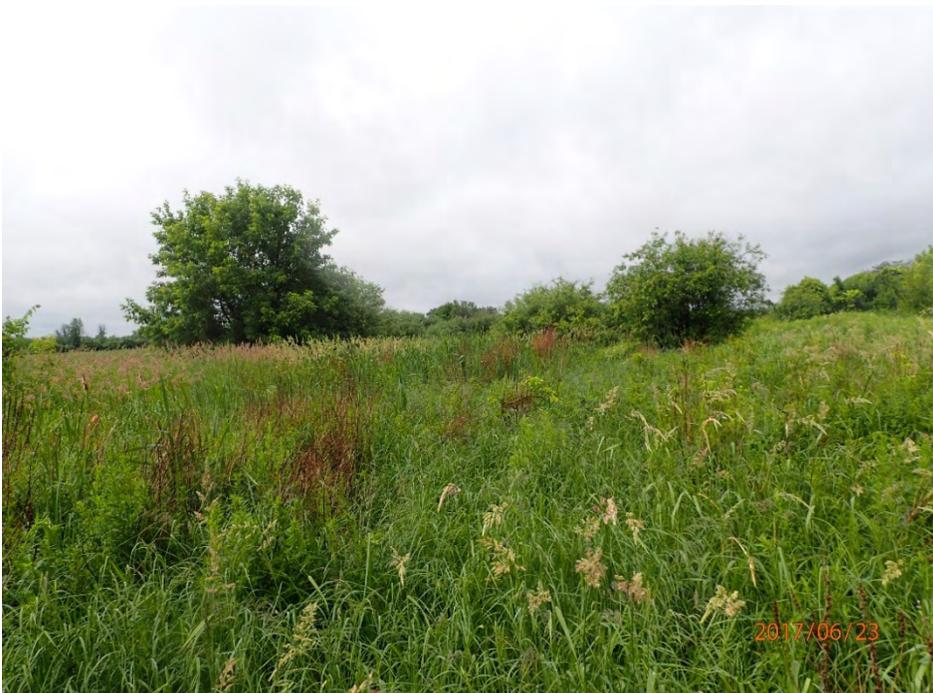
<p>Photo 5</p> <p>Reach FCD3- 1</p>

<p>2017/06/23</p>
<p>Photograph taken facing east. Riparian buffer composed of trees, grasses and shrubs.</p>	
<p>Photo 6</p> <p>Reach FCD3- 1</p>

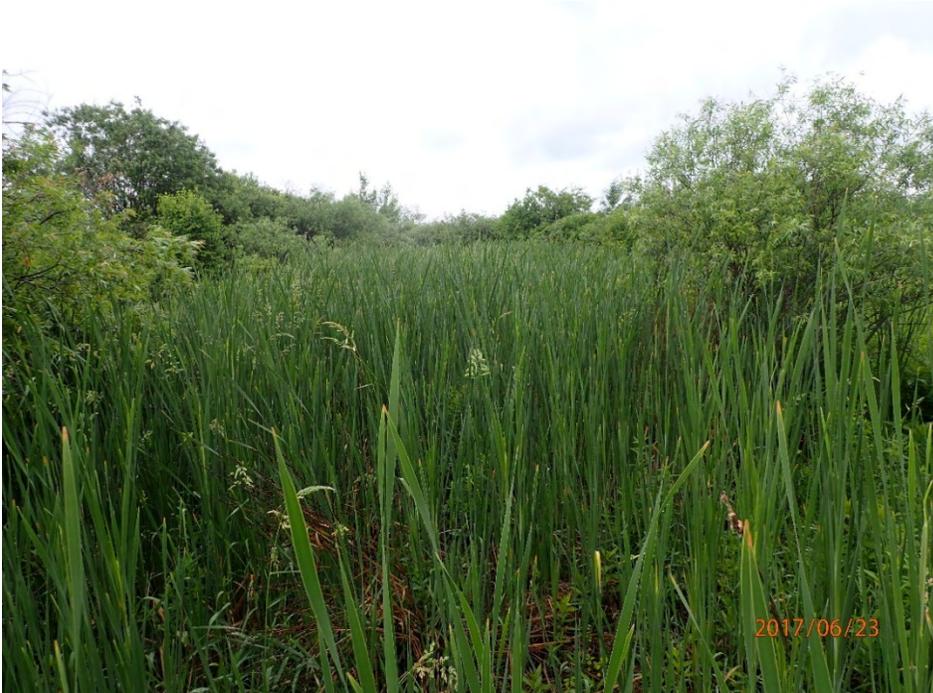
<p>2017/06/23</p>
<p>Photograph taken in the middle of the feature, facing east. Swale was primarily composed of reeds and was dry at the time of assessment.</p>

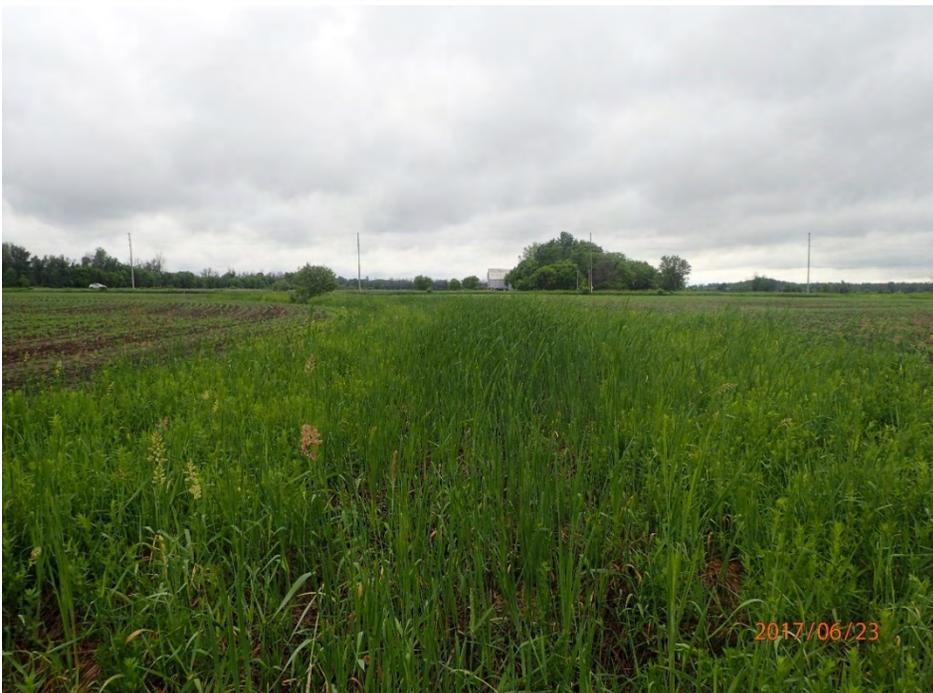
<p>Photo 7</p> <p>Reach FCD3- 2</p>

<p>Photograph taken facing south east. Center of swale was encroached with reeds, with a primarily grass buffer.</p>	
<p>Photo 8</p> <p>Reach FCD3- 2</p>

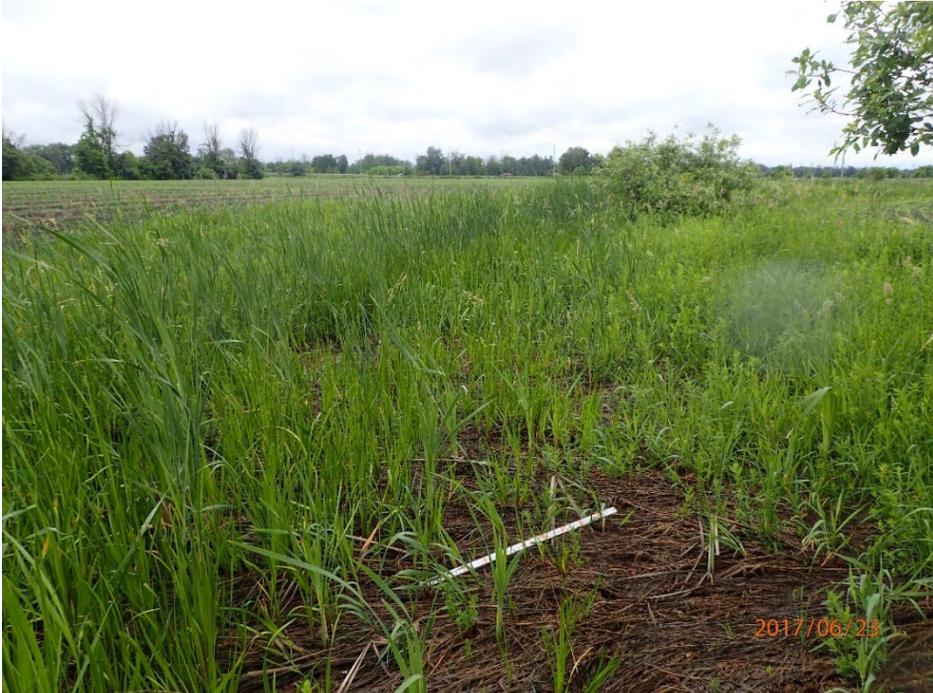
<p>Photograph taken facing south east. No water was present in the feature at the time of assessment.</p>

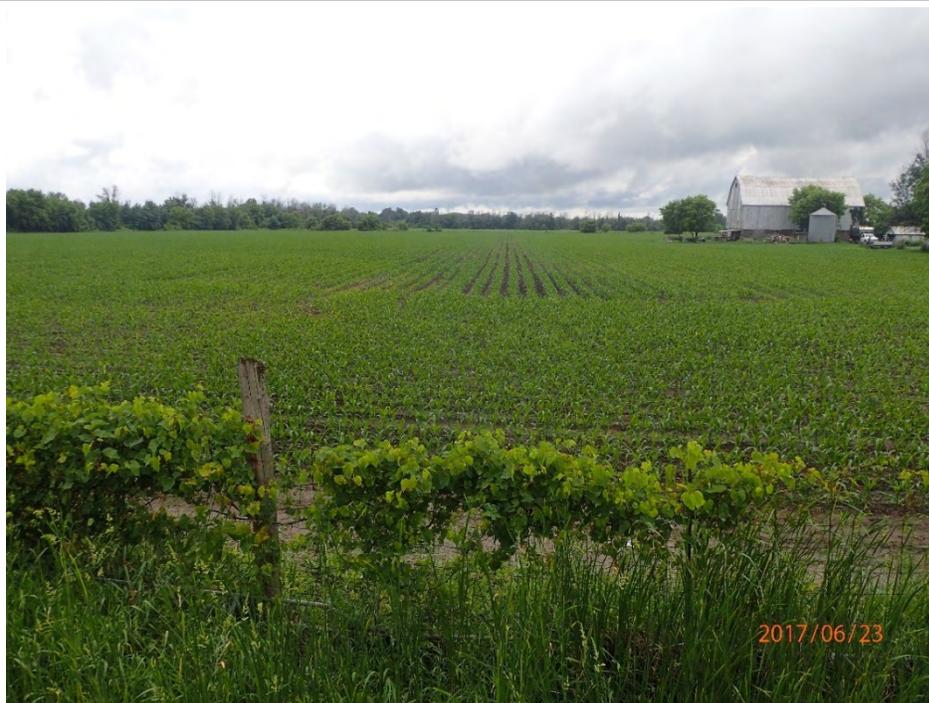
Photo
9

Photograph taken facing south east.
Feature not present at time of assessment.

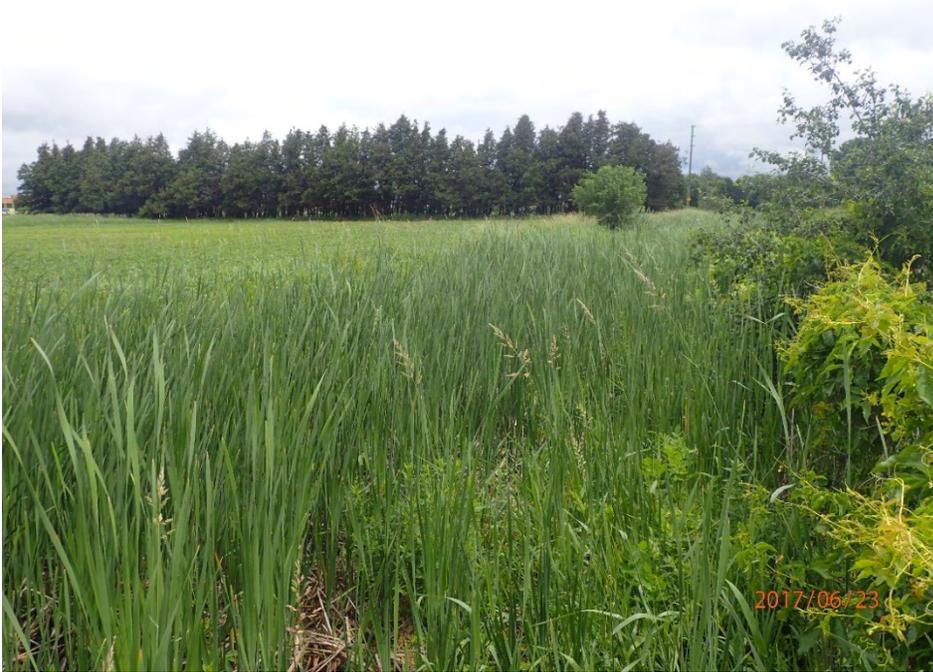
<p>Photo 10 Reach FCD5</p>

<p>Photograph taken facing downstream towards left bank. Channel dry at time of assessment.</p>
<p>Photo 11 Reach FCD5</p>

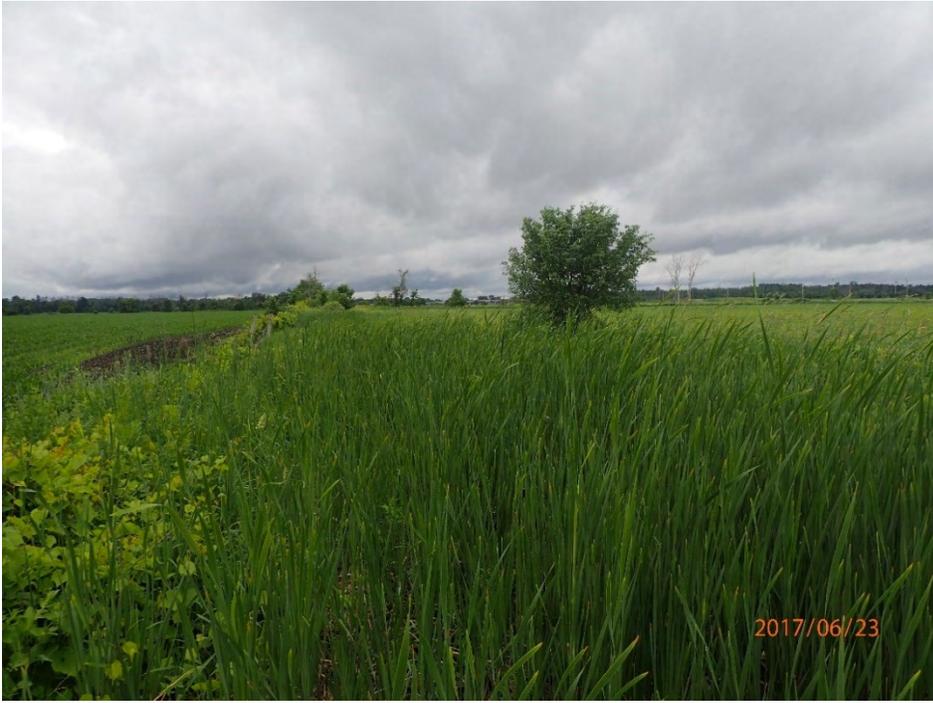
<p>Photograph taken facing upstream. Heavy encroachment of tall reeds was observed.</p>

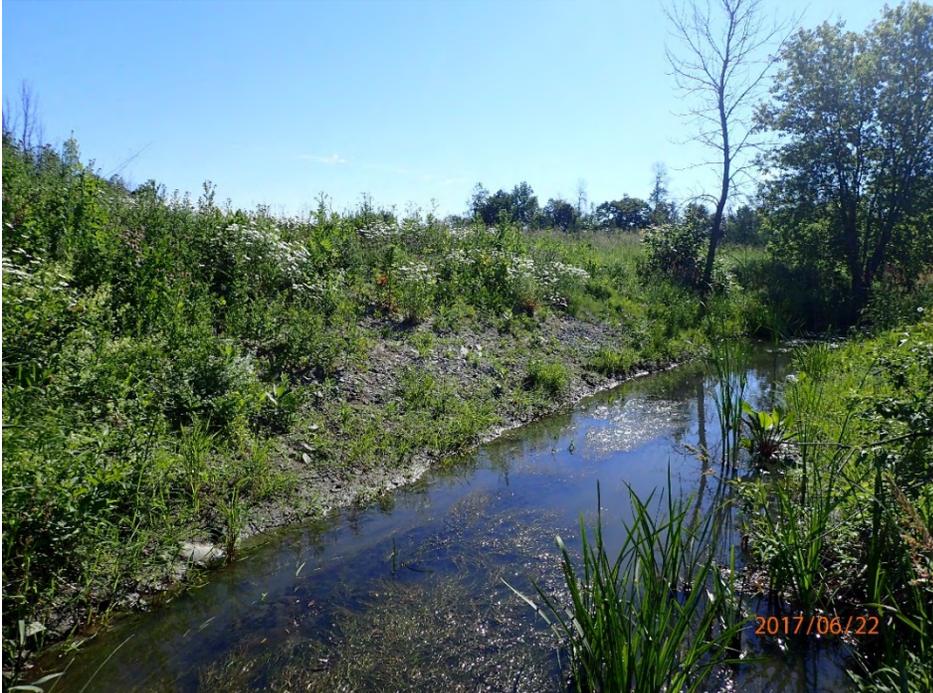
<p>Photo 12</p> <p>Reach FD1</p>

<p>2017/06/22</p>
<p>Photograph taken facing downstream towards left bank. Channel was entrenched. Rip rap was observed along the banks in some areas.</p>	
<p>Photo 13</p> <p>Reach FD1</p>

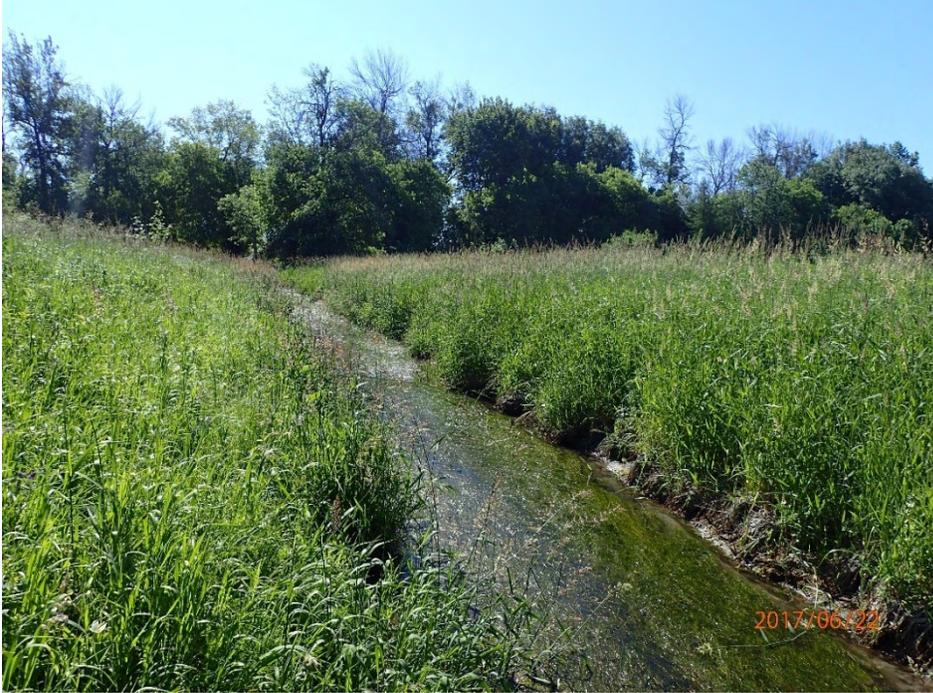
<p>2017/06/22</p>
<p>Photograph taken facing downstream towards right bank. Minor undercutting observed on right bank.</p>

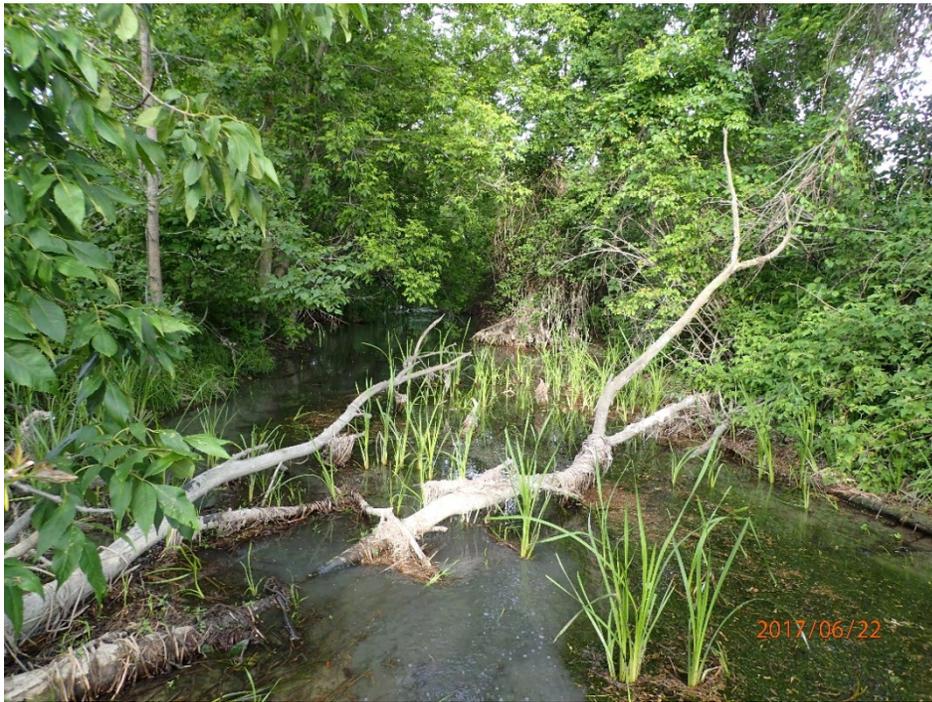
Photo
16
Reach
FD2

Photograph taken facing upstream.
The channel was slightly entrenched and large woody debris was observed.

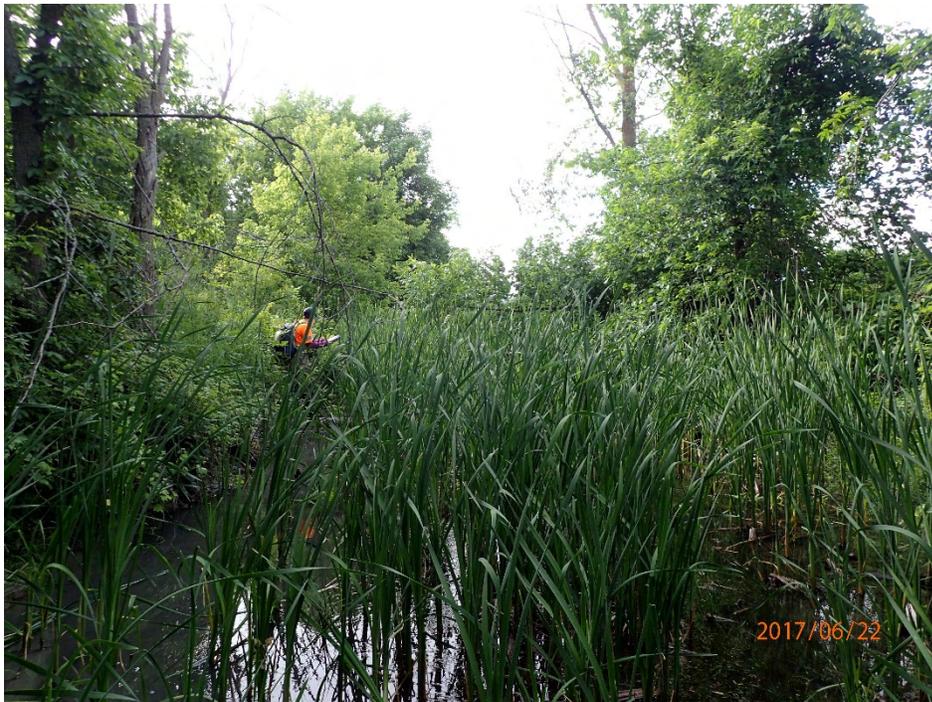
Photo
17
Reach
FD2

Photograph taken facing upstream from Reach FD1 break.
Reeds heavily encroached the channel near the downstream reach break.

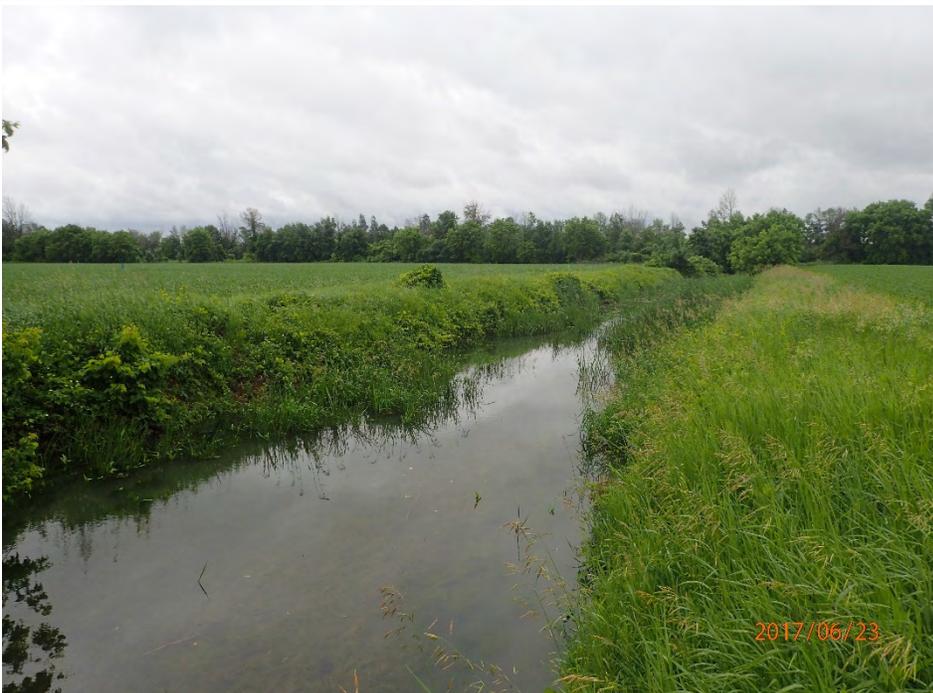
<p>Photo 18</p> <p>Reach FD3</p>

<p>Photograph taken facing upstream towards left bank. Channel was a straightened and ditched feature.</p>	
<p>Photo 19</p> <p>Reach FD3</p>

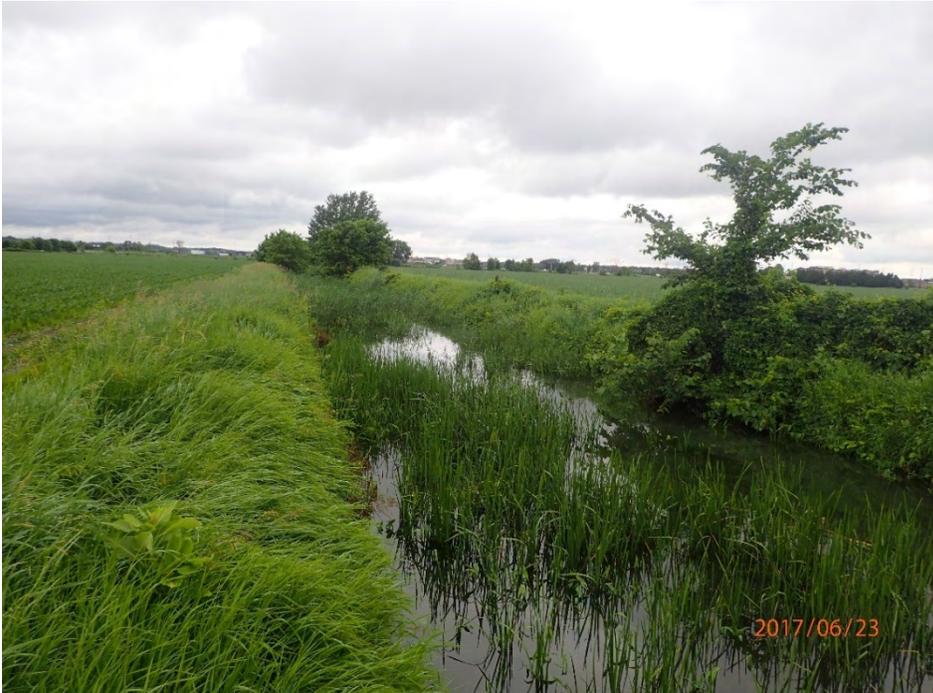
<p>Photograph taken facing downstream. Extensive backwatering observed upstream of large woody debris jam.</p>

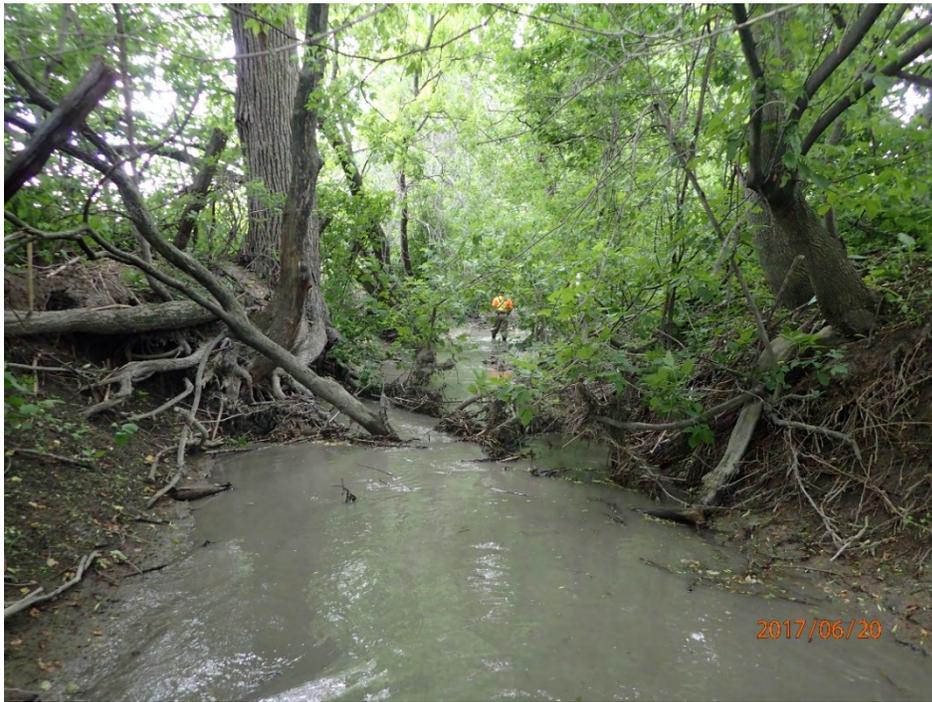
Photo
20

Reach OKD1 is a previously straightened and ditched channel flowing between agricultural fields. The reach had a low gradient and was unconfined. Riparian vegetation was continuous and dominated by trees and grasses. The channel was highly entrenched, with high bank angles between 60-90 degrees. Fluvial entrainment and exposed tree roots were commonly observed, with an extent of 60-100% of the reach exhibiting erosion. Encroachment was minimal. Woody debris was high in density with two woody debris jams per 50 m. Average bankfull width and depth were 4.6 and 0.7 m, respectively. The reach had no riffle-pool features. Substrate of the bed and bank ranged between clay, silt, sand, and organics. At the time of assessment, approximately 0.2 – 0.3 m of loose bed material was present on the bed.

Photograph taken facing downstream.
Channel was a straightened and ditched feature.

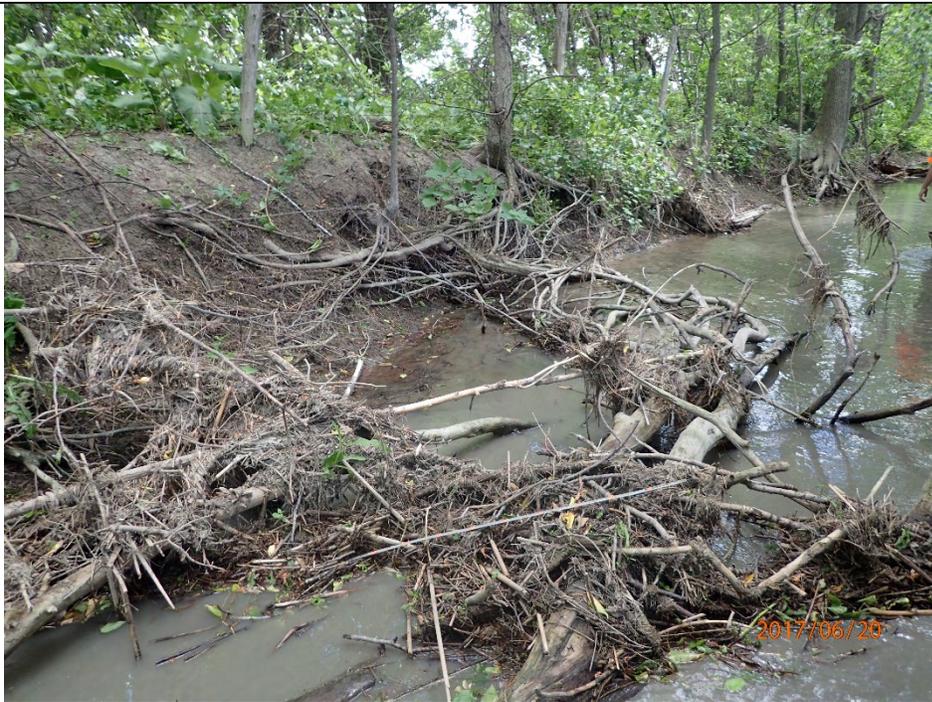
Photo
21

Photograph taken facing left bank.
Channel was highly entrenched, woody debris was commonly observed.

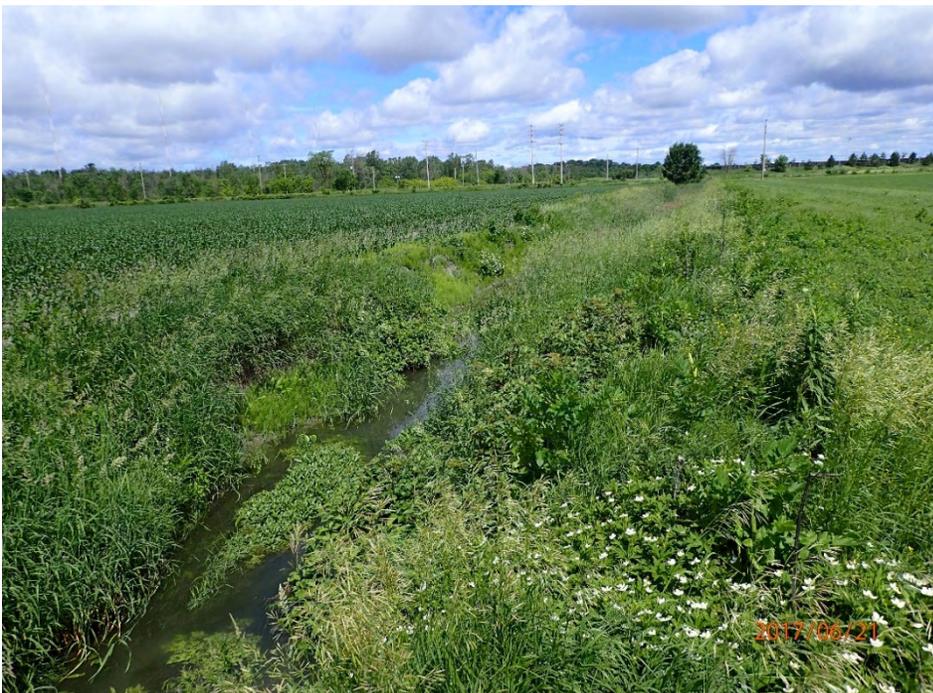
<p>Photo 22</p> <p>Reach OKD2</p>

Reach OKD2 was previously straightened and ditched. Riparian vegetation was narrow and consisted of grasses. Reed encroachment was moderate. The banks were highly entrenched with high angles of 60-90 degrees. Erosion was present in 30-60% of the reach. Two erosion scars were observed along the right bank. Average bankfull width and depth were 4.4 m and 0.7 m, respectively. Riffle-pool features were not observed. Bed and bank material included clay and silt. A low density of woody debris was present in the channel.

<p>Photograph taken facing upstream. Channel exists as a highly entrenched, straightened and ditched feature.</p>	
<p>Photo 23</p> <p>Reach OKD2</p>

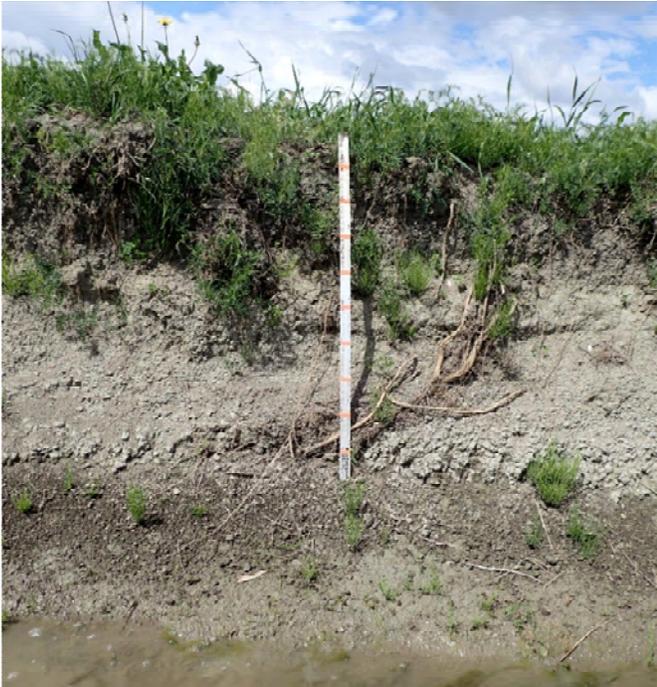
<p>Photograph taken facing right bank. Erosion scarring was observed.</p>

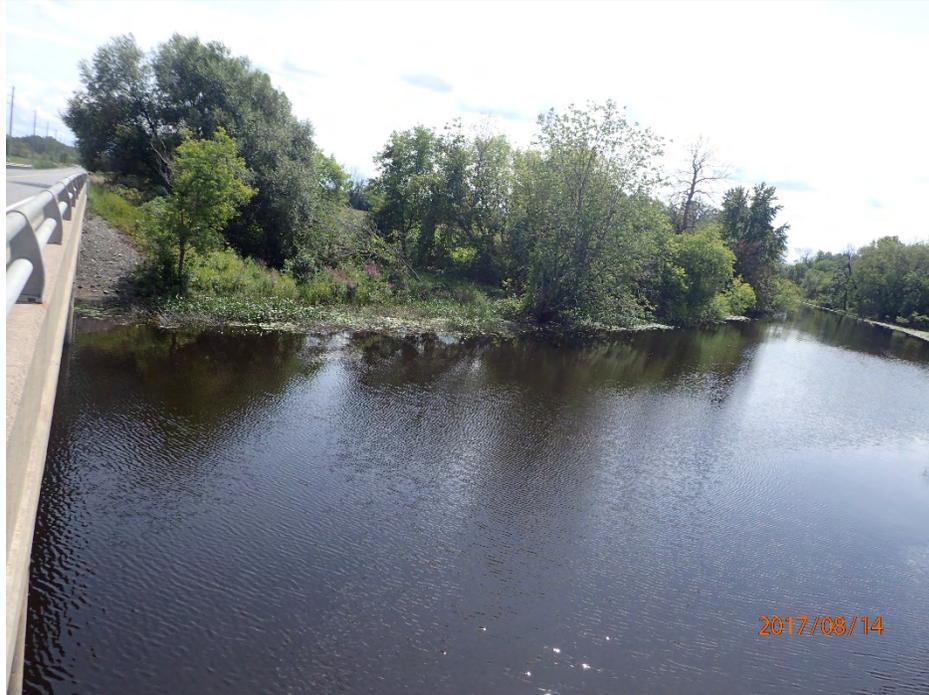
Photo
25

Photograph taken facing right bank, south, from Borrisokane Road.
The reach was unconfined.

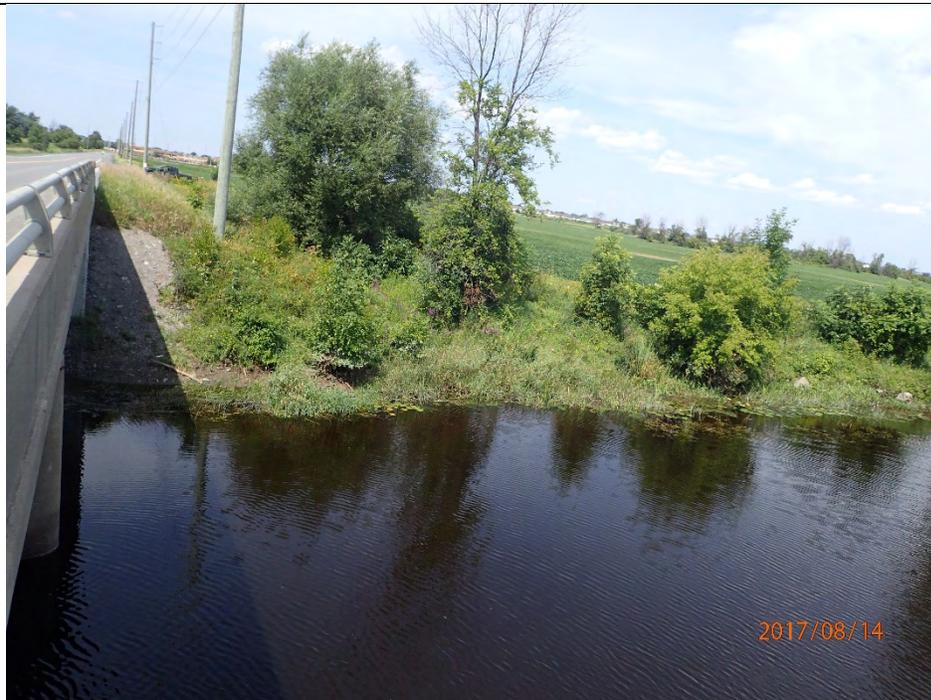
Photo
27
Reach
JR-3

Photograph taken facing the left bank, north, from Borriskane Road.
The reach was unconfined with a narrow riparian buffer zones.

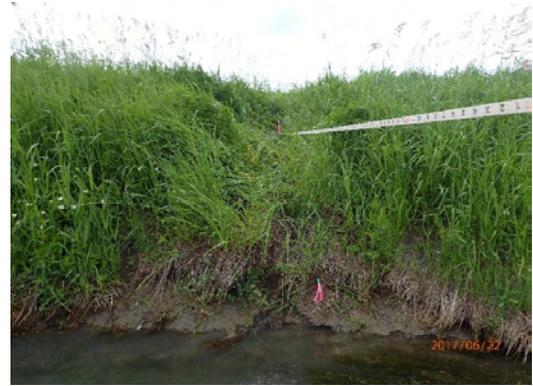
All watercourses within the study site are within unconfined valley systems. Since the drainage features have been heavily modified, the meander belt width cannot be determined using orthorectified aerial imagery. Therefore, the modelling approach was used for all the drainage feature within the study site.

Bank Characteristics						
	Minimum	Maximum	Average	Minimum	Maximum	Average
Bank Height (m):	1.3	1.75	1.48			
Bank Angle (deg):	45	70	53	Torvane Value (kg/cm²):	Not measured	
Root Depth (m):	0.10	0.10	0.10	Penetrometer Value (kg/cm³):	Not measured	
Root Density (%):	40	90	84	Bank Material (range):	Clay, Silt, Sand, some Rip-Rap present	
Bank Undercut (m):	0.05	0.30	0.13
