Phase I Environmental Site Assessment

Residential Properties
23, 33 and 39 Deerfox Drive - Ottawa

April 17, 2018

Report: PE4233-1

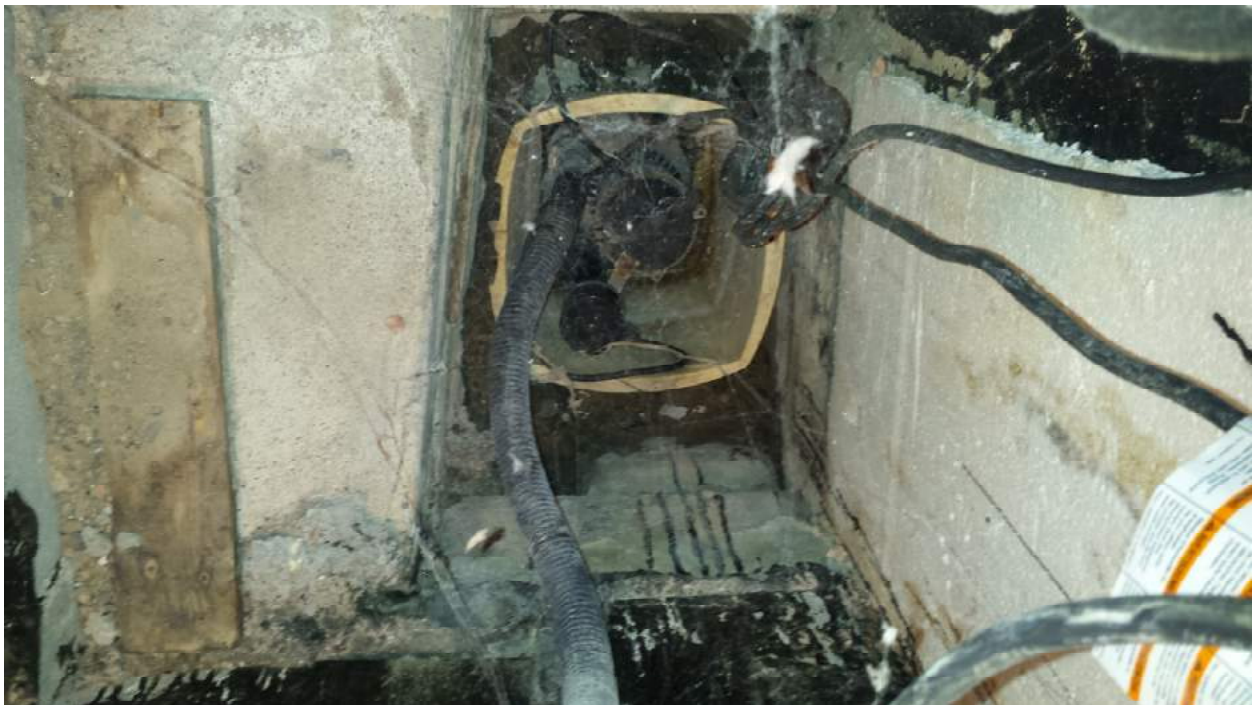
Liquid discharged from the Phase I Properties includes wash water and sewage from the residential dwellings. Two (2) sump pits were observed in the basement at 23 Deerfox Drive, and one (1) at 39 Deerfox Drive. The water in the pits did not have any sheen or odour.

Photograph 2: Sump pit in basement of 23 Deerfox Drive.

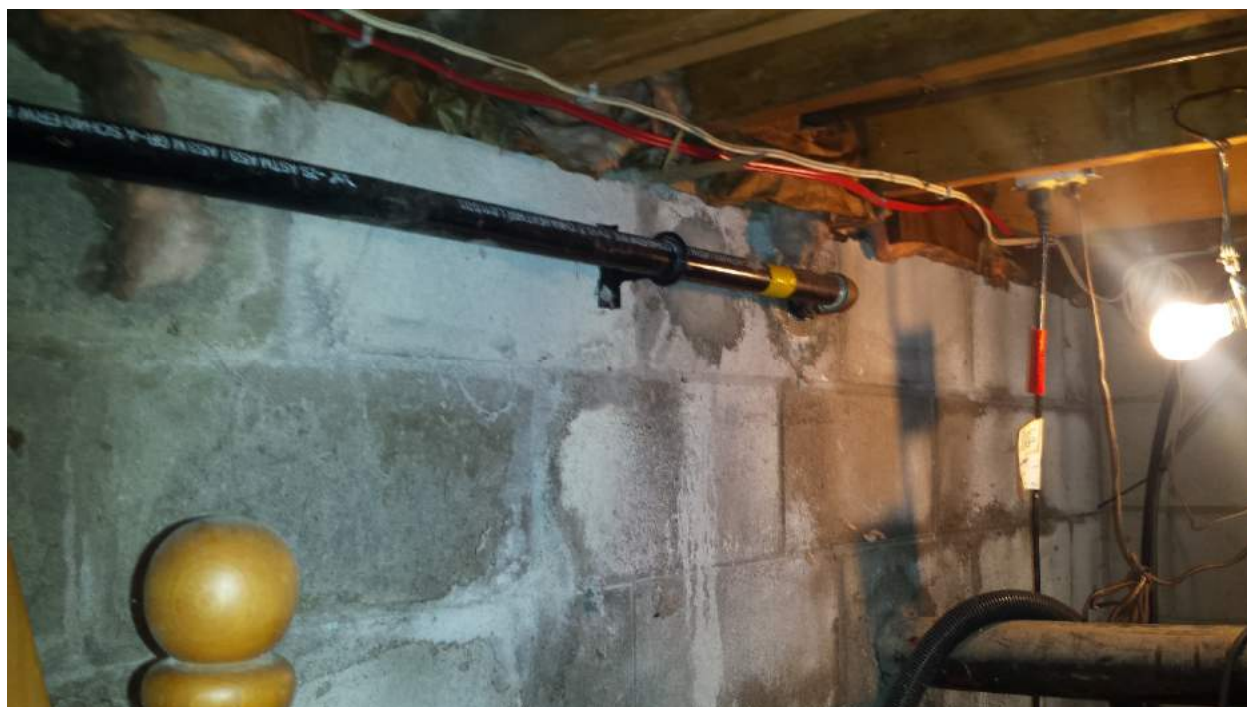
The current resident and owner of 23 Deerfox Drive, Joseph Turner, purchased the property in 1996, and indicated that the previous oil furnace had been replaced in approximately 2010 with a natural gas furnace; Mr. Turner indicated that he never experienced any problems (i.e. leaks, spills) with the oil furnace. During Mr. Turner's occupancy, he converted the attached garage into a series of music recording rooms, which are heated with electric baseboard heaters.

Photograph 3: The former location of a fuel oil tank at 23 Deerfox Drive. The vent and fill pipe holes have been patched in the concrete wall.

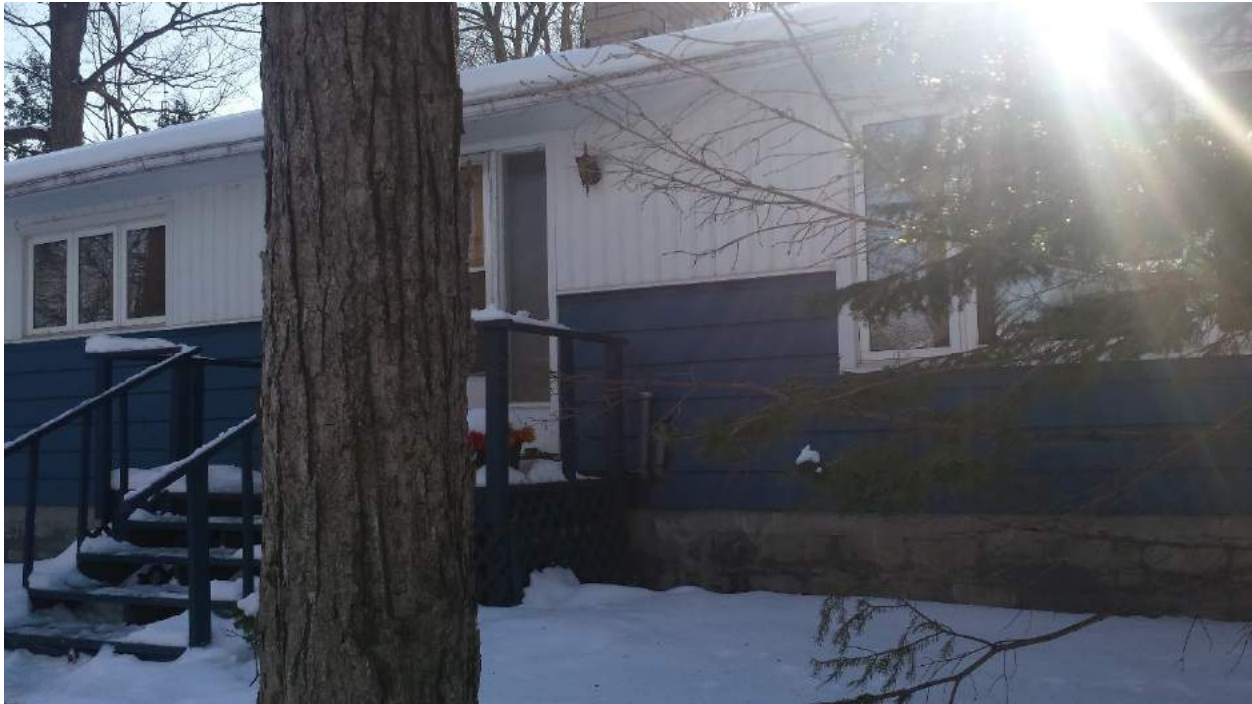
The dwelling at 33 Deerfox Drive is occupied by the current owner, who had the dwelling constructed in 1960. The building is a single storey structure with a basement, is finished on the exterior with wood siding, and has a sloped and shingled roof. No sump pit was observed in the basement. The building is heated with an oil-fired boiler; the vent and fill pipes are visible at the front of the building, adjacent to the front door.

Photograph 5: Front view of 33 Deerfox Drive, looking south. Vent and fill pipes are visible at centre.

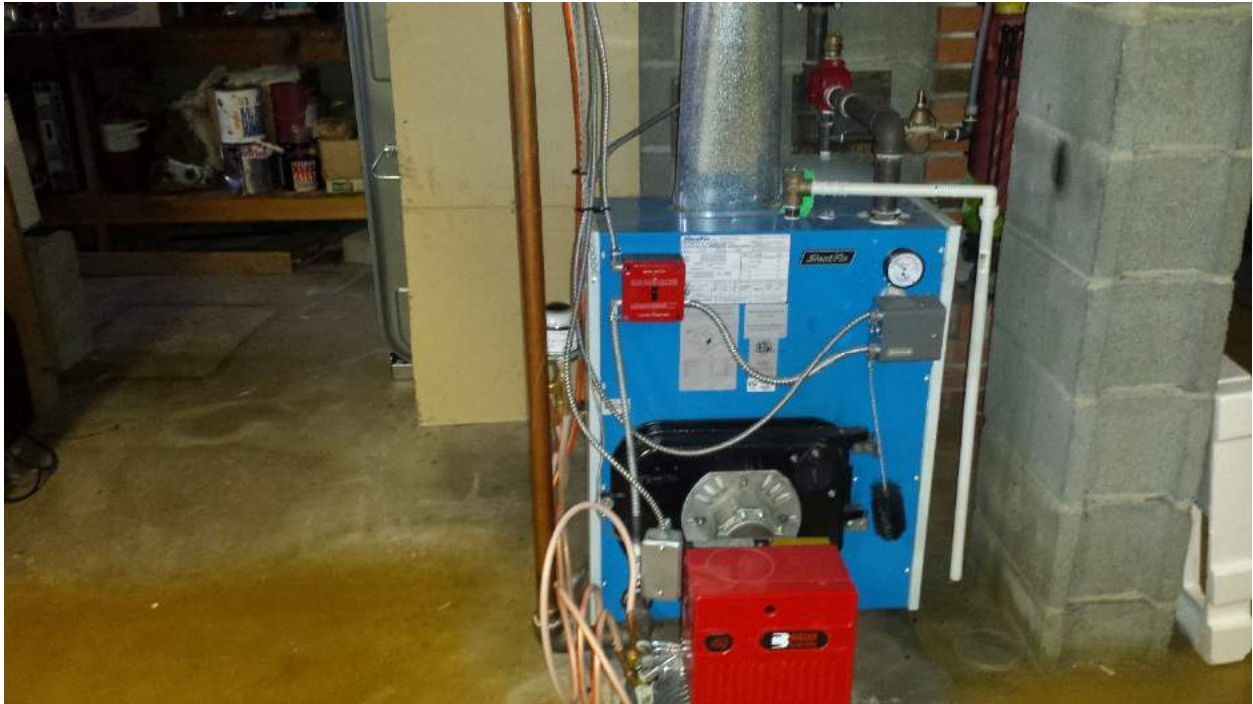
As previously noted, the building addressed 33 Deerfox Drive is currently heated with fuel oil. Based on observations made during the site visit (no stains, odours), the use of fuel oil on the subject property is not considered to pose a concern to the subject land.

Photograph 7: Boiler in the basement at 33 Deerfox Drive, with the oil tank visible behind.

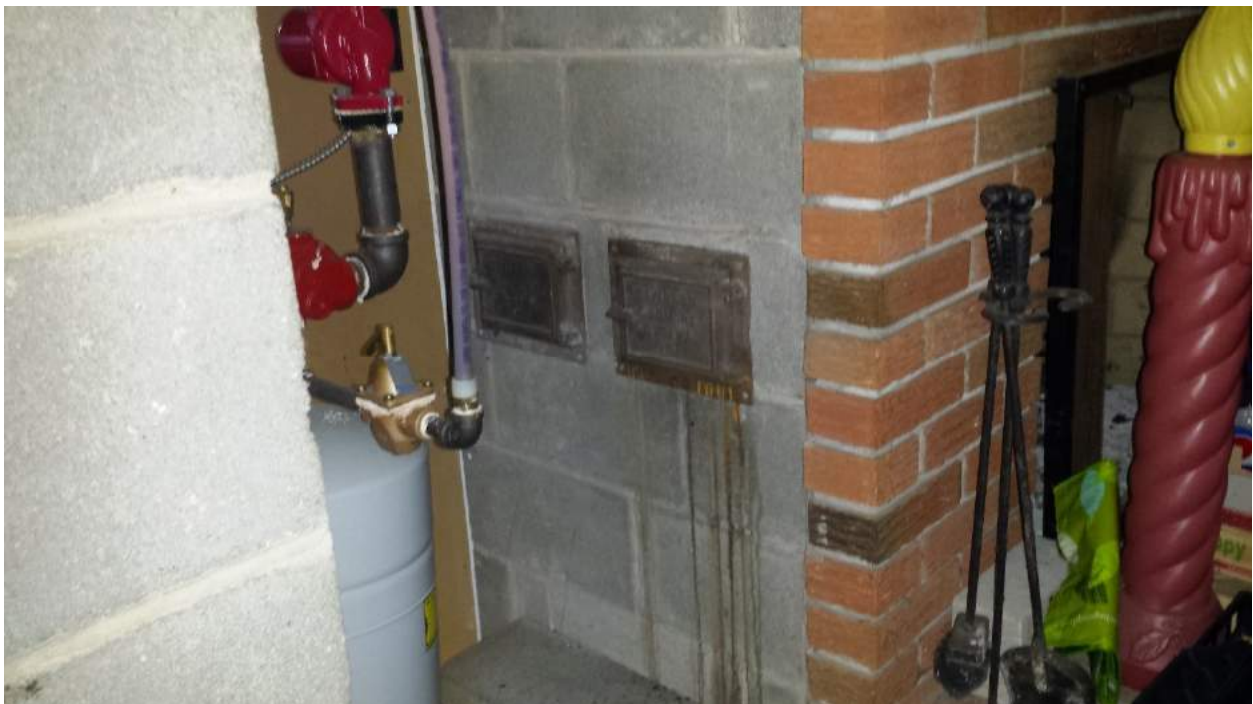
Photograph 8: Fireplace and cleanouts in the basement of 33 Deerfox Drive.

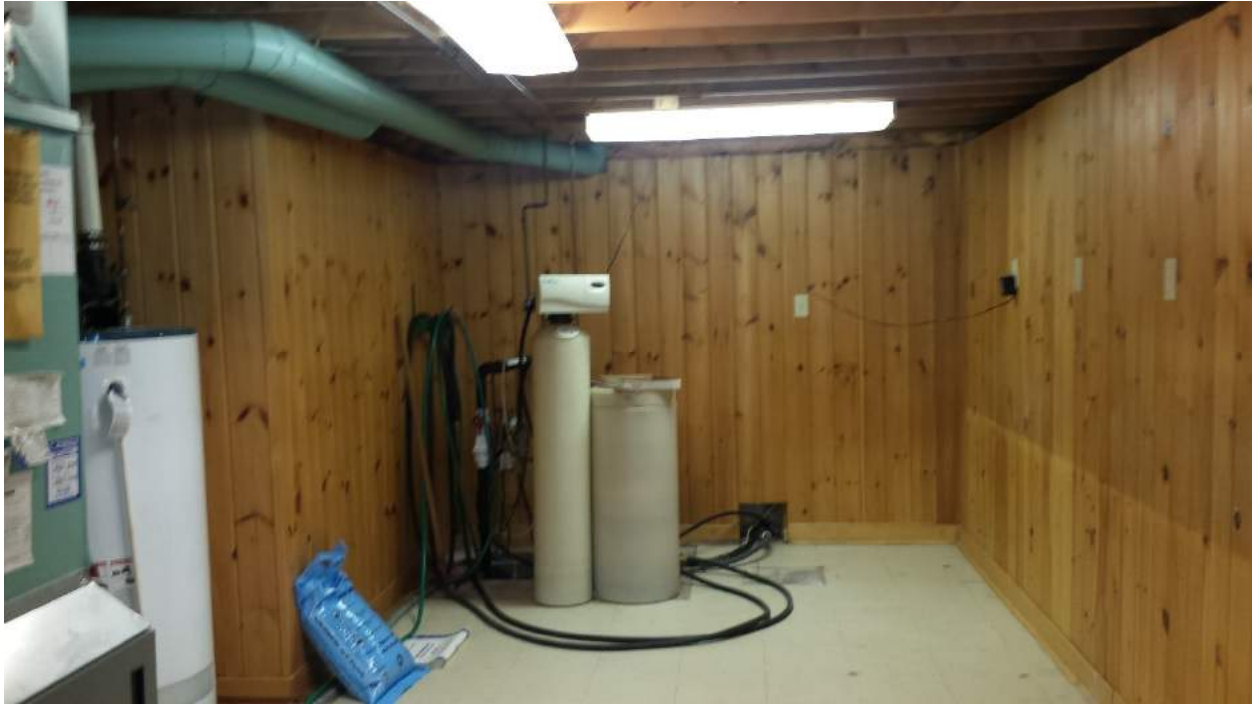
Photograph 9: Sump pit (left) and water softener in the basement of 39 Deerfox Drive.

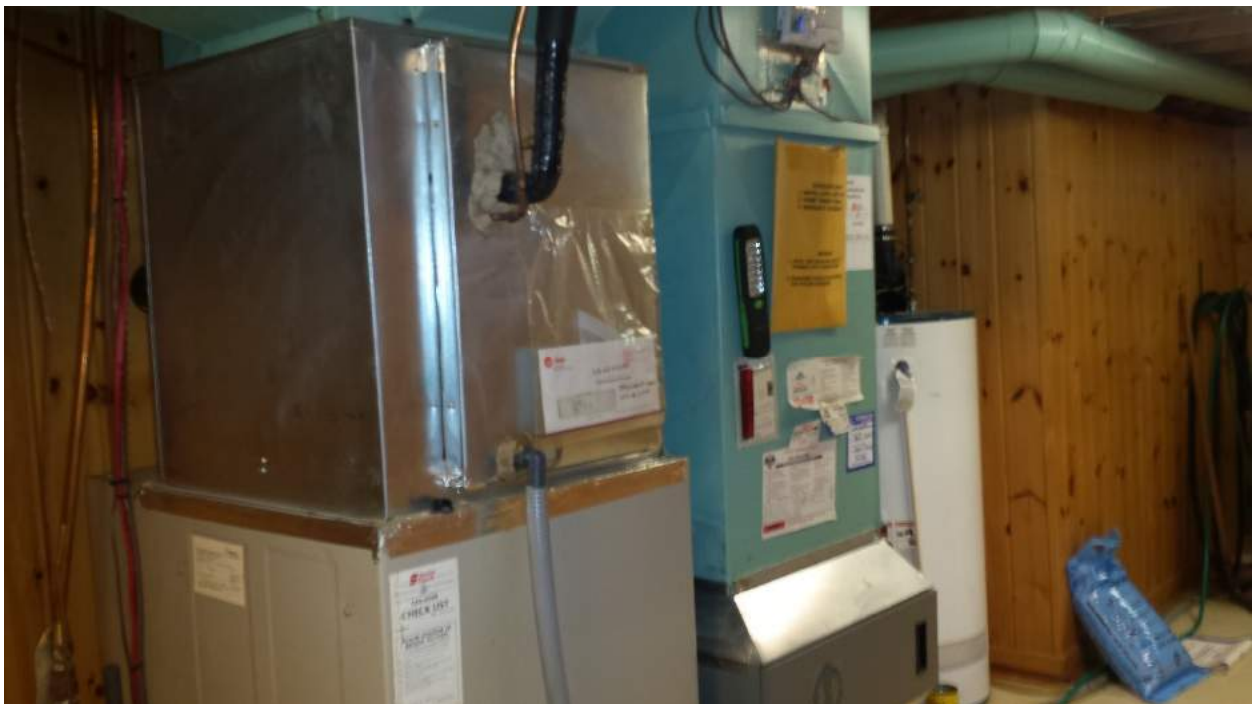
used to store lawn maintenance equipment. An air conditioning unit was present along the east side of the dwelling. The house is heated with a natural gas furnace, and reportedly has never been heated with fuel oil.

Photograph 10: Natural gas furnace in the basement of 39 Deerfox Drive.

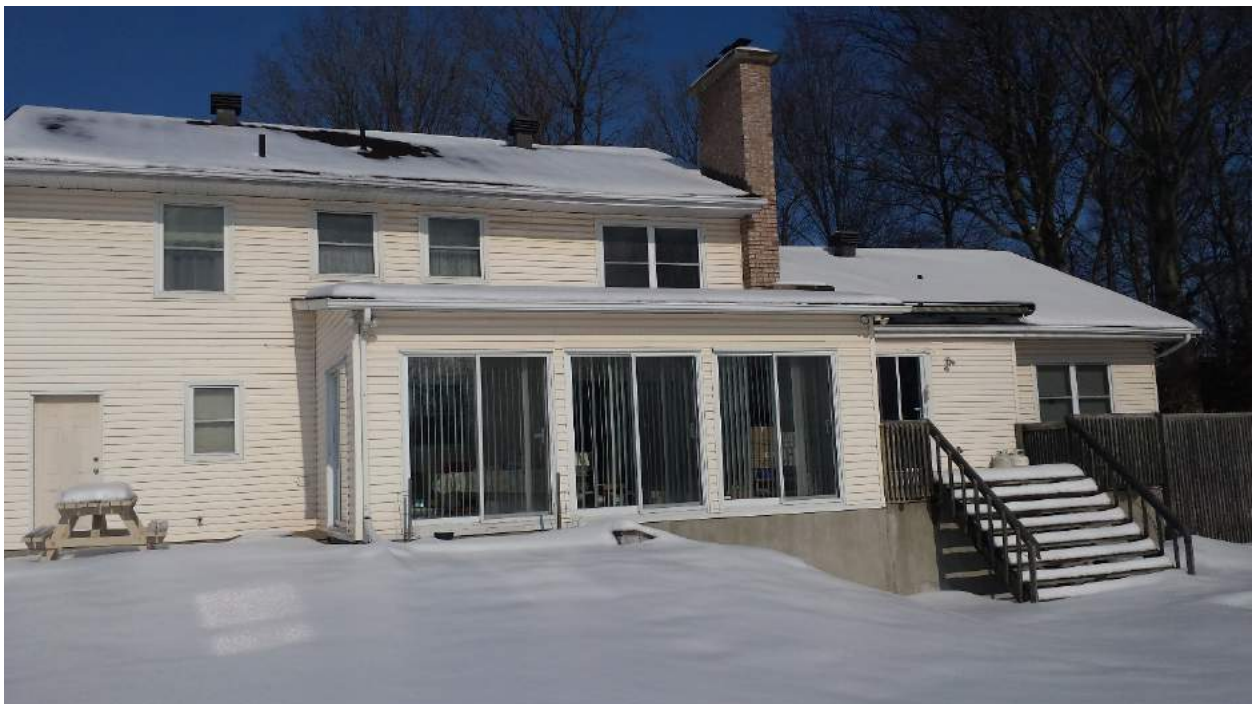
Photograph 12: View of the rear of 39 Deerfox Drive, looking north. The pool is located to the right of the photo, and the septic tank is at the left.
