December 5, 2018

Version 1.0  
Matrix 27873-504

**Subject: 762 March Road – Shirley's Brook Meander Belt Width**

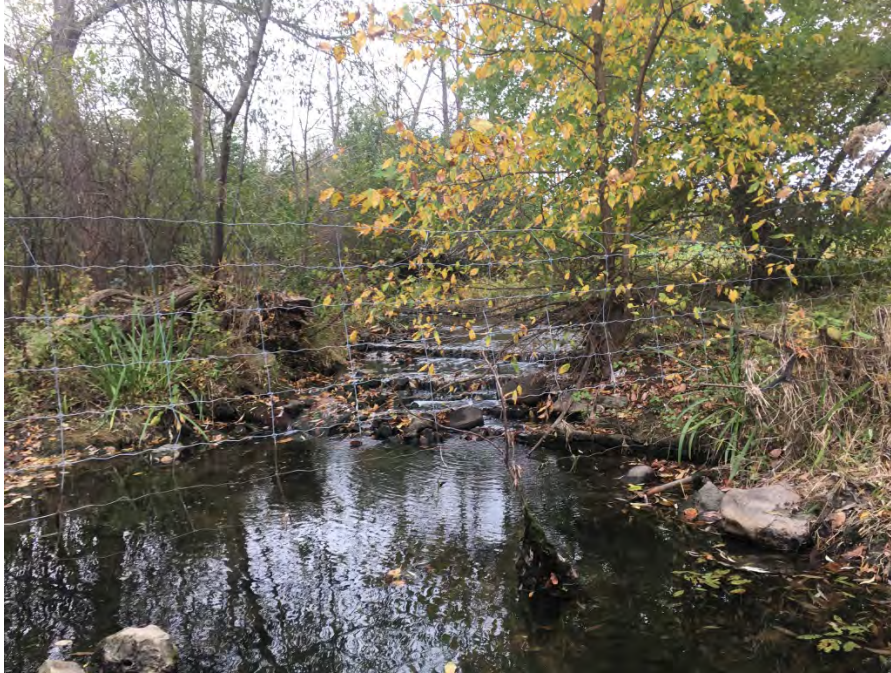
1. Fence marking the upstream extent of the site with knickpoint/waterfall upstream forming pool at start of the study area.

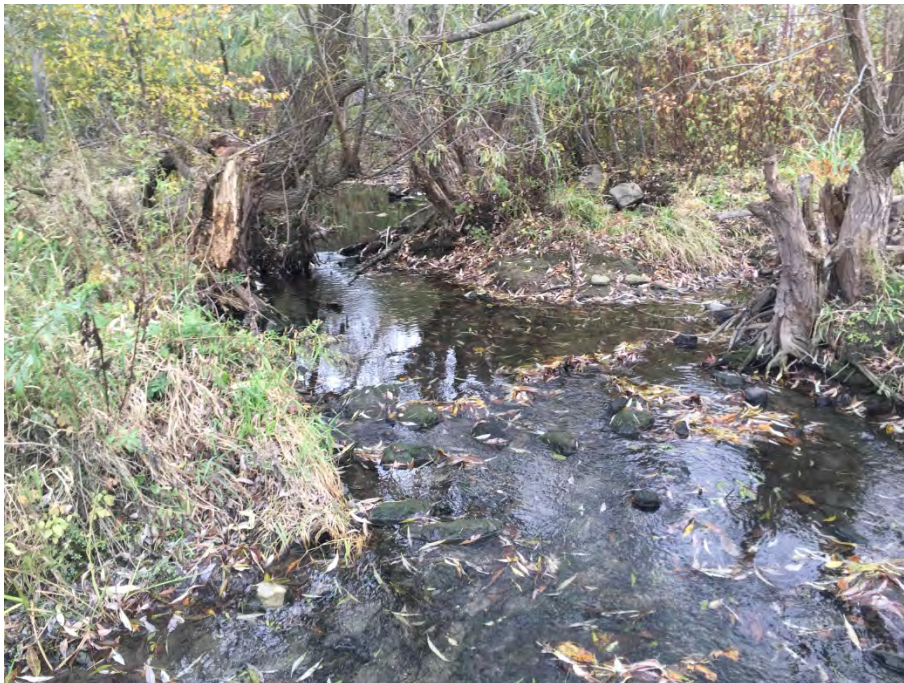
2. Island forming at downstream end of pool to start of riffle/run features downstream.

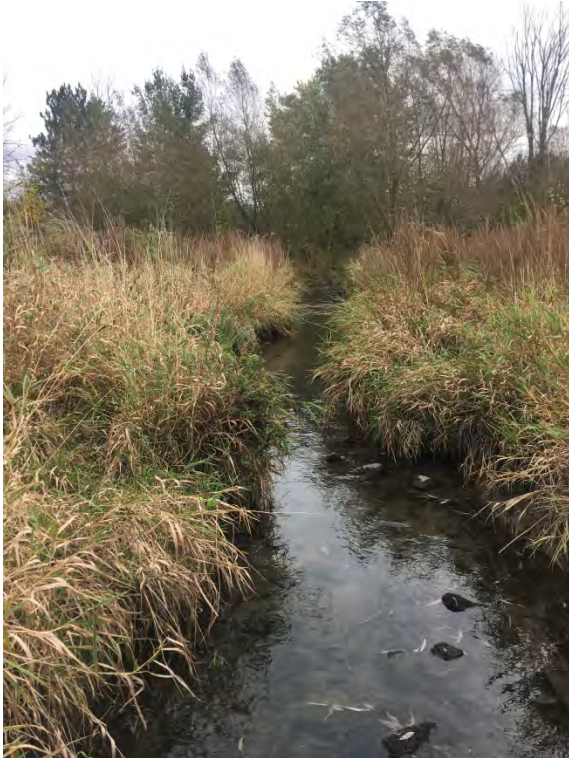
The upstream half of the section of channel investigated as part of this assessment appears to be adjusting more actively than the downstream half. In the upstream half, active lateral migration can be observed into the riparian zone which is composed of tall grasses, herbs, and shrubs. In this area the cross-section is slightly narrower and is composed of small runs and pools. Active adjustment was observed as the channel begins to establish a more natural form.

3. Typical cross-section through upstream ~45 m of site where slight sinuosity observed with signs of active channel erosion and relatively coarse bottom.

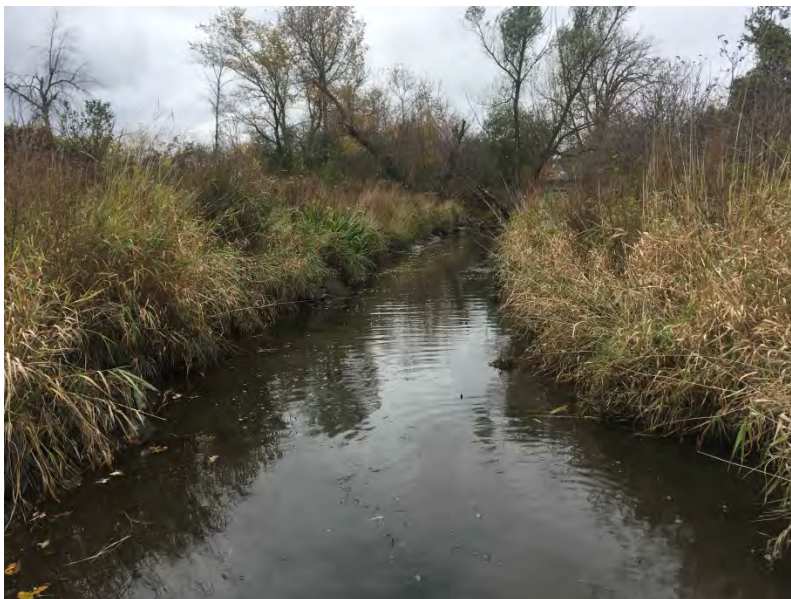
Downstream of this narrower section, the channel widens (4.3 m bankfull width in areas) and the bottom is composed of unconsolidated silt and organic materials. With a wider cross-section and a lower longitudinal slope, the downstream half of the channel is much more depositional. It is expected that the upstream active adjustment will migrate downstream with time as meanders continue to migrate. These observations of active channel adjustment are in general agreement with the finding by AECOM (2015) that the watercourse is in the process of equilibrating and that these adjustments are likely due to land use changes. At the downstream extent of the reach is an open bottom concrete box culvert approximately 3 m wide in very poor condition. The concrete wing walls on the downstream side of the crossing have completely collapsed and the walls of the structure have partially collapsed and have been braced with a wood beam to prevent them from falling into the channel. The structure is undersized and is likely outflanked seasonally.

4. Typical cross-section through downstream ~ 50 m of site where the channel is wider, straight and aggrading

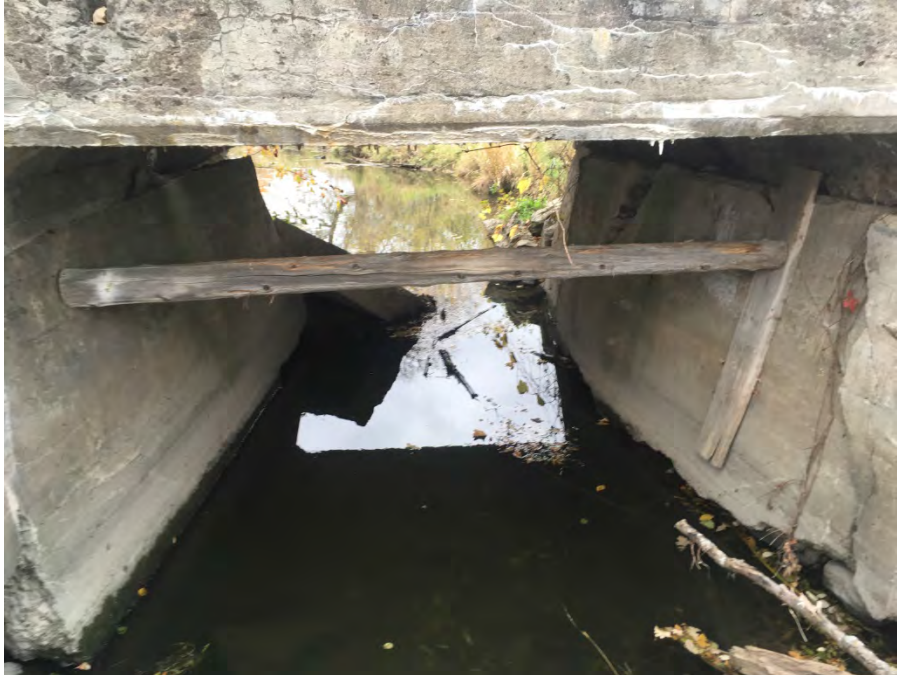
5. Open bottom concrete box culvert marking the downstream extent of the site. The culvert is undersized and in very poor condition as a result of outflanking.

1. Shirley's Brook will likely continue to migrate laterally and downstream, especially as development continues to expand within its watershed. Given the on-going migration of the channel and the condition of the downstream culvert, culvert removal would prevent the further collapse of the structure into the channel which could obstruct flows resulting in

flooding and forcing a re-alignment of the channel. Future culverts should consider a span with consideration for fluvial geomorphic processes to account for future channel evolution.
