June 22, 2018

Project No. 1668958/2100

**PHASE I ENVIRONMENTAL SITE ASSESSMENT UPDATE
2280 CITY PARK DRIVE
OTTAWA, ONTARIO**

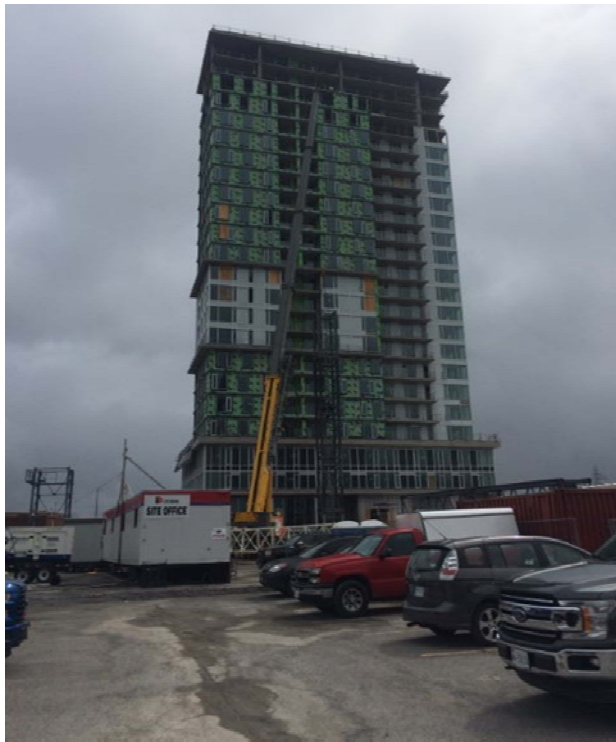
- The commercial retail units that were present during the 2015 Phase I ESA have been demolished. A 24-storey (with one underground level) multi-tenant residential building was under construction at the time of the site reconnaissance. The building is located in the southeastern portion of the site.

Photo 1: View of residential building under development, facing east.

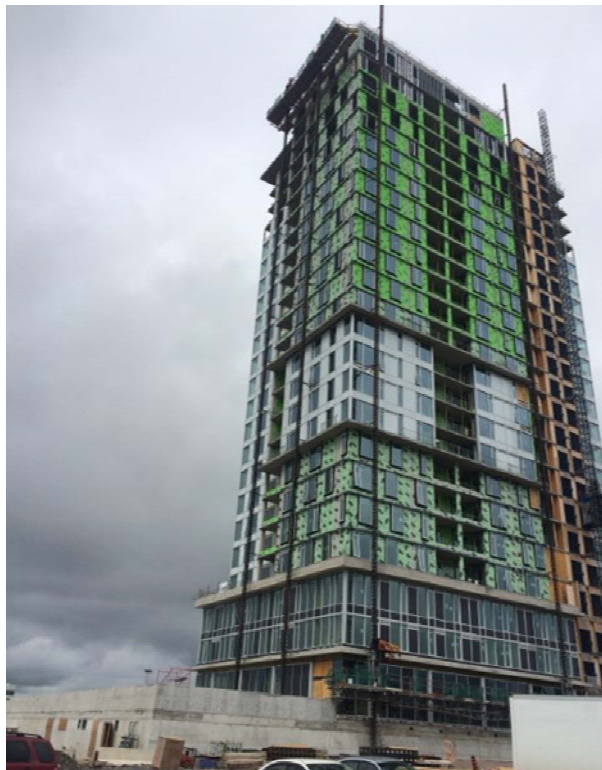
Photo 2: View of residential building under development, facing northwest.

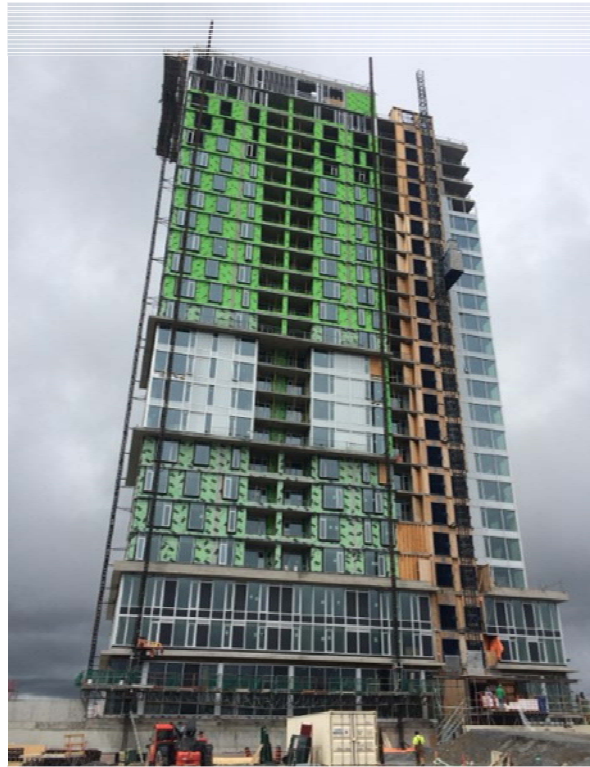
Photo 3: View of residential building under development, facing west.

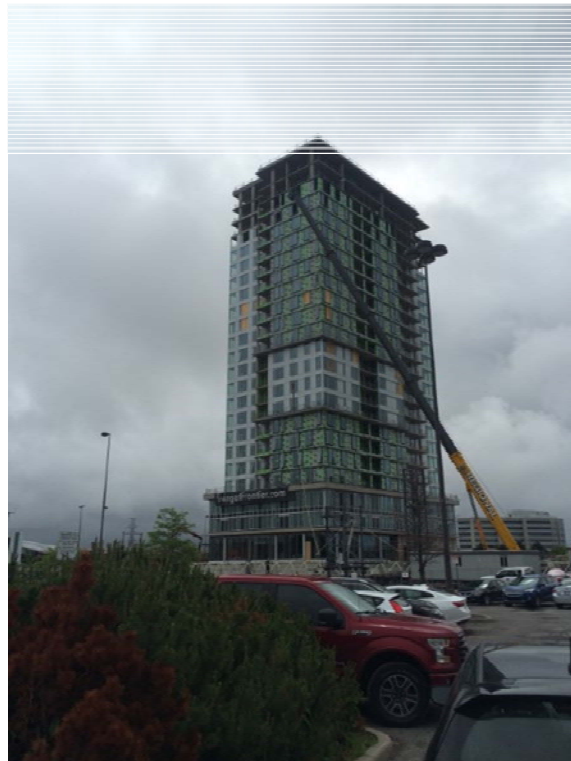
Photo 4: View of residential building under development, facing southeast.

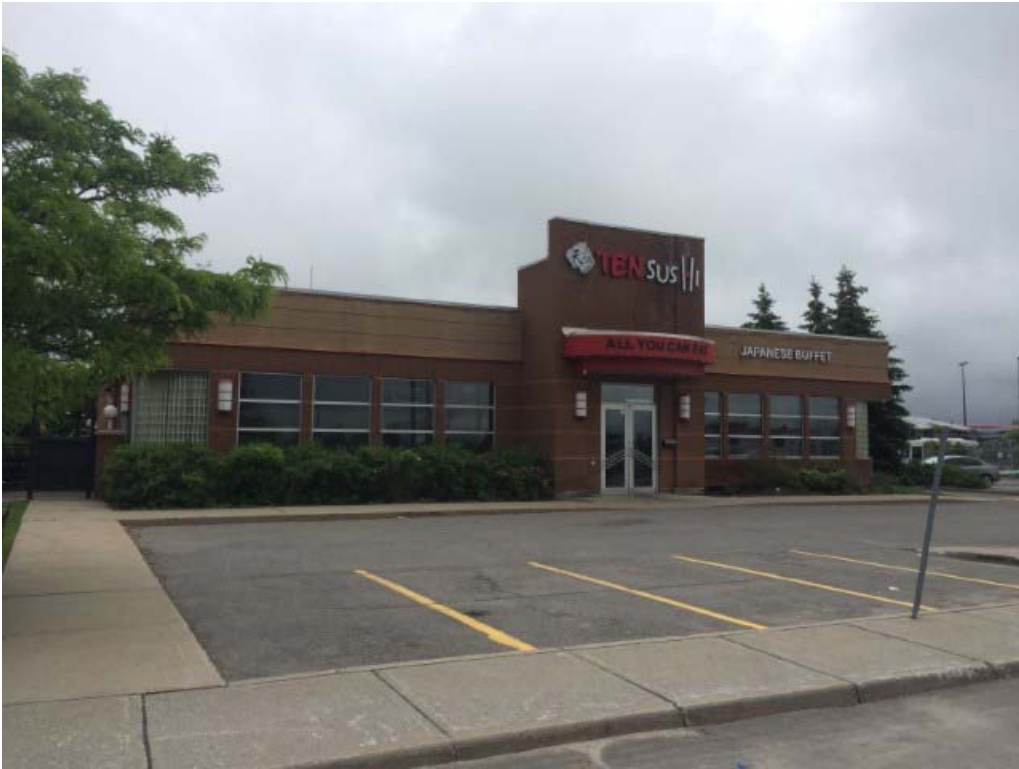
- The restaurant building remains in the northeastern portion of the site. The restaurant now operates as Ten Sushi. The restaurant was not accessed during the site reconnaissance.

Photo 5: View of Ten Sushi restaurant, facing east.

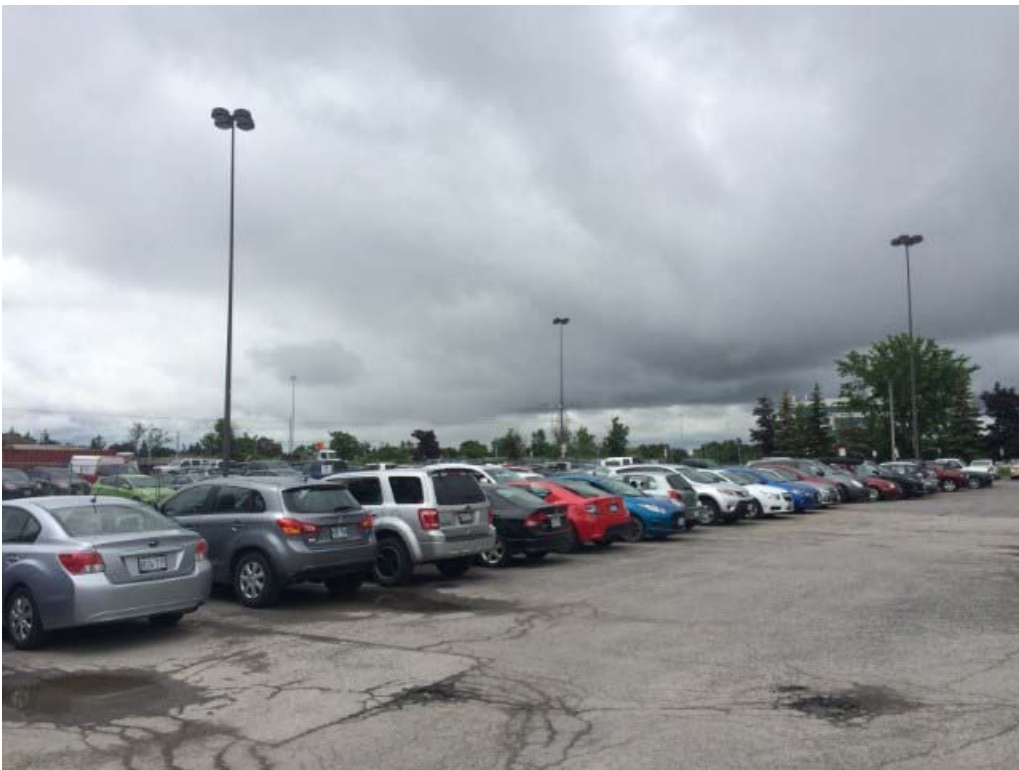
Photo 6: View of on-site parking area, facing southwest.

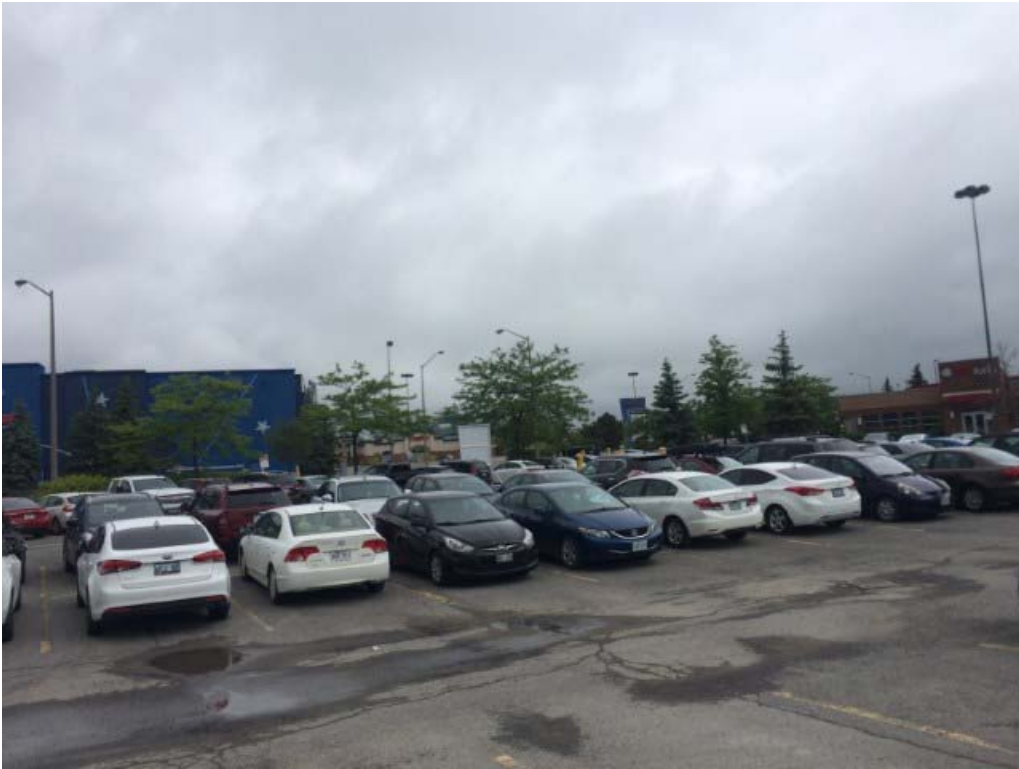
Photo 7: View of on-site parking area, facing north.

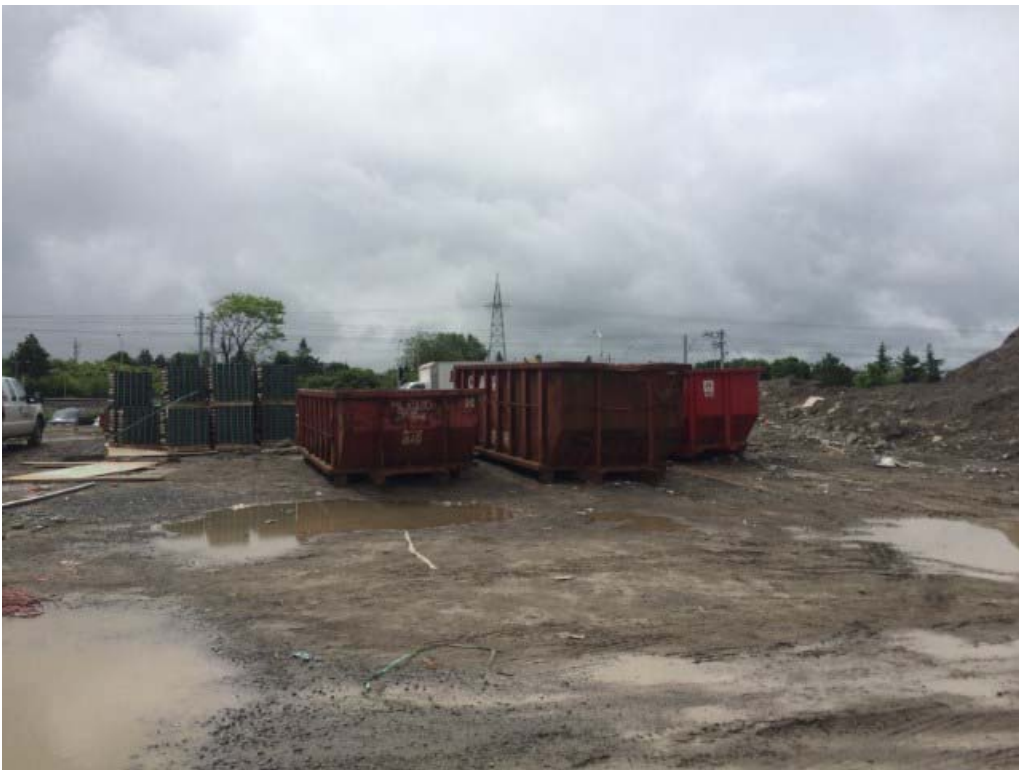
Photo 8: View of garbage receptacles, central portion of site, facing south.

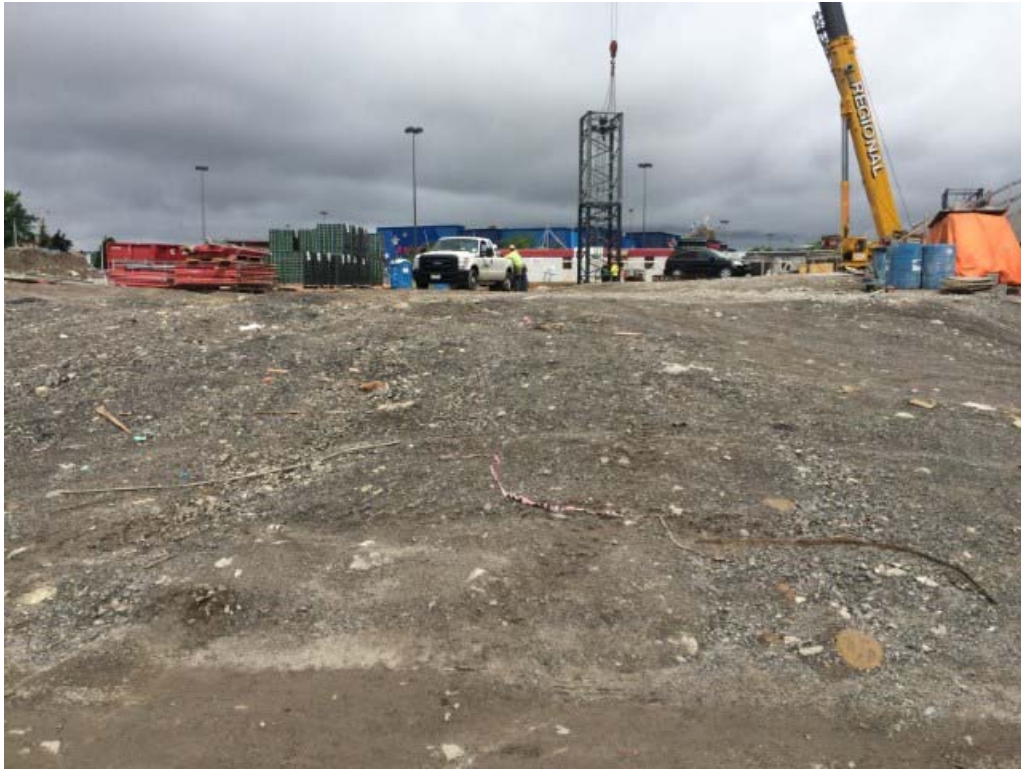
- A stockpile of soil was observed in the central portion of the site. The site representative stated that this pile was excavated material from on-site that will be used to level out the future parking area.

Photo 9: View of construction staging area and stockpiled excavated material (will be used as fill to level parking area around new construction building).

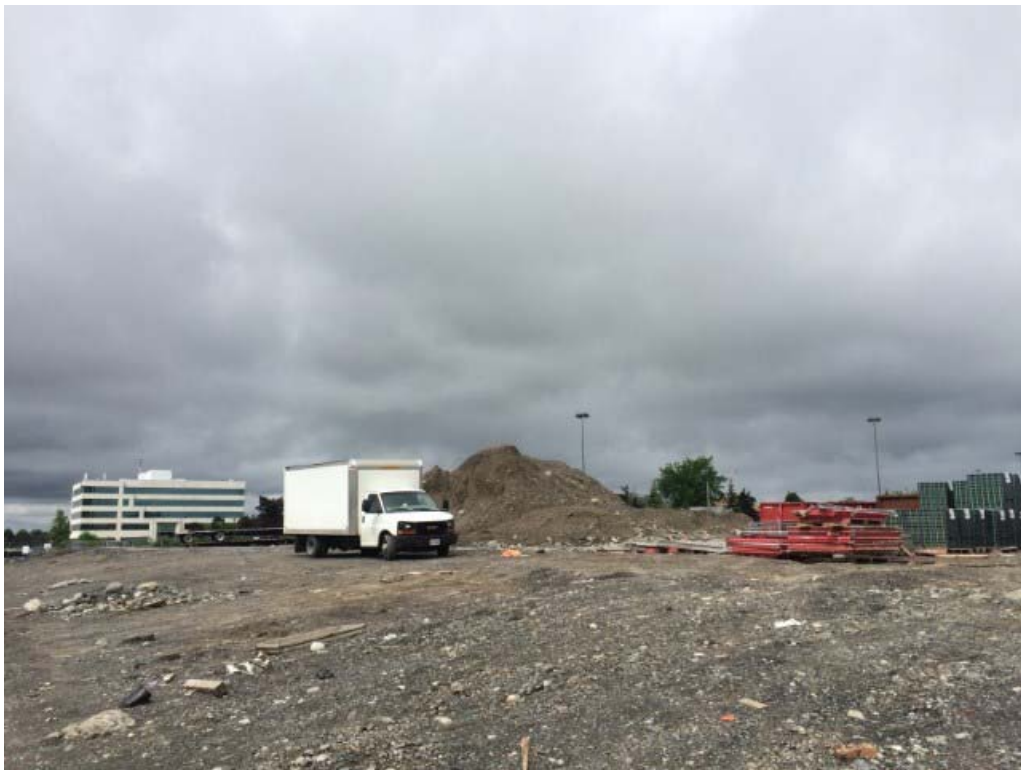
Photo 10: View of stockpiled excavated material.

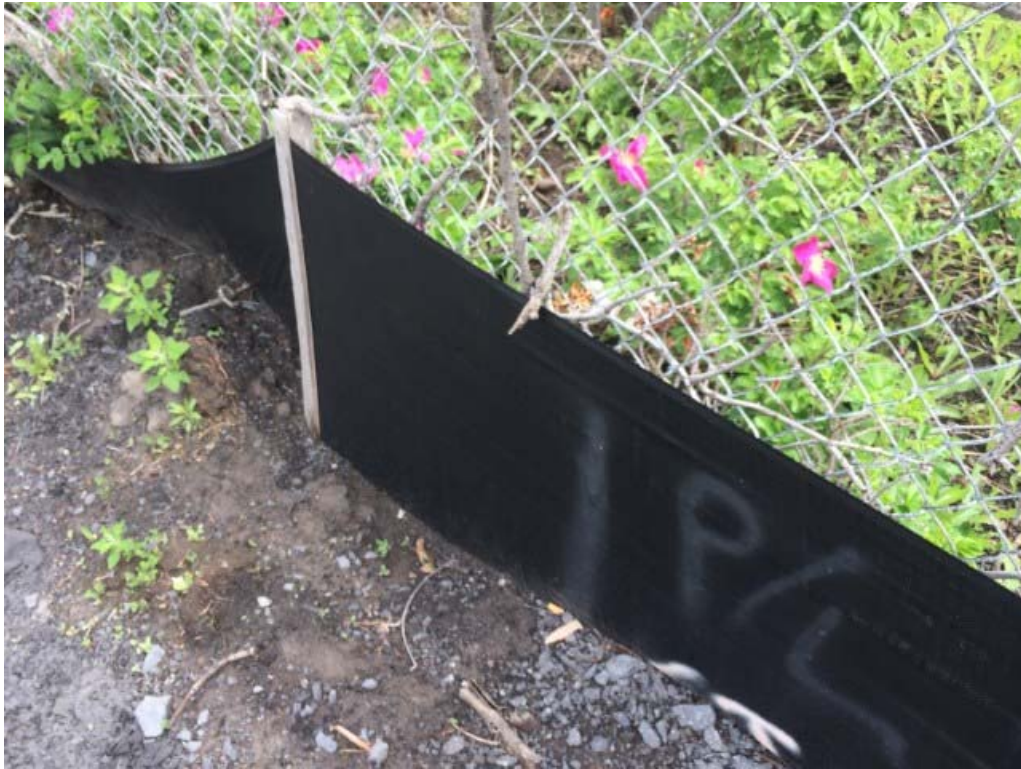
Photo 11: View of on-site silt fence, along eastern boundary of construction area.

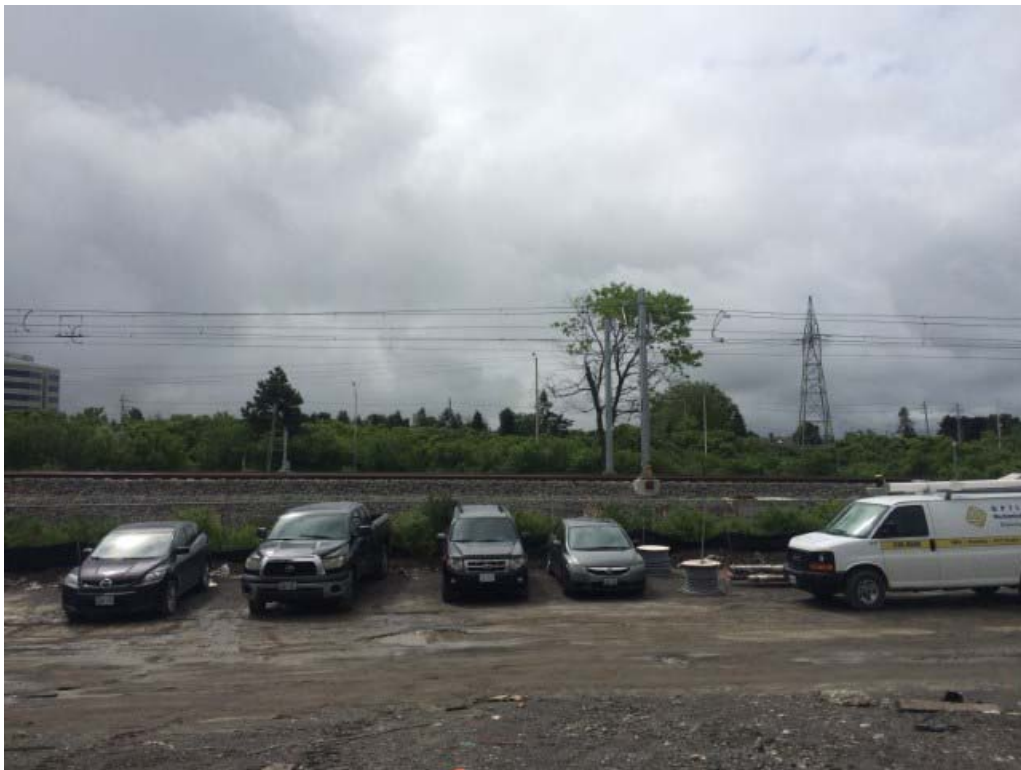
Photo 12: View of LRT, south of site, facing south.

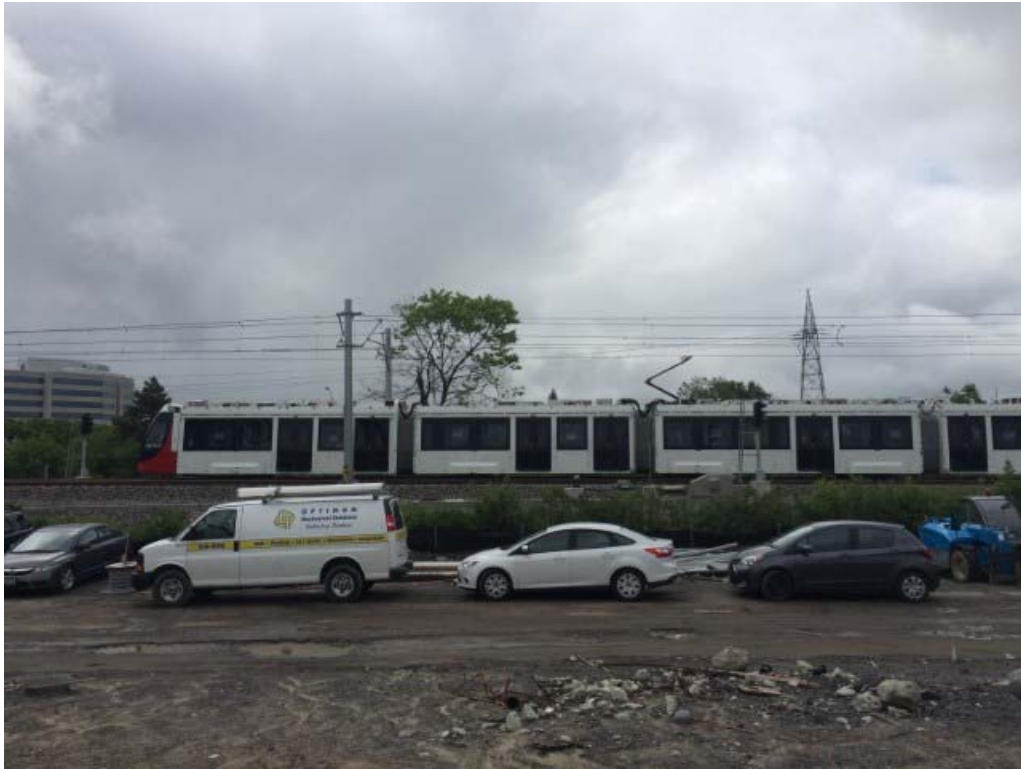
Photo 13: View of LRT, south of site, facing south.

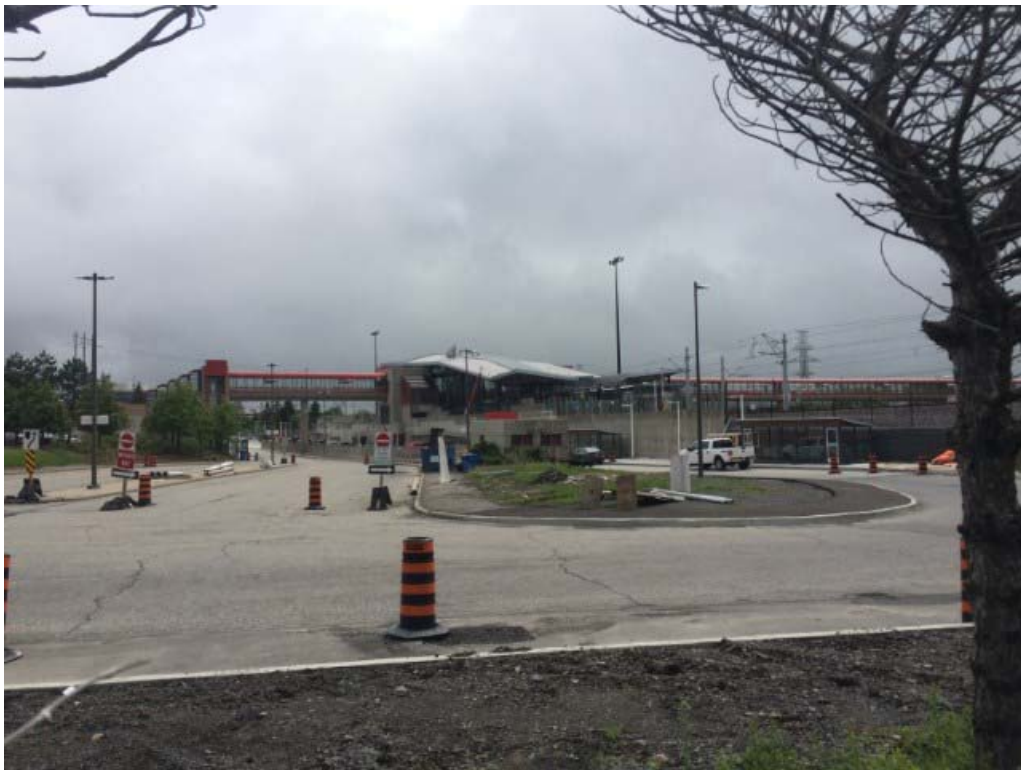
Photo 14: View of Blair LRT station under construction, facing east.

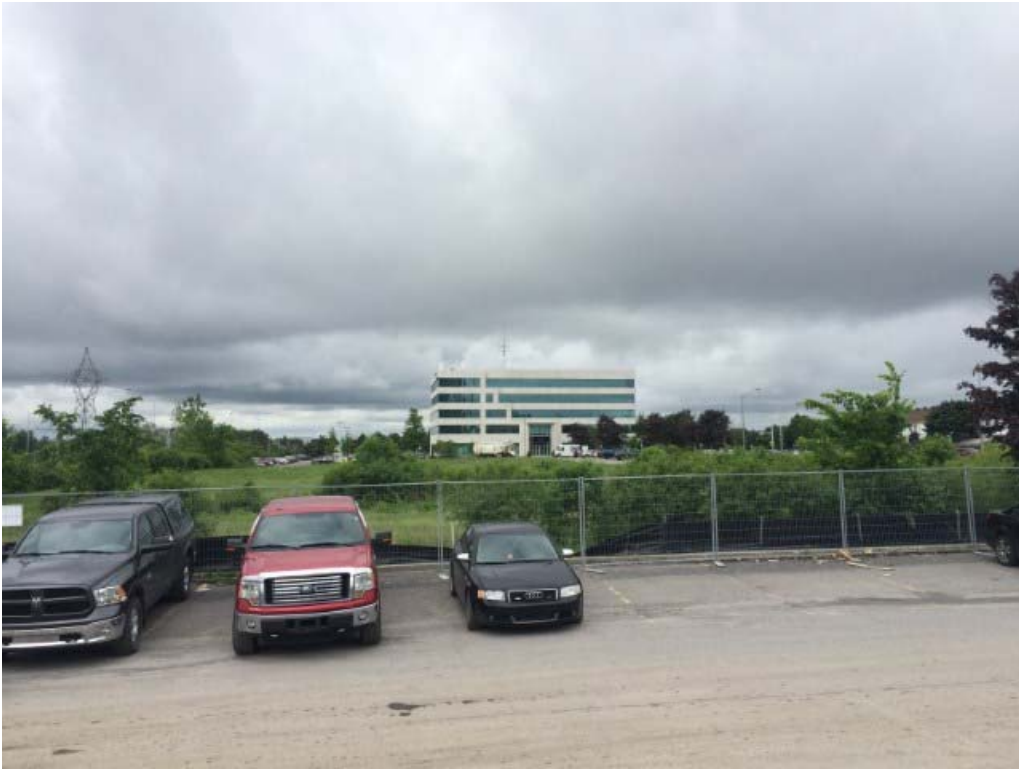
Photo 15: View of undeveloped property west of site, facing west.

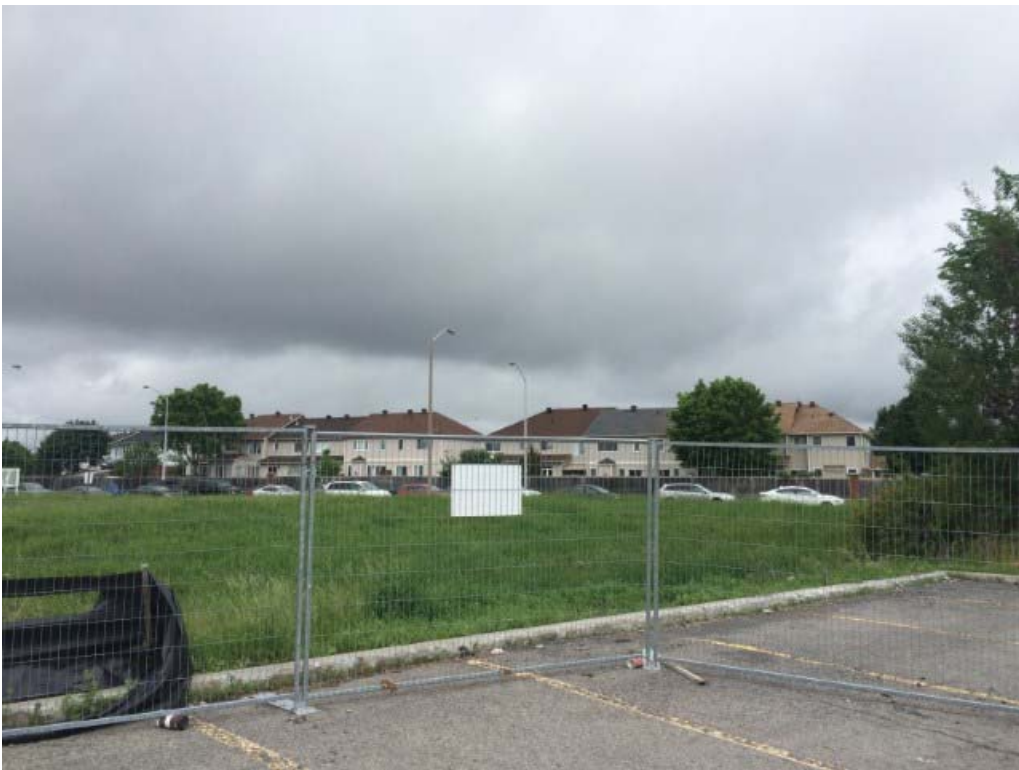
Photo 16: View of residential development northwest of site, facing northwest.

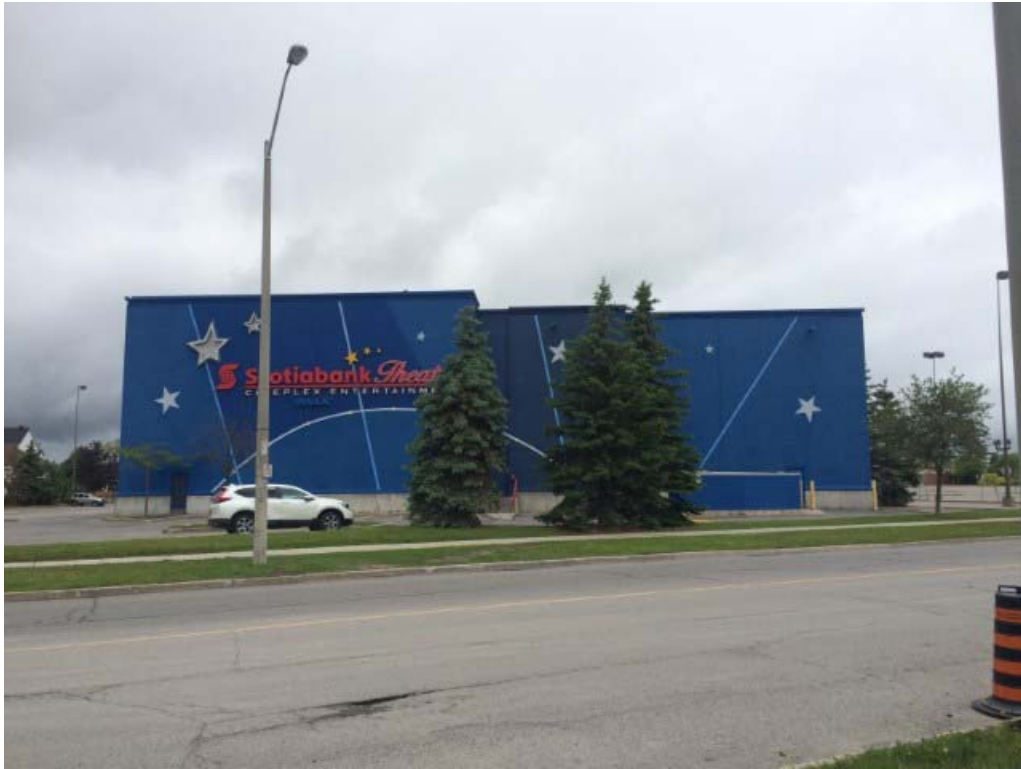
Photo 17: View of Scotiabank Silver City Theatre, north of site, facing north.
