April 25, 2019

Version 2.0  
Matrix 27873-504

**Subject: 762 March Road – Shirley’s Brook Meander Belt Width**

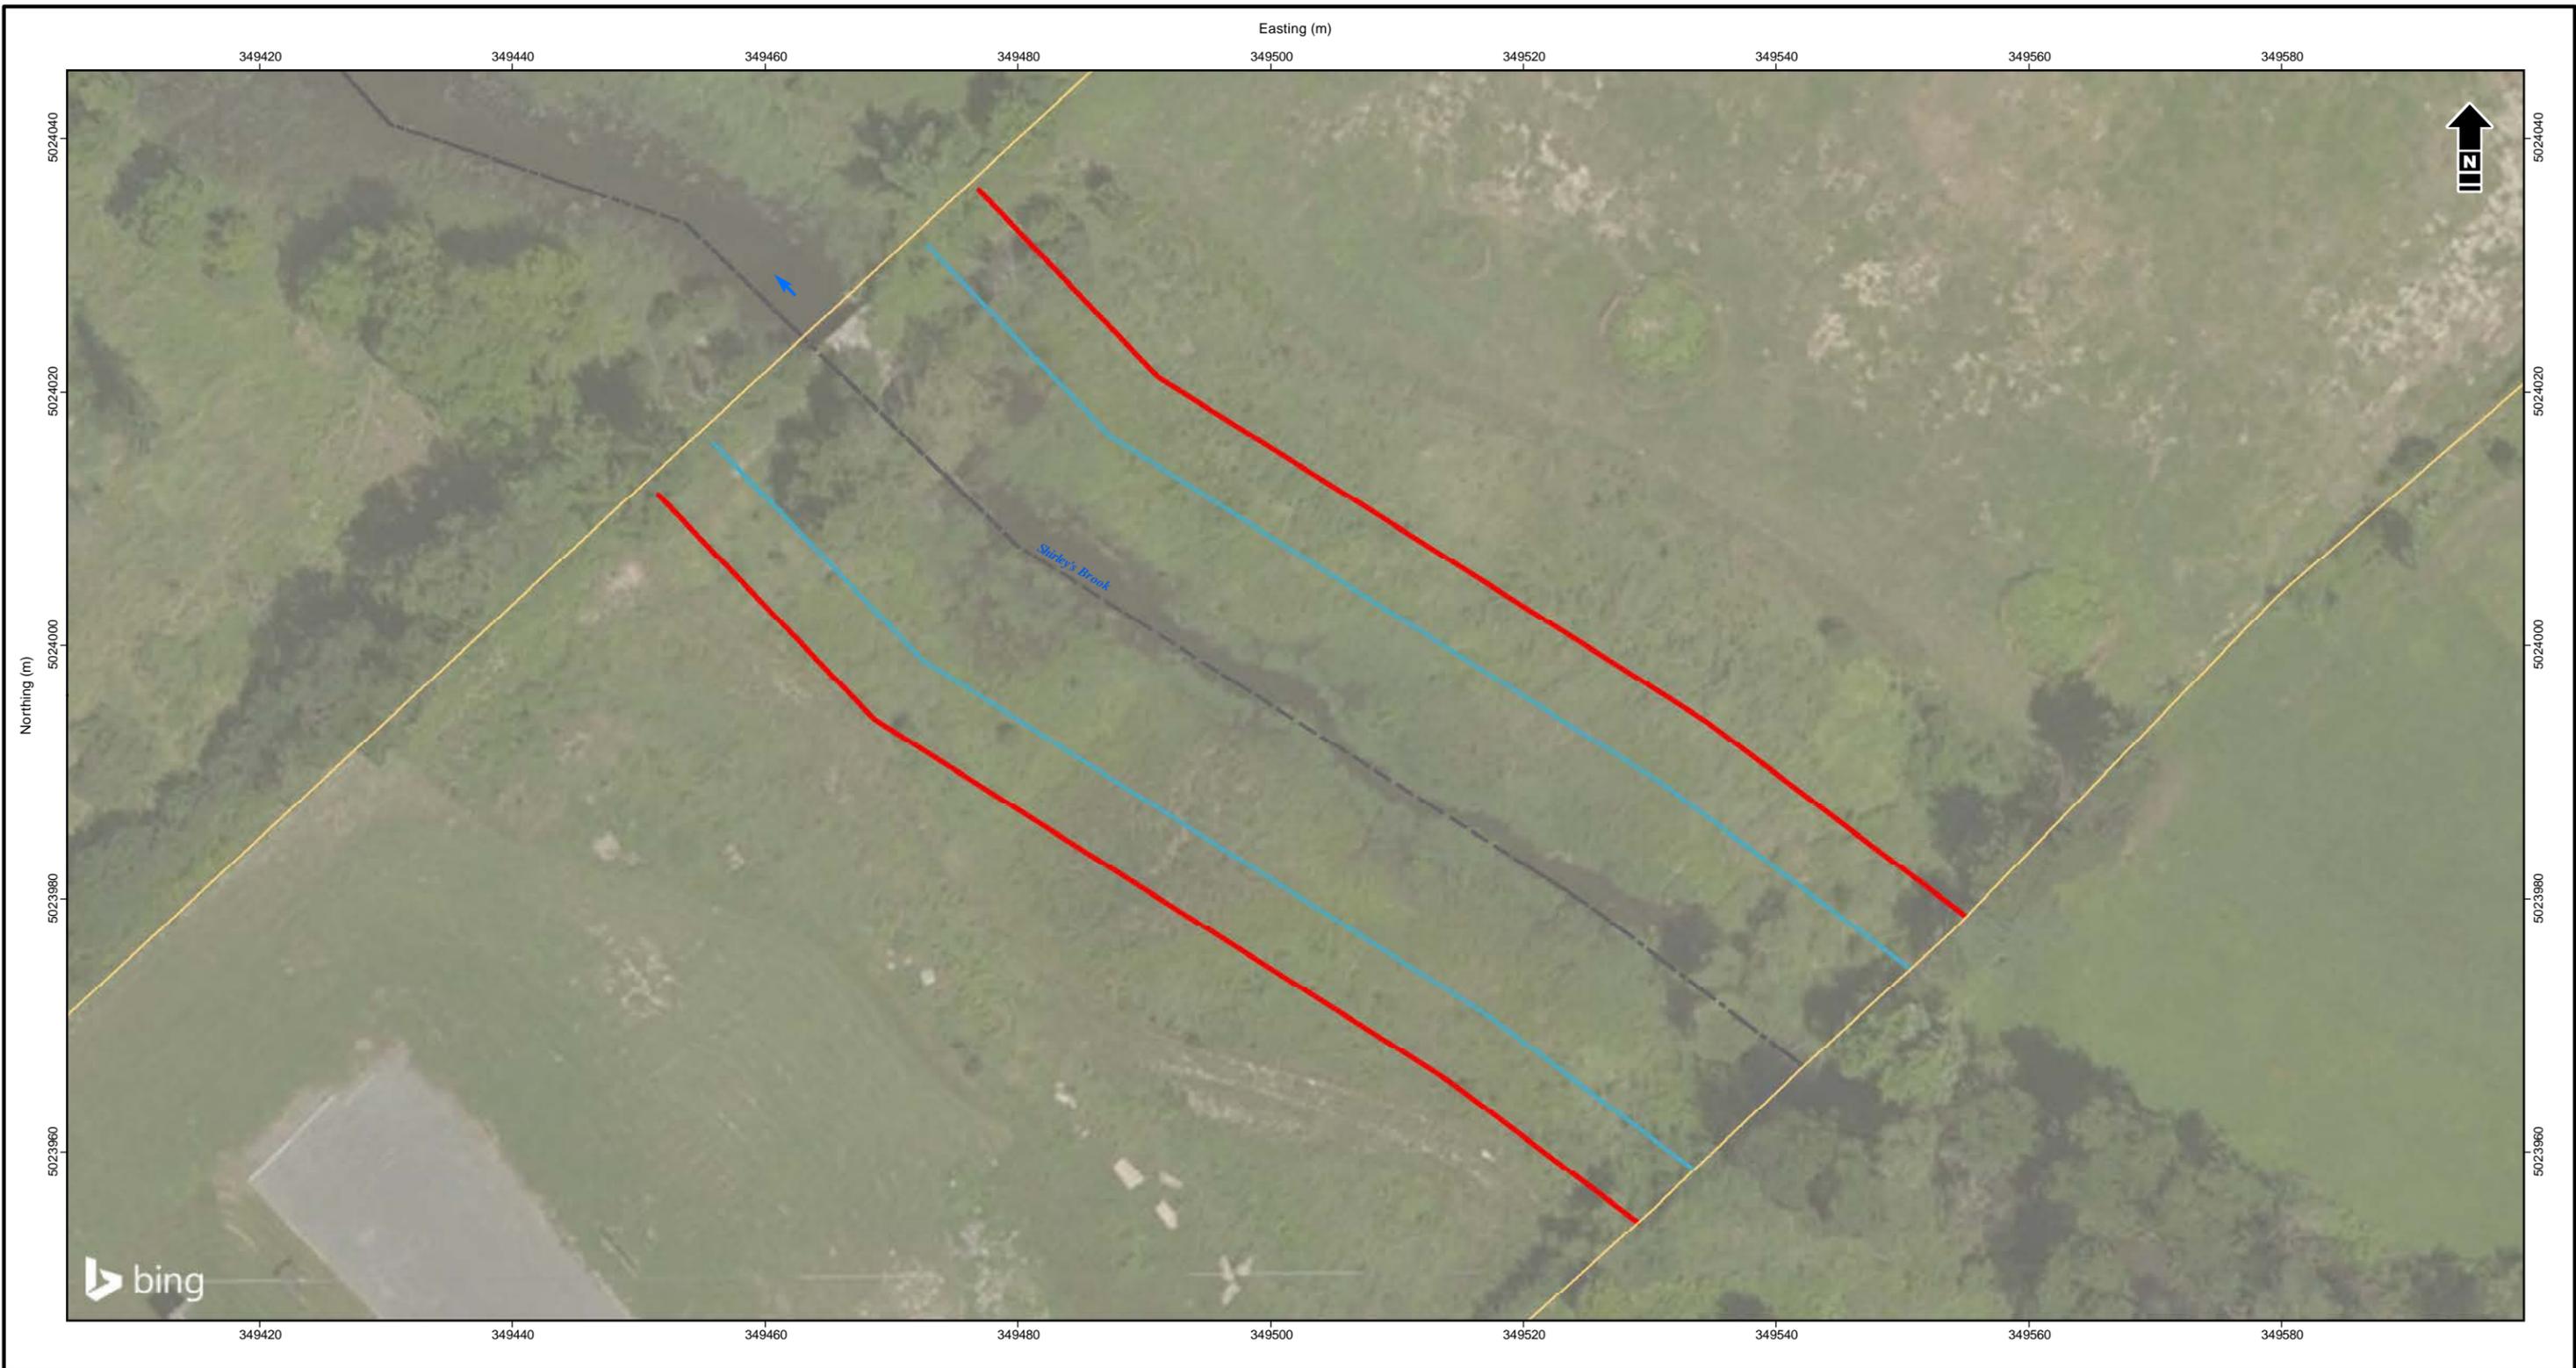
### Erosion Hazard Limit

Based on the finding presented in Table 3 and the comparability to up and downstream meander belt widths, a preliminary meander belt width of 23 m is recommended for the study reach. This value represents the total width. A 6 m erosion access allowance is added on each side of the preliminary meander belt width for a total erosion hazard limit of 35 m.

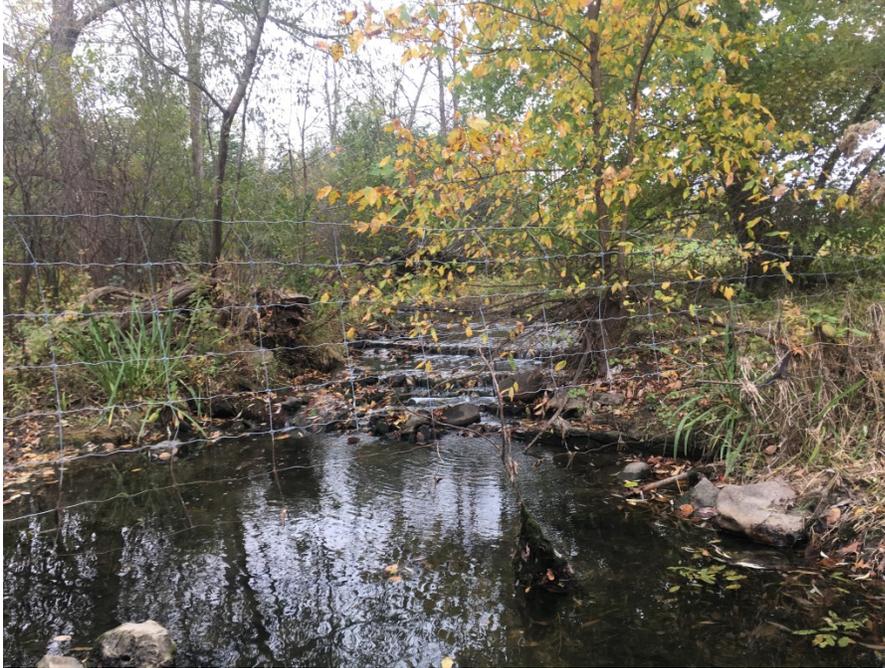
1. Fence marking the upstream extent of the site with knickpoint/waterfall upstream forming pool at start of the study area.

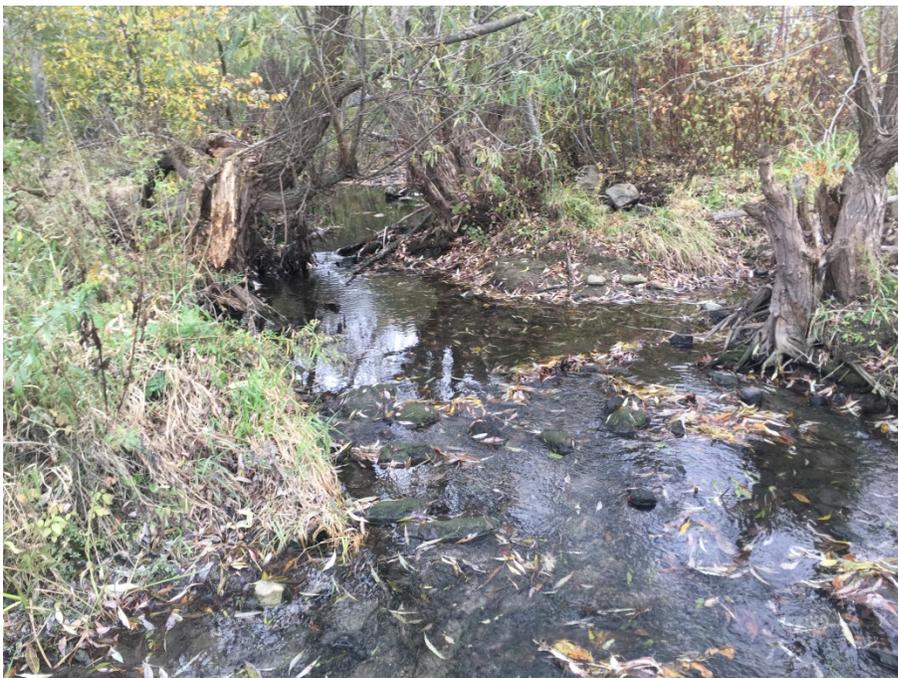
2. Island forming at downstream end of pool to start of riffle/run features downstream.

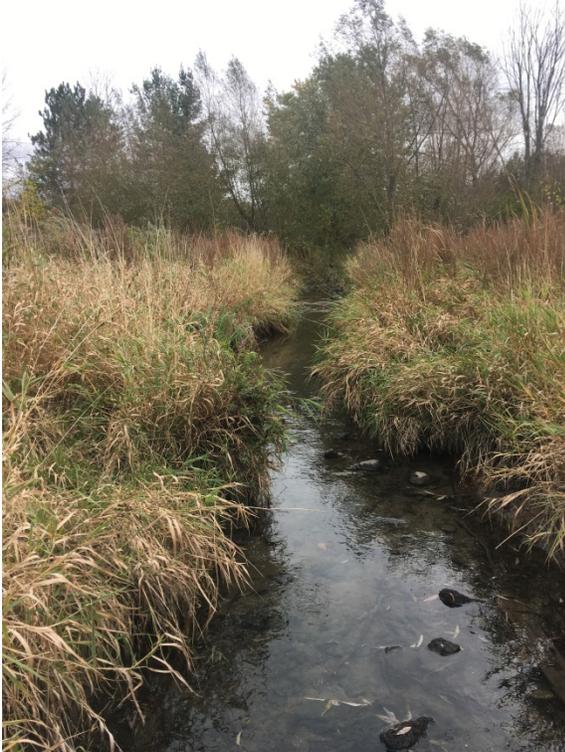
The upstream half of the section of channel investigated as part of this assessment appears to be adjusting more actively than the downstream half. In the upstream half, active lateral migration can be observed into the riparian zone which is composed of tall grasses, herbs, and shrubs. In this area the cross-section is slightly narrower and is composed of small runs and pools. Active adjustment was observed as the channel begins to establish a more natural form.

3. Typical cross-section through upstream ~45 m of site where slight sinuosity observed with signs of active channel erosion and relatively coarse bottom.

2. A number of tree stumps with exposed roots along the banks were observed during the site visit. Tree plantings would create rooting systems which can provide erosion protection and can provide significant improvements to a variety of habitats.

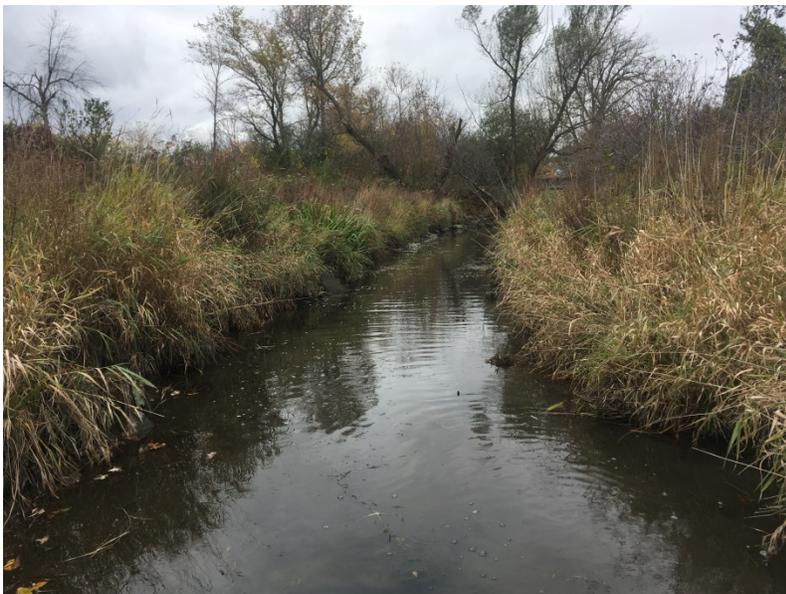
Downstream of this narrower section, the channel widens (4.3 m bankfull width in areas) and the bottom is composed of unconsolidated silt and organic materials. With a wider cross-section and a lower longitudinal slope, the downstream half of the channel is much more depositional. It is expected that the upstream active adjustment will migrate downstream with time as meanders continue to migrate. These observations of active channel adjustment are in general agreement with the finding by AECOM (2015) that the watercourse is in the process of equilibrating and that these adjustments are likely due to land use changes. At the downstream extent of the reach is an open bottom concrete box culvert approximately 3 m wide in very poor condition. The concrete wing walls on the downstream side of the crossing have completely collapsed and the walls of the structure have partially collapsed and have been braced with a wood beam to prevent them from falling into the channel. The structure is undersized and is likely outflanked seasonally.

4. Typical cross-section through downstream ~ 50 m of site where the channel is wider, straight and aggrading

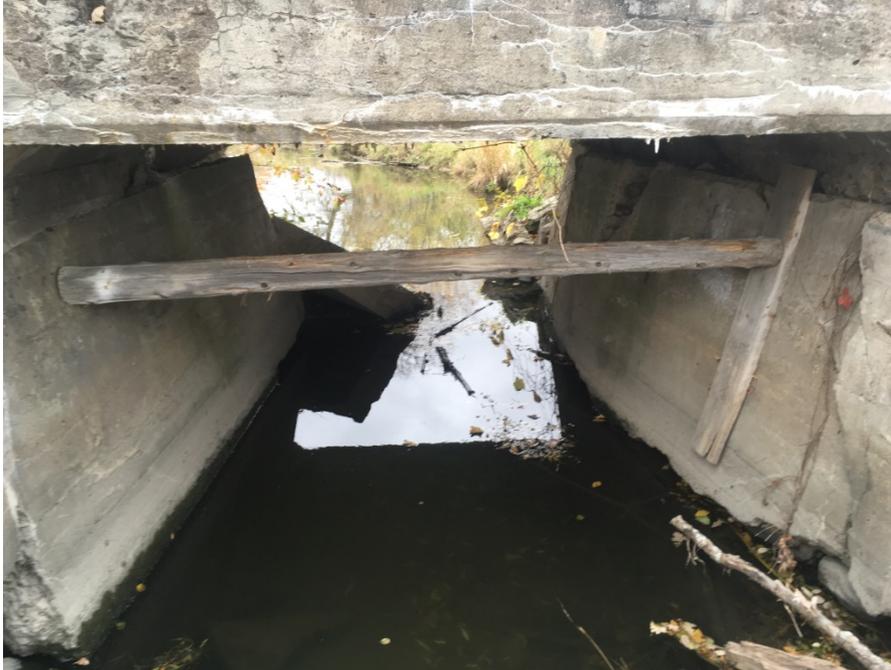
5. Open bottom concrete box culvert marking the downstream extent of the site. The culvert is undersized and in very poor condition as a result of outflanking.

1. Shirley’s Brook will likely continue to migrate laterally and downstream, especially as development continues to expand within its watershed. Given the on-going migration of the channel and the condition of the downstream culvert, culvert removal would prevent the further collapse of the structure into the channel which could obstruct flows resulting in flooding and forcing a re-alignment of the channel. Future culverts should consider a span with consideration for fluvial geomorphic processes to account for future channel evolution.
