147 Langstaff Drive, Carp, Ontario

Fluvial Geomorphological and Erosion Hazard Assessment

October 23, 2019
PN19072

Report Title: 147 Langstaff Drive, Carp Ontario
Fluvial Geomorphological and Erosion Hazard
Assessment

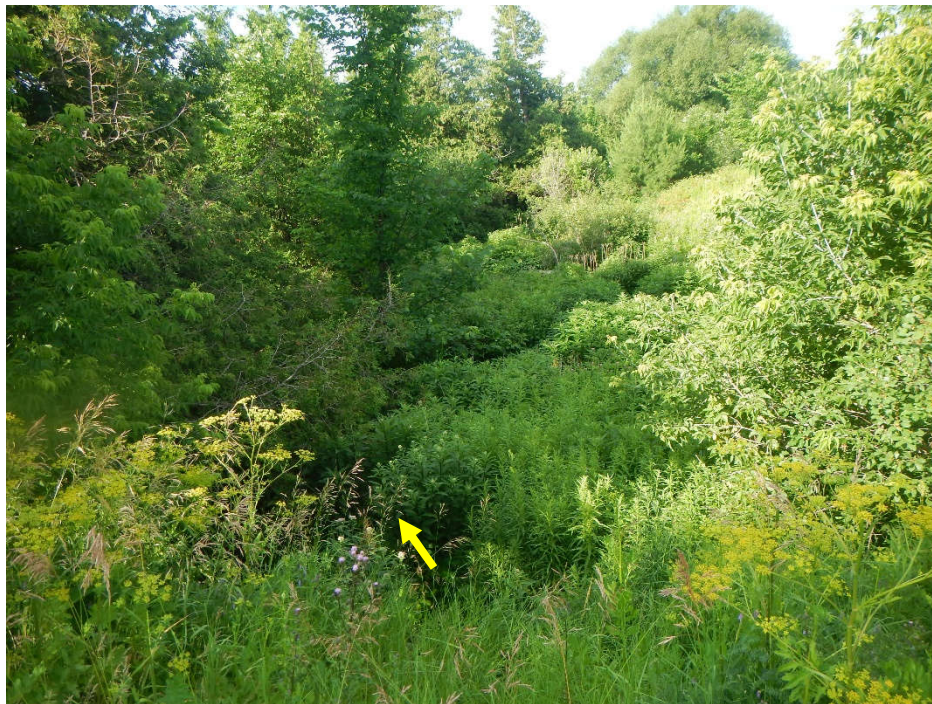
Photo 1
Tributary of Carp River: View Downstream
Reach CR-1

View of the reach downstream of Langstaff Drive. The channel was heavily encroached with vegetation at the upstream extent and was partially confined. Yellow arrow indicates flow direction.

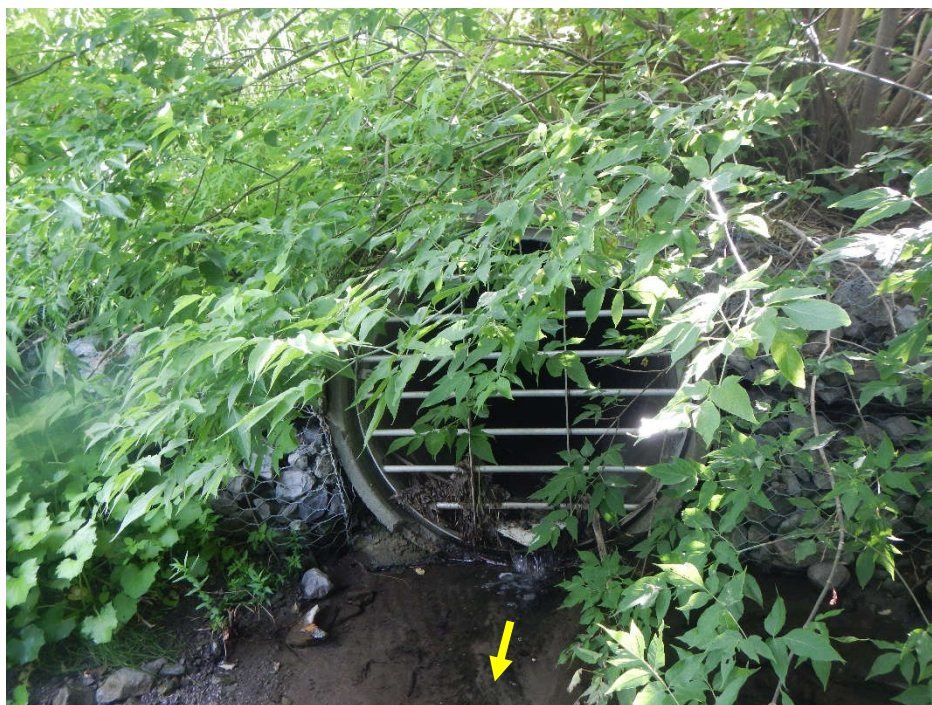
Photo 2
Tributary of Carp River: View Upstream
Reach CR-1

View of the culvert conveying flows under Langstaff Drive.

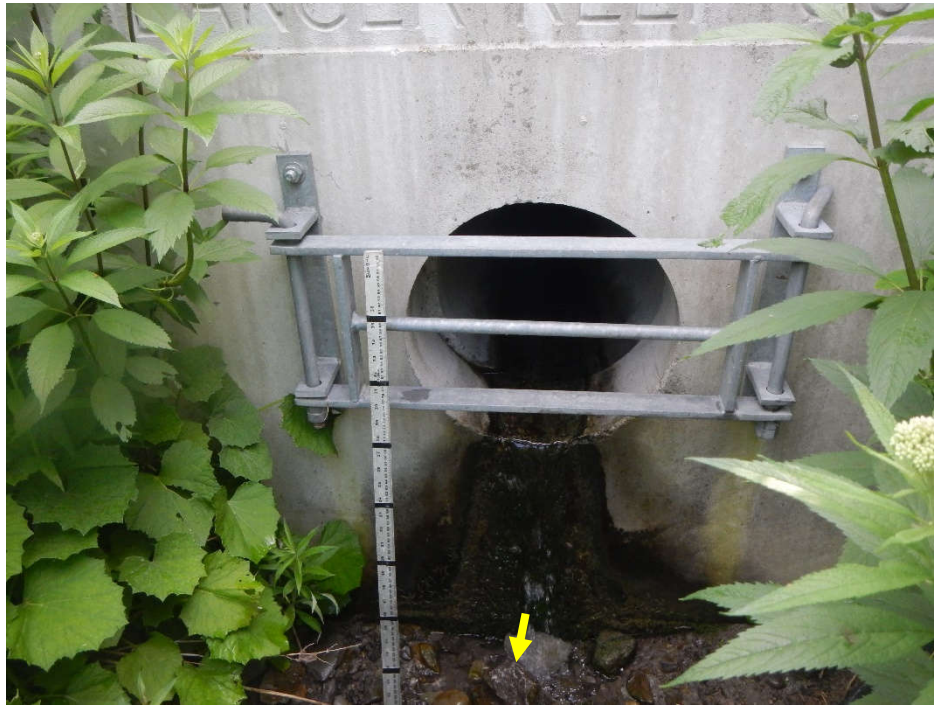
Photo 3
Tributary of Carp River: View Upstream
Reach CR-1

Stormwater outlet that discharged into the reach from Langstaff Drive. This outlet was located on the north side of the channel and flowed over small cobbles towards the reach.

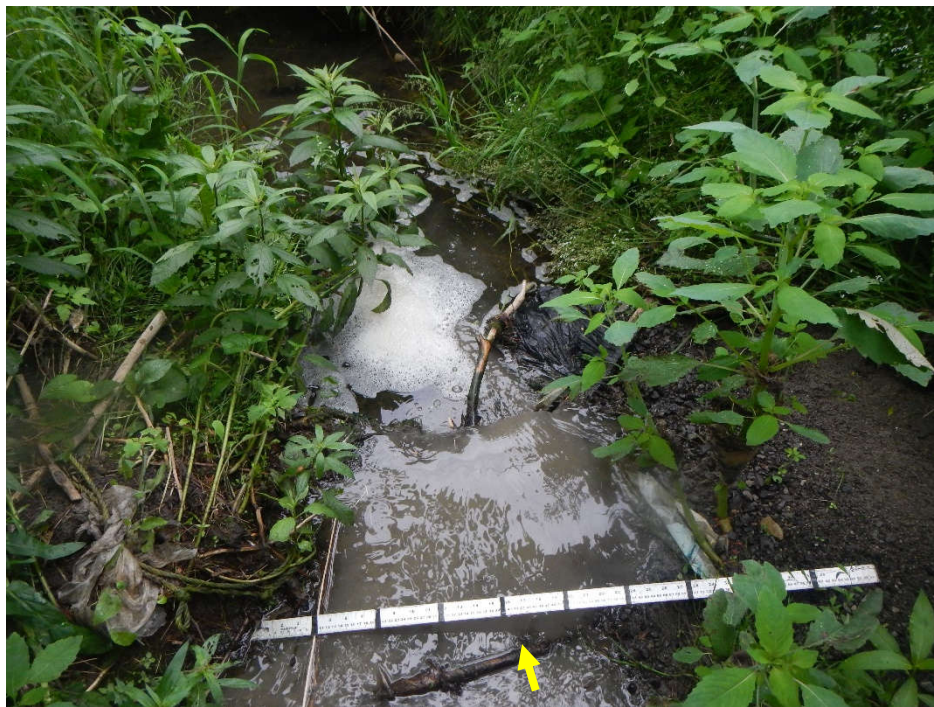
Photo 4
Tributary of Carp River: View Downstream
Reach CR-1

An approximately 0.15 m knickpoint created by roots in the channel bed. There was a pool downstream of this location.

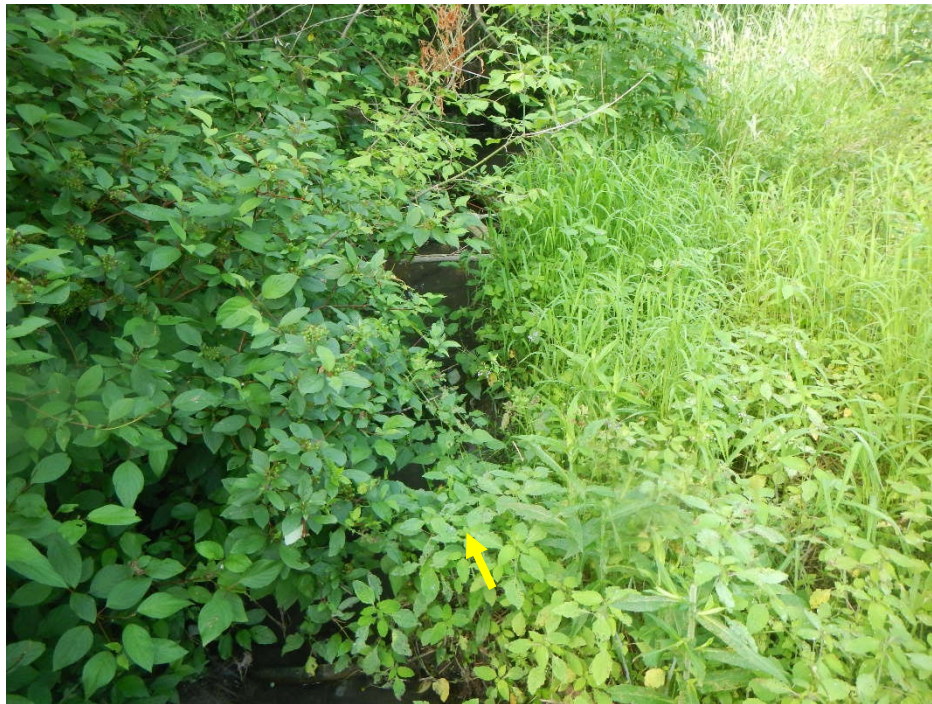
Photo 5
Tributary of Carp River: View Downstream
Reach CR-1

The reach was extensively encroached with vegetation and contained well-developed riffle-pool sequences at the upstream extent.

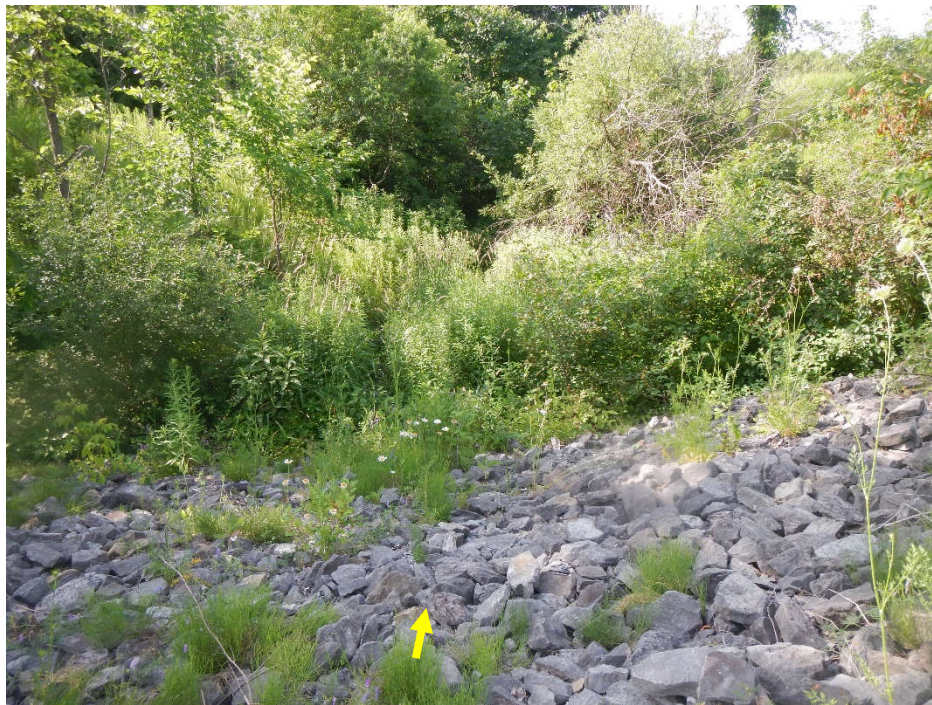
Photo 6
Tributary of Carp River: View Downstream
Reach CR-1

Riprap stabilization on top of a concrete culvert in the upper third of the reach. Note the channel remained extensively encroached with vegetation and flowed through a confined valley. No erosion was observed in vicinity of the crossing.

- Replacement structures should be open bottom or embedded a minimum of 0.3 m
- Where possible, avoid the need for channel armouring or adjustment
- Address potential channel migration
- Maintain flow velocities and sediment transport processes for frequent storm events
- Be located at a straight section of channel
- Cross the channel at a perpendicular angle
- Be located at a reasonably stable length of channel

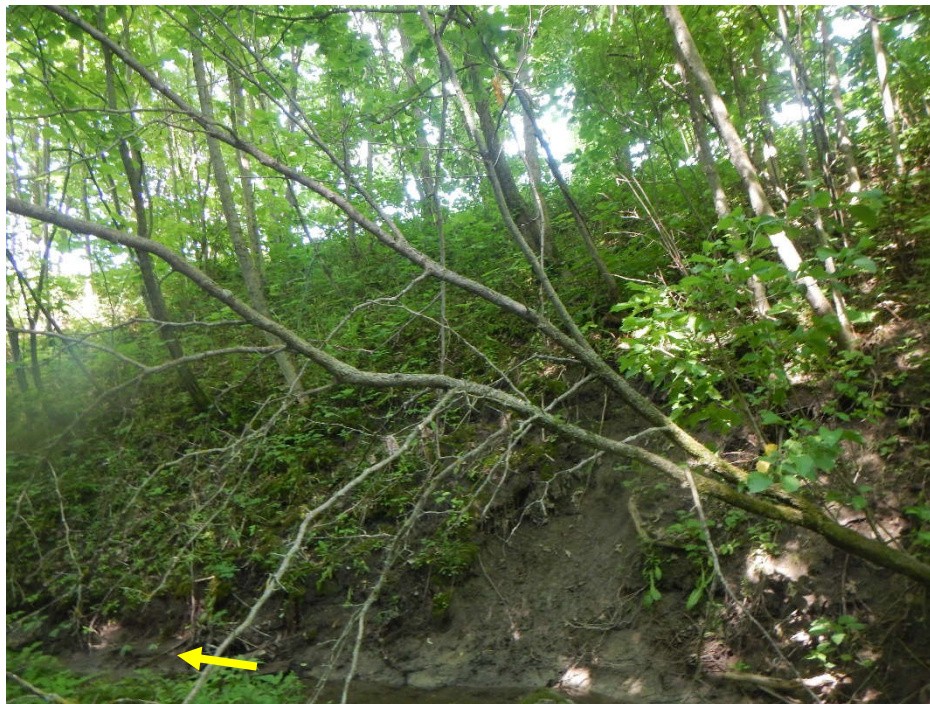
Photo 7
Tributary of Carp River: View Downstream/Left Bank
Reach CR-1

The reach entered a forested area with signs of slumping. Note the valley wall contact in this image.

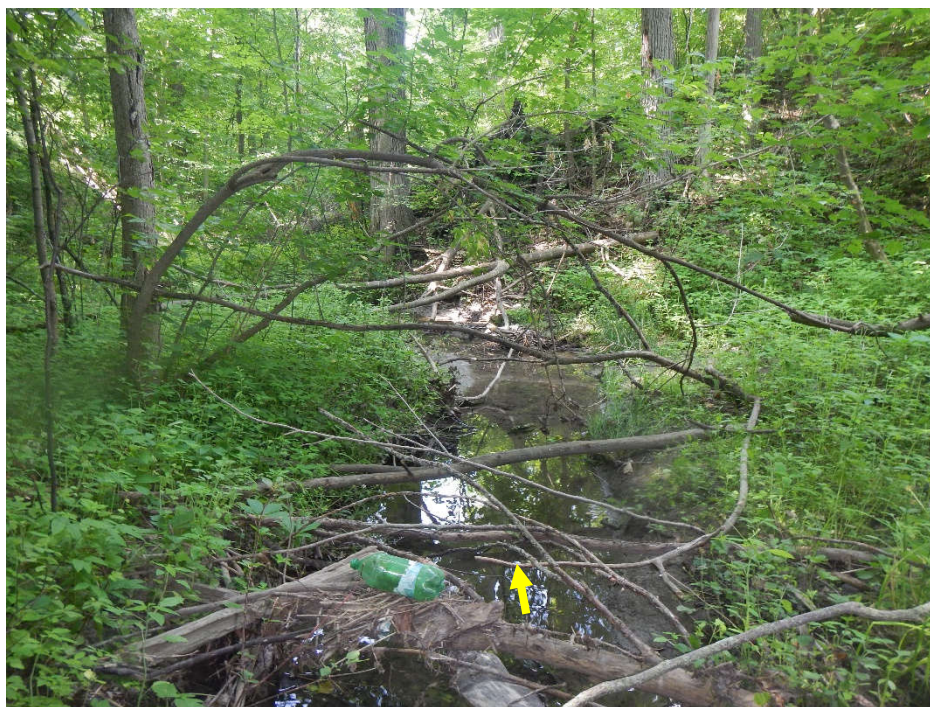
Photo 8
Tributary of Carp River: View Downstream
Reach CR-1

Within the forested section, the channel was less defined with multiple areas of woody debris.

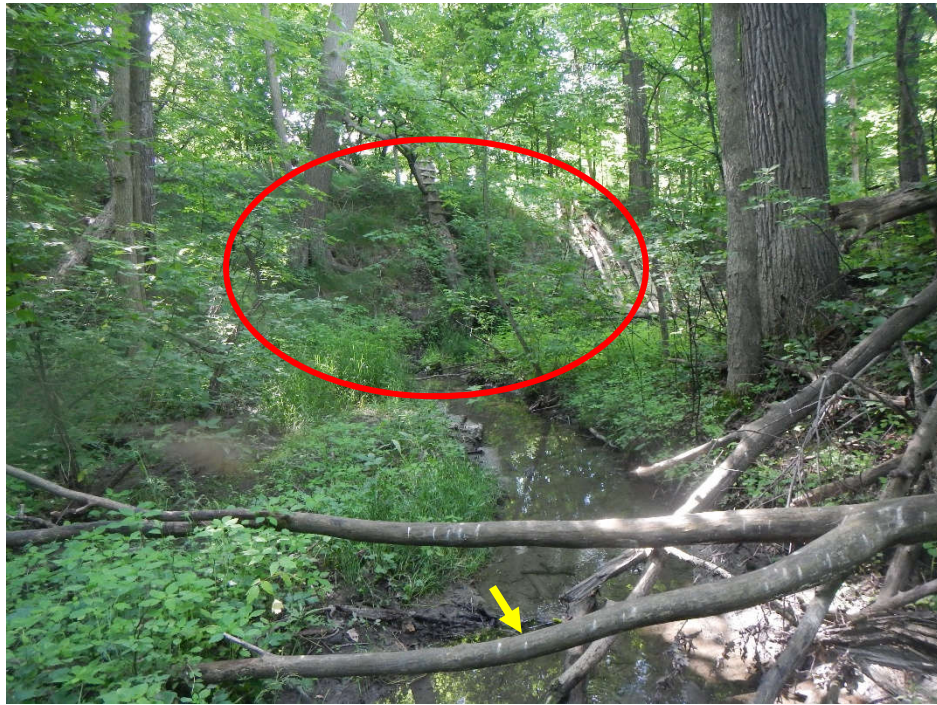
Photo 9
Tributary of Carp River: View Upstream
Reach CR-1

Woody debris within the forested section of the channel. Note the valley wall contact circled in red.

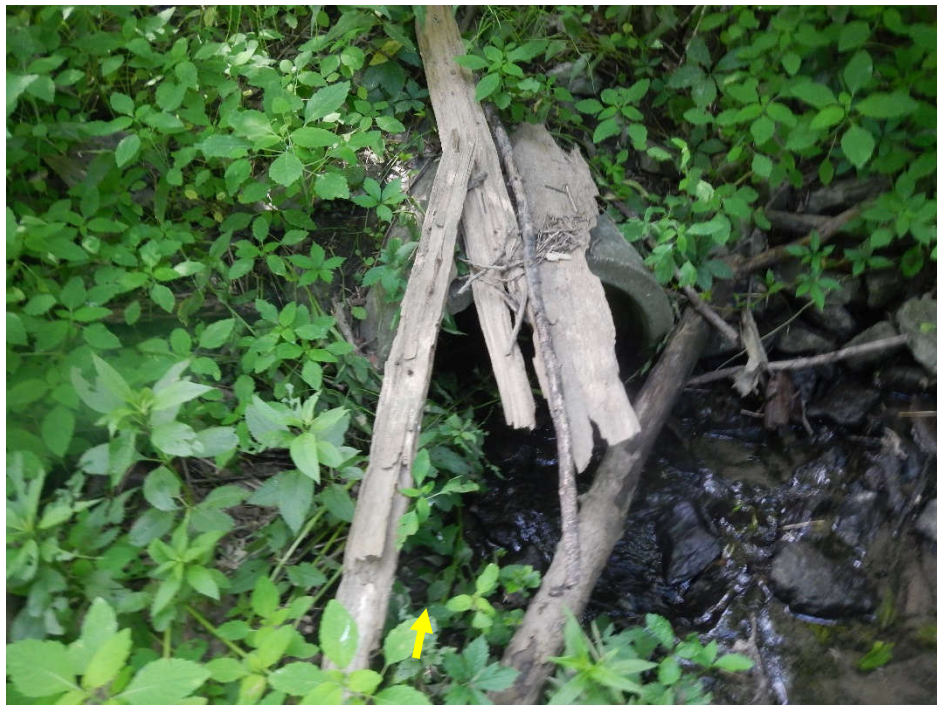
Photo 10
Tributary of Carp River: View Downstream
Reach CR-1

Concrete culvert located in the lower third of the reach. Rip rap stabilization was observed on top of the culvert. No erosion was observed in vicinity of the crossing.

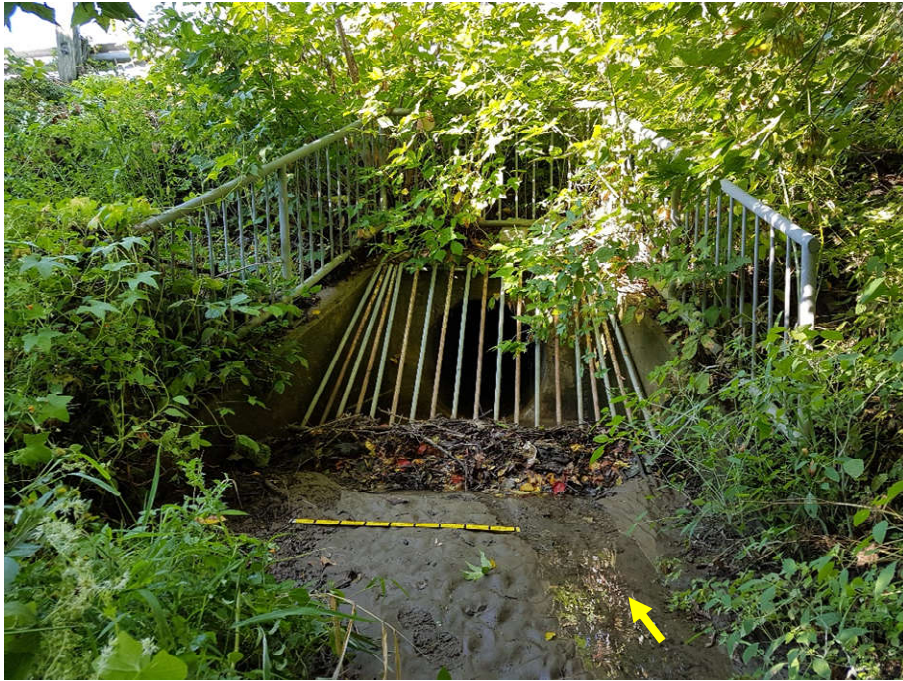
Photo 11
Tributary of Carp River: View Downstream
Reach CR-2

Downstream extent of the reach at Carp Road, where the tributary flowed into a 0.90 m diameter concrete pipe.

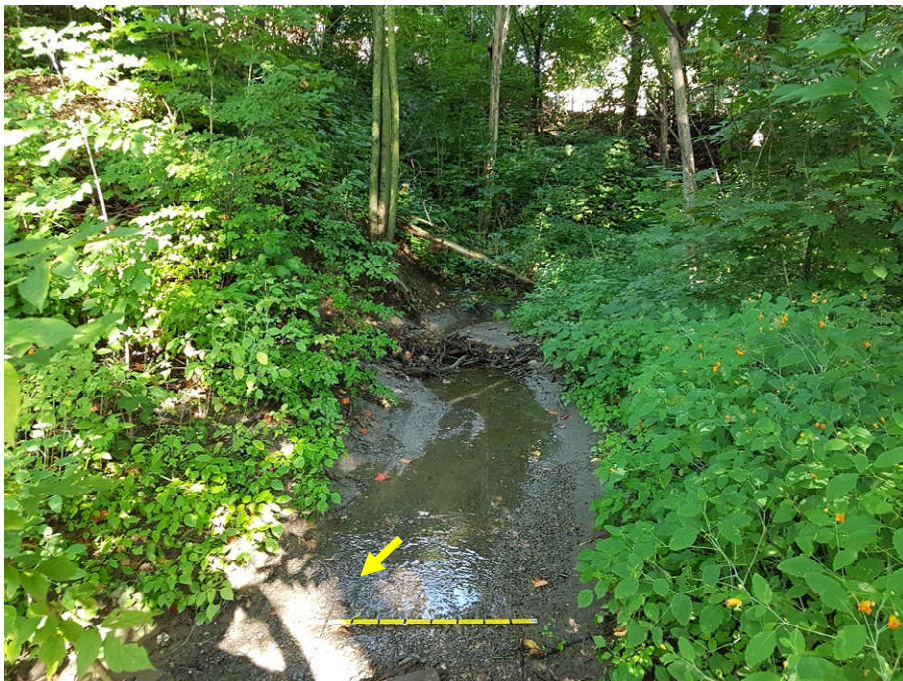
Photo 12
Tributary of Carp River: View Downstream
Reach CR-2

Downstream extent of assessed portion of reach. Channel flowed within a forested and confined valley. Bed material consisted mainly of silt, sand, and gravel.

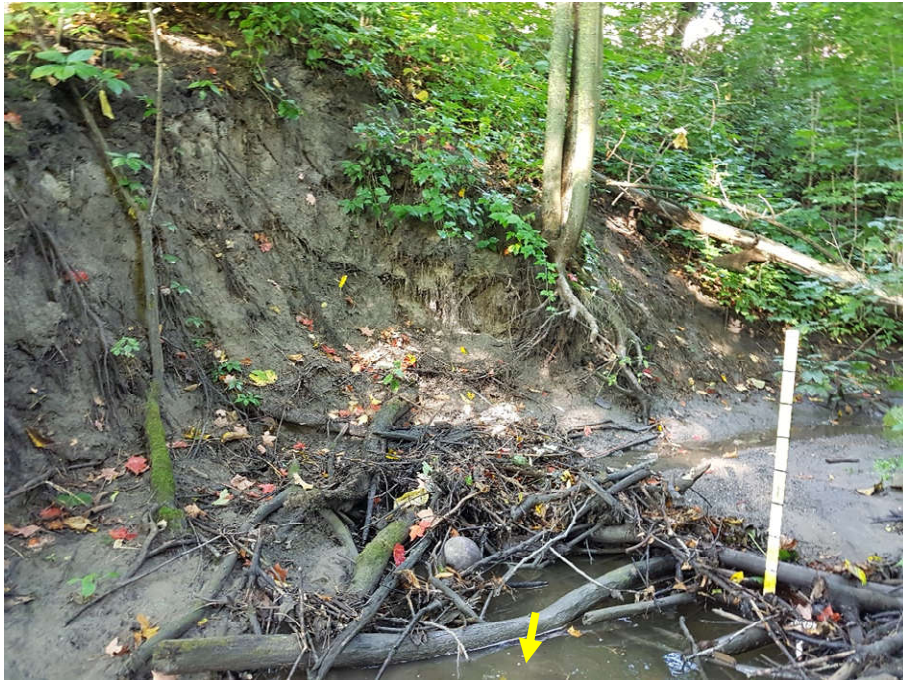
Photo 13
Tributary of Carp River: View Upstream
Reach CR-2

Eroded outside bank with a moderately dense root network.
Several woody debris jams were present throughout the reach.

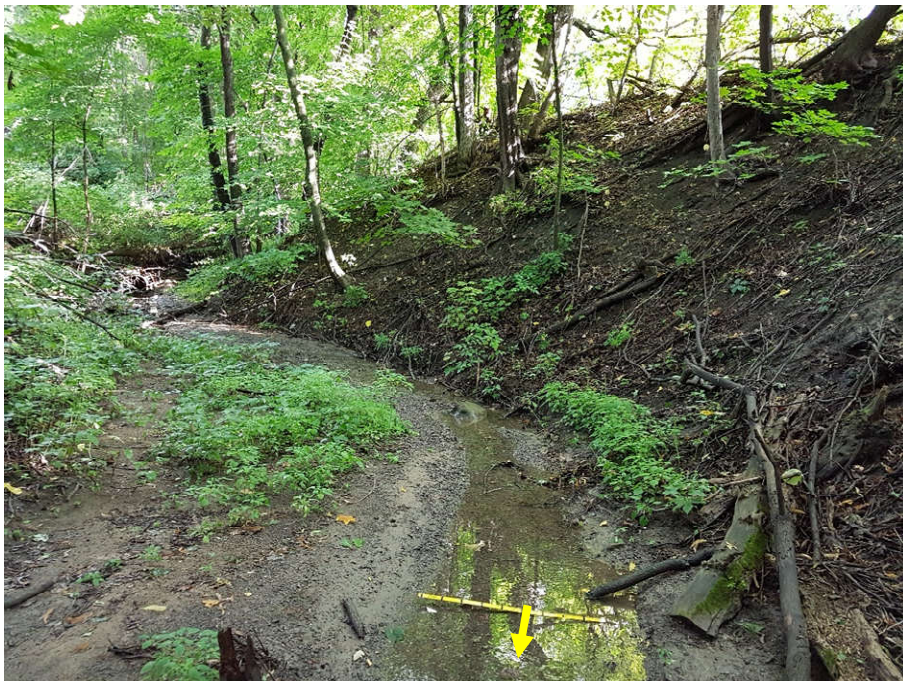
Photo 14
Tributary of Carp River: View Upstream
Reach CR-2

Channel flowed along the toe of slope of the left bank for most of the extent assessed.
Minor bank erosion was present and several fallen trees were observed.

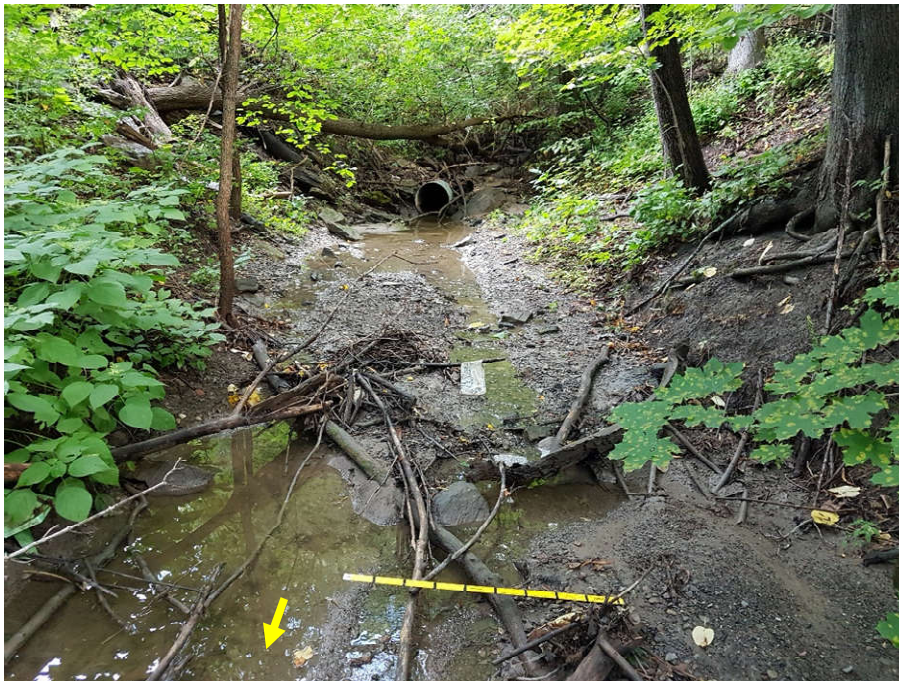
Photo 15
Tributary of Carp River: View Upstream
Reach CR-2

Upstream extent of assessed portion of reach. Flows entered the site through a compromised corrugated steel pipe that appeared to be overtopped during larger flow events.

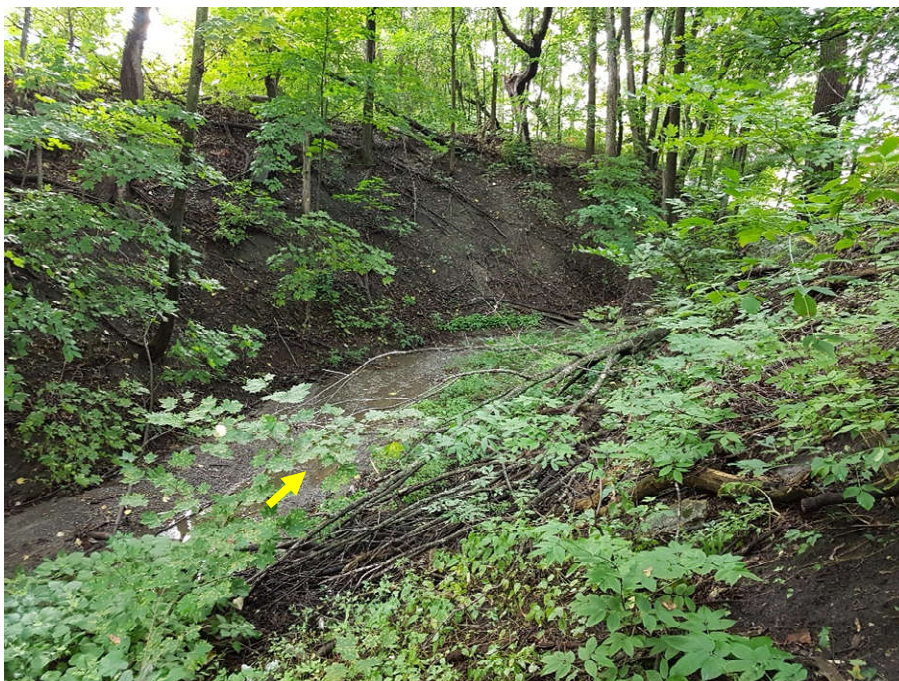
Photo 16
Tributary of Carp River: View Upstream
Reach CR-2

View of left valley wall that had little evidence of active erosion.

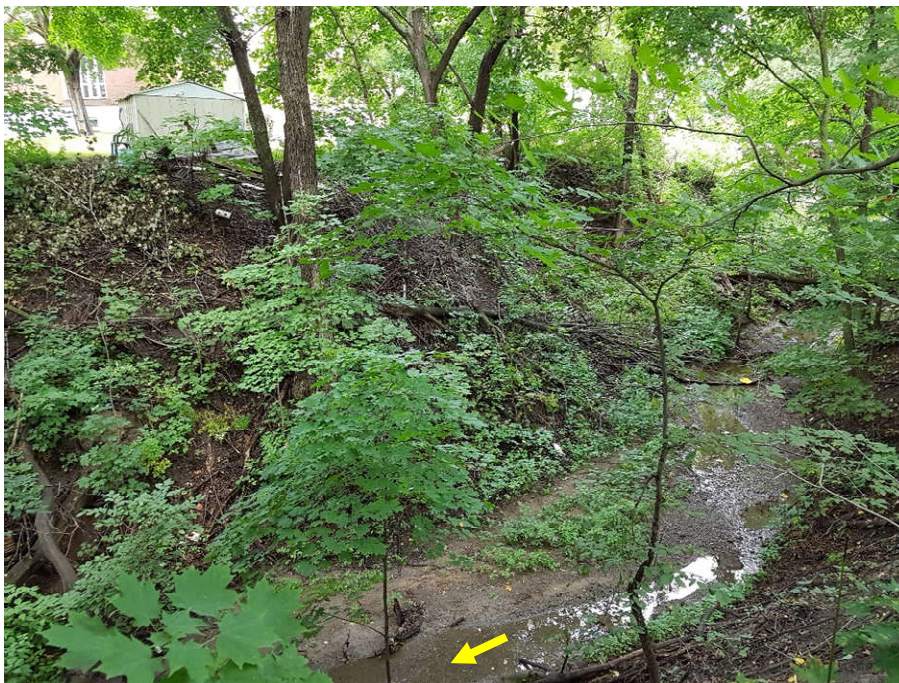
Photo 17
Tributary of Carp River: View Downstream
Reach CR-2

View of right valley wall and channel corridor.
Right valley wall was more densely vegetated.
