#### **FINAL REPORT**

# Phase One Environmental Site Assessment

6409, 6363 and 6295 Perth Street, Ottawa, Ontario

## Golder Associates Ltd.

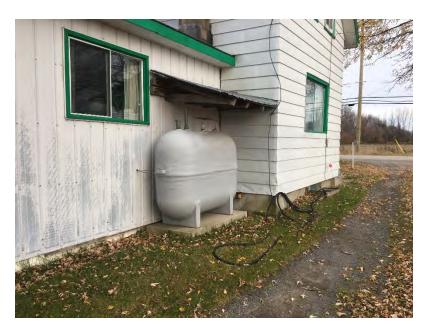
At the time of the Site visit, a fuel oil AST was observed along the exterior portion of the western house wall. The AST was located on a concrete pad and installed in 2015. Based on the review of the 2020 Remediation Report, hydrocarbon impacts were previously identified in the surface soil in the vicinity of this AST; however, all impacted soil was remediated in June 2020.

Photo 2 - View of the heating oil AST located along the exterior of the western wall of the house on the 6409 Perth Street portion of the Site.

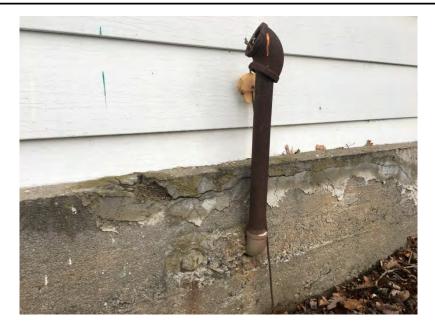
Additionally, a pipe and a filled in hole for a former pipe was observed along the exterior of the basement foundation of the house on the north side of the house. These were likely the former fill and vent pipes for a heating oil AST formerly located in the basement as no heating oil AST was present at the time of the May 22 2020 Site visit. However, an old empty discarded heating oil AST was observed at the rear/north side of the barn. This was likely a former AST from the basement of the house. No evidence of spills or leaks (i.e., odours, staining on walls or staining in soil of dirt floor) was observed in the basement at time of the May 22 Site visit.

Photo 3 – Piping assumed to be from old fuel oil AST in the basement. Observed along the north wall of the house.

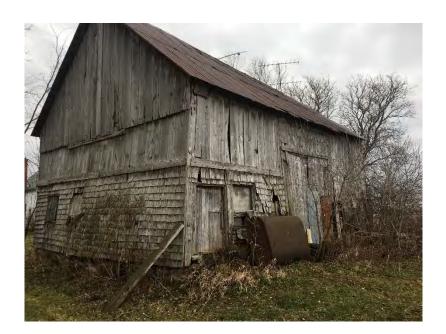
Photo 4 – Looking southwest at the barn and discarded heating oil AST behind/north of the house.

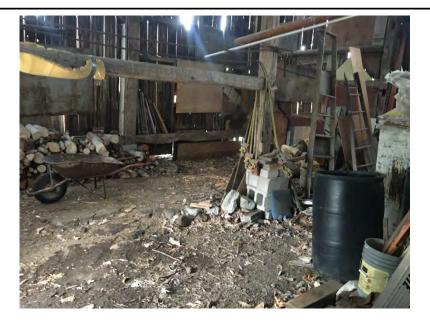
Photo 5 – Photo of the empty drums, wood and storage in the barn.

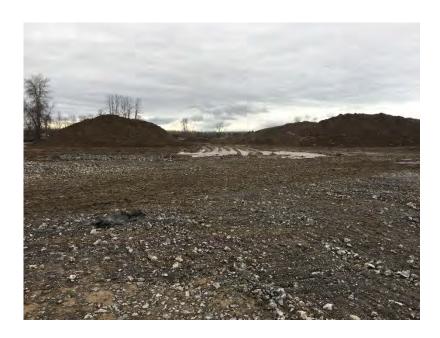
During the Site visit, a few piles of fill were observed on the 6363 Perth Street portion of the Site, just north of the Home Hardware property. The Site Representative indicated that the fill was topsoil that had been scraped from the property itself and the adjacent property to the east, likely related to the future residential development of this property. Given that the topsoil was sourced from the property itself and the adjacent property, both of which have never been developed and have only ever been vacant or agricultural fields where no issues of concern were identified, and that no evidence of contamination (staining, odours, debris) was observed in the fill, the presence of this fill is not considered to be a PCA. Furthermore, the 2020 Remediation Report indicated that fill material was present in the excavation; however, given that it was reworked native material and not imported material, is it not considered to be a PCA. However, the former presence of a heating oil AST located on the west side of the house and the former presence of a heating oil AST is the basement of the house are considered to be on-Site PCAs.

Photo 6 – Looking northwest at the fill piles on the 6363 Perth Street portion of the Site.

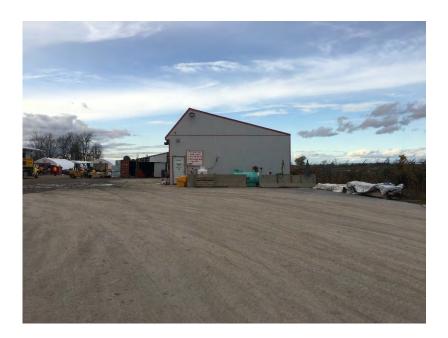
Phase One Study Area	28. Gasoline and Associated Products Storage in Fixed Tanks – Current presence of two fuel ASTs located approximately 10 m west of the 6363 Perth Street portion of the Site on the Home Hardware property at 6379 Perth Street.	Site observations	Given that these tanks were ASTs, any spills or leaks would have been likely been noticed and cleaned up quickly as opposed to USTs which can have unnoticed spills for long periods of time. Given that there have been no documented spills from these tanks, the potential for extensive subsurface impacts from the tanks is low. Additionally, given that the subsurface conditions at the Site and adjacent lands consist of low permeability clay, the potential for contaminant migration from the tanks to the Site, if any, is reduced. Therefore, this PCA is not considered to represent an APEC on the Site.

Photo 8 – Two Diesel ASTs located on the easternmost portion of the Home Depot property at 6369 Perth Street, adjacent to the 6409 and 6363 Perth Street portions of the Site.
