Kizell Drain Downstream of 7000 Campeau Drive Geomorphological and Erosion Threshold Assessment

**Kizell Drain
Kanata, Ontario**

July 7, 2020
PN20053

Report Prepared by: GEO Morphix Ltd.
PO Box 205, 36 Main St. N.
Campbellville, ON L0P 1B0

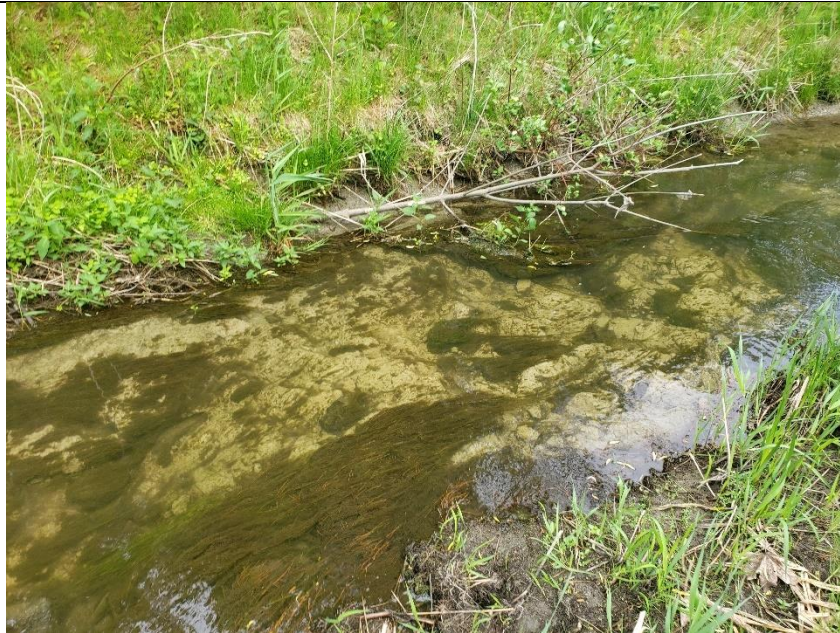
Photo 2

Downstream of the armoured section near the pedestrian bridge, exposed compact clay was observed. This material was consistently observed as the underlying material throughout Kizell Drain.

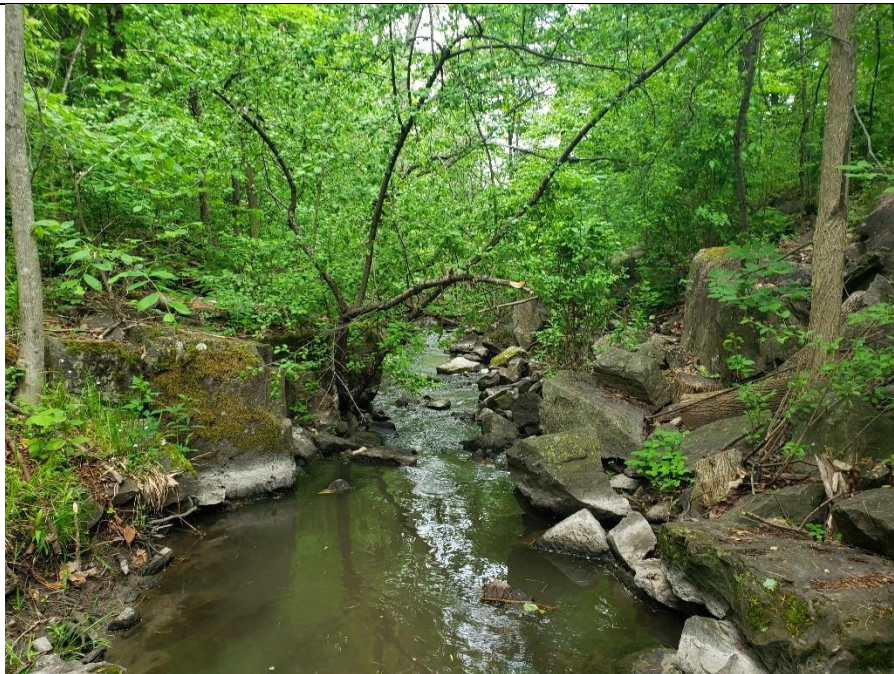
Photo 4

Upstream extent of an approximately 90 m bedrock outcropping which appeared to be composed of native bedrock and deposited boulders

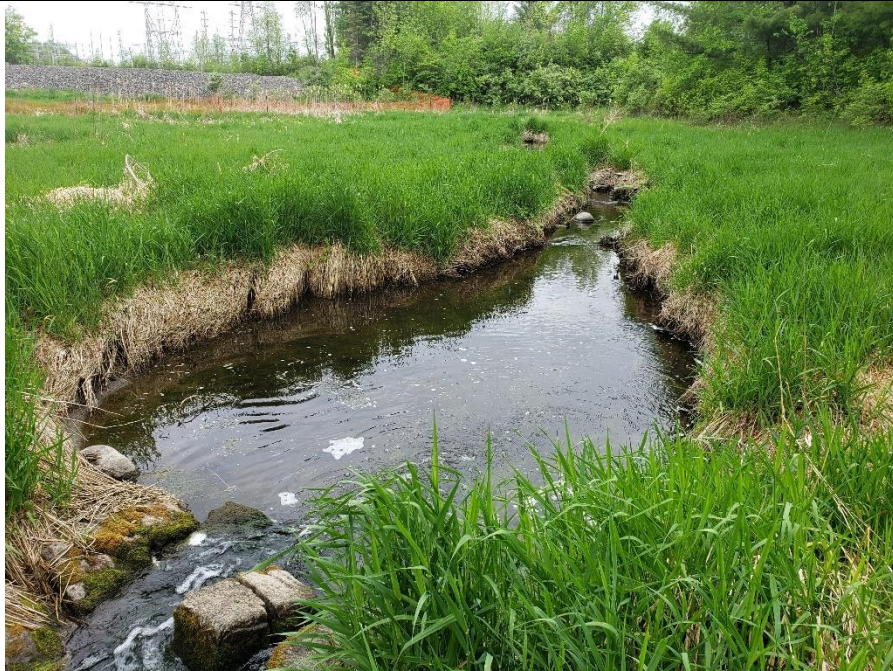
Photo 5

The downstream extent of the bedrock outcrop is a shallow waterfall or knickpoint, and a wide and relatively shallow scour pool. Downstream of the scour pool, the channel conveys flows through a grassy meadow.

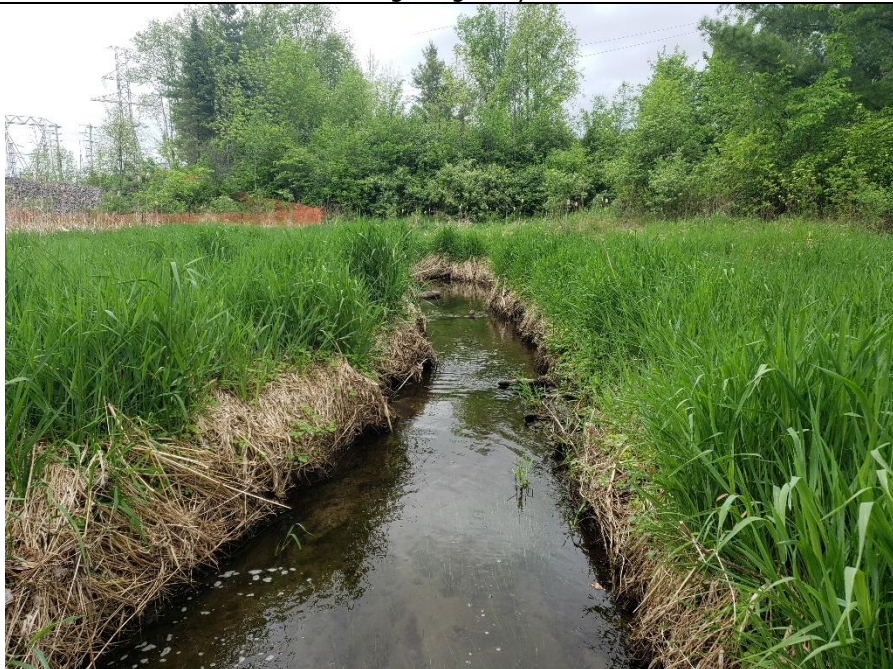
Photo 6

In this section of KDR-4 where the riparian area has been subjected to less disturbance than adjacent reaches of the Kizell Drain, the banks are generally steep and composed of a loamy clay.

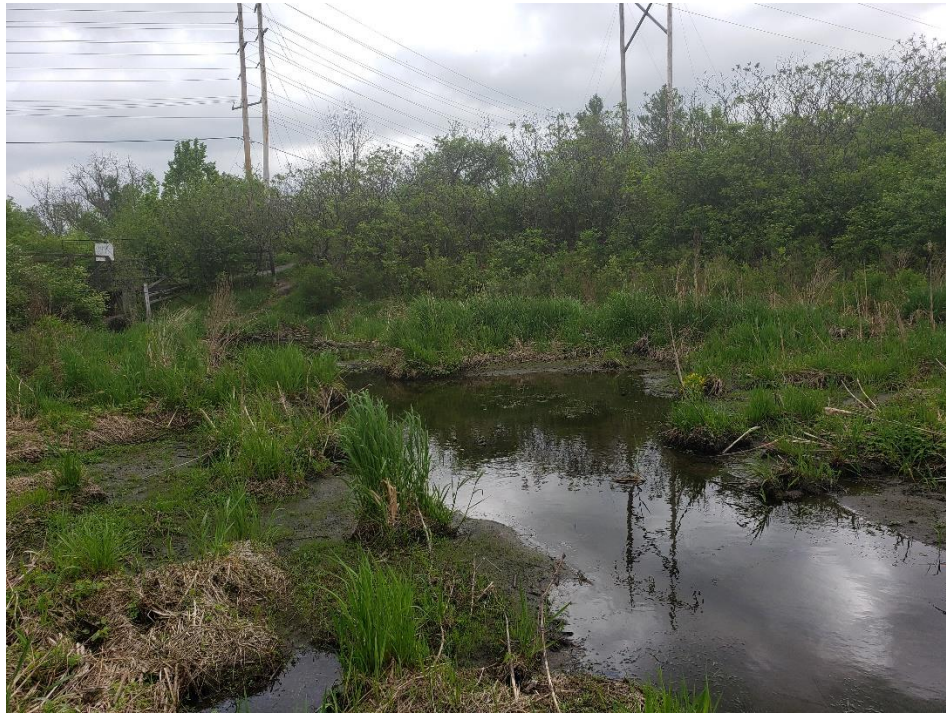
Photo 7

At the downstream extent of the natural riparian area, the channel is backwatered by exposed bedrock creating a depositional area with a soft, unconsolidated sandy silt overlying cohesive clay on the channel bed.

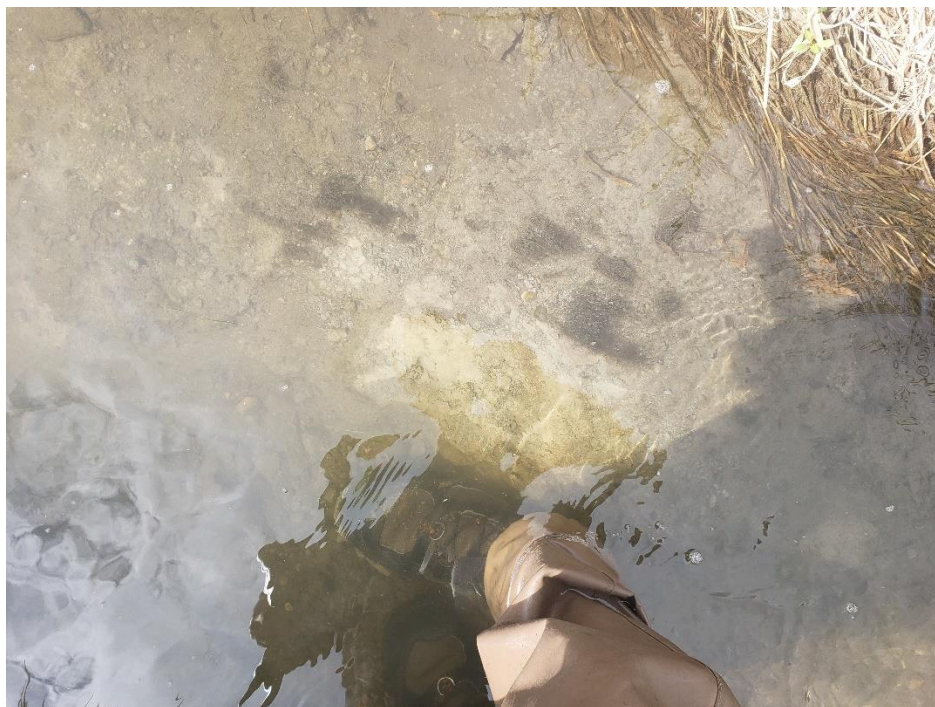
Photo 8

Exposed compact grey clay was frequently observed along the bed of the channel.

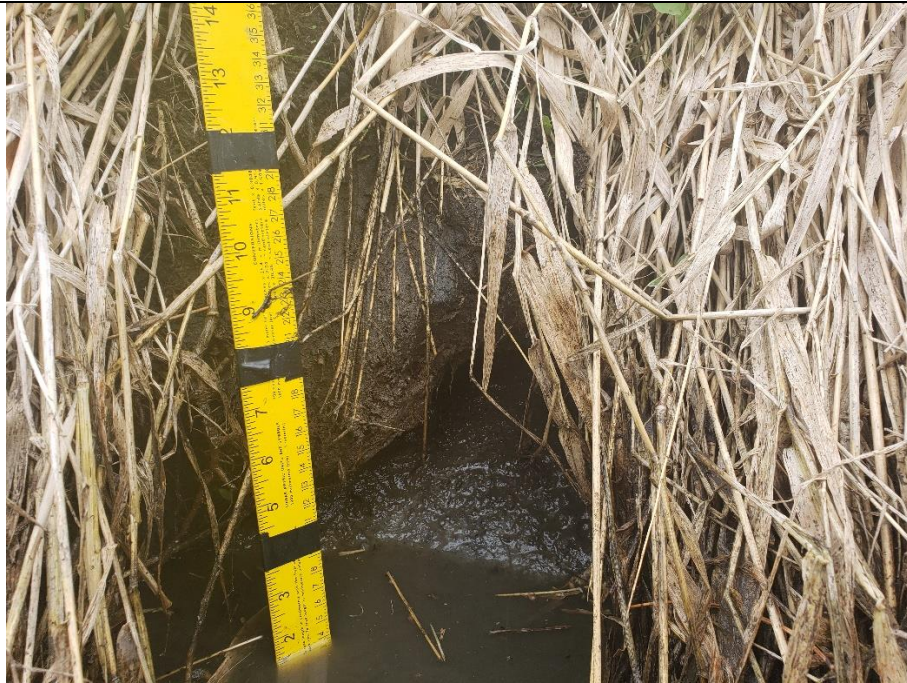
Photo 9

Below the dense grass rooting structure, both banks through the natural riparian area of KDR-4 are composed of a loamy clay.

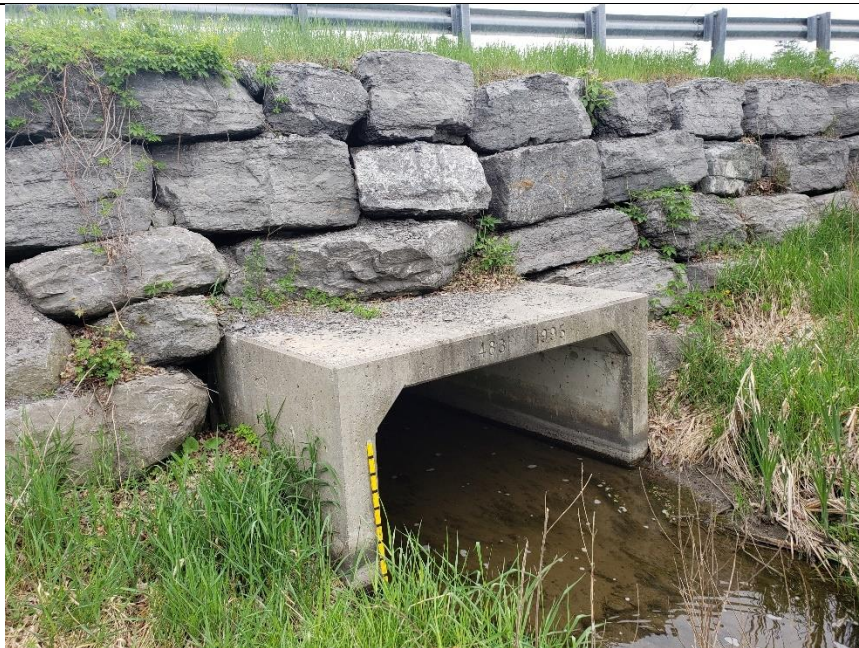
Photo 10

Culvert marking the upstream extent of AECOM detailed reach, KDR-3. This reach was also partially backwatered in May, 2020 at the time of the rapid assessment when these photographs were taken.

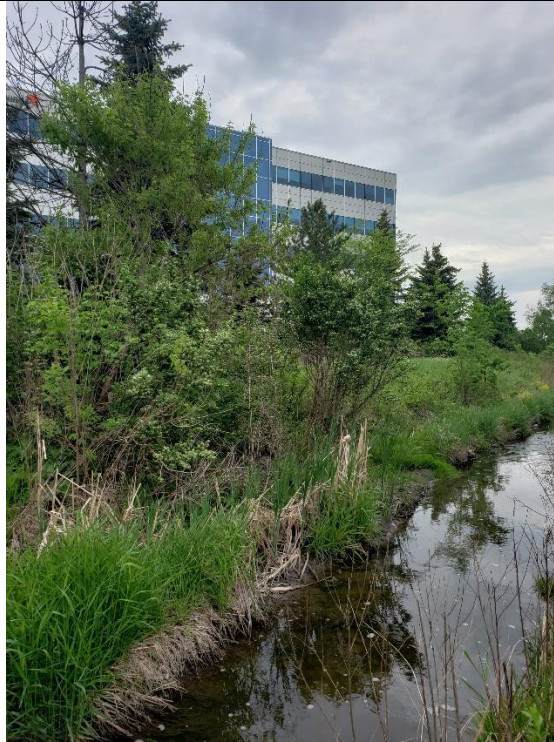
Photo 11

View looking downstream at left bank riparian habitat. The channel is confined by parking lots for large office buildings on either side. The parking lots appear to drain towards the channel.

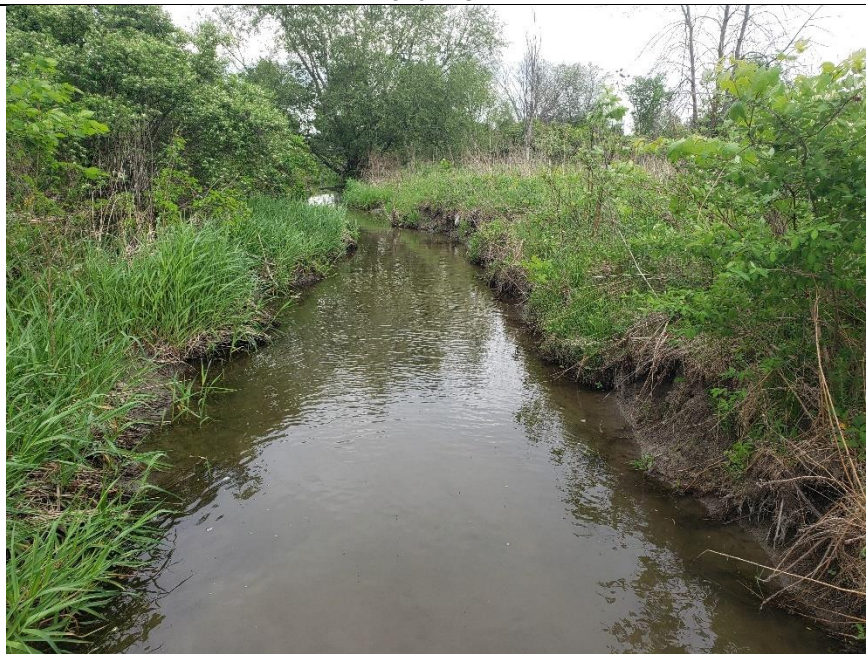
Photo 12

Similar to KDR-4, the banks were steep with undercutting below the rooting system.

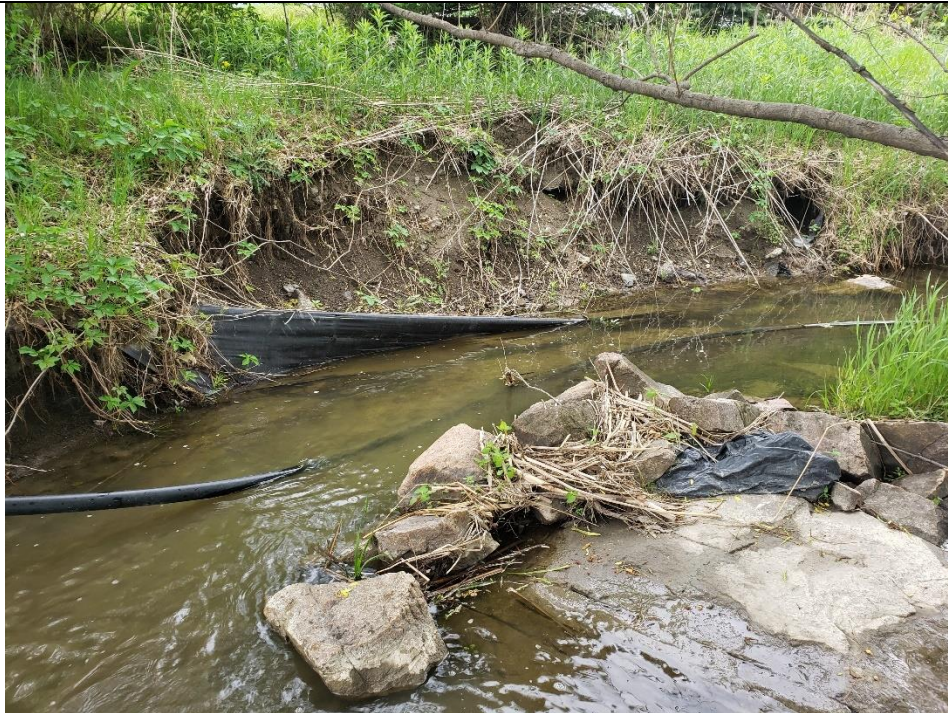
Photo 13

Exposed filter cloth and bank erosion adjacent to exposed bedrock along the right bank. At this location, it is assumed that the presence of bedrock increases channel energy to the left bank.

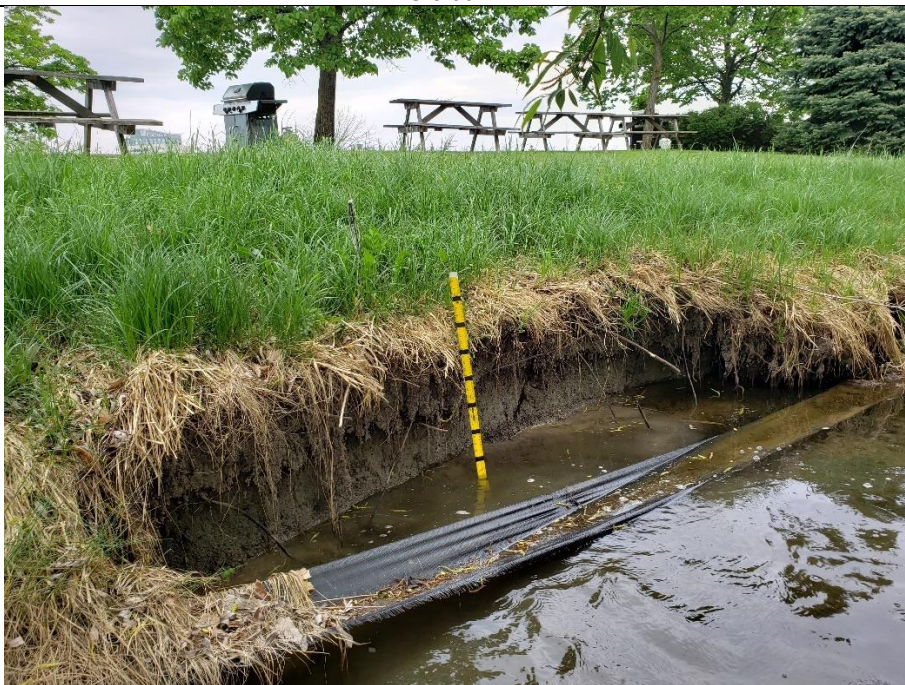
Photo 14

In this instance of bank erosion, the riparian vegetation has been cut and maintained. The lack of riparian vegetation and rooting structure is assumed to have resulted in the increased erosion.

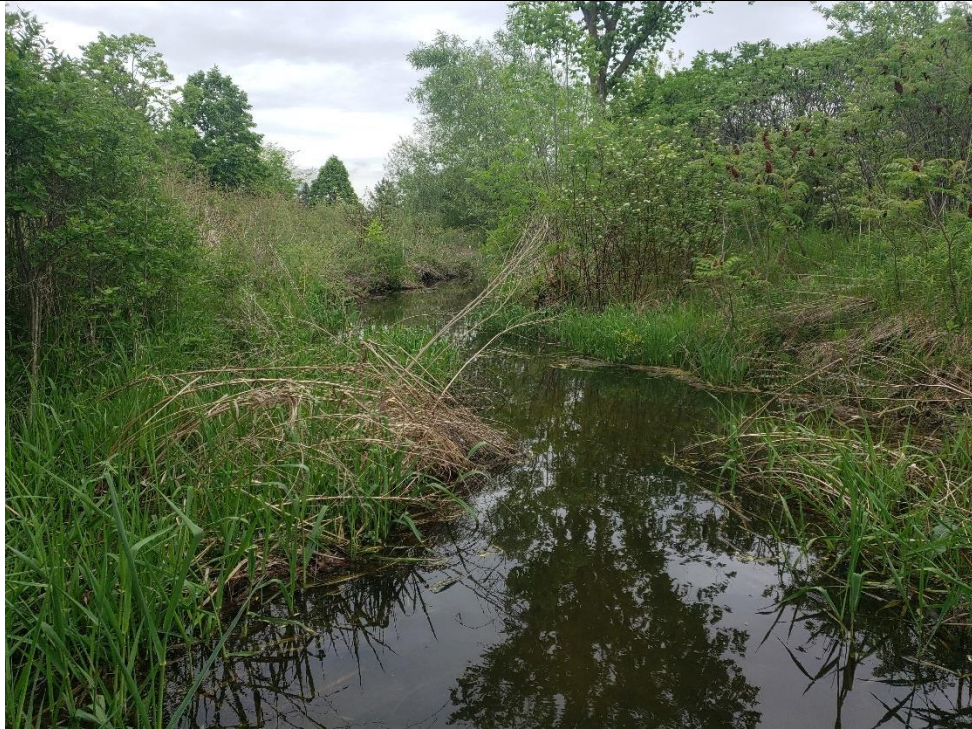
Photo 15

Downstream of channel disturbances, the channel is significantly backwatered by a beaver dam, limiting the ability to make observations of erosion. The channel was mostly depositional in this backwatered area.

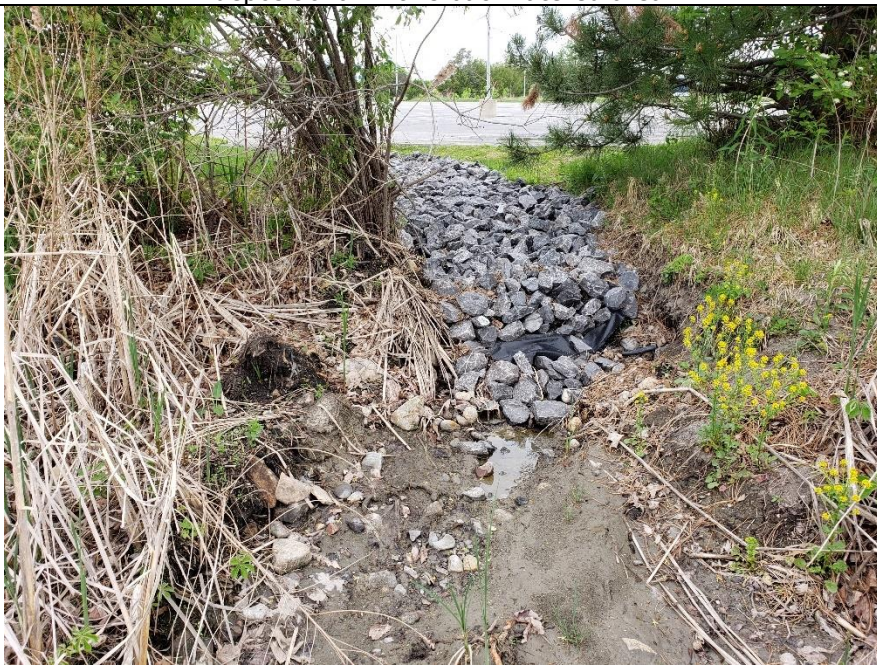
Photo 16

Example of direct parking lot drainage into the riparian zone/channel.

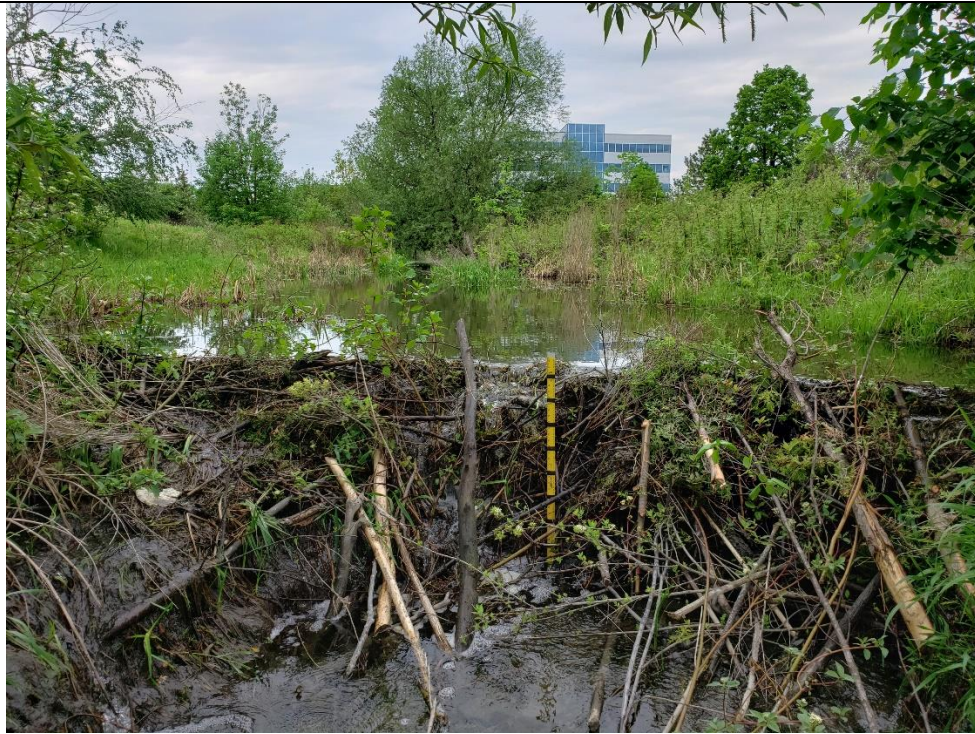
Photo 17

Beaver dam located near the downstream extent of KDR-3.

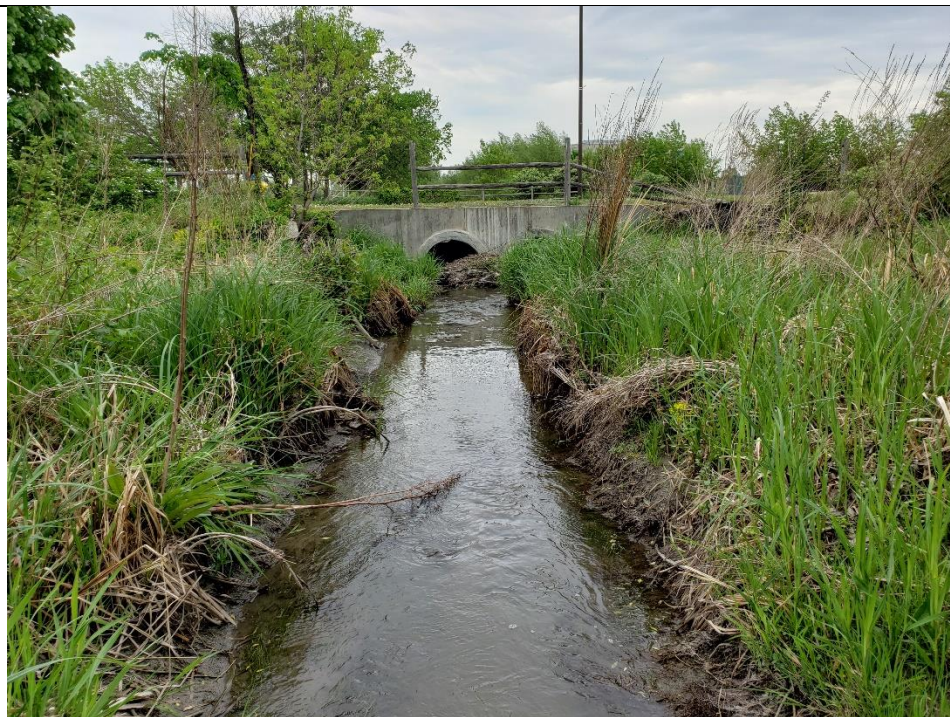
Photo 18

View downstream of beaver dam where the exposed silt and clay toe of bank can be observed

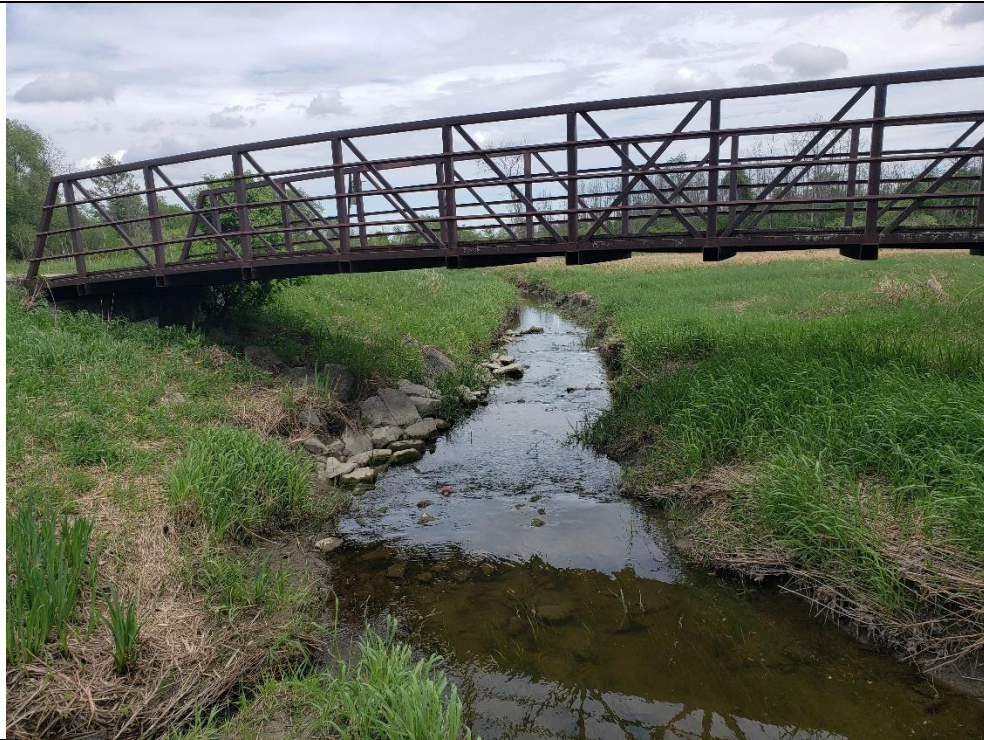
Photo 21

Pedestrian bridge marking the upstream extent of KDR-1. Here, there is an approximately 15 m long riffle

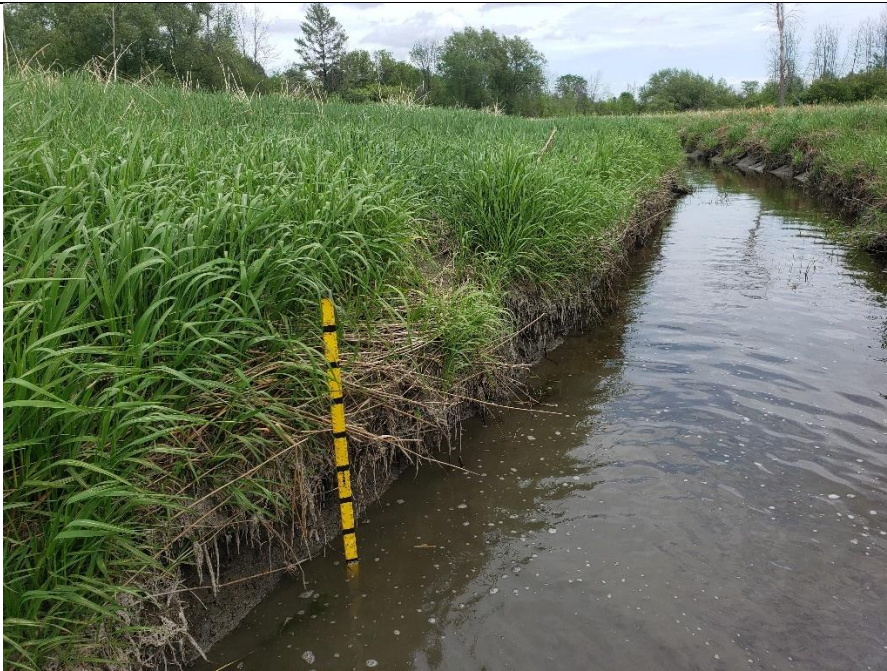
Photo 22

KDR-1 is relatively straight and represents a section of the furthest downstream reach of the Kizell Drain before its confluence with Watts Creek. The channel in this location is incised into the compact clay at its bed with undercutting observed along the banks.

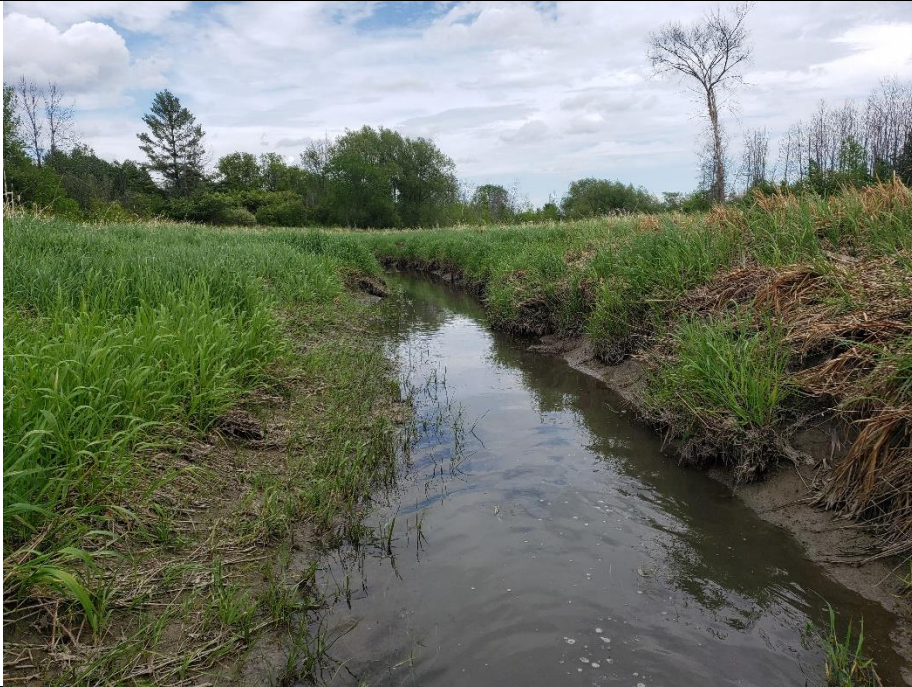
Photo 23

Through KDR-1, there is evidence of lateral migration. In this photograph (looking downstream), deposition of sandy silts were observed along the left bank and slumping was observed along the right bank.

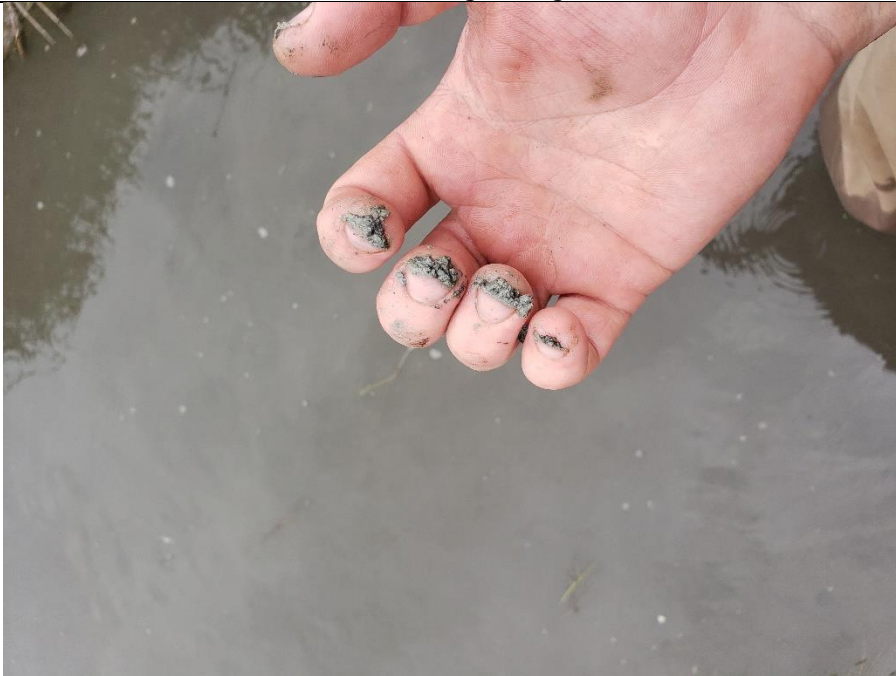
Photo 24

Through the majority of the reach, the bed was composed of highly compact grey clay which could only be disturbed by scratching at the bed.
