Landslide Hazard and Risk Assessment

Final Report

December 13, 2021
File: 121624058

DCR/Phoenix Group of Companies
Ottawa, ON

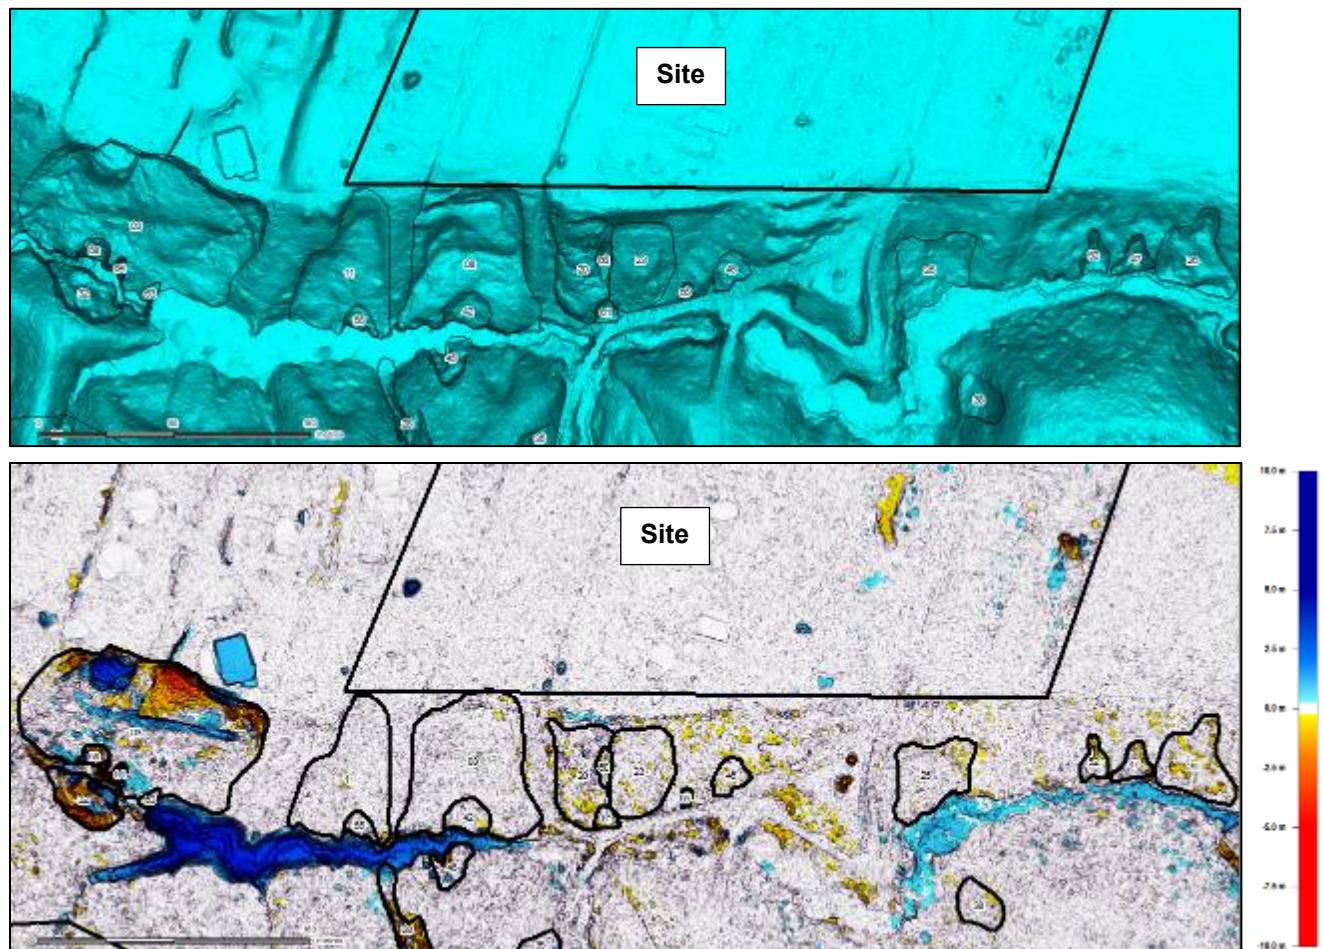
Figure 3-5 Recorded ground movements along the south-facing slope

Notes: LiDAR suggest some ground movements within a landslide some 100 m southwest of the site. Three recent failures are present in that same area. The “blue” color along the stream channel, upstream of from the recent landslides corresponds to standing water that has accumulated due to the presence of a beaver dam. Note that some of the negative changes are assumed related to changes in vegetation density (e.g., the “yellow” areas along the south-facing slope), and therefore not representative of actual ground movements.

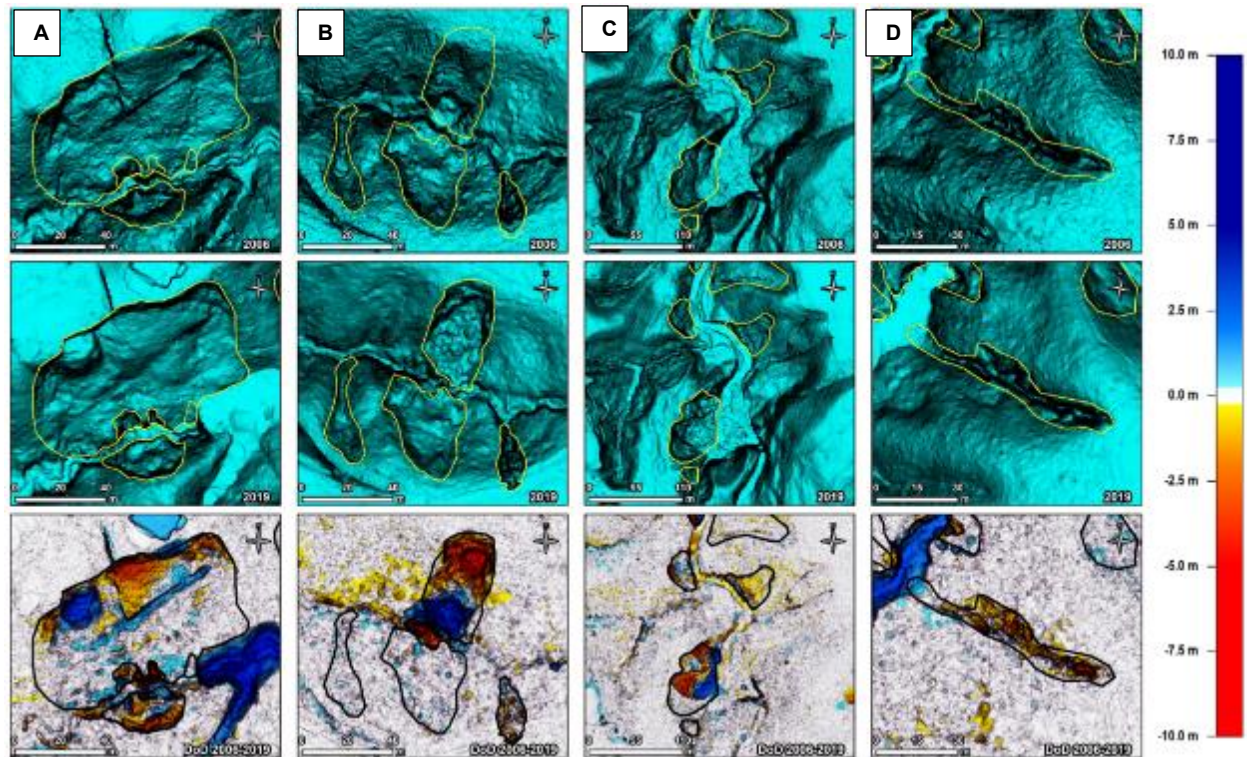
- A Group of landslides showing recent movement (same as displayed in Figure 3.5)
- B Reactivation of a landslide along a tributary gully 200m south of the Site
- C Example of landslides showing recent movement (Cardinal Creek area)
- D Small but active gully that has develop in the clay deposits along a slope across from the site.

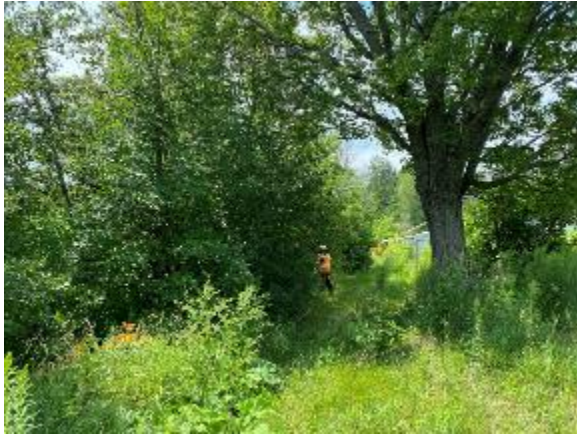
Photo 1: View of upper limit of the south-facing slope at the edge of the plateau (looking west, the slope is on the left).

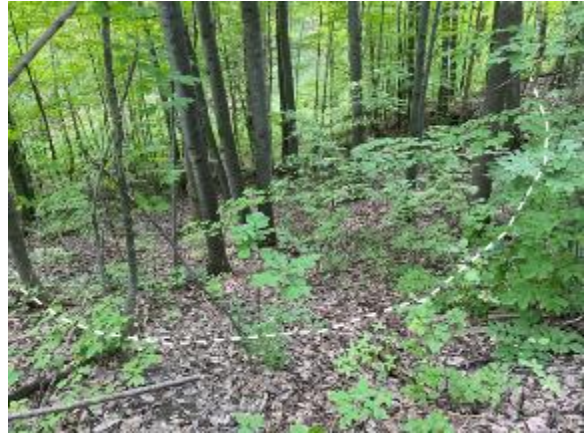
Photo 2: Downslope view of landslide ID 11. Approximate landslide limit in white.

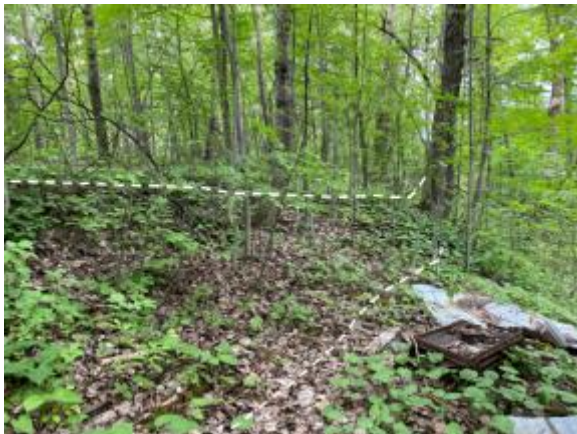
Photo 3: Poorly defined headscarp at landslide ID 11.

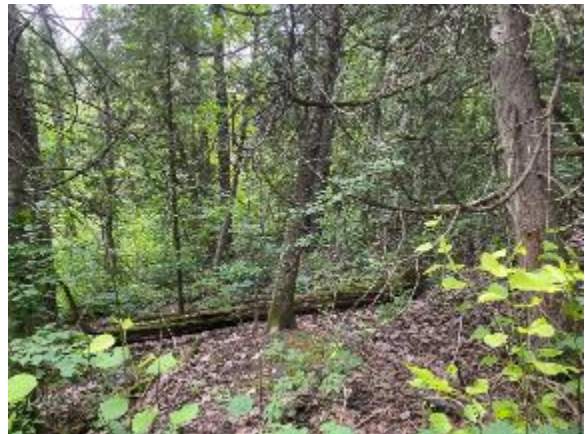
Photo 4: Undulating to hummocky terrain along the base of landslide ID 55. Movement from right to left.

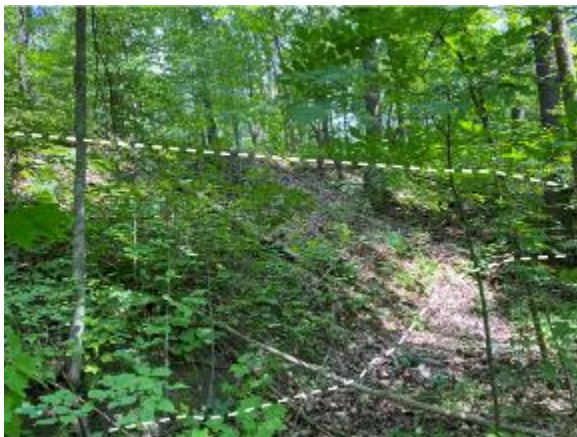
Photo 5: Lateral view of stable headscarp at landslide ID 08. The feature matches the crest of the south-facing slope along the southwest limit of the Site.

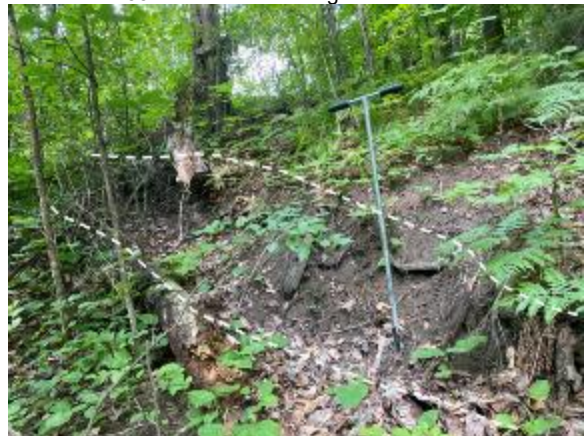
Photo 6: View of a section of the headscarp observed at landslide ID 03, in the area showing movement on the LiDAR change detection.

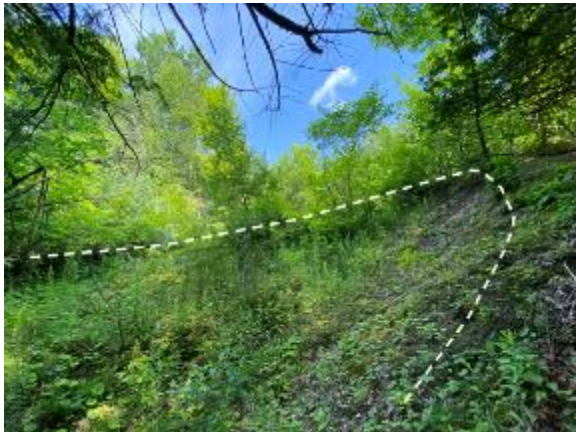
Photo 7: View of the headscarp (white) at landslide ID 14. The landslide is less than 15 years and showing signs of recent movement.

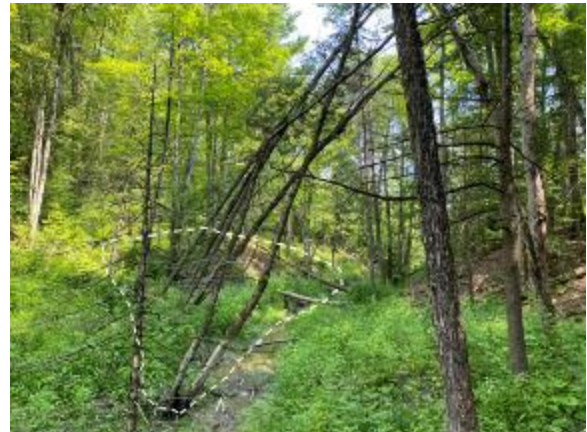
Photo 8: Small landslide (ID 42) along the unnamed creek at the based of the south-facing slope (looking upstream).

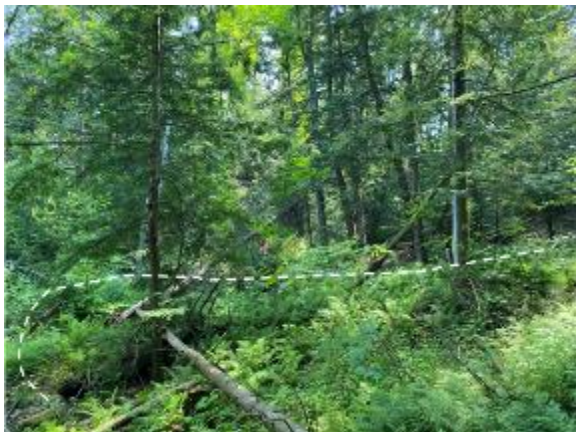
Photo 9: Base of landslide ID 14 showing back-tilted trees (movement from right to left, approximate landslide limit in white).

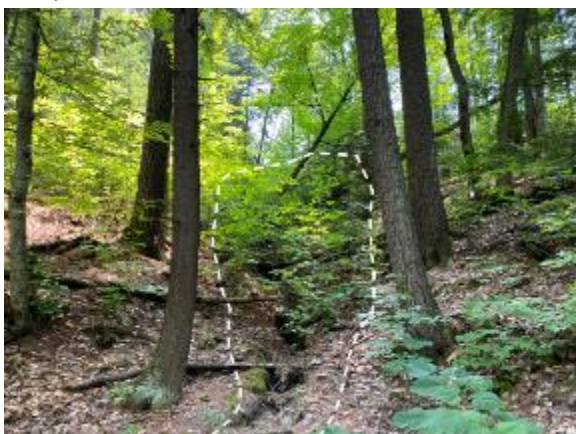
Photo 11: Base of active gully along north-facing slope across from the site (ID 28).

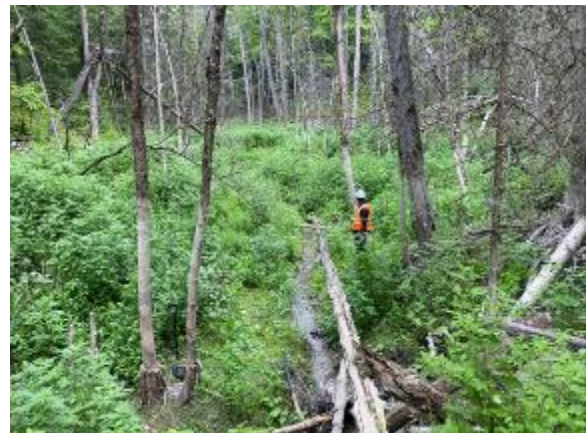
Photo 12: Upstream view of previously flooded area at the base of gully system (south-facing slope on the left side). Note: Maximum water level visible from tree bark.
