## Geotechnical Investigation

Proposed Residential Development  
Cardinal Creek Village South  
Old Montreal Road  
Ottawa, Ontario

November 29, 2021

Report: PG5201-1  
Revision 5

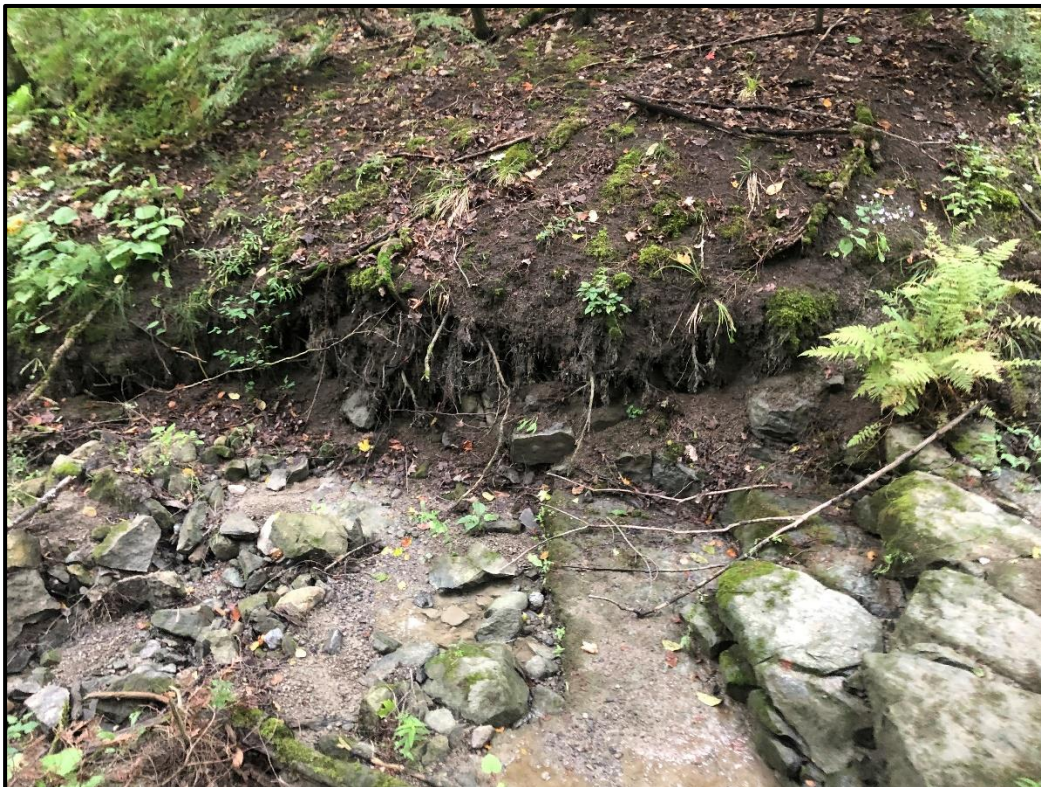
Photo 22: Photo taken on September 10, 2020 along the watercourse along Mid-Branch 1 looking north.
