Landslide Risk Assessment
Proposed Residential Development
Old Montreal Road
Ottawa, Ontario

Taggart Investments

March 2, 2022

Report: PG5201-1

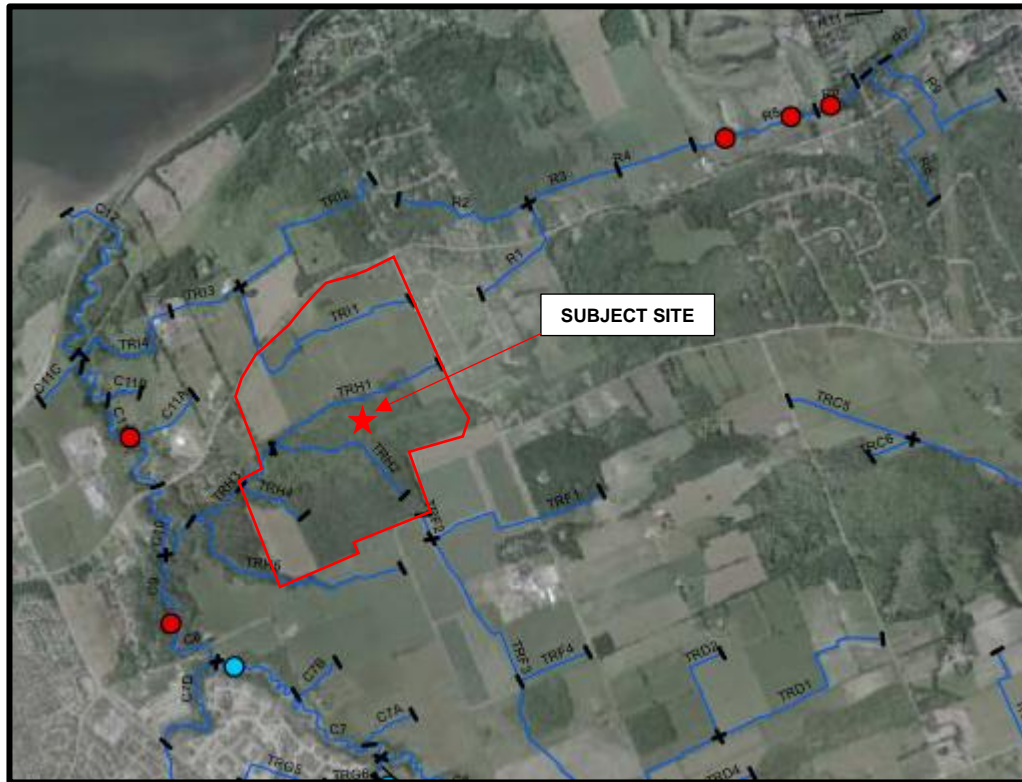
Figure 1 - Cardinal Creek Subwatershed (Geomorphic Solutions, 2007)

Tributaries TRH1, TRH2, TRH3, TRH4 and TRH5 are located throughout the subject site and are considered the areas of interest with regards to landslide susceptibility. TRH1, TRH2 and TRH4 would be considered the “south tributary”, “mid-branch 1” and “mid-branch 2” portions of the tributary discussed throughout this report, respectively. The study provided the following information with respect to the stream order and sinuosity for these reaches of the tributaries:

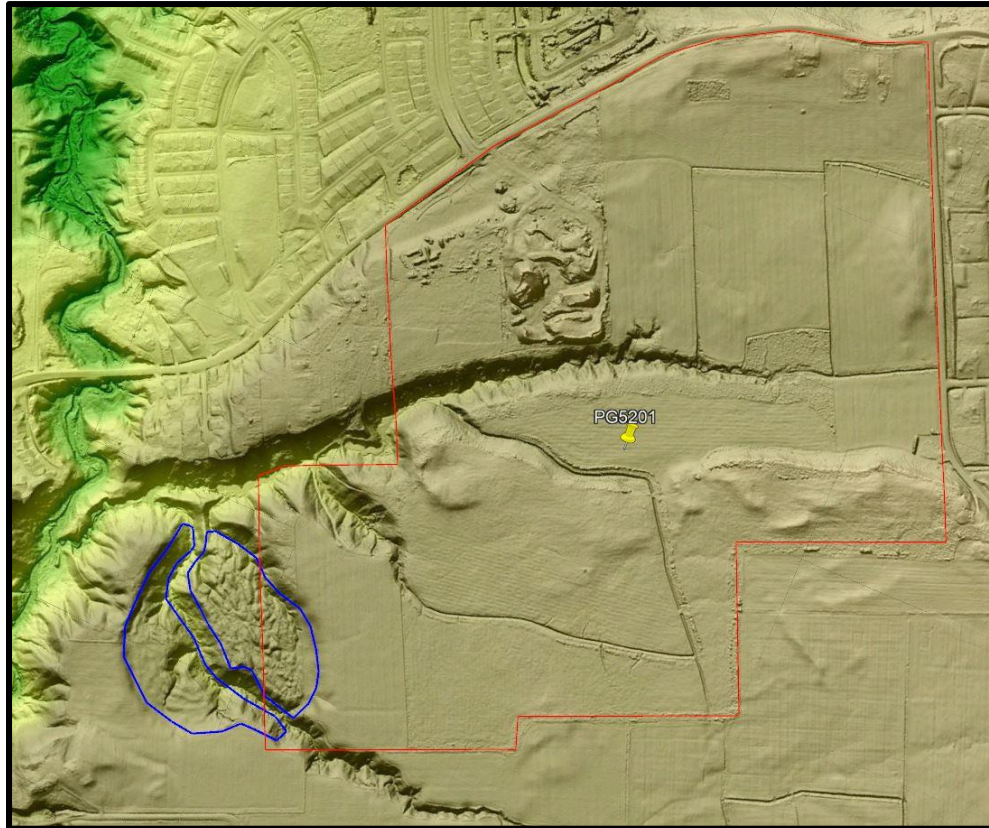
Figure 2 - LiDAR Image of Subject Site and Landslides. From Left to right: Oln17 (blue), Oln18 (blue), Subject Site (red)

It is understood up to potentially five landslides have been documented within 2 km of the subject site. Two of these landslides, Oln17 and Oln18, intersect the southwestern boundary of the subject site. Both Oln17 and Oln18 have been reported by GSC to have retrogressed into their respective sides of the incised valley of a tributary of Cardinal Creek (GSC OF8600, 2019), and are depicted on Figure 2 for reference.

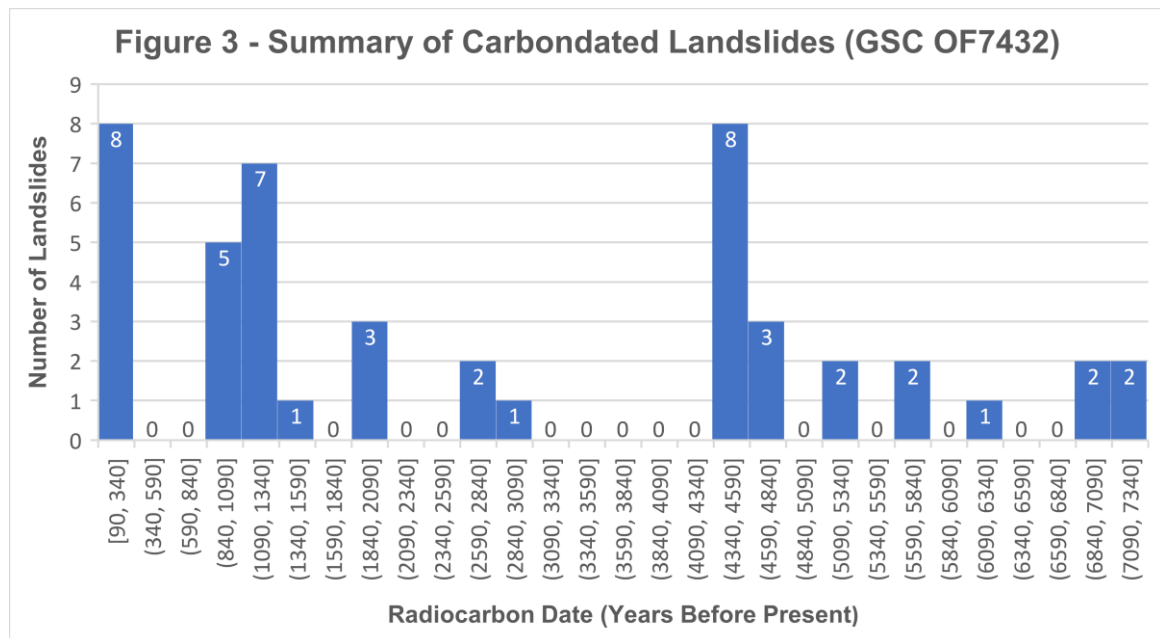
The temporal frequency of landslide occurrence may vary substantially across the study area. OF7432 sought to carbon date 45 separate landslide features throughout the study area. Landslides interpreted by that study documented landslides having occurred potentially between approximately 90 to 7,140 years before present. The results from the study and approximations provided by OF8600, neglecting the potential deviation and range of uncertainty, are summarized in Figure 3 below:

Temporal factors such as periods of increased earthquakes and climatic factors affecting these frequencies have been explored by others. Based on the above, more than half of the carbon dated landslides have occurred within the past 3,090 years, and over a quarter within the past 1,090 years.

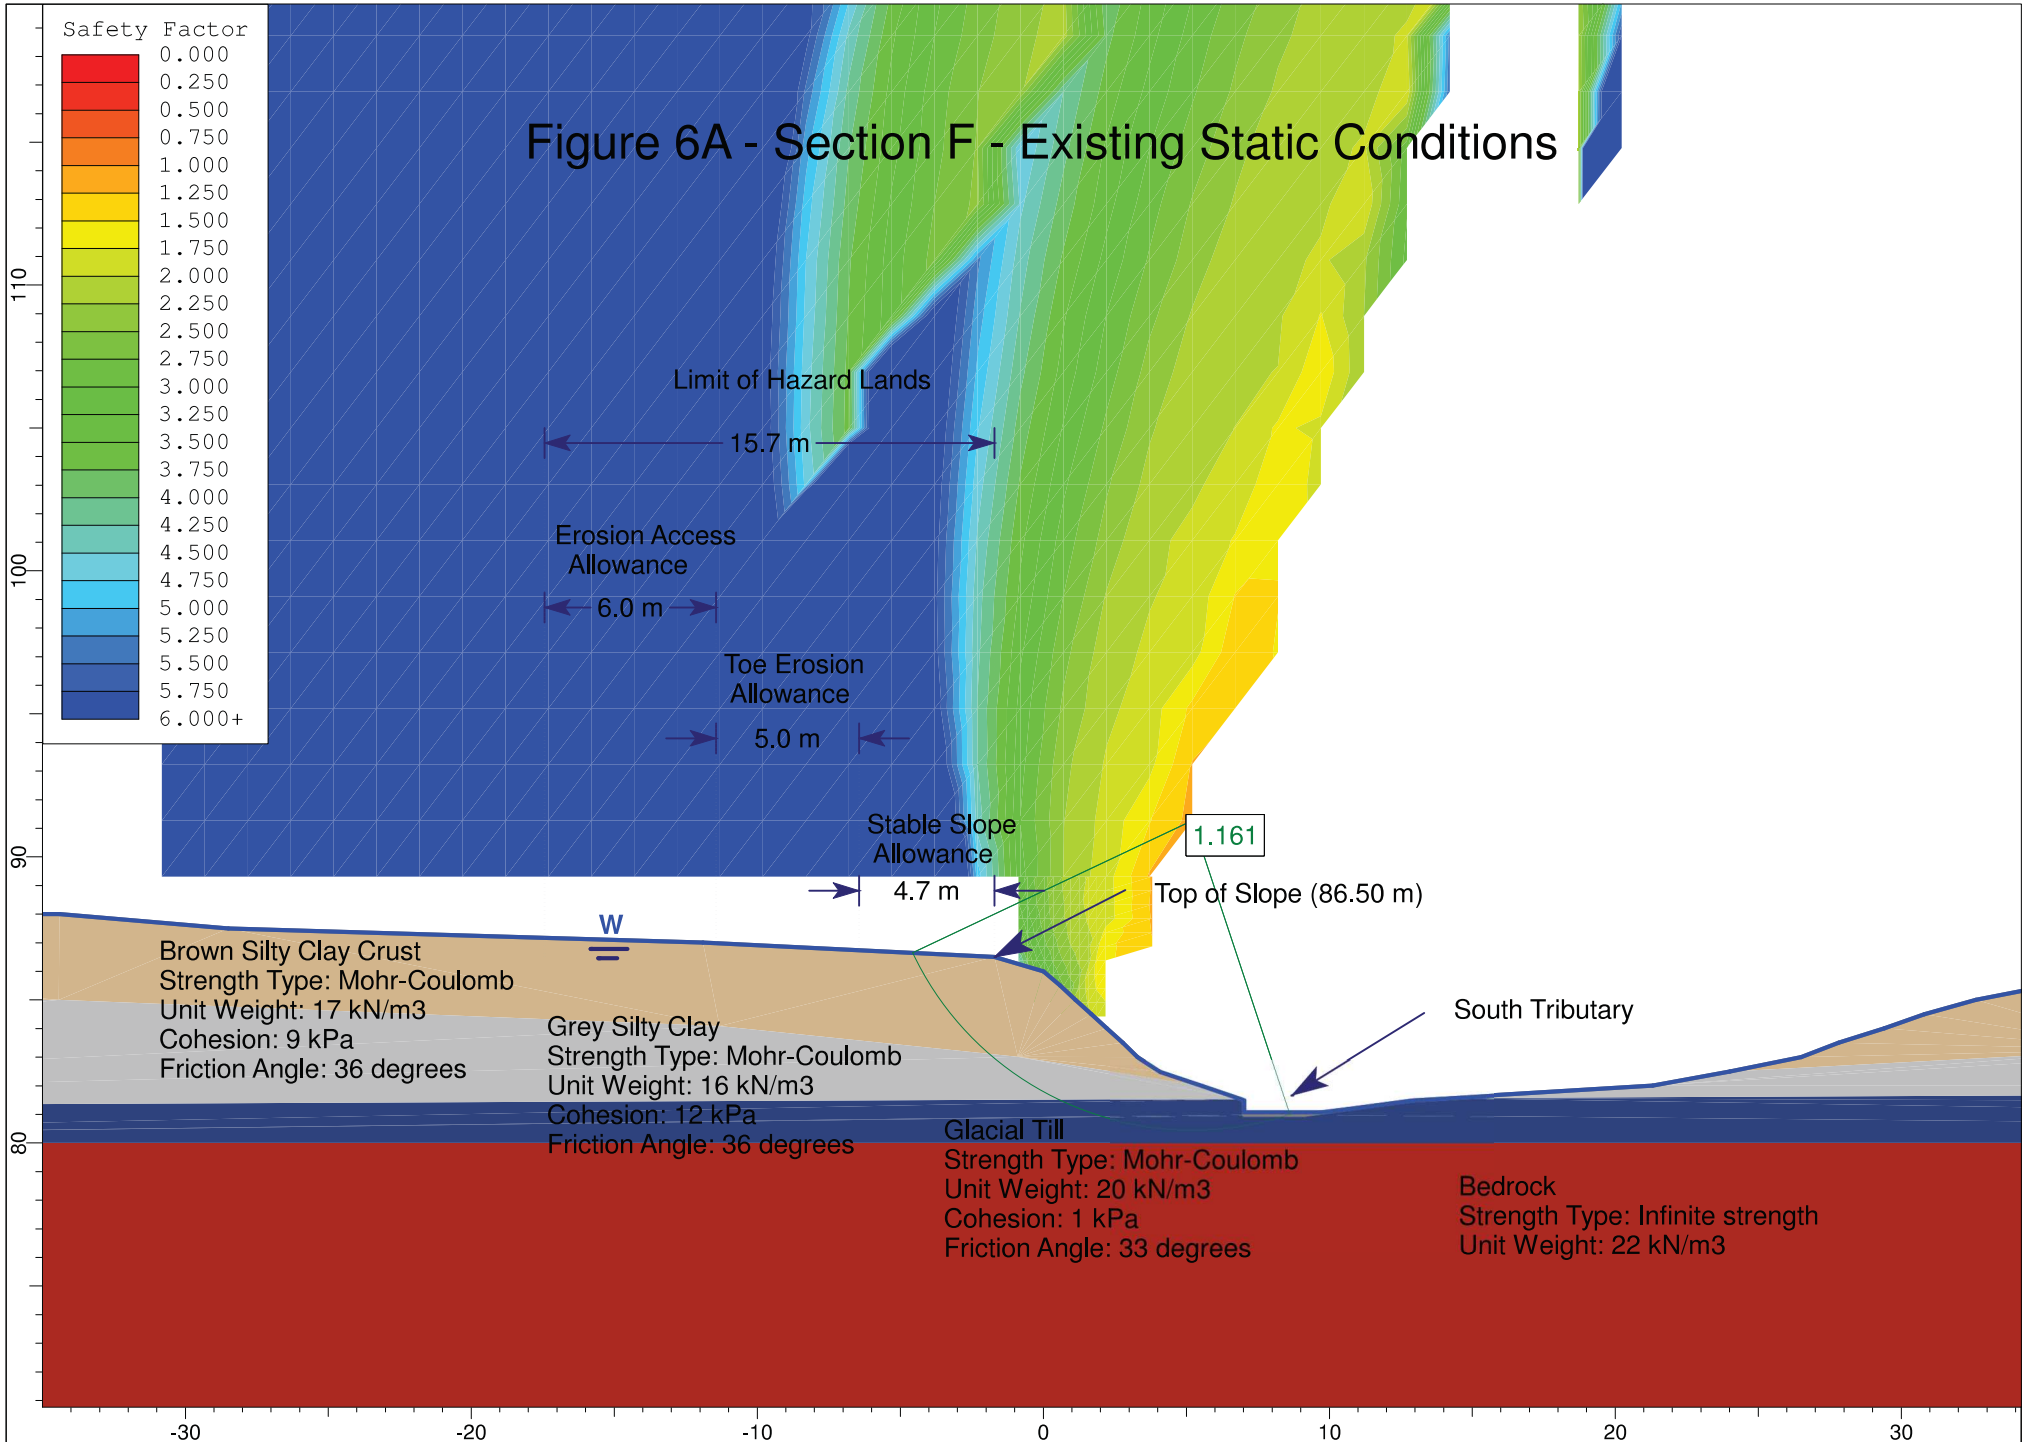
Figure 6A - Section F - Existing Static Conditions

The results for the existing static slope conditions at the slope stability sections are presented in Appendix 2. The slope stability factors of safety were found to be greater than 1.5 at all sections analyzed, except for Sections F and JJ, which are located along the south valley corridor wall of the stable slope allowance from top of slope, respectively.
