FLUVIAL GEOMORPHIC AND EROSION HAZARD ASSESSMENT
STINSON LANDS
OTTAWA, ONTARIO

Prepared for:
NOVATECH ENGINEERING AND CONSULTANTS LTD.

Prepared by:
MATRIX SOLUTIONS INC.

Version 1.0
November 2022
Guelph, Ontario

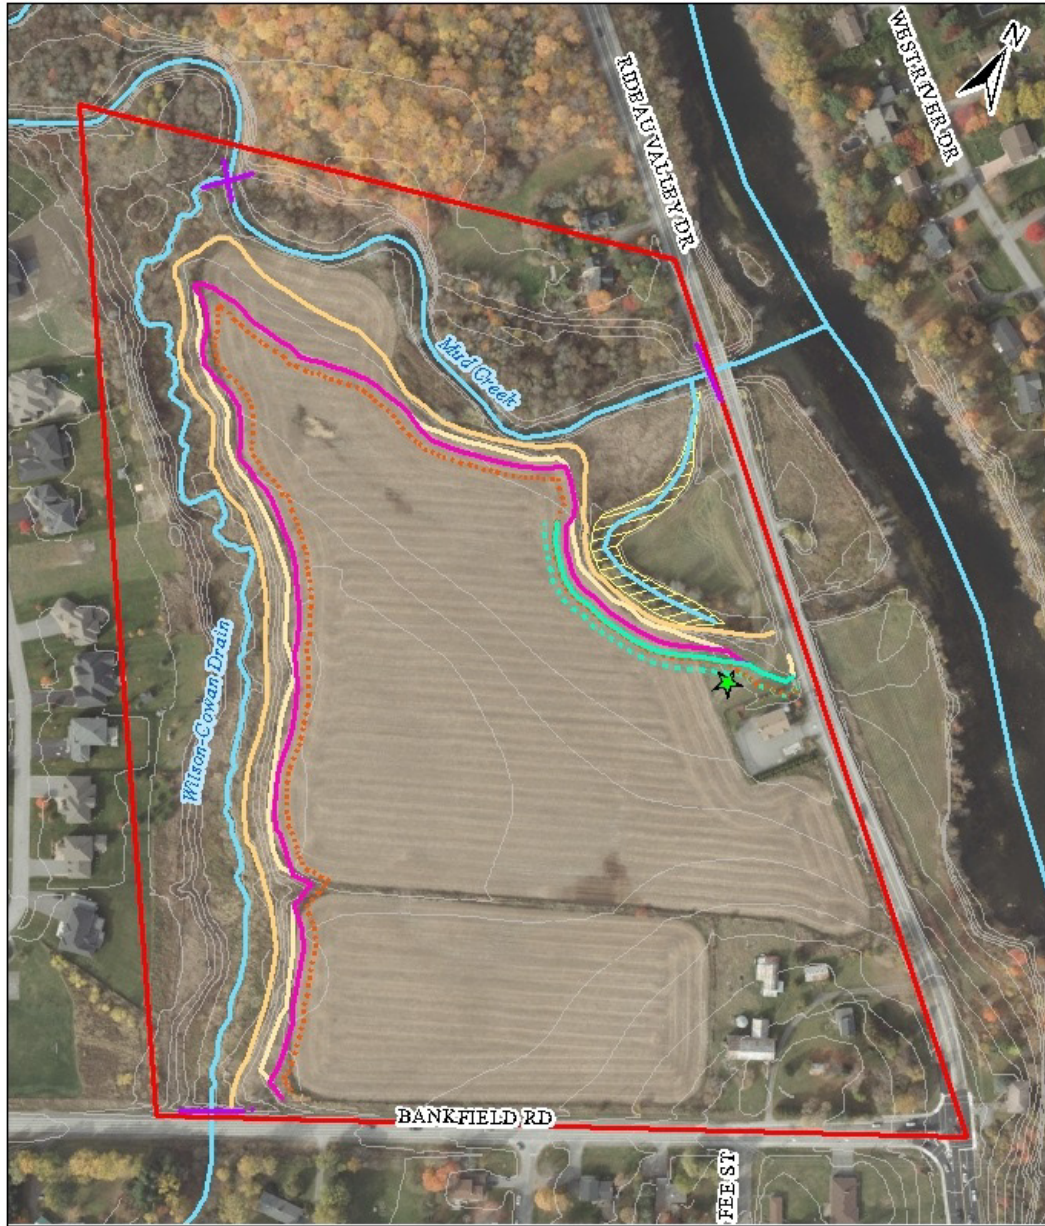
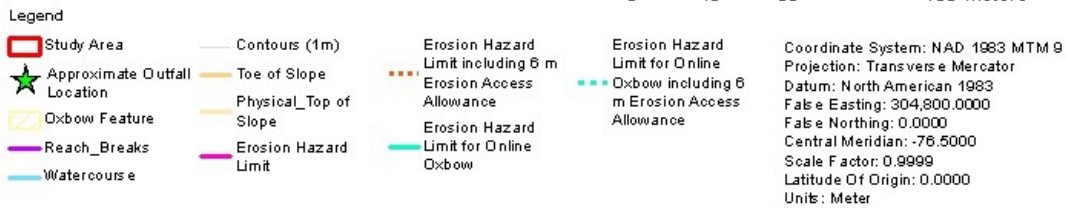
FIGURE 7 Erosion Hazard Limit, Long-term Stable Top-of-slope Assessment for Mud Creek, Wilson-Cowan Drain, and the Oxbow Feature

For this confined setting, Figure 7 presents the combined erosion hazard limit, whereby a single polyline captures the greater of the physical top-of-slope, long-term stable top-of-slope (3:1 setback), or the long-term stable top-of-slope with a toe erosion allowance of 5 m. The Paterson (2021) geotechnical study for the Stinson Lands was reviewed for a potential stable slope allowance (other than the assumed 3:1); however, it was not explicitly stated. Therefore, an assumed 3:1 stable slope allowance was maintained in this analysis. As per the Technical Guide (MNR 2002b), this final erosion hazard limit should include a 6 m erosion access allowance added to each side of the channel.

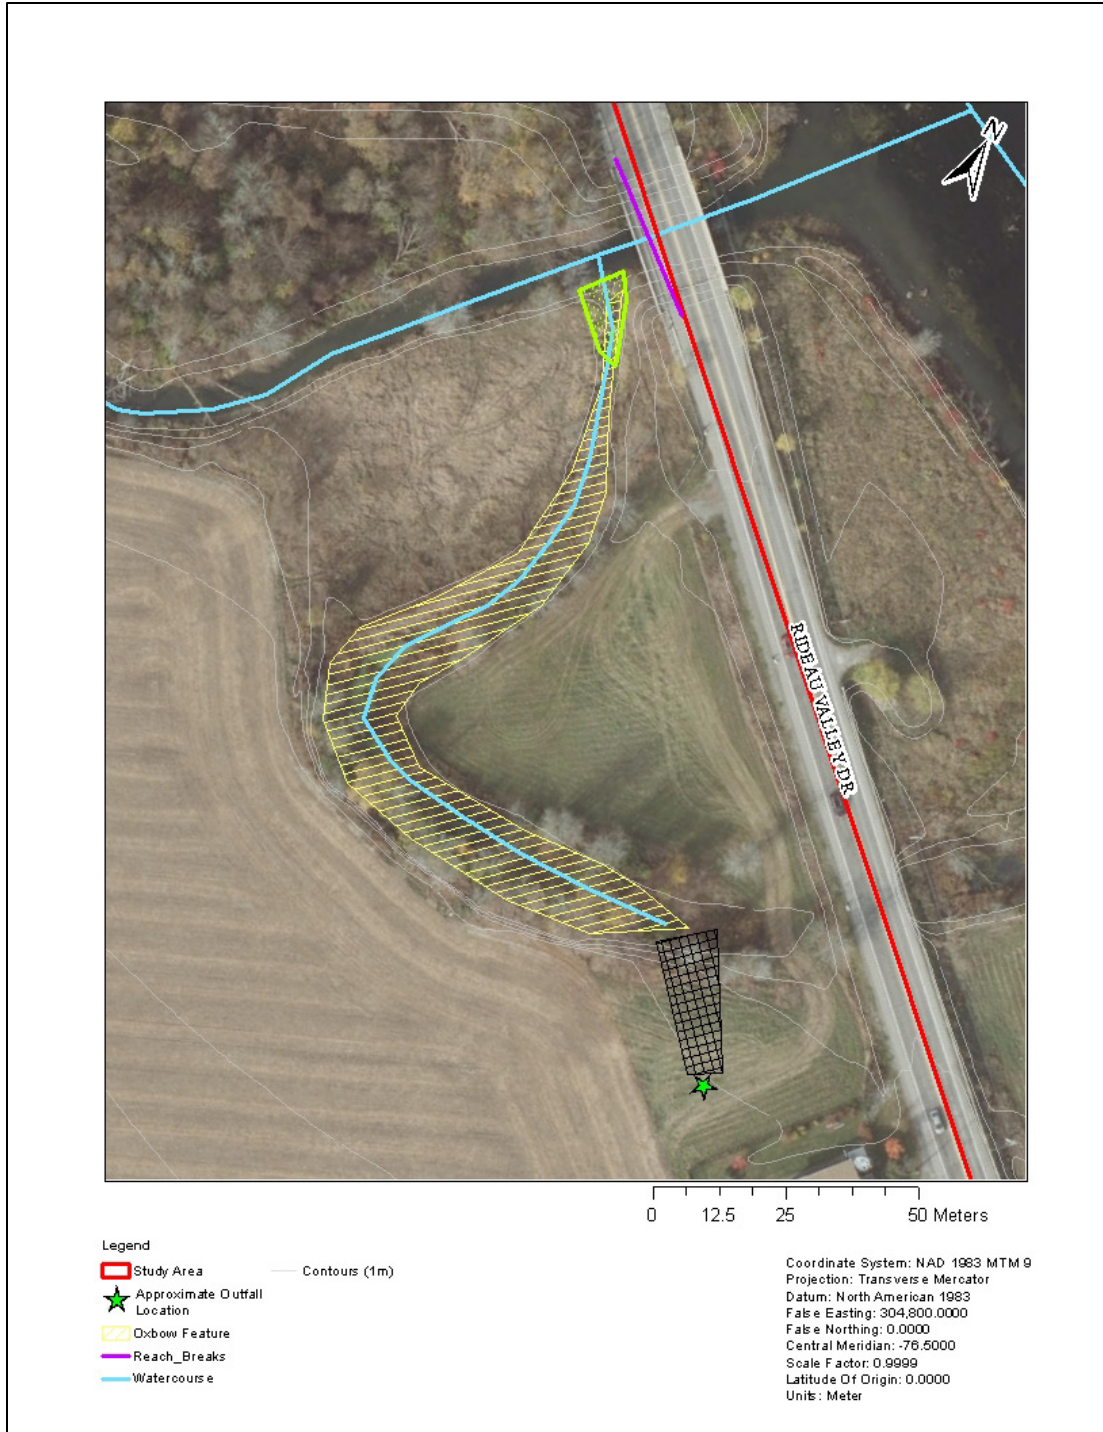
FIGURE 8 Recommended Design Opportunities for Stormwater Management Outflows

With velocities at the connection to Mud Creek being four times the permissible velocity under the 2-year, it is recommended that a connection to Mud Creek be formalized (Figure 8) with a gentler slope, design cross-section, and appropriately sized/selected lining materials to avoid headcutting into the floodplain, towards the oxbow feature. This would have to consider changes in the water level of Mud Creek for sustained stability.

Figure 8 provides the approximate location and extent of required stabilization works for a formalized Mud Creek connection to be developed through detailed design. Furthermore, at the detailed design stage, Matrix recommends the confirmation of stability of the oxbow under future scenarios through detailed hydraulic modelling (e.g., HEC-RAS) and any potential mitigation or alternate design options to convey flows from the development to Mud Creek that may be required pending the result of detailed design analysis. As mentioned earlier in this section, it is understood that further analysis will be completed at the detailed design stage to ensure that there will be no negative impacts to the oxbow feature, Mud Creek, or the Rideau River that may result from increased peak flows (Novatech 2022). The formalization of a connection down the bank of Mud Creek, the outflow channel design, and other floodplain modifications (if required) should be designed by or in collaboration with practitioners in fluvial geomorphology.

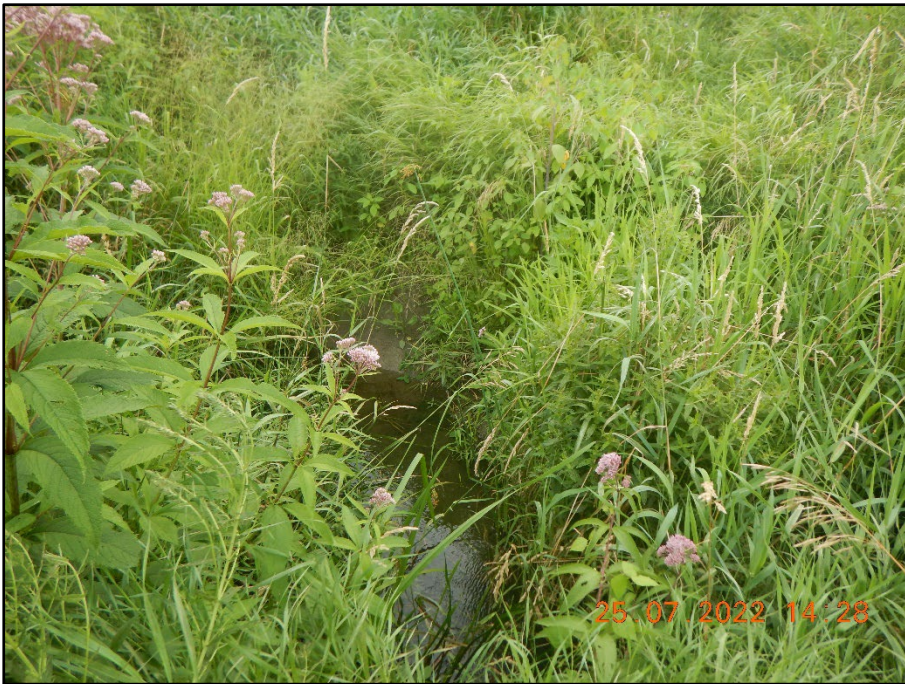
6. Wilson Cowan Drain - Facing downstream, the reach showed consistent signs of erosion in the form of steep outside meander banks, slumped banks, and failed banks

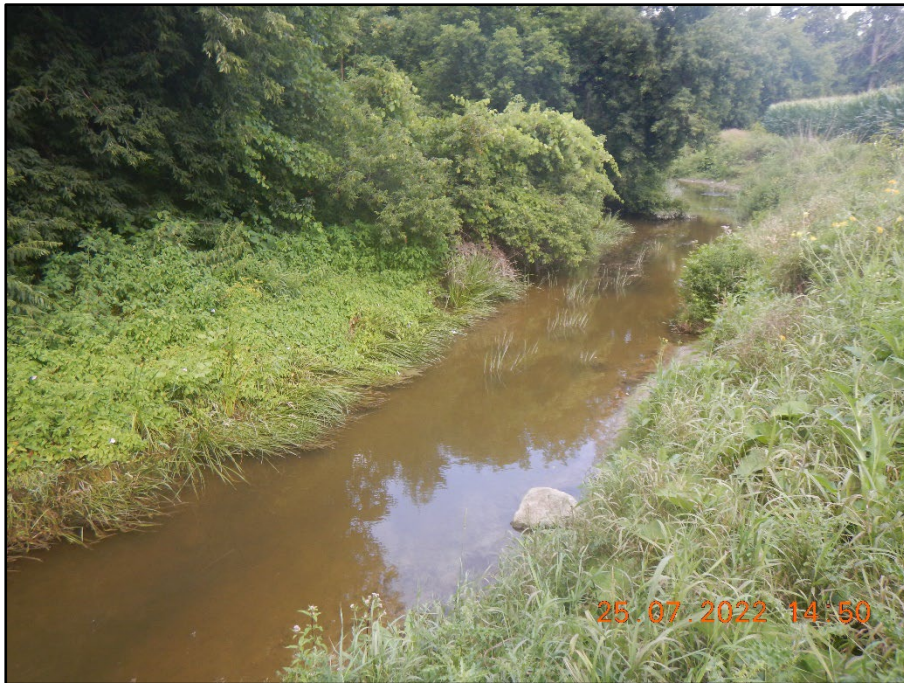
7. Mud Creek – Facing downstream, the creek shows low flow velocities at time of visit with established in stream vegetation with step outer meander bends and point bars established on the inside of beds

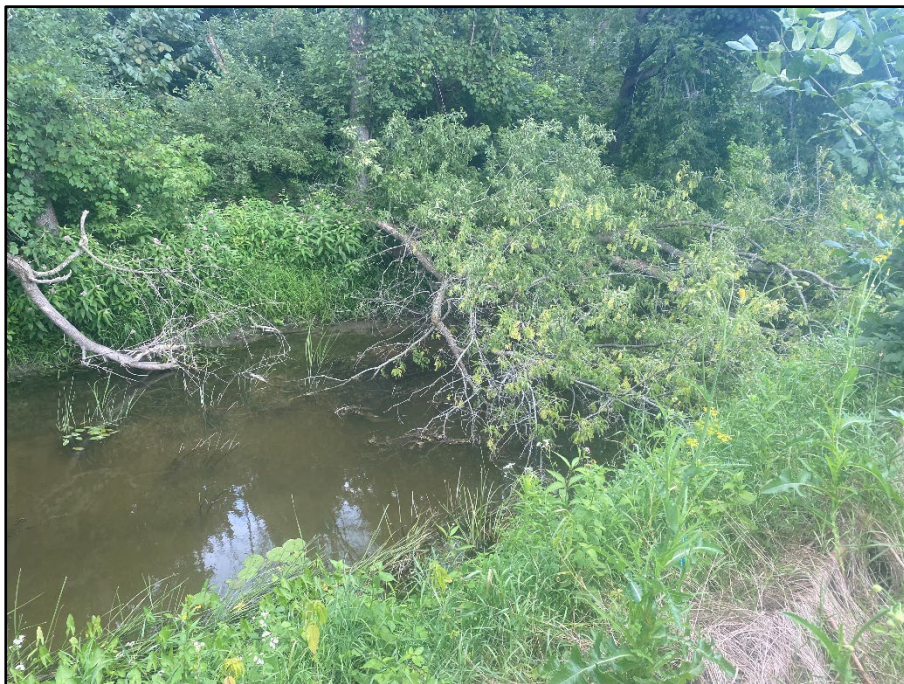
8. Mud Creek – Facing downstream, creek shows evidence of erosion and widening with many downed and leaning trees

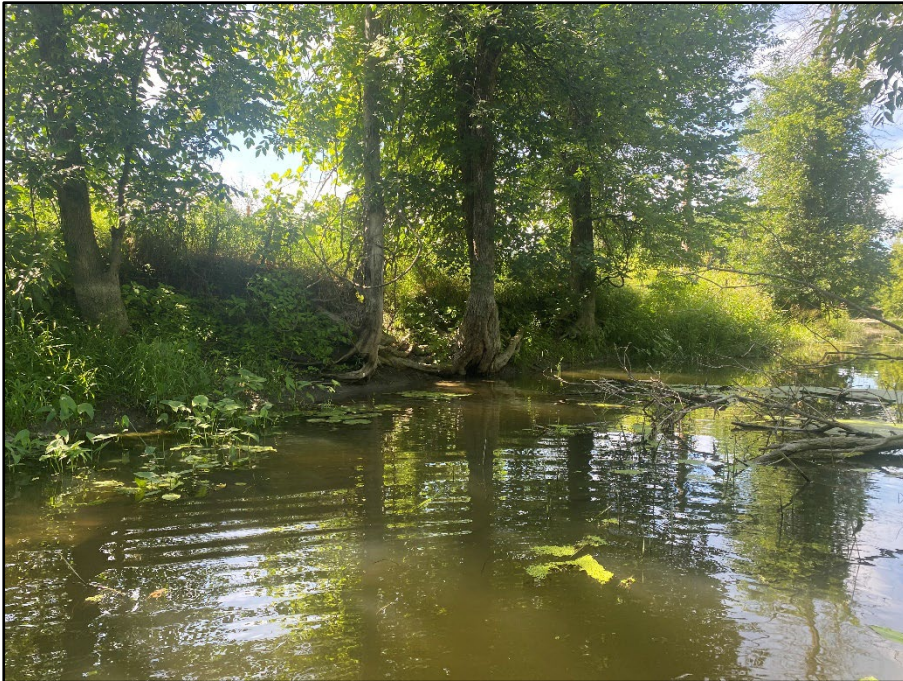
9. Mud Creek – Facing upstream, creek banks commonly show exposed tree roots

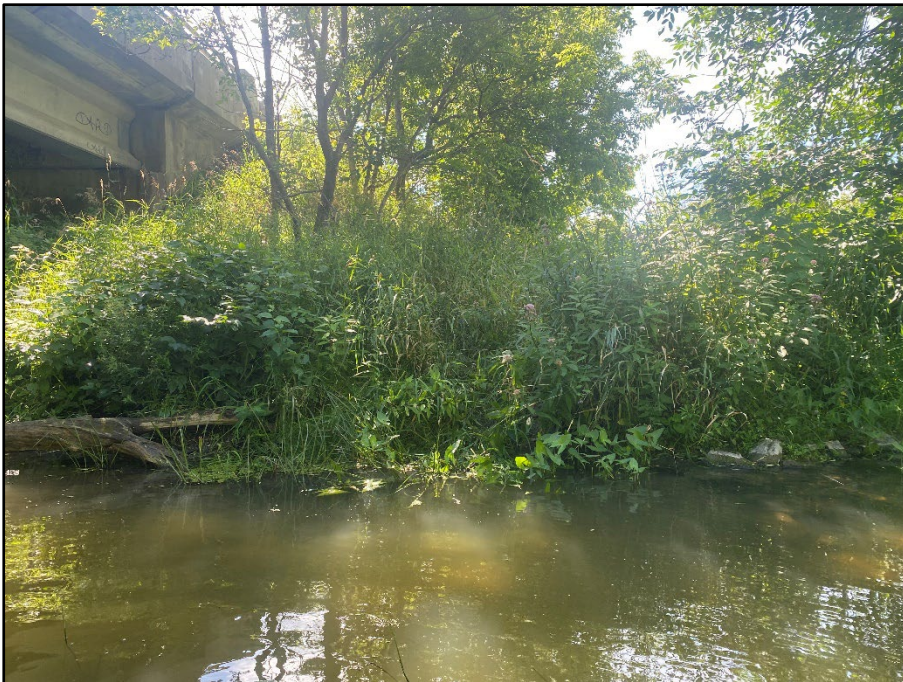
10. Mud Creek – Facing parallel to Rideau Valley Drive N, inlet location from the Oxbow feature into Mud Creek with an approximate 1 – 1.5 m elevation change

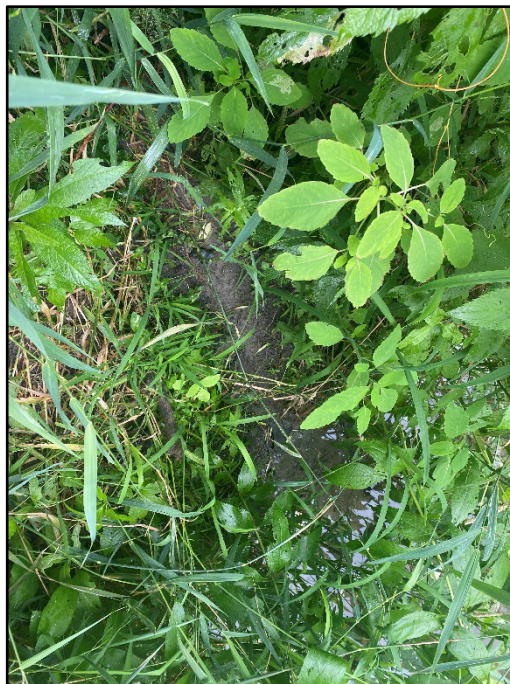
12. Oxbow Feature – Facing down, elevated area separating the standing water in the Oxbow and Mud Creek has a clear and define flow path but was above the water level at the time of the field visit

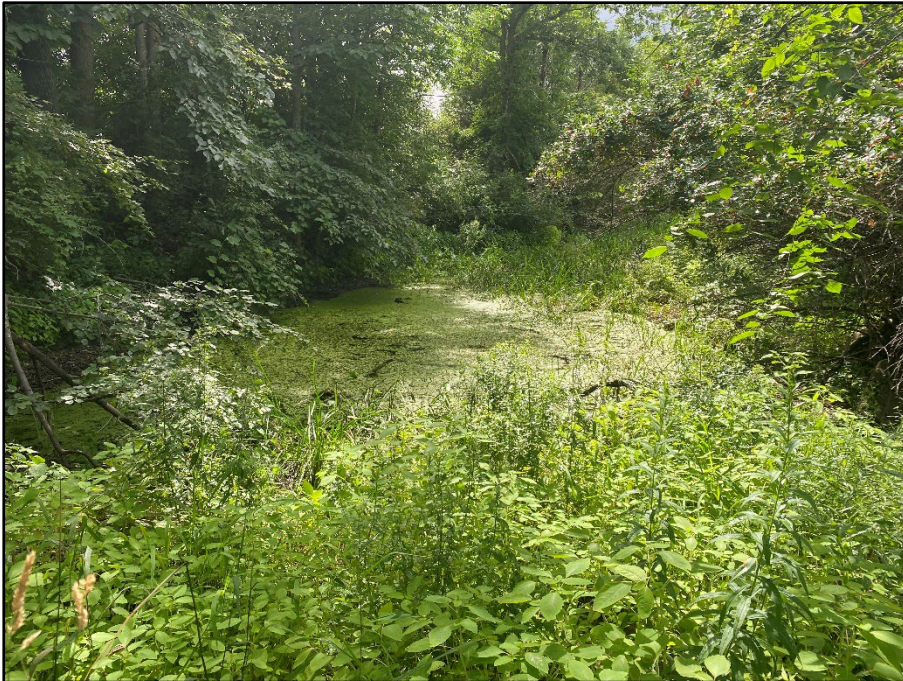
13. Oxbow Feature – Facing downstream, the depression maintained standing water at the time of the site visit, with saturated and unconsolidated soil underneath

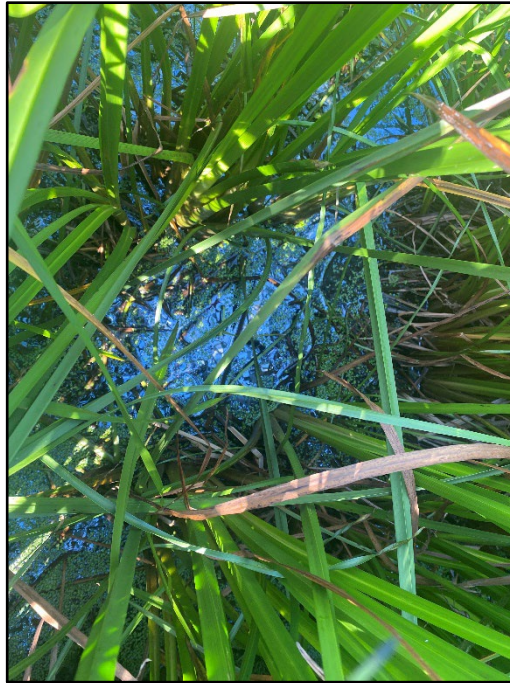
15. Oxbow Feature – Facing down, water surfaces in parts of the oxbow show pollution in the form of mineral staining

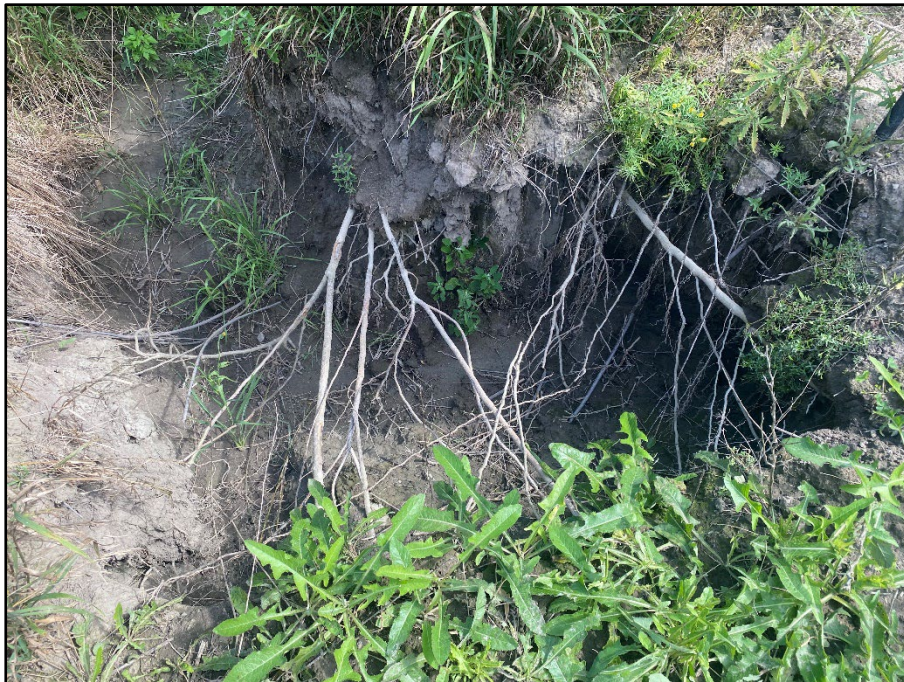
16. Mud Creek– Drainage from the adjacent field has resulted in a significant washout along the southern bank of Mud Creek
