TECHNICAL MEMORANDUM

Project No. 21482114

FLUVIAL GEOMORPHIC ASSESSMENT AT SUBJECT AREA OF THE RIDEAU RIVER TO SUPPORT PROPOSED DEVELOPMENT AT 3930 AND 3960 RIVERSIDE DRIVE

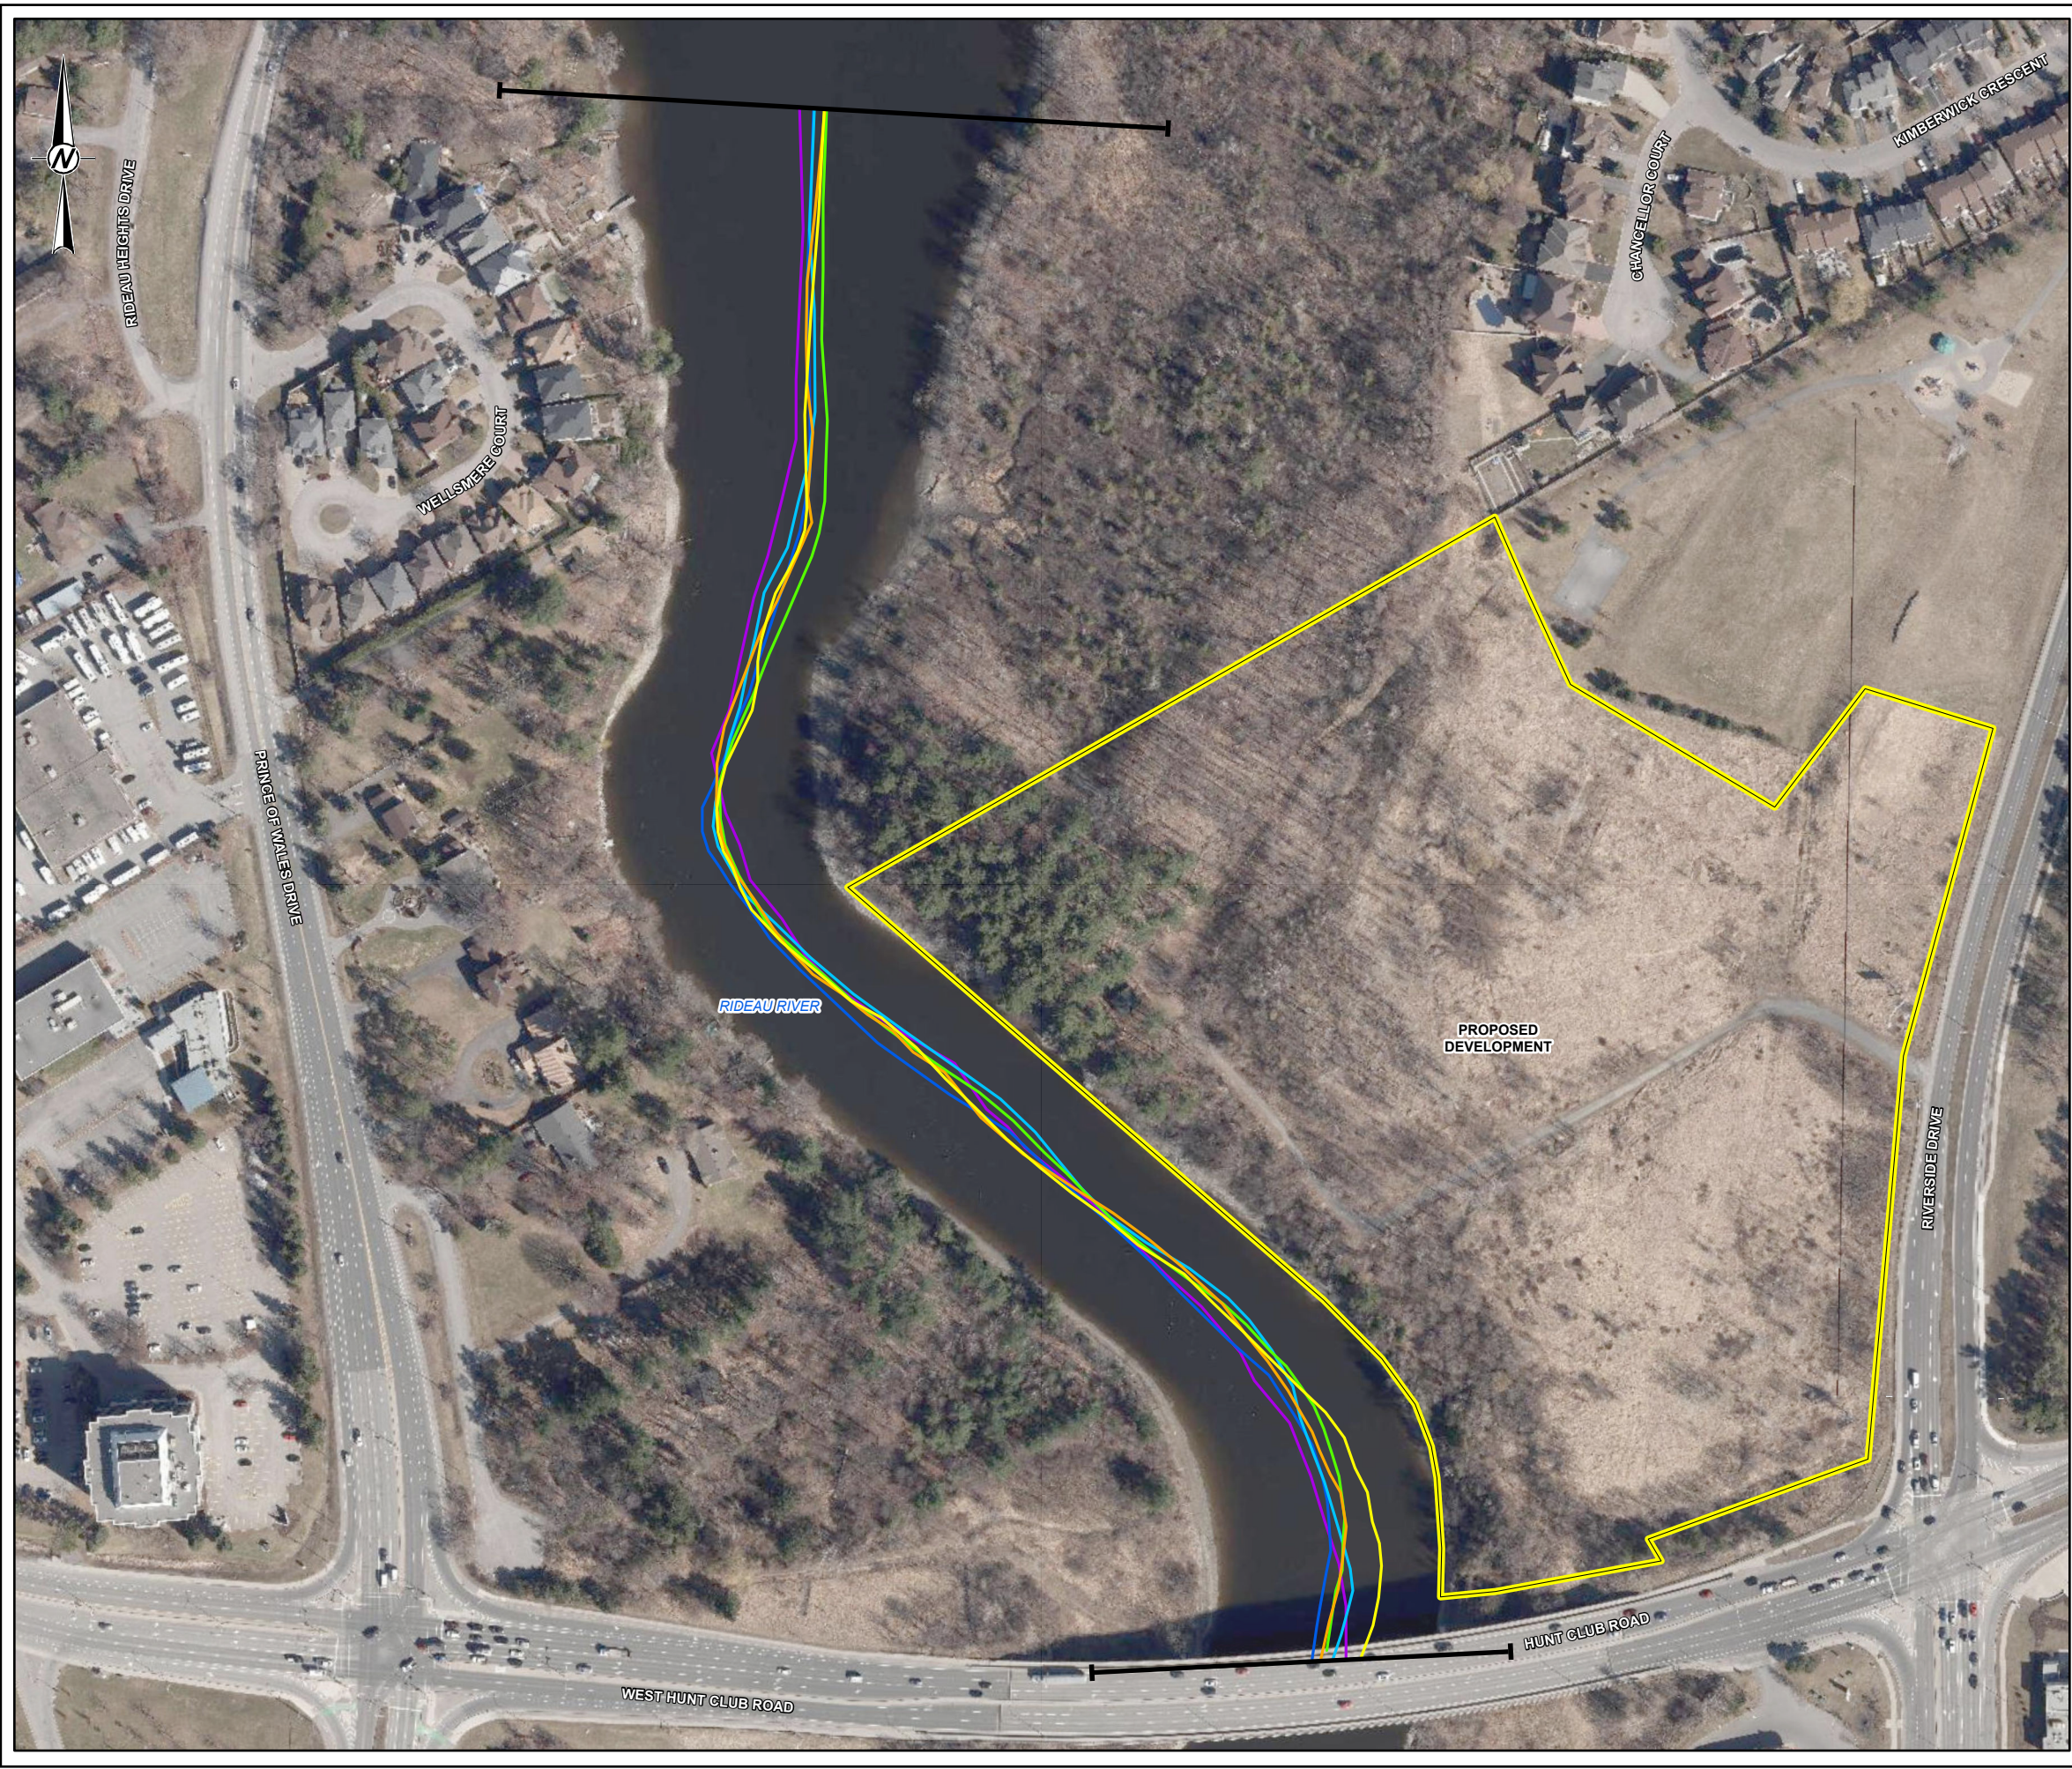
TITLE
SUMMARY OF OBSERVED CHANGES TO CHANNEL PLANFORM AT SUBJECT REACH BASED ON HISTORICAL AIR PHOTOGRAPH ANALYSIS

⁽¹⁾ The channel planform at this location was observed, over time, to be widening at both banks (albeit slightly) and/or shifting laterally toward each side (by an equally marginal amount), meaning that the centerline of the channel remained largely unchanged (and yielded an approximate migration rate of 0 cm/yr).

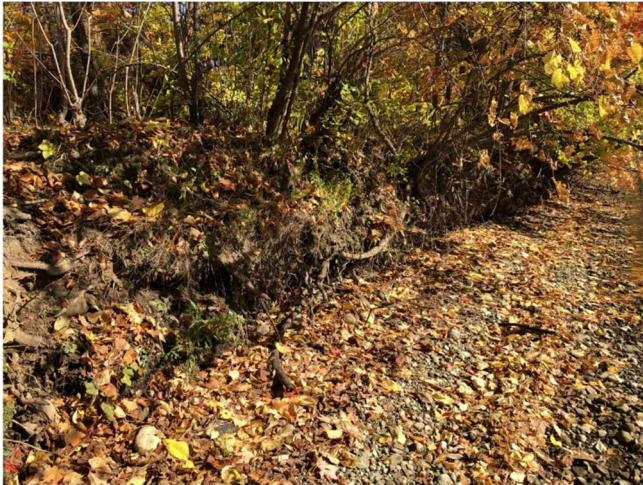
Photo 1: View looking upstream at S1 on October 14, 2022.

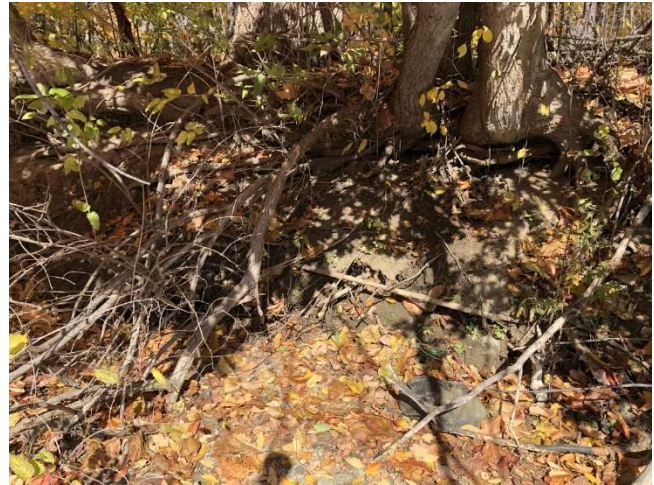
Photo 2: View looking at S2 (perpendicular to bank) on October 14, 2022.

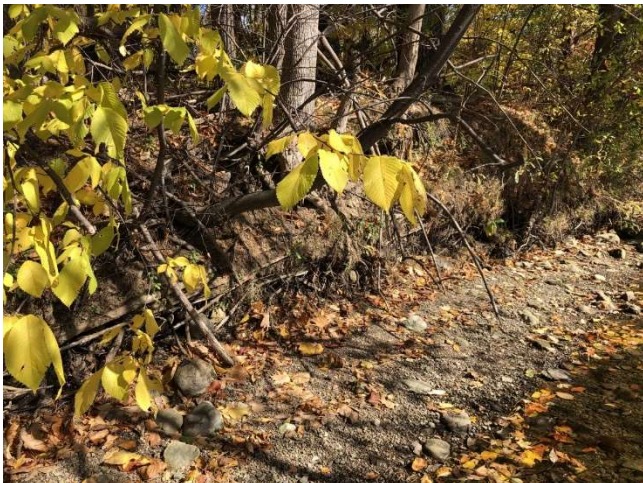
Photo 3: View looking upstream at S3 on October 14, 2022.

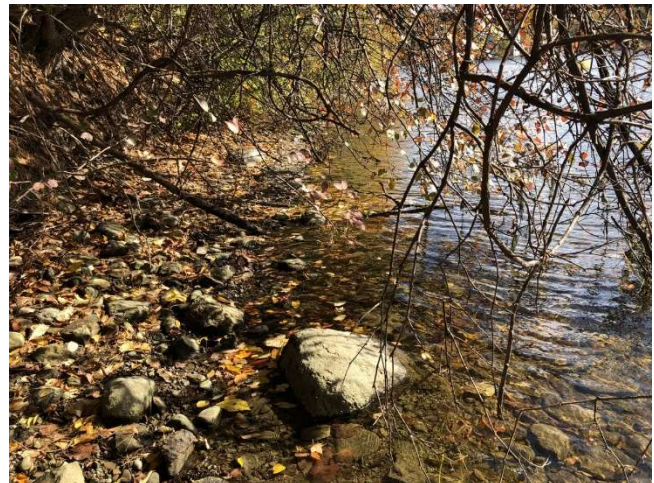
Photo 4: View looking upstream at S4 on October 14, 2022

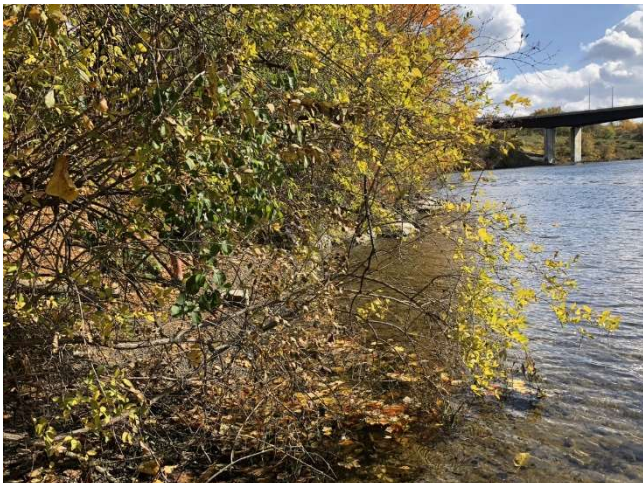
Photo 5: View looking upstream at S5 on October 14, 2022

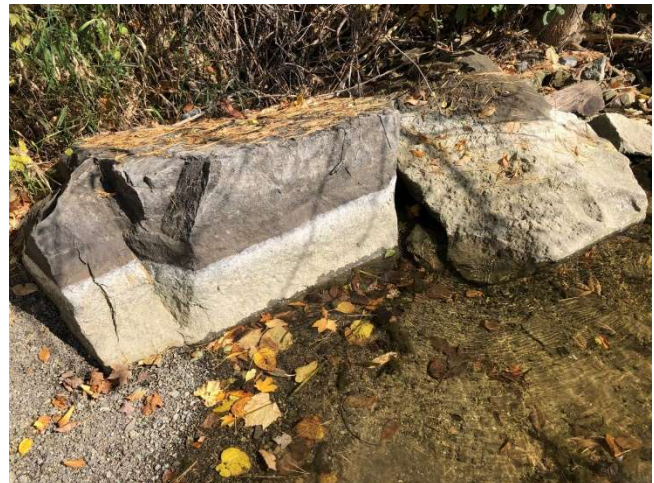
Photo 6: View looking at S6 (perpendicular to bank) on October 14, 2022.

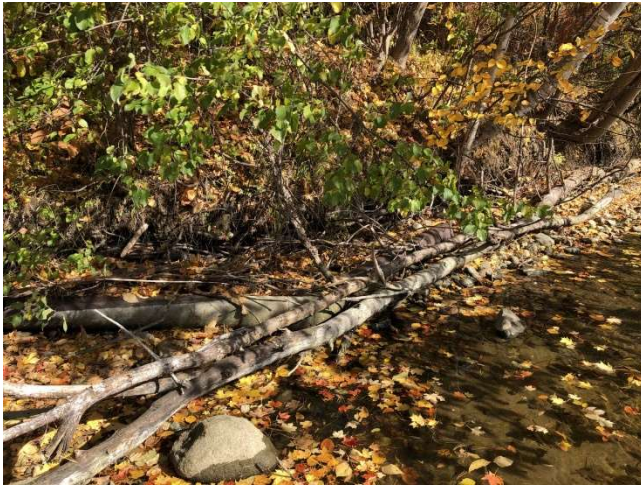
Photo 7: View looking at S7 (perpendicular to bank) on October 14, 2022.

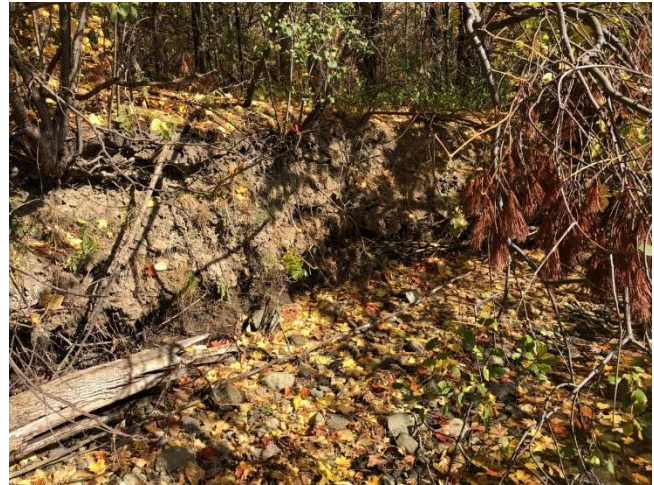
Photo 8: View looking at S8 (perpendicular to bank) on October 14, 2022.

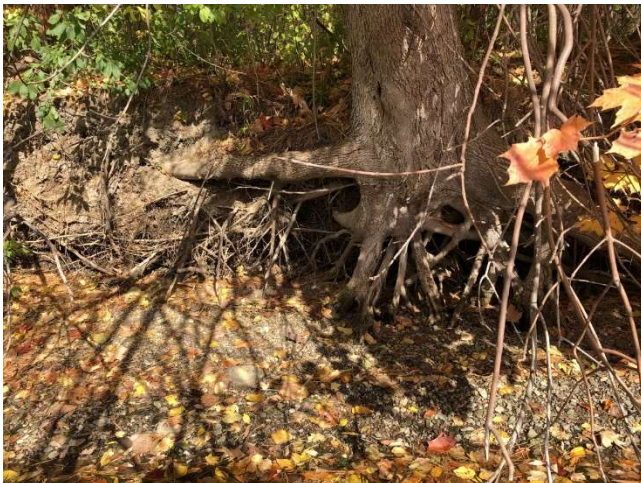
Photo 9: View looking at S9 (perpendicular to bank) on October 14, 2022.

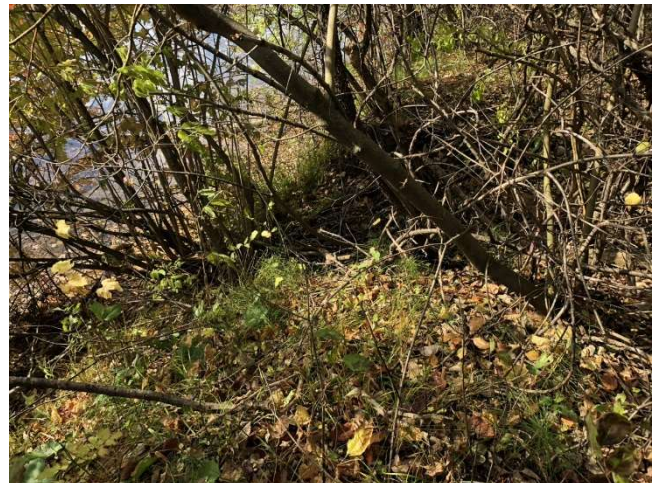
Photo 10: View looking at S10 (downslope to bank) on October 14, 2022.

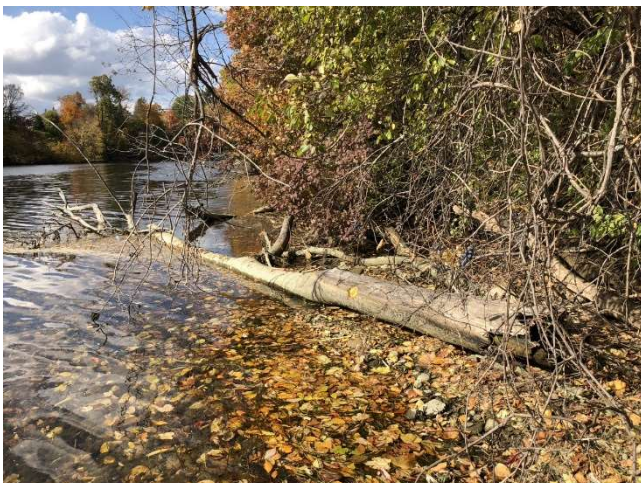
Photo 11: View looking upstream at S11 on October 14, 2022.

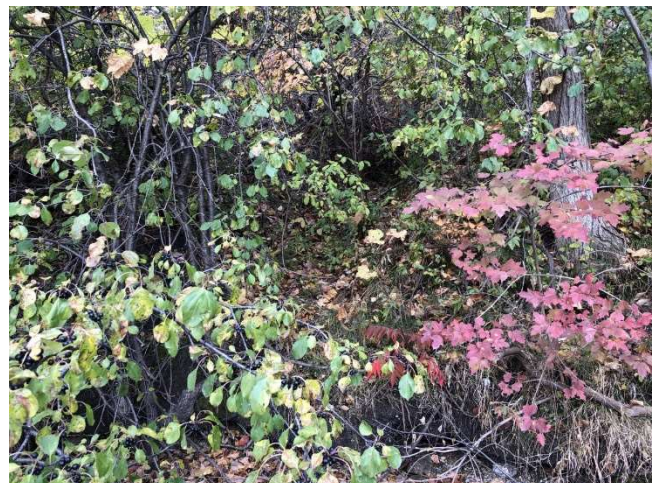
Photo 12: View looking at S12 (perpendicular to bank) on October 14, 2022, noting evidence of runoff pathways.

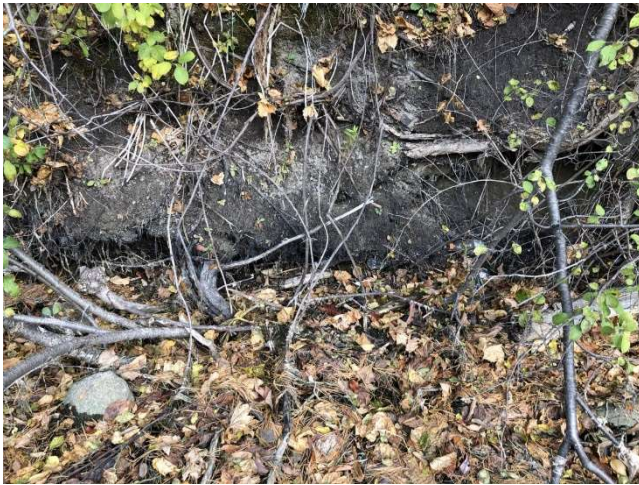
Photo 13: View looking at S13 (perpendicular to bank) on October 14, 2022.

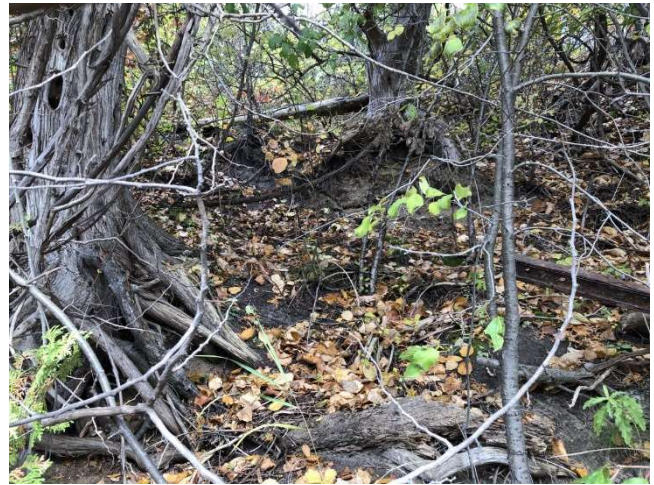
Photo 14: View looking at S14 (perpendicular to bank) on October 14, 2022.

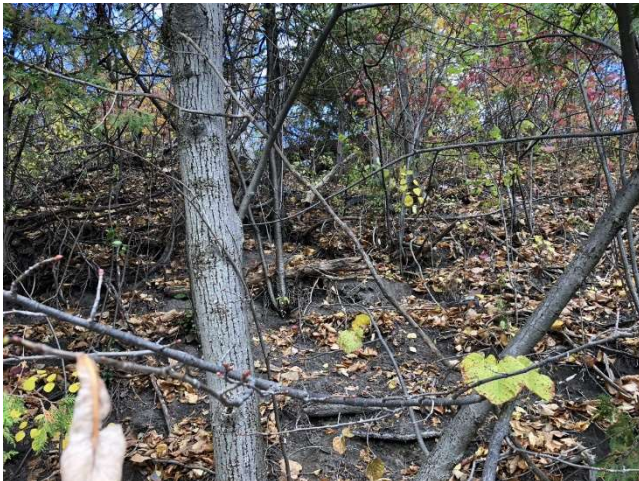
Photo 15: View looking at S15 (perpendicular to bank) on October 14, 2022.

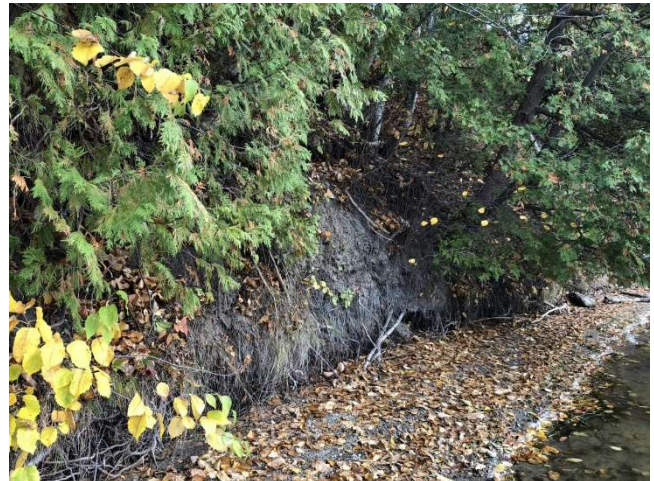
Photo 16: View looking upstream at S16 on October 14, 2022

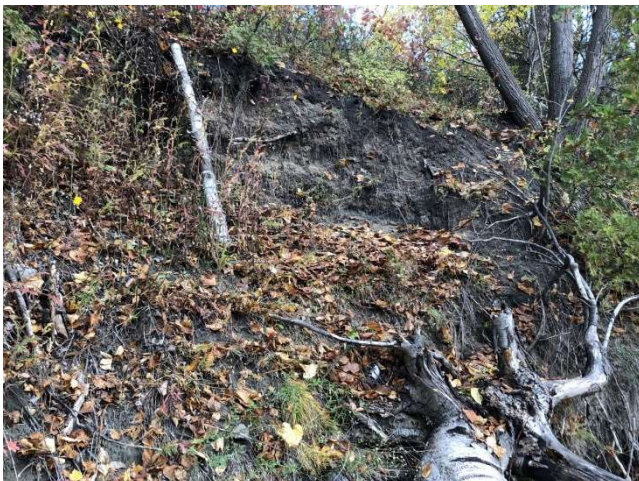
Photo 17: View looking at S17 (perpendicular to bank) on October 14, 2022.

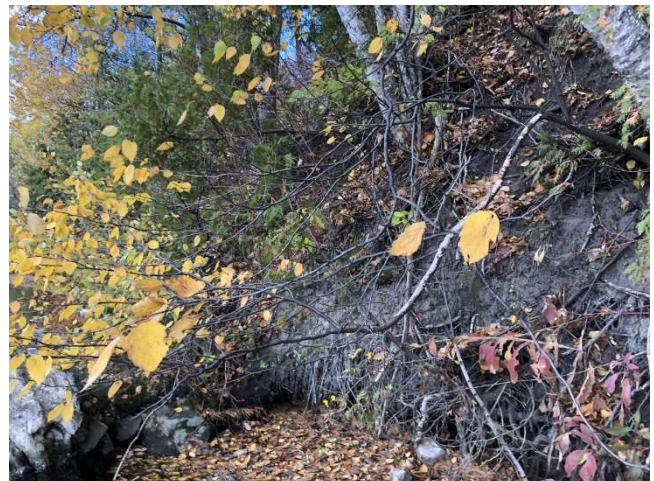
Photo 18: View looking at S18 (perpendicular to bank) on October 14, 2022.

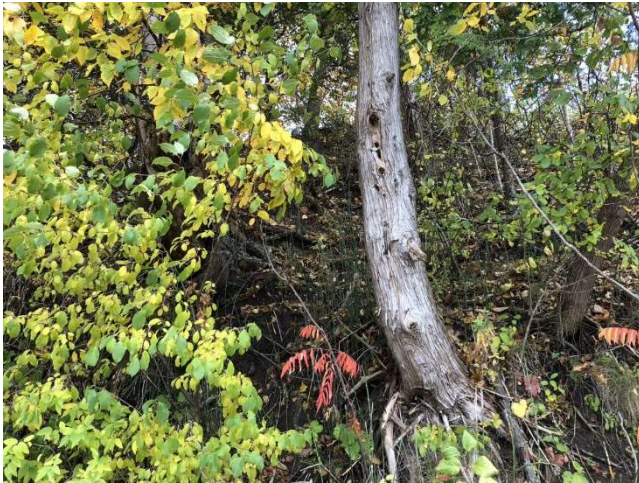
Photo 19: View looking at S19 (perpendicular to bank) on October 14, 2022.

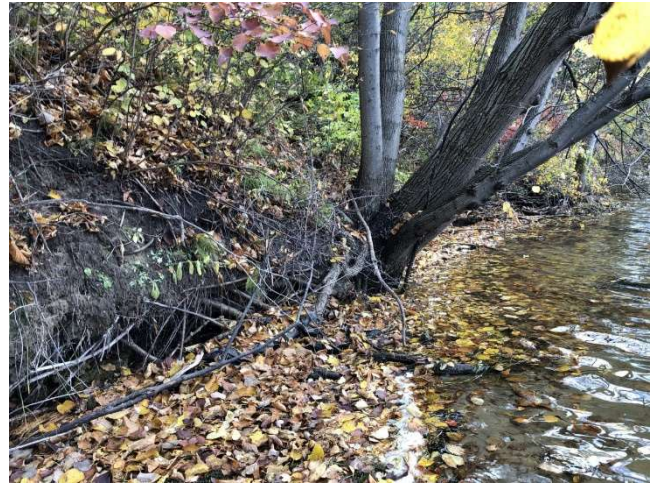
Photo 20: View looking upstream at S20 on October 14, 2022.

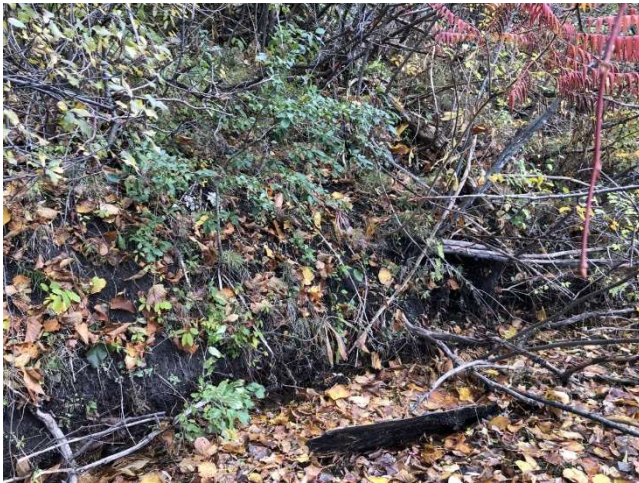
Photo 21: View looking at S21 (perpendicular to bank) on October 14, 2022.

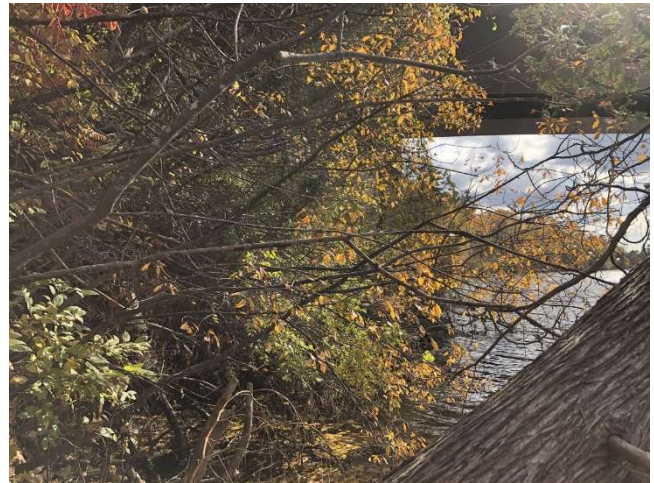
Photo 22: View looking upstream at S22 on October 14, 2022.
