Landslide Hazard Assessment

Petrie's Landing III

8600 Jeanne D'Arc Boulevard
Ottawa, Ontario

Report PG6414 – 2 dated May 5, 2023

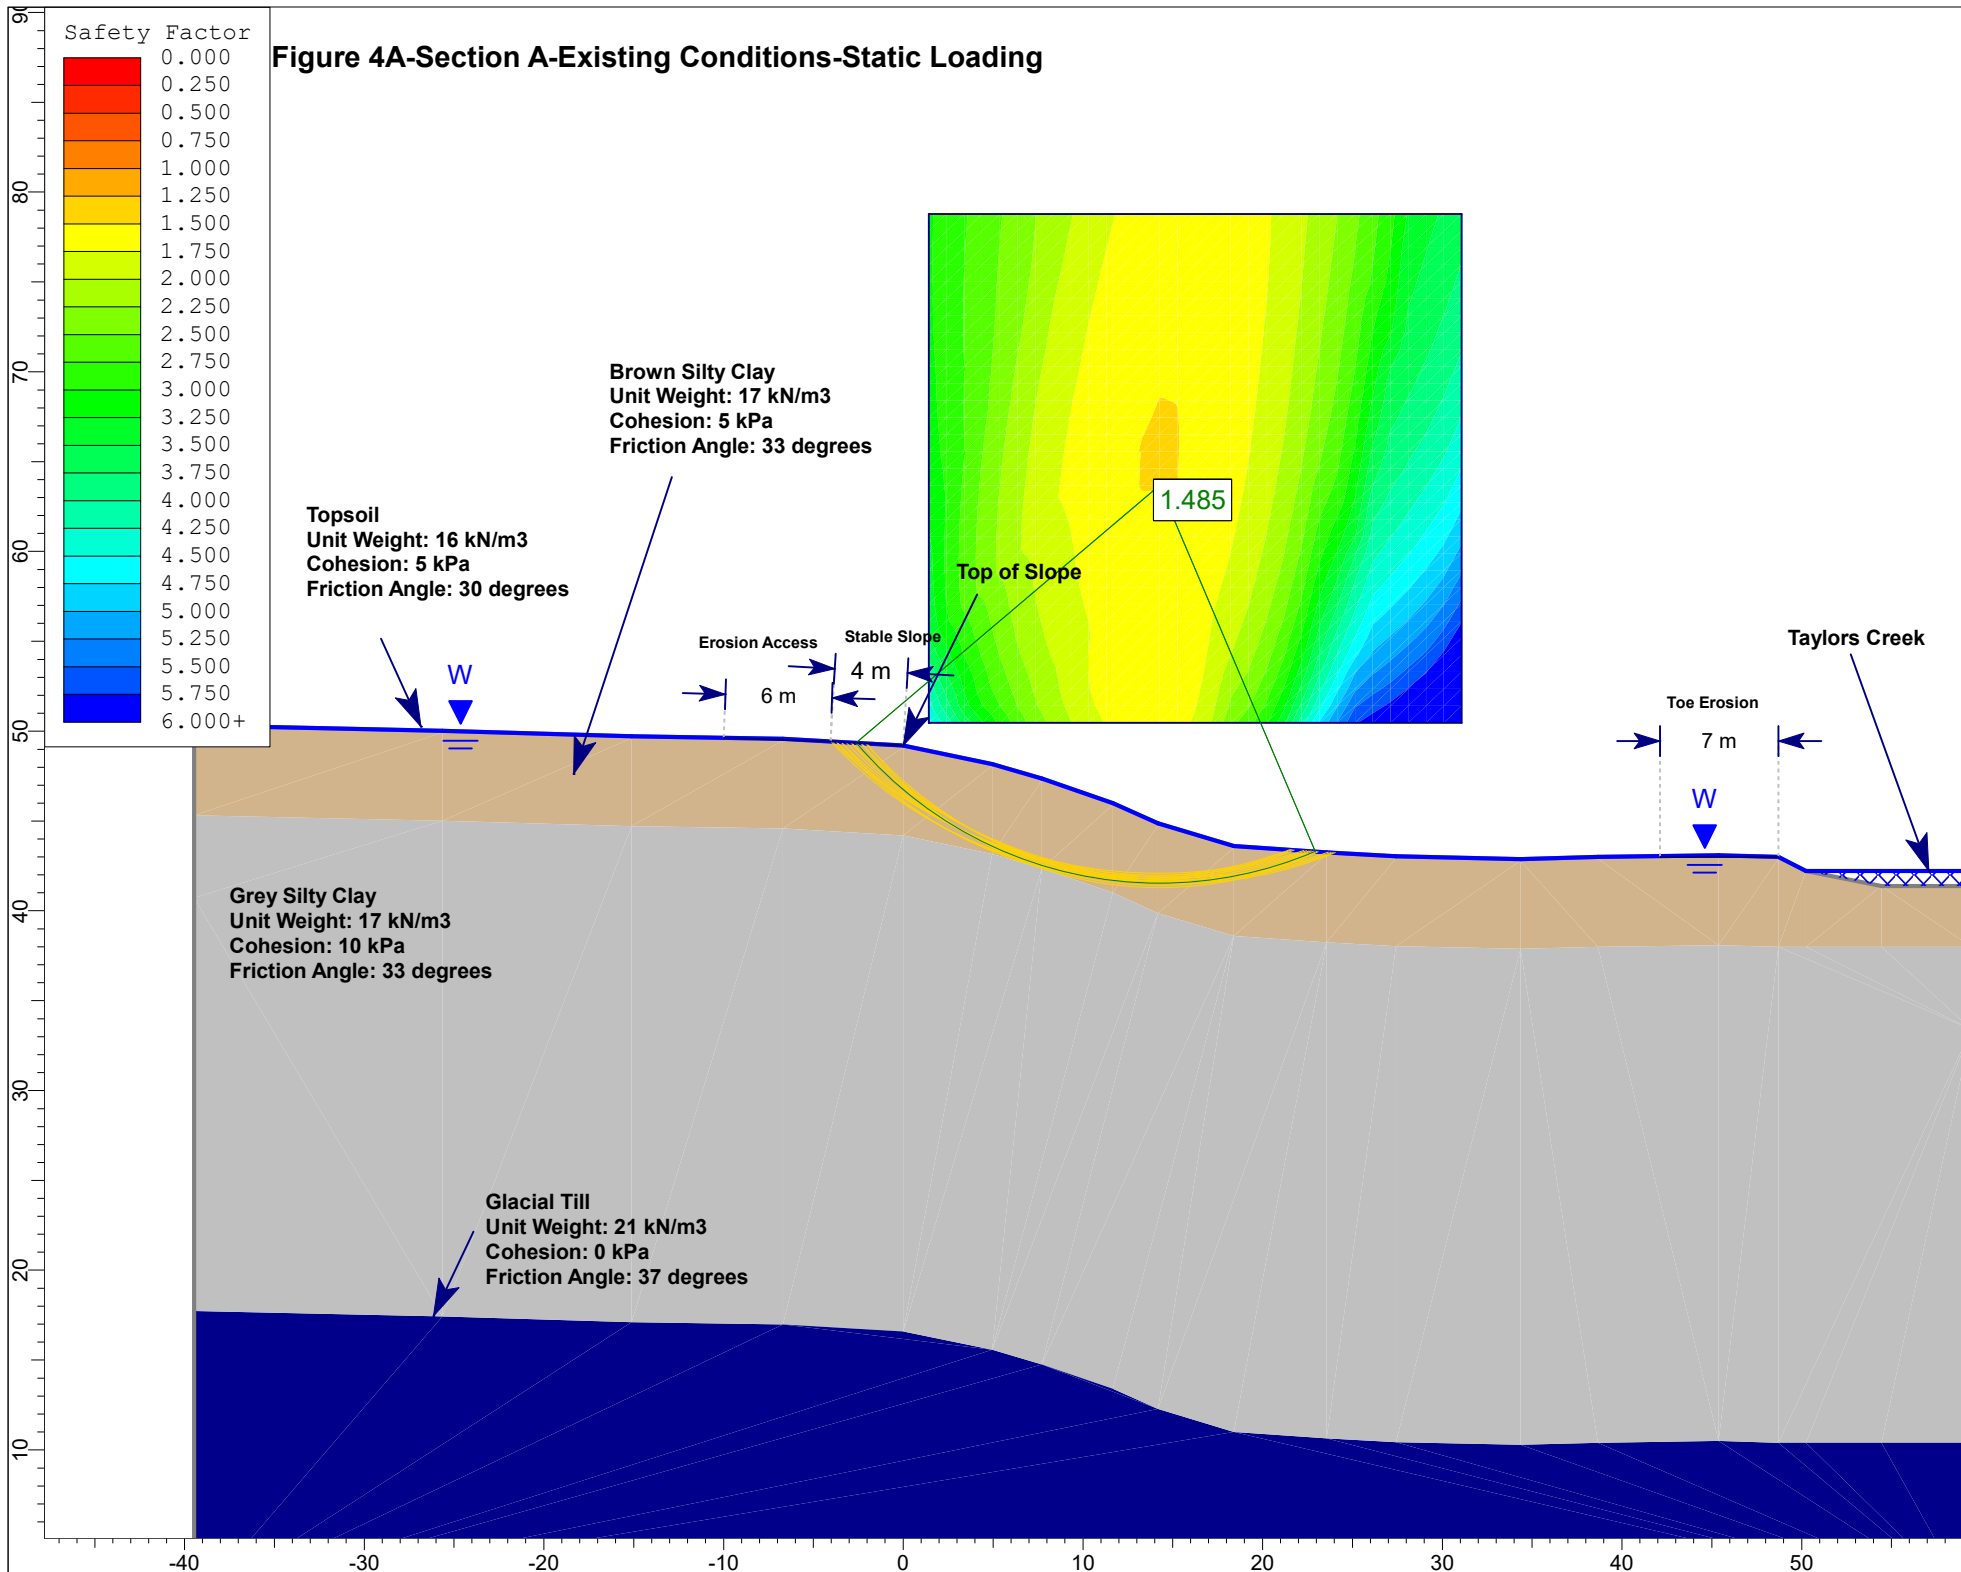
Figure 4A-Section A-Existing Conditions-Static Loading

The factor of safety for the slope was greater than 1.5 for slope section B. A factor of safety less than 1.5 was noted for Section A, C, D and E, therefore a slope stability setback would be required, if the existing slope was not re-graded as part of the proposed development. A stable slope setback of 4 m, 15 m and 4 m for Section A, C and Section D, respectively would be required if the existing slope is not modified.

It should be noted that toe erosion at slope section A was measured from the toe of the slope as allowed by the guidelines when the watercourse is located at 30 m or greater from the base of the slope. It is expected that failure of the slope due to toe erosion would occur along the flat plane adjacent to the watercourse. As such, the toe erosion for slope section A does not affect the required setback at section A.

The results of the slope stability assessment indicate that Limit of Hazard Lands setbacks of 10, 27, 28, 17 and 14 m, as measured from the top of the slope, should be provided for any proposed structures at the subject site in the areas of Section A, B, C, D and E respectively, in order to provide a suitable factor of safety of 1.5 under static conditions and 1.1 under seismic conditions.

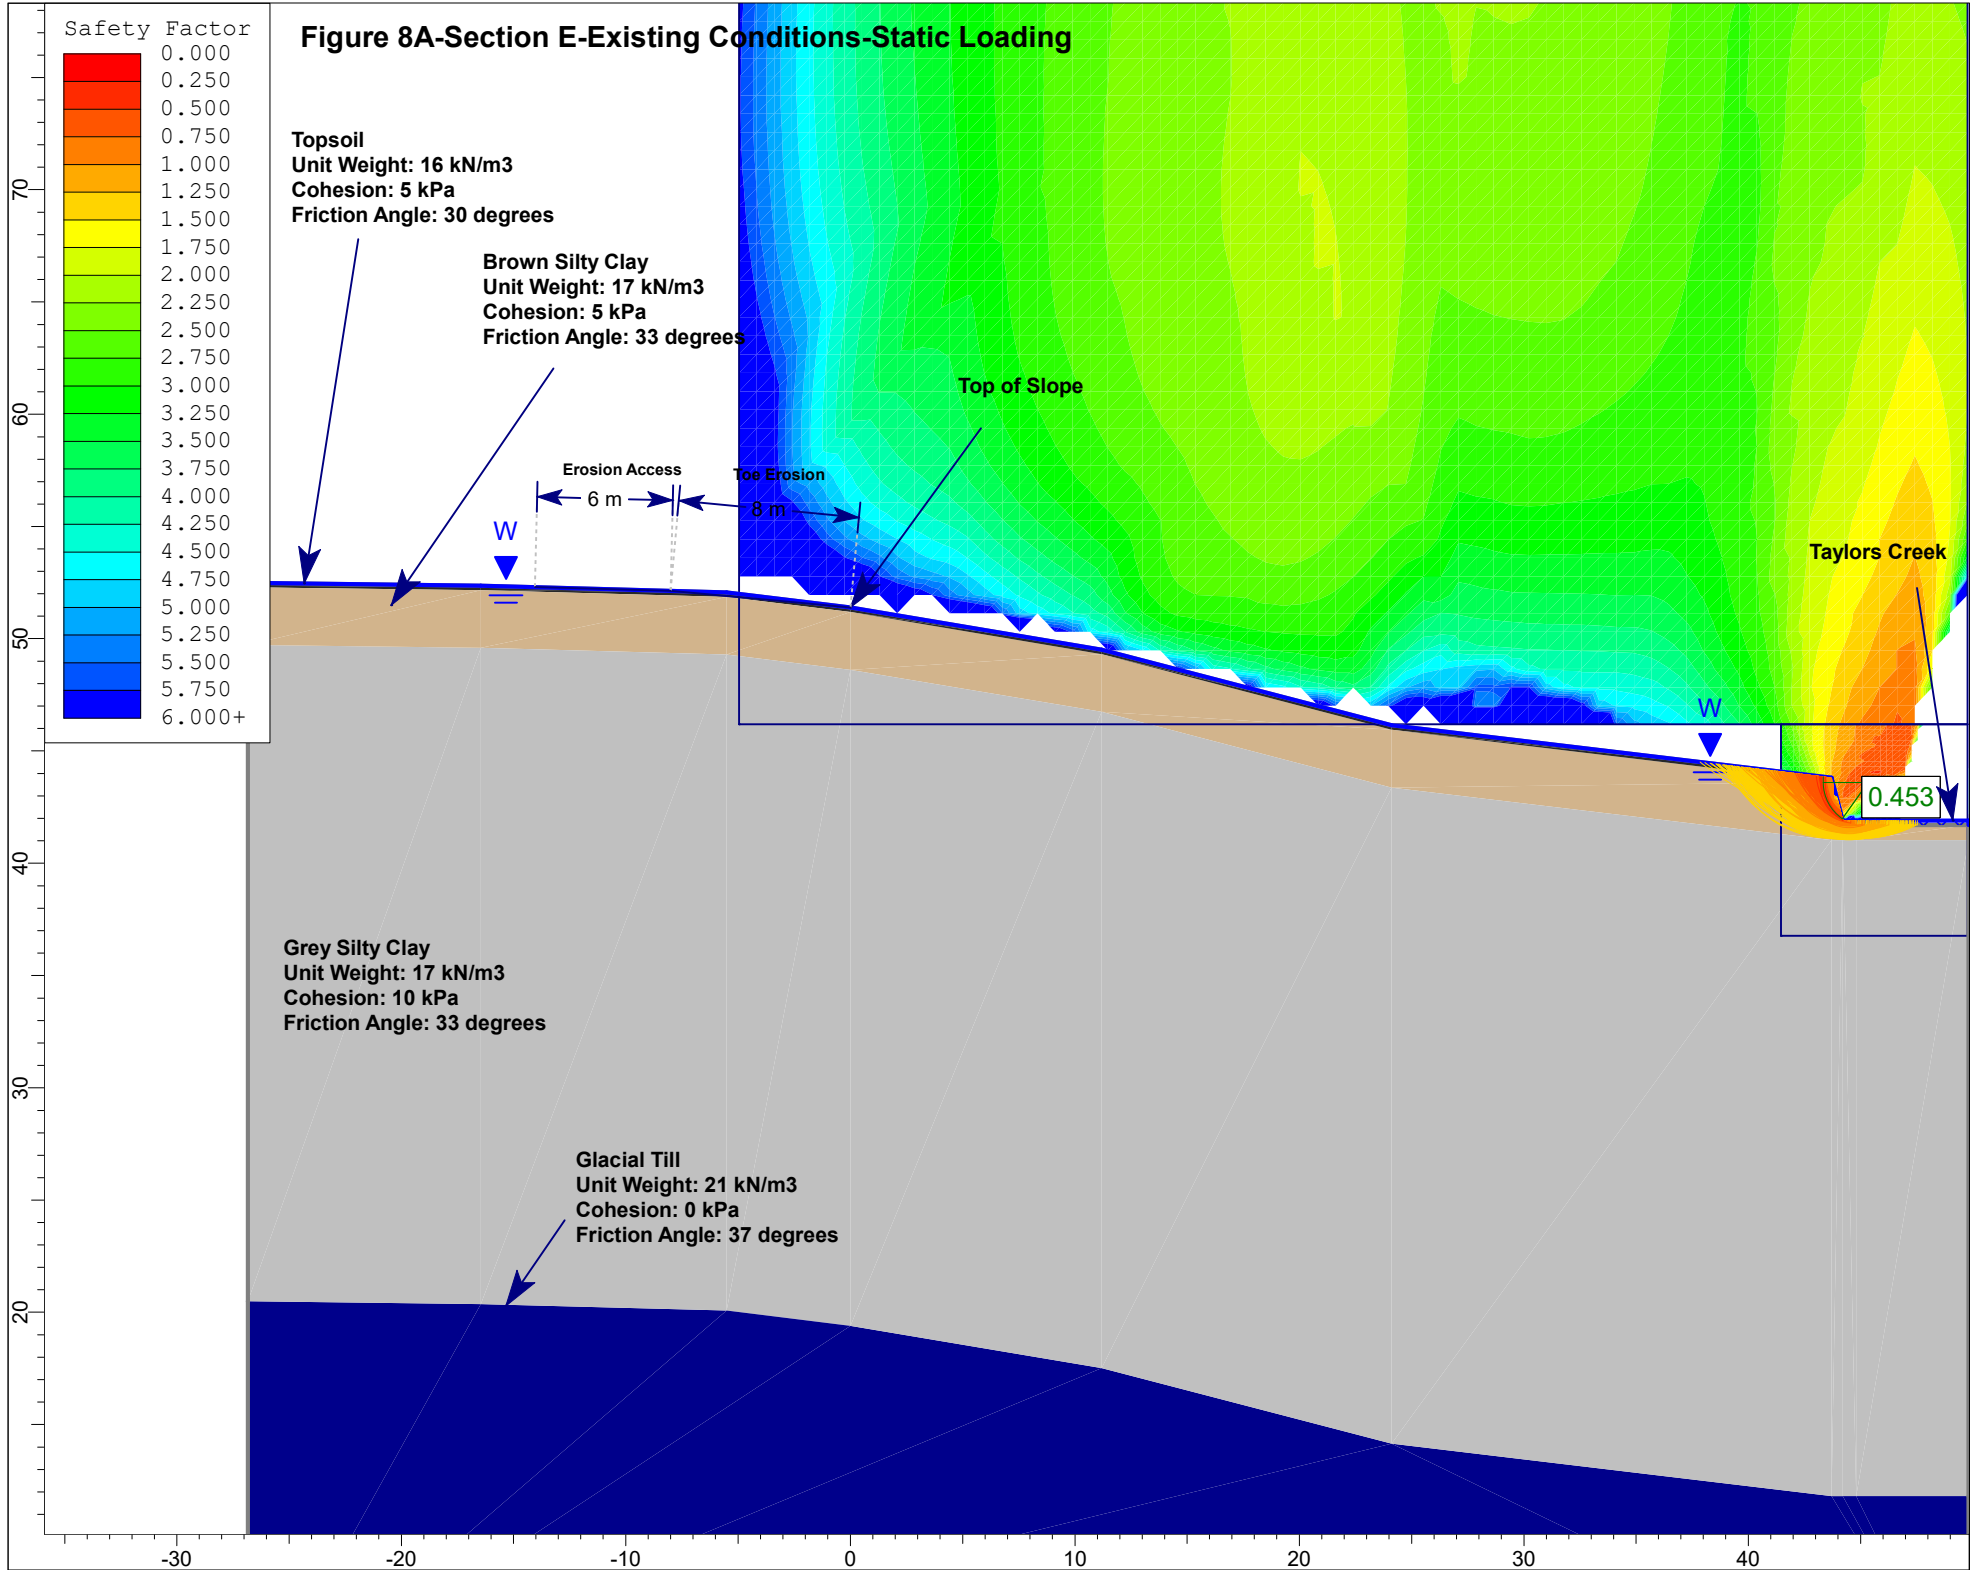
Figure 8A-Section E-Existing Conditions-Static Loading

Slope section E was noted to have a factor of safety lower than 1.5 under static loading at the toe of the slope. The low factor of safety indicates a potential of minor surficial slope failure at the toe of the slope mainly caused by erosion. The potential slope failure is limited to the upper layer of soil and concentrated at the toe of the slope. Such failure will not affect the stability of the upper section of the slope.

As noted above, the slope section E was noted to have a factor of safety lower than 1.5 under static loading at the toe of the slope. Such failure will not affect the stability of the upper section of the slope. However, given the lower factor of safety, an increased toe allowance of 8 m was utilized for slope section E.
