Phase One Environmental Site Assessment
Creekside 2 Subdivision,
2770 Eagleson Road,
Village of Richmond
Ottawa, Ontario

GEMTEC Project: 61899.04

Re: Phase One Environmental Site Assessment

Creekside 2 Subdivision, 2770 Eagleson Road, Village of Richmond

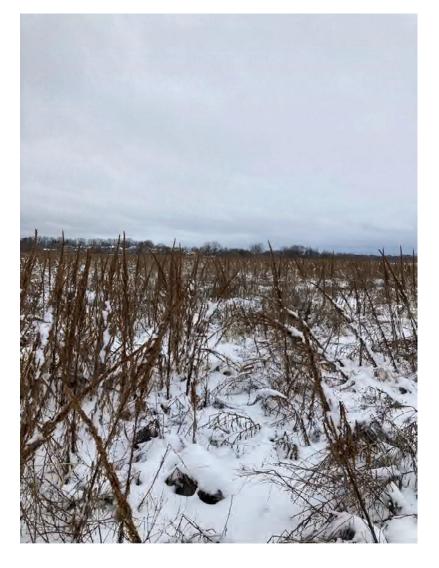
Photograph 1 – Centre of Site consisting of vacant field. (Looking northeast)

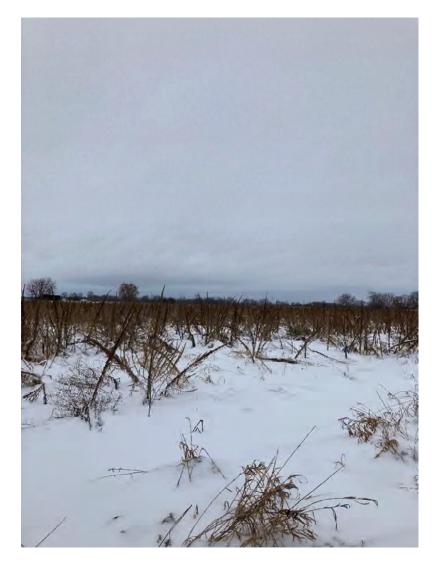
Photograph 2 – Centre of Site consisting of vacant field. (looking southeast)

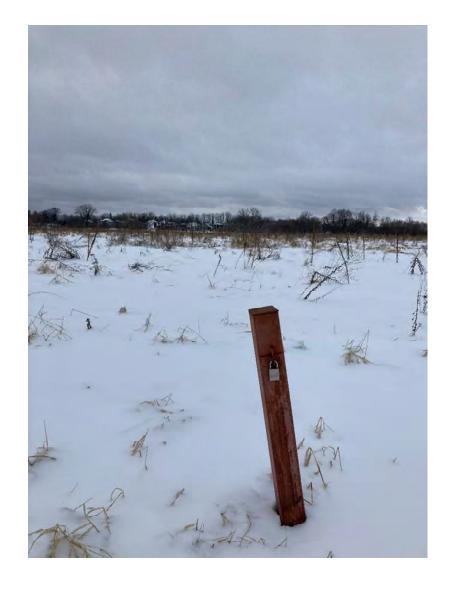
Photograph 3 – One of several monitoring wells identified across the Site.

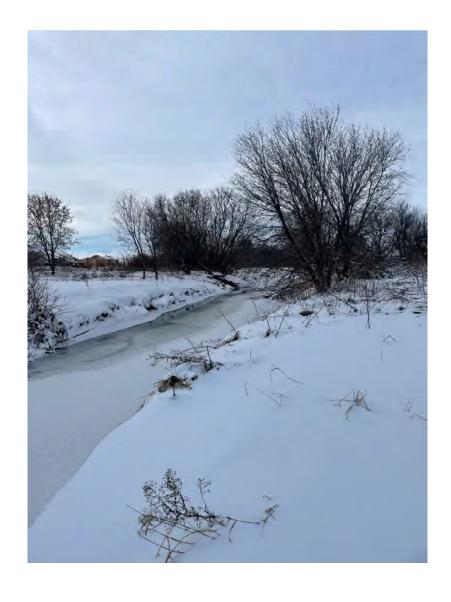
Photograph 4 – Watercourse observed directly west of the Site (looking north).

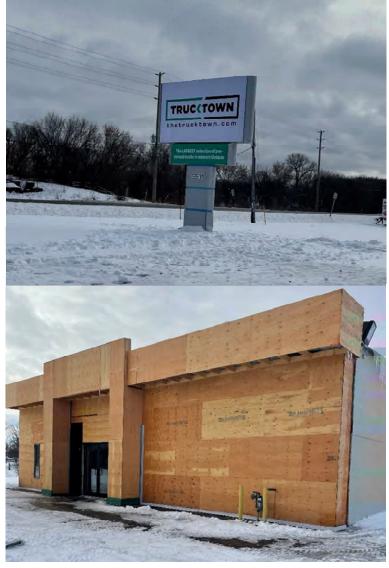
PCA	\ #	Address/ Location	PCA ID	Distance from Site	Description	APEC Rationale
8		5831 Perth Street	OT 2. Equipment and Vehicle Servicing	Adjacent south of the Site	From aerial photographs, the property is located adjacent south of the Site and commercial activities can be seen as early as 1991. Aerials suggest that the property was historically used to sell agricultural machinery as recently as 2011. Property formerly used for equipment and vehicle servicing. Aerial photographs and a review of Google Imagery indicate that the property was used as an RV and automotive repair shop as recently as 2019. Aerial photographs show vehicles parked along the property boundary adjacent to the Site. A used vehicle dealership under construction was noted on the property during the site recon.	Yes. Based on the nature of the PCA and the proximity to the Site.

Photograph 5 - Front of commercial business adjacent south of the Site (formerly Kilby's Auto, now TruckTown) at 5831 Perth Street.

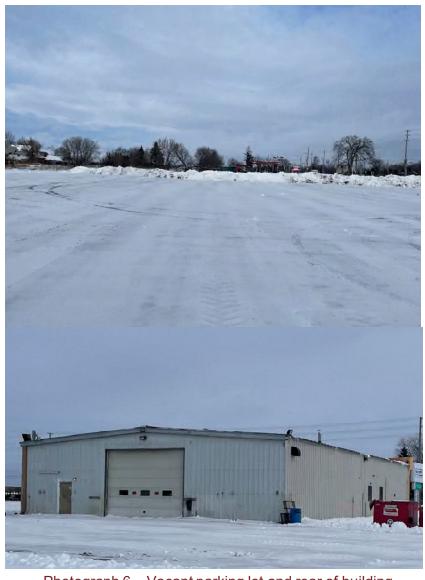
Photograph 6 – Vacant parking lot and rear of building at 5831 Perth Street.

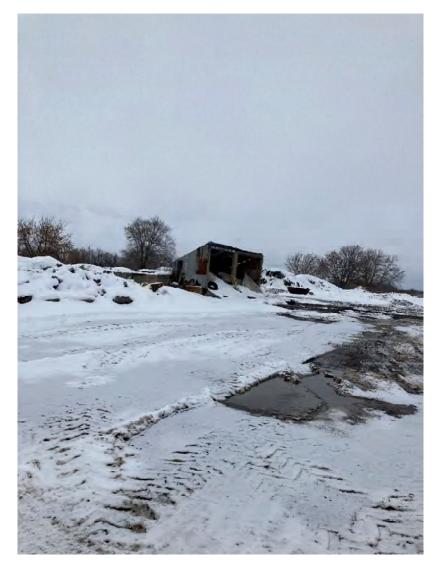
Topic	Observations	Source	
Building Areas	No buildings were present on-Site. A small three-sided shed was present at the southeast corner of the Site where the former commercial operations at the adjacent property encroached onto the Site.		
Number of Floors (include all levels, whether above or below ground)	Not applicable.	Not applicable.	
Number, Age, and Depth of Levels Below Ground Level	Not applicable.	Not applicable.	
Number and Details of all Aboveground Storage Tanks ("ASTs")	No ASTs were observed on the Phase One Property.	Site observations, Site representative.	
Number and Details of all Underground Storage Tanks ("USTs")	No USTs were observed on the Phase One Property.	Site observations, Site representative.

Photograph 7: Shed and fill material/debris found on the southeast corner of the Site.

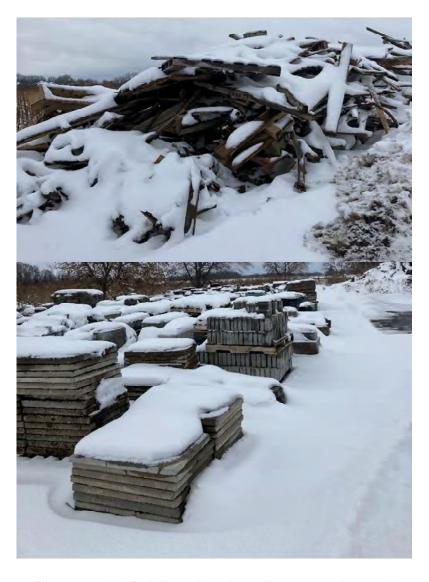
Topic	Observations	Source	
Ground Cover (i.e., grass, gravel, soil, or pavement, etc.)	The Site consists of an agricultural field.	Site observations.	
Current or Former Railway Lines or Spurs	None observed or reported.	Site observations.	
Presence of Stained Soil, Vegetation, or Pavement	None observed.	Site observations.	
Presence of Stressed Vegetation	None observed.	Site observations.	
Areas Where Fill and/or Debris Materials Appear to Have Been Placed	Fill material of unknown origin and construction debris (wood and patio stones) were identified on the southeast corner of the Site. The fill and debris appear to have originated from the former adjacent commercial operations encroached onto the Site. The fill material included gravel used for leveling the parking area and stockpiled soil.	Site observations.	
Potentially Contaminating Activity	A former RV and automotive repair shop was identified adjacent south of the Site. Fill material of unknown origin and construction debris observed on southeast portion of the Site.	Site observations.

Photograph 8: Debris and landscaping stones observed on the southeast corner of the Site.

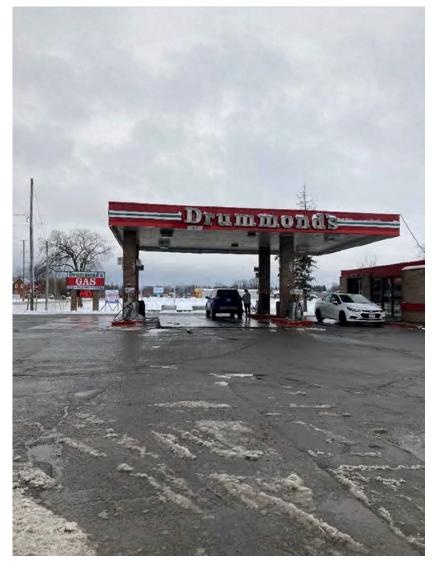
3	5789 Perth Street	28. Gasoline and Associated Products Storage in Fixed Tanks	75 m southeast	The property is listed as a service station for gasoline, oil & natural gas. Records noted that three gasoline USTs, one diesel UST, and one diesel AST (all single wall) were active as of August 2007. An additional record noted a double wall diesel AST was installed in 2009.	No. The service station is considered to be hydraulically downgradient of the Site, as groundwater is expected to flow south to southwesterly.

Photograph 10: Gas station to the southeast of the Site at 5789 Perth Street..

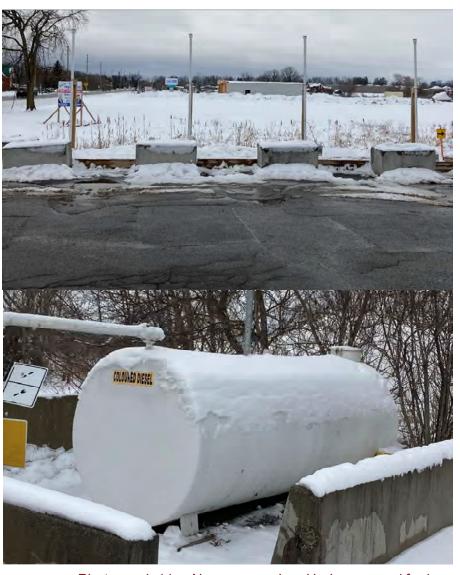
Photograph 11 – Above-ground and below-ground fuel storage tanks at the gas station approximately 75 meters south of the Site.
