**re: Slope Stability Assessment of Existing Slope Failure**  
Existing Residential Dwelling  
1320 Grand-Chêne Court – Ottawa, Ontario

**date:** November 13, 2023

**file:** PG5201-MEMO.03

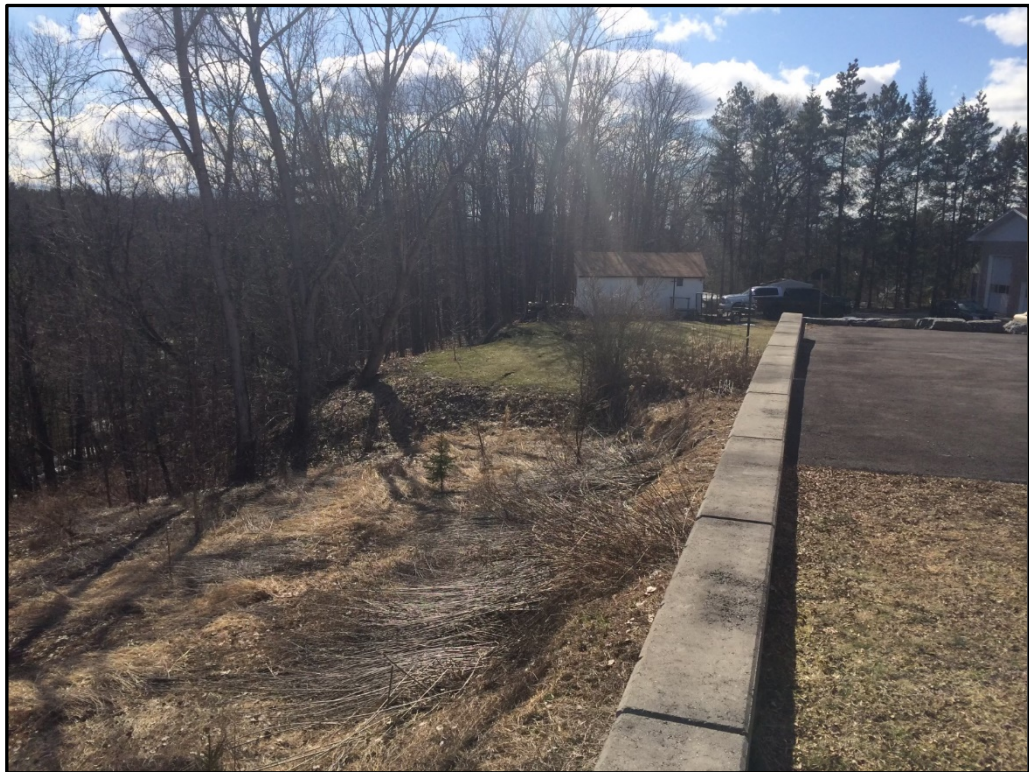
**Photo 1:** Photograph of failure observed along the top of slope at the property site. Photo taken from 1325 Grand Chêne Court. Photograph provided by the property owner.

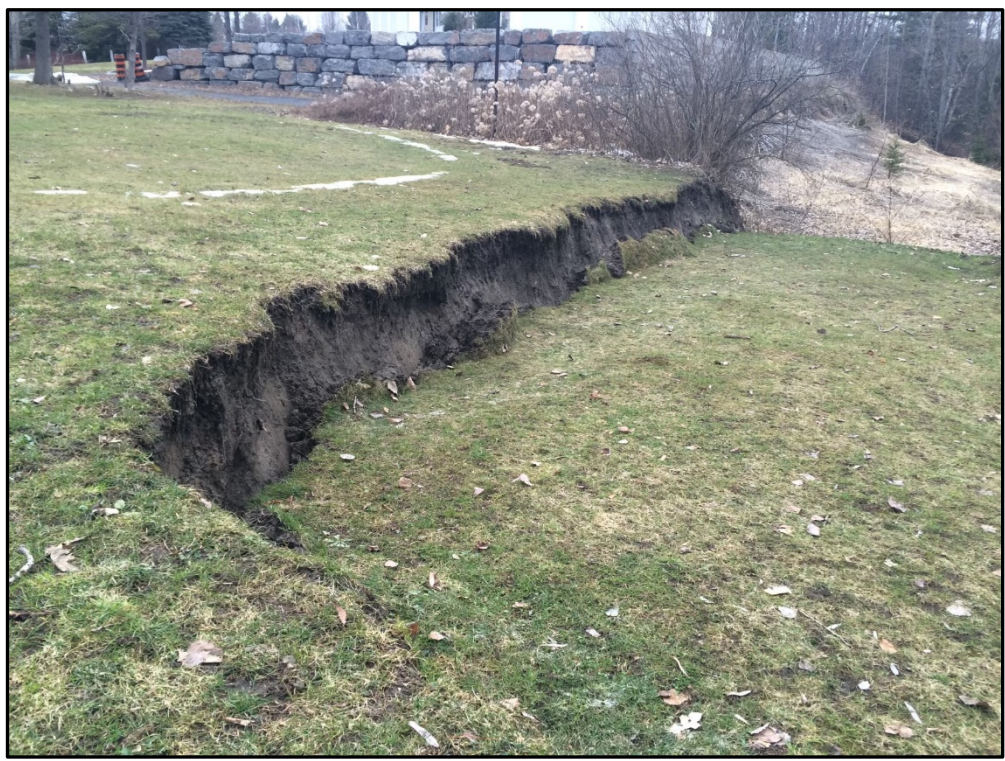
**Photo 2:** Photograph of failure observed along the top of slope at the property site. Photo taken from the southwest portion of the subject site. Photograph provided by the property owner.

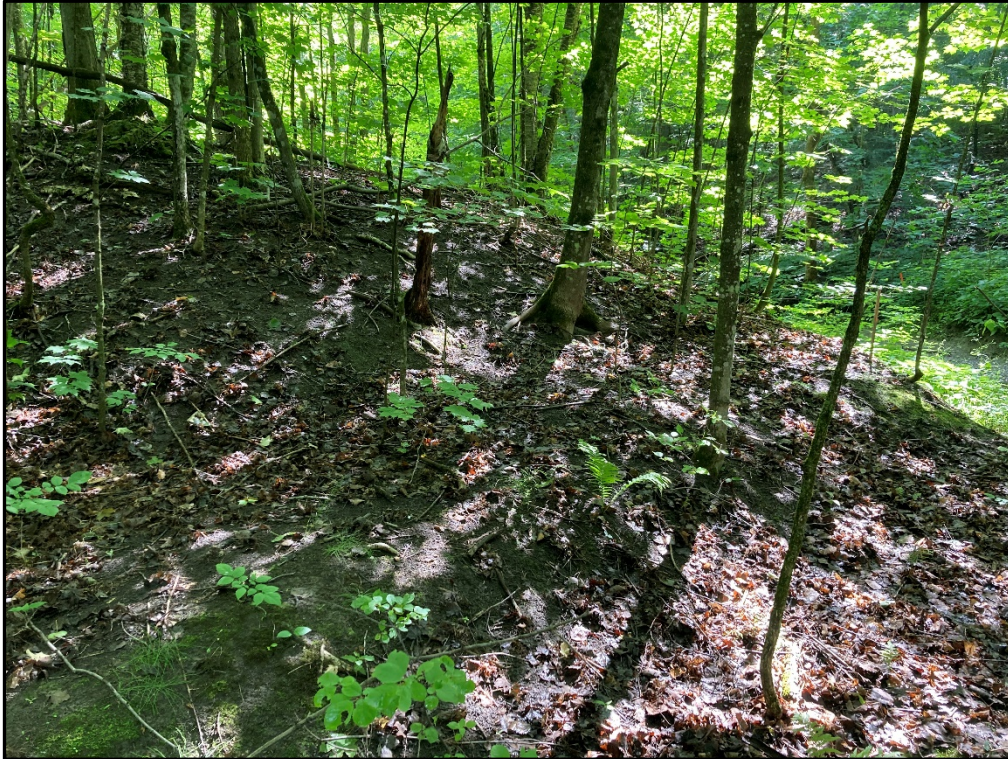
**Photo 3:** Photograph along the slope face, facing northeast. The photograph depicts the presence of mature vegetation. The face of slope can be observed to consist of brown silty clay.

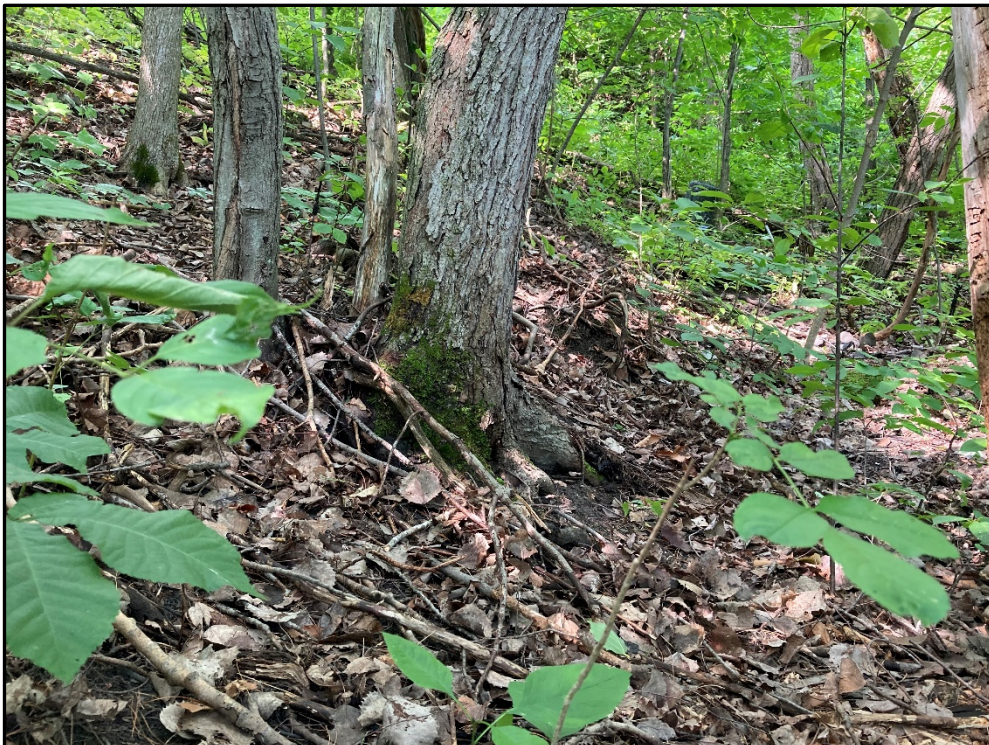
**Photo 4:** Photograph of the face of slope indicating the presence of mature vegetation. The face of slope is observed to consist mostly of brown silty clay.

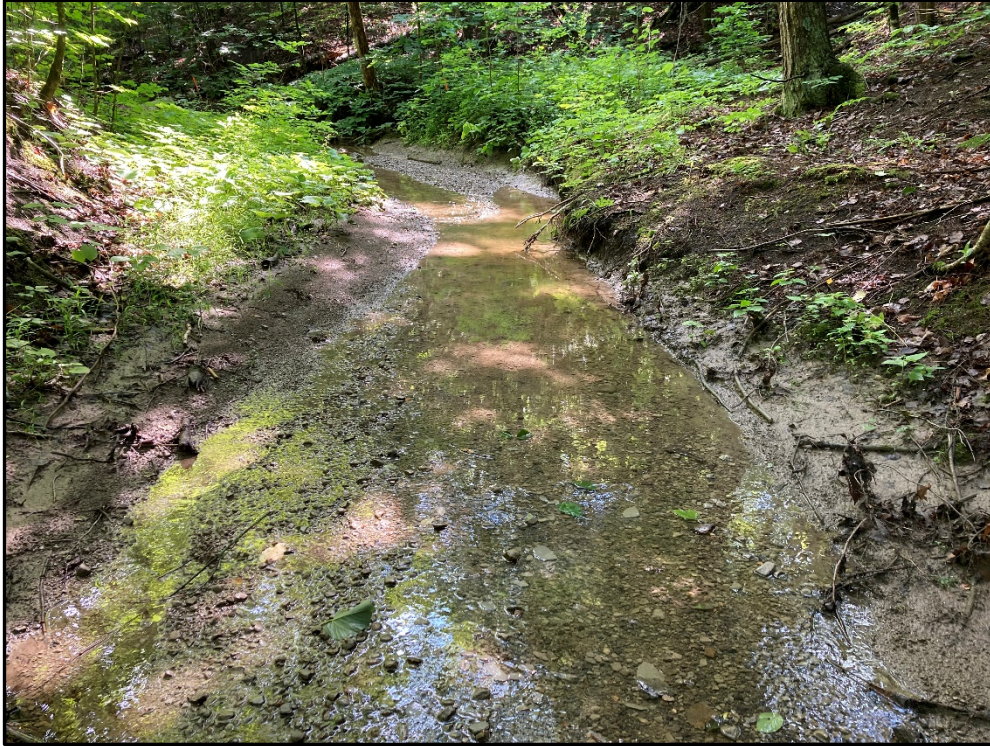
Based on our review, the observed slope failure is expected to have been triggered by a combination of erosion of the toe of the slope by the active watercourse at the bottom of the slope which was exacerbated by the presence of historically placed fill across the slope surface and area overlying the slope. Due to the placement of fill and other structures along the top and face of slope within the limit of hazard land setback, additional loading was induced on the slope face.

Since movement has been observed annually by the landowner at the top of the slope during spring seasons, its expected that on-going erosion at the toe of the slope is occurring and resulting in further loss of support to the previously failed section of the slope. With on-going loss of the support, the failed section of slope may be slowly sliding into the creek during periods when rates of erosion are highest, such as spring after periods of heavy snowmelt and rain.

**Photo 5:** Photograph of the toe of slope and along the north tributary to Cardinal Creek. The toe of slope is observed to consist of grey silty clay with minor signs of erosion.

Depending on the outcome of the additional analysis, instability of the slope may be able to be resolved by a combination of efforts. On-going erosion may be able to be mitigated by the implementation of erosion protection throughout the area of 1320 and 1325 Grand-Chêne Court. This would resolve on-going loss of support at the toe of the slope and further movements in the slope surface extending into the rear-yard of the subject site.

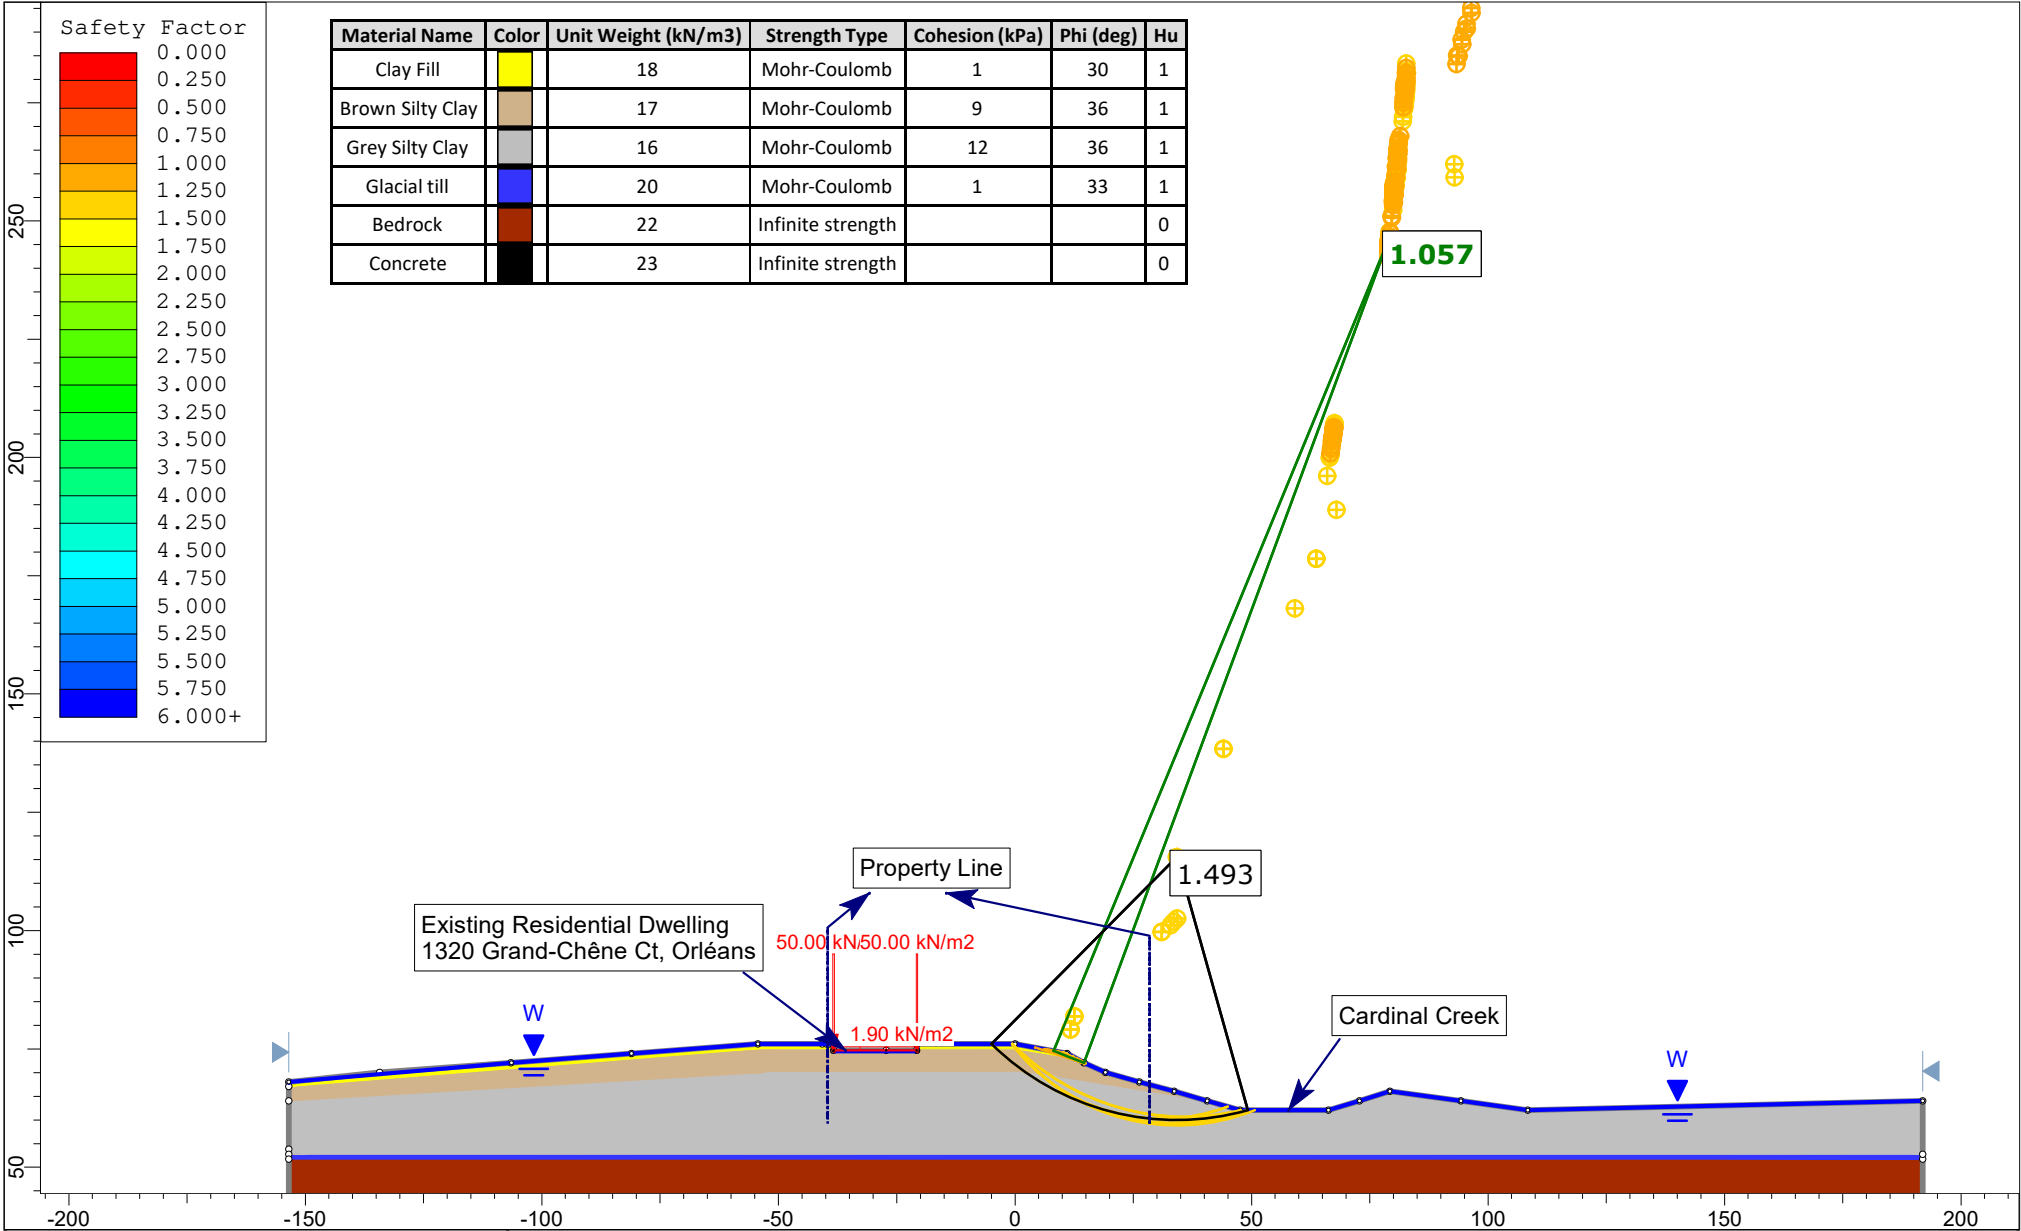
Project		PG5201- 1320 Grand-Chene Ct, Orleans	
	Cross Section	PP	Scenario	Static Condition
	Drawn By	EA	Company	Tamarack Homes
	Date	8/31/2023	File Name	Geotechnical Investigation
	SLIDEINTERPRET 9.025

The results for the slope stability analysis at Section A are shown in Figure 1A, attached to the present memo report. The factor of safety was found to be less than 1.5 and mostly affecting the infilled portion of the slope. The lower factor of safety can be attributed to increased grade raise and surcharge along the top of the slope. Based on our review, the above-mentioned lowest factor of safety generally coincided with the location of the observed existing failure surface at the top of slope.

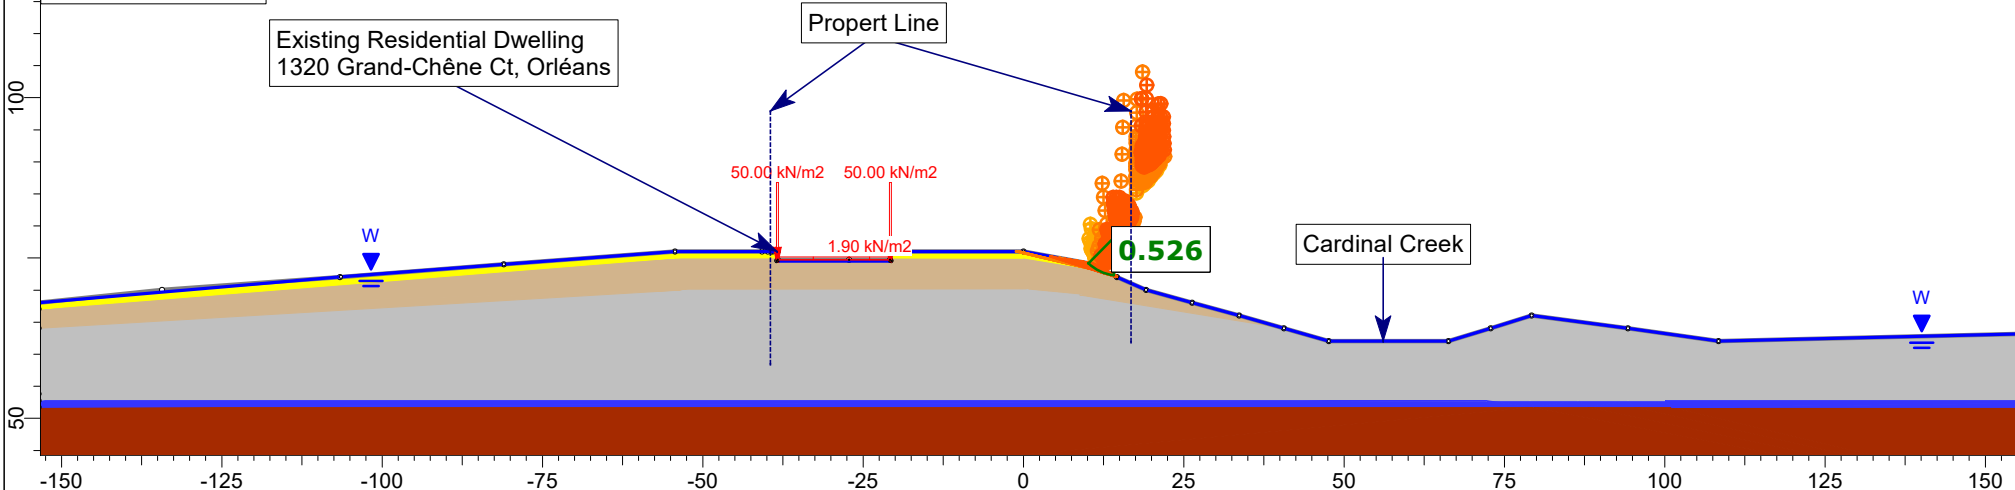
Project		PG5201 - 1320 Grand-Chene Ct, Orleans	
Cross Section	PP	Scenario	Seismic Condition
Drawn By	EA	Company	Tamarack Homes
Date	11/16/2023	File Name	Geotechnial Investigation

The cross-section models the pre-existing condition before the development of the failure at the top of slope. The results of the analysis including seismic loading are shown in Figure 1B attached to the present memo report. The factor of safety was found to be less than 1.1 along the top of slope and within the fill material. However, a factor of safety of 1.1 is present within the native overburden.

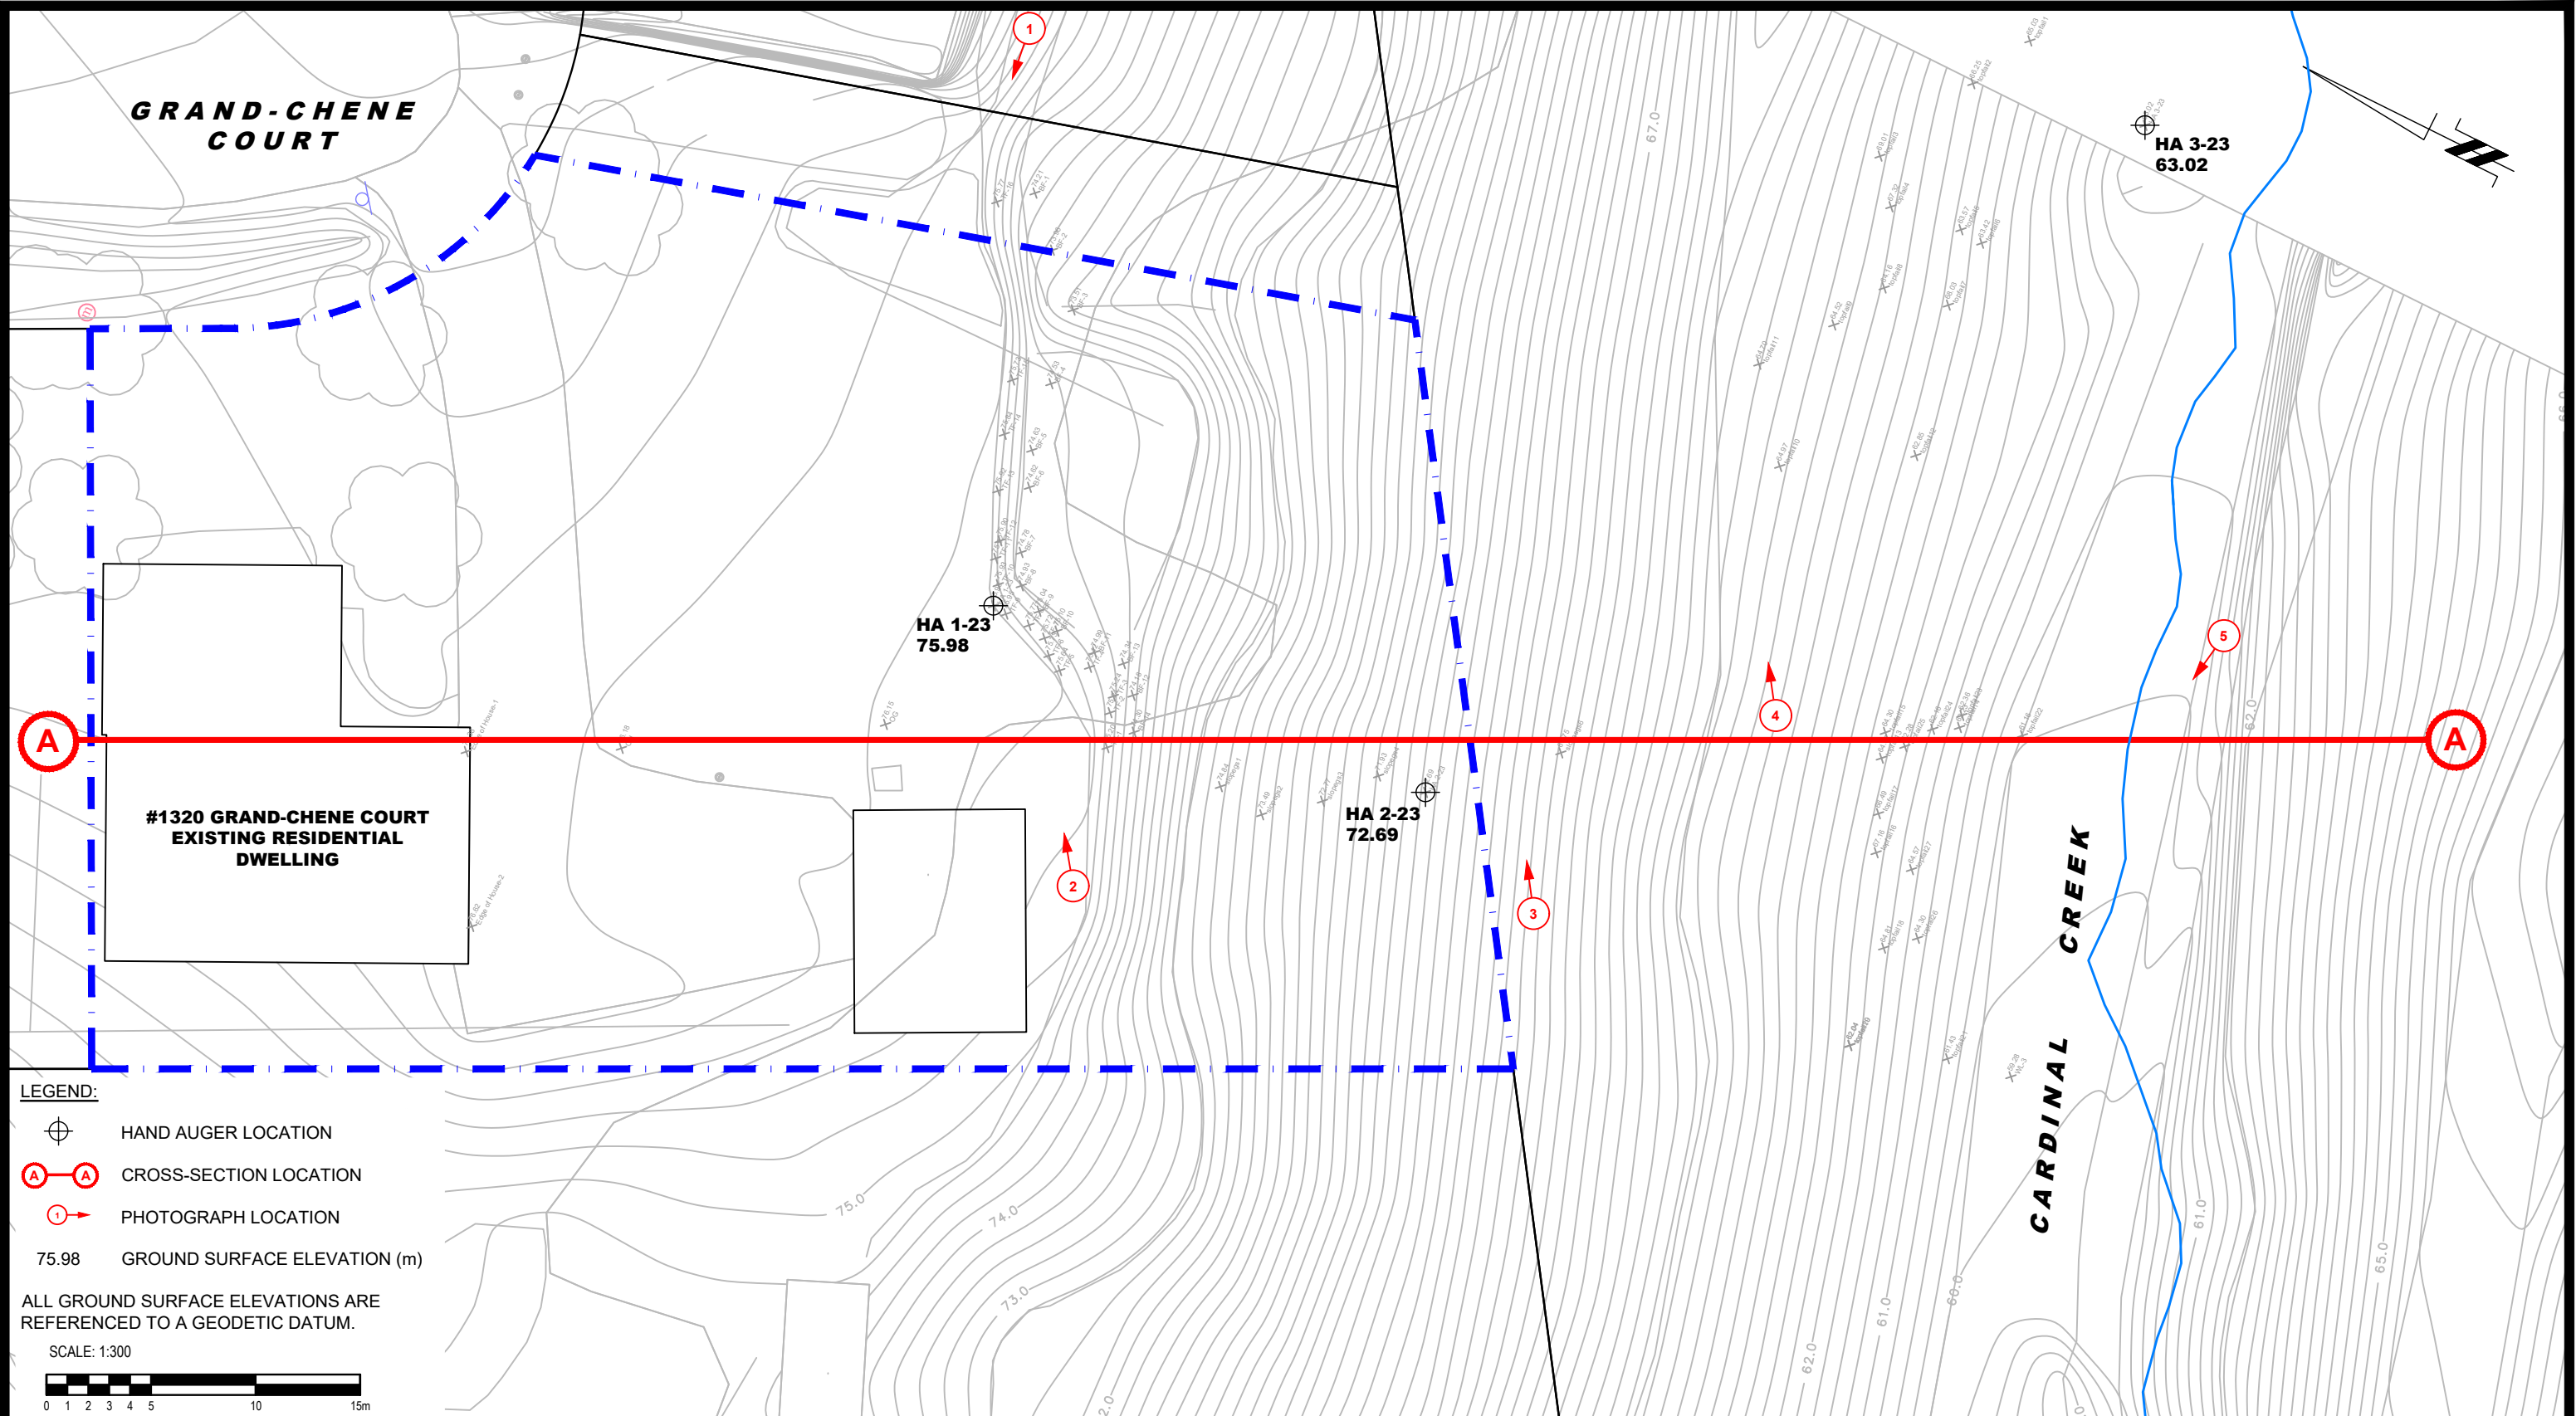
The top of the slope failure was observed throughout the rear-yard of 1320 Grand-Chêne Court and along the top of the existing slope. The area was surveyed in the field and may be observed on Drawing PG5201-6 - Test Hole Location Plan attached to this report by the topographic shots labeled “TF-xx” and “BF-xx” denoting the top and bottom of the face of the failure, respectively. The height of the face of the failure is approximately between 400 mm and 1.2 m high across its footprint.

Additional slip surfaces were also visible along the bottom of the slope and coinciding with the watercourse within the tributary and are identified on the Drawing PG5201-6 - Test Hole Location Plan as topographic shots labeled as “topfailx”. The ground surface throughout the portion of the slope failure located within the rear-yard of 1320 Grand-Chêne Court was relatively flat at the time of our review.
