Landslide Hazard Assessment

Proposed Residential Development

Ottawa, Ontario

Report PG5201-2 Revision 3 dated October 18, 2024

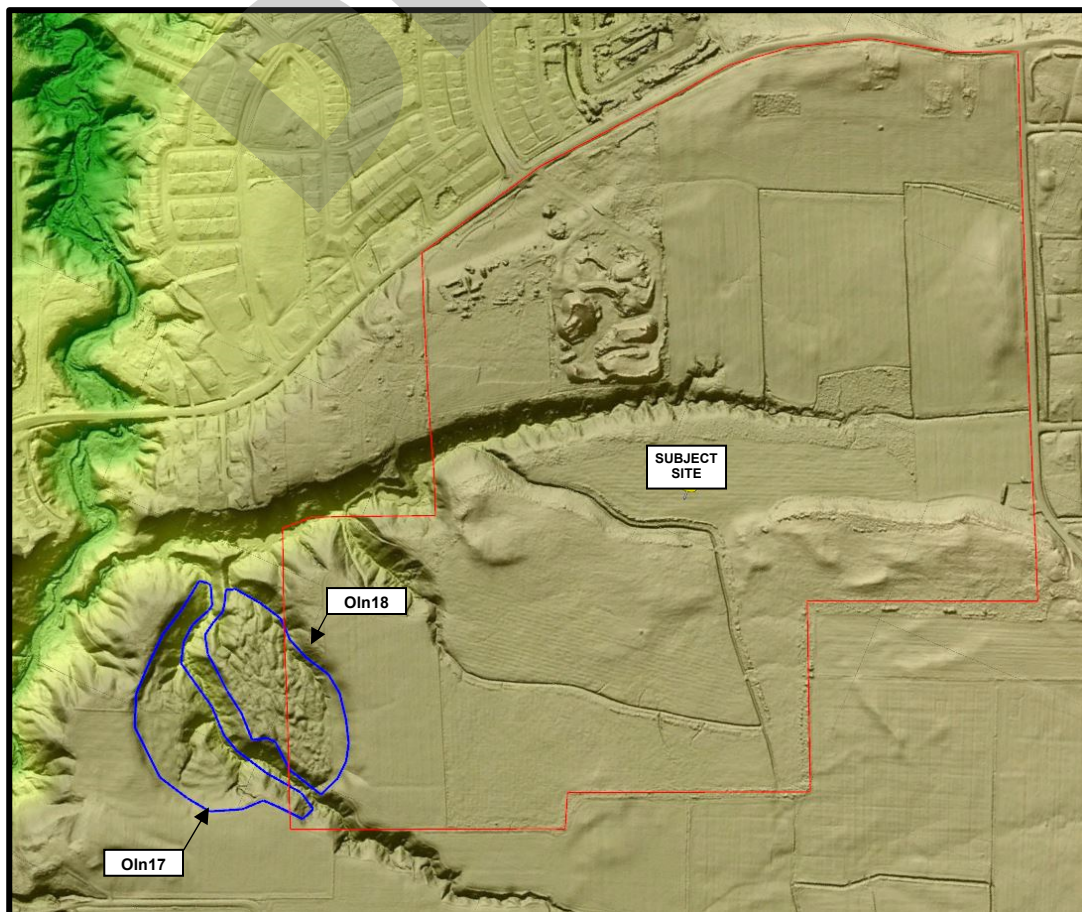
Figure 2 – LiDAR Image of Subject Site and closest landslide and slope failure.

Further to the above-noted large-scale landslides that have occurred within the vicinity of the subject site, recent small-scale and localized slumps have formed in recent years in response to active erosion and sheet drainage. Given the high concentration of local small- and large-scale landslides throughout the area and within the subject site, it is considered appropriate to increase the baseline probability for landslides to occur throughout the subject site by a factor of 2 in Section 4.3 – Hazard Assessment of this report.

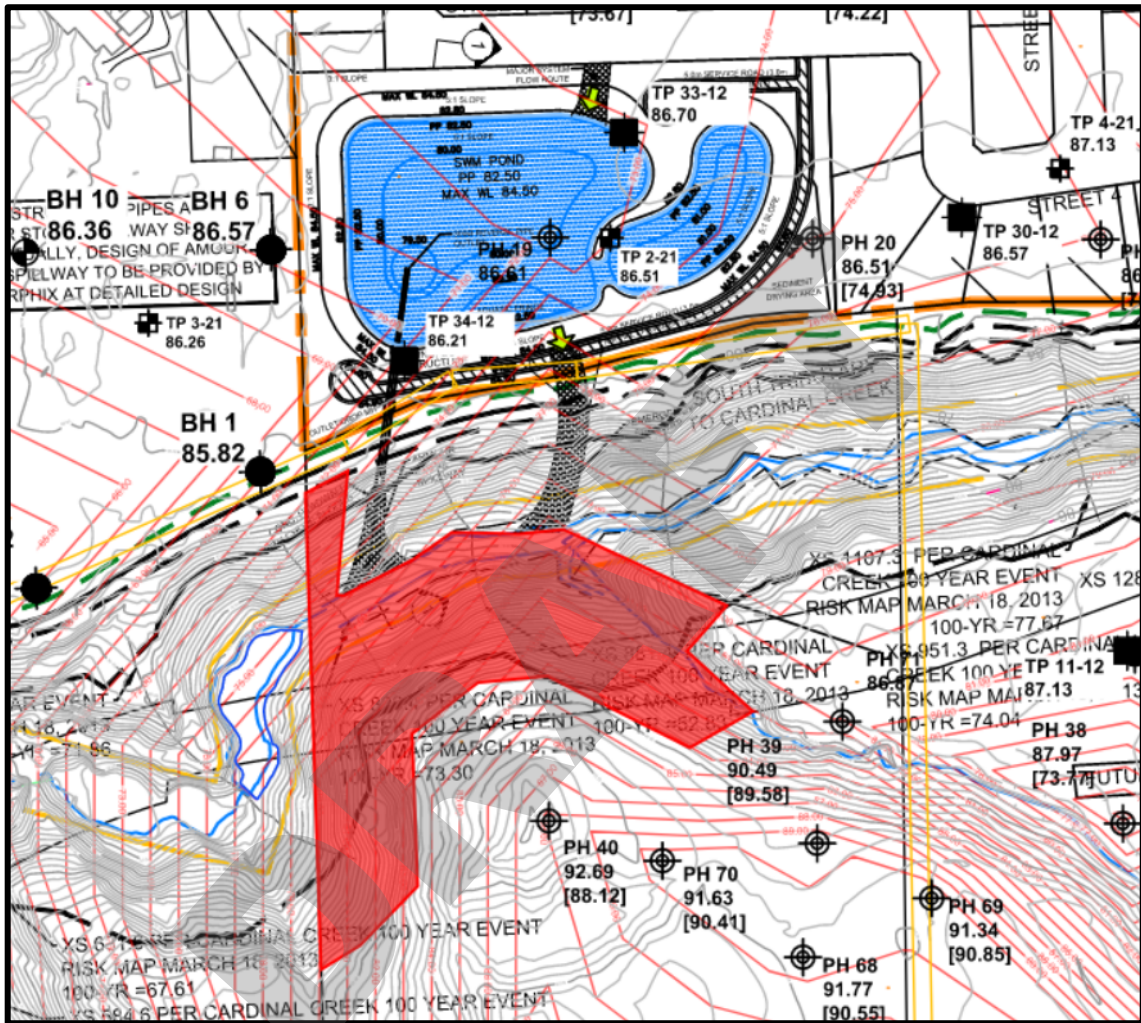
Based on our assessment, the probability for a landslide to occur throughout the western portion of the subject site has been estimated to be **1:5,158 per year**. Based on the above, the annual probability of a large landslide occurring at or directly impacting the subject site is estimated to be more than 1:10,000 per year for portions of the subject site where drift thickness exceeds 15 m and topographic relief exceeds 12 m. Based on this, the area of the subject site corresponding to a probability exceeding 1:10,000 is located at the western boundary of the subject site, and as depicted in Figure 4 below.

Figure 4 – Area of Subject Site Above 1:10,000-Annual Probability Threshold

Based on our review, pre-development and post-development conditions throughout this portion of the subject site are such that the probability for a landslide to occur is considered to be more than 1:10,000 per year.
