Project Number: 30282688 Submission Date: August 2025

# **Tree Conservation Report**

Double Deck - 560 Hazeldean Road

August 2025

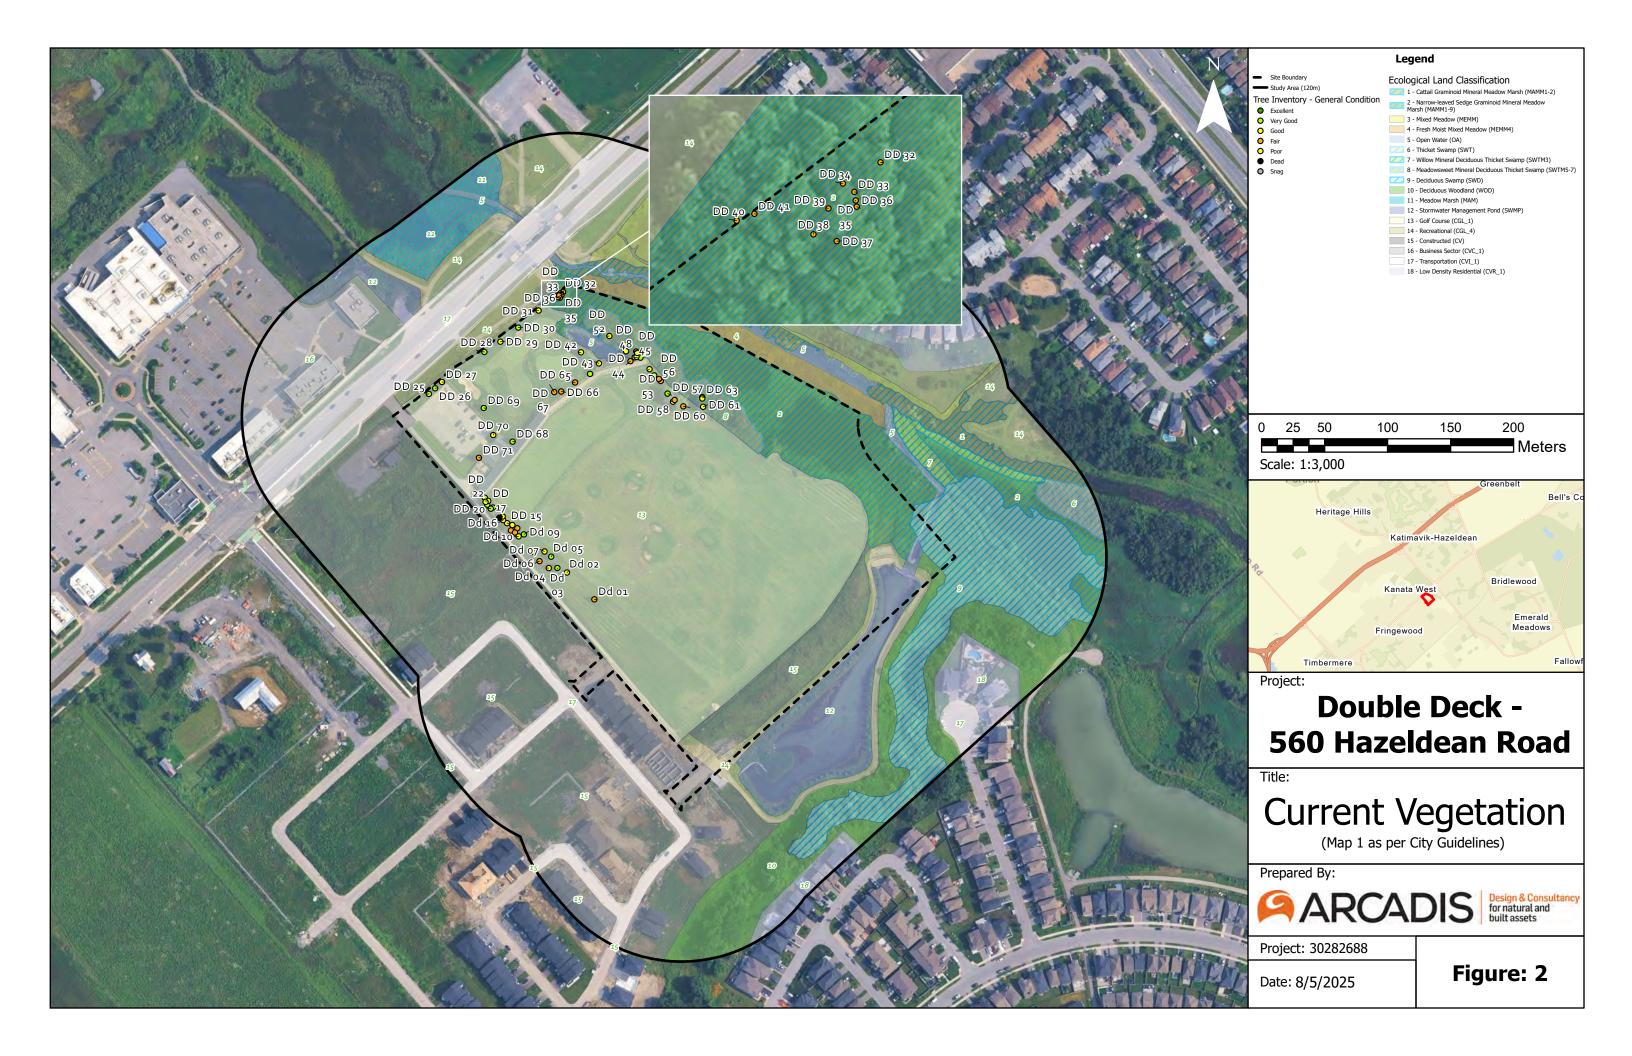
A total of 71 individual trees were assessed as part of this inventory. The condition of the trees on Site ranged from Very Good to Dead, approximately 56% of which were in Very Good - Good condition. The most common species are Blue Spruce (34%), White Spruce (28%), and Black Willow (23%).

All trees inventoried on Site along with their designated health condition are displayed in Figure 2 below.

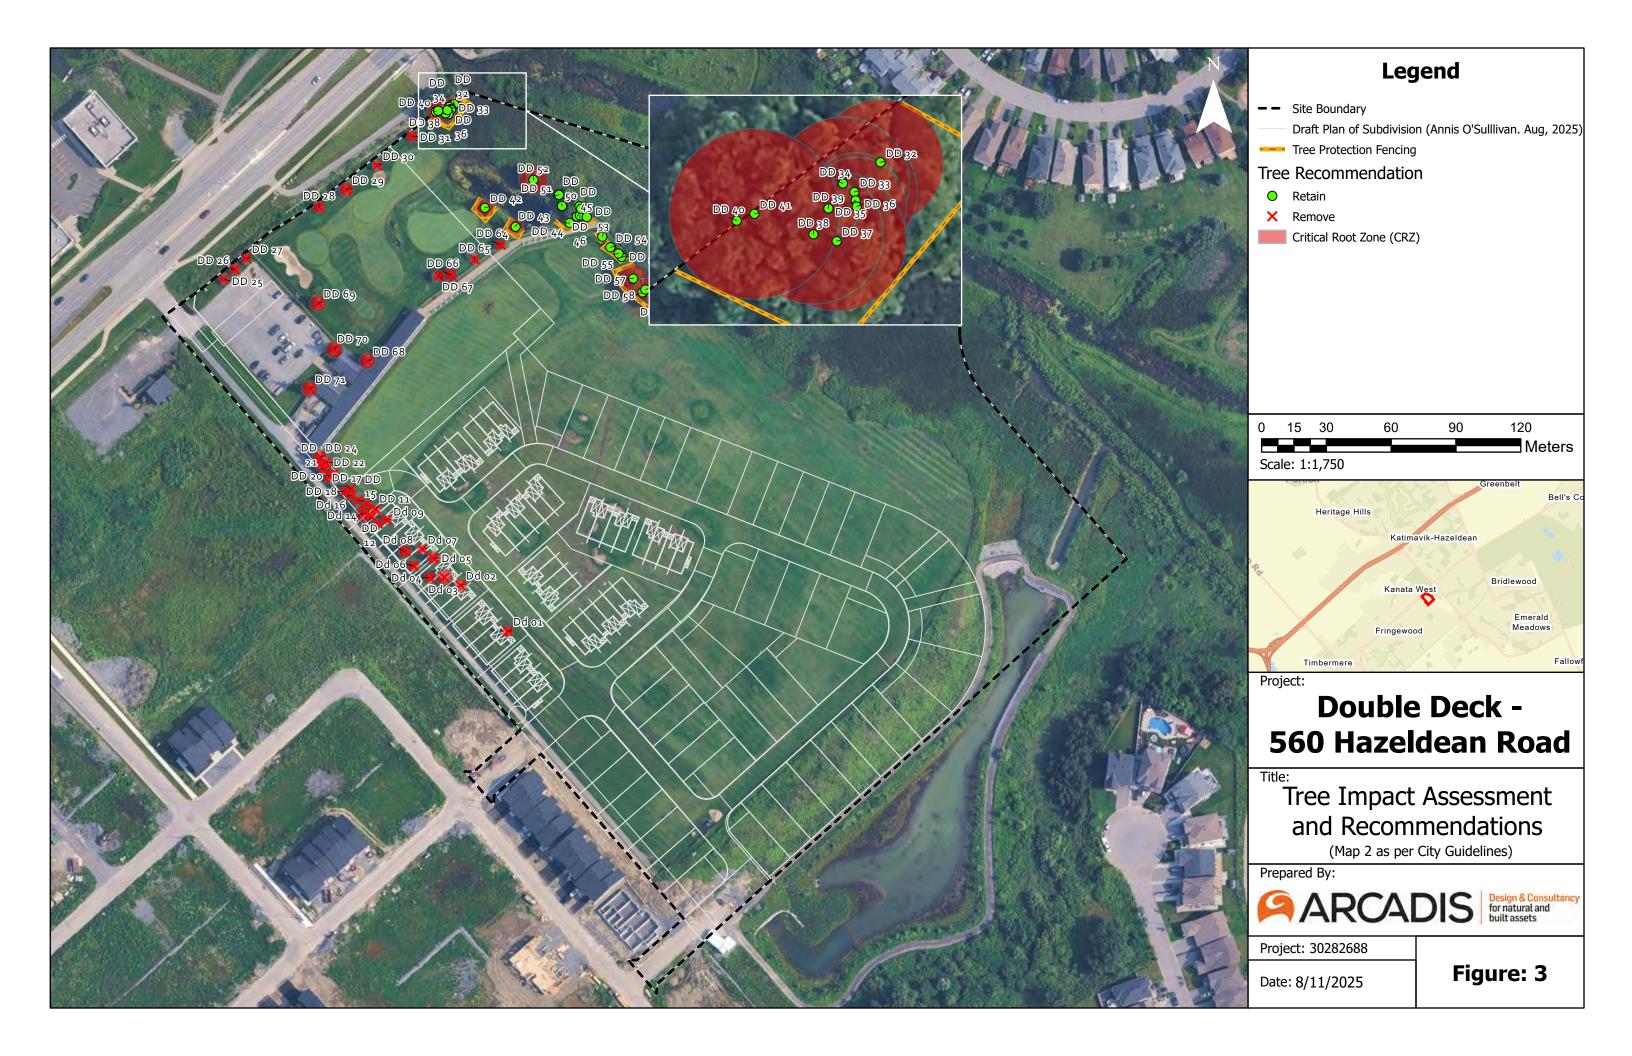
Using data collected during the tree inventory and assessment, drawings showing the tree locations (collected through topographic survey), and the proposed development footprint and anticipated area of impact, tree impact analysis was completed, resulting in recommendations to Retain or Remove trees. Tree impact and associated recommendations is described in Section 7, as well as included in the Tree Inventory and Assessment Table in **Appendix A** and displayed on **Figure 3**.

Based on the conditions of the trees and extent of the proposed construction limits, **Table 2** summarizes the impact and recommended actions of the 71 trees assessed within the Site. It is anticipated that 39 trees >10 cm diameter at breast height (DBH) will need to be removed. These details are depicted in **Figure 3**: Tree Impact Assessment and Recommendation (Mandatory Map 2 as per the City of Ottawa, 2021) and outlined in the Tree Inventory and Assessment Table included in **Appendix A**.

For all trees to be retained, tree protection fencing must be installed to separate trees from the work area. Tree protection fencing must be installed no closer to the trunk than the Critical Root Zone but should be placed as far as possible from the tree, as displayed in **Figure 3**.

- Tree protection fencing shall be at least 1.2 m in height and installed in such a way that the fence cannot be altered as depicted in Figure 3.
  - o Refer to **Appendix B** for the City of Ottawa's Tree Protection Fencing Specification.
