## Appendix 5

### Fluvial Geomorphological Detailed Information

## INTRODUCTION

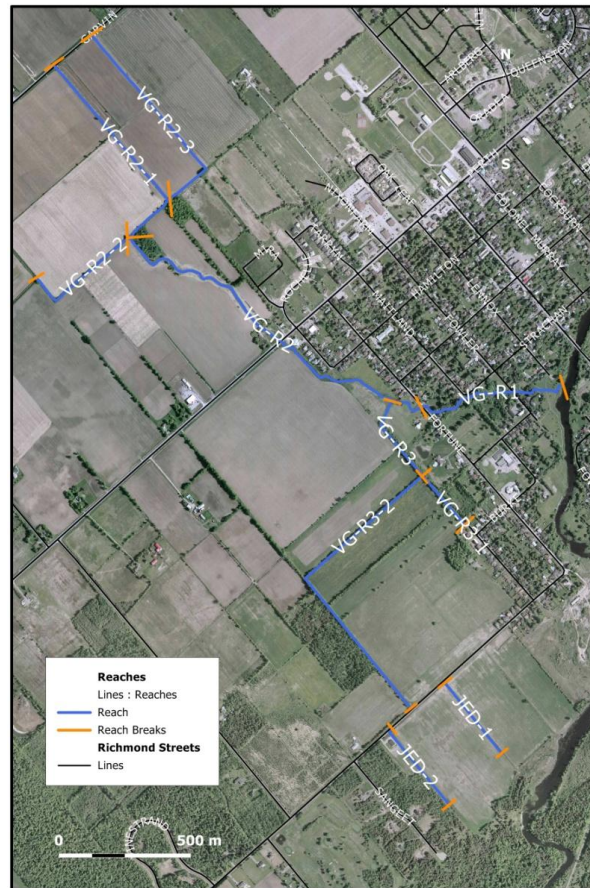
**Figure 1.** Watercourse reach delineation on Mattamy Richmond Lands.
