VAN GAAL DRAIN EROSION ASSESSMENT

RICHMOND, ONTARIO

26 October 2012

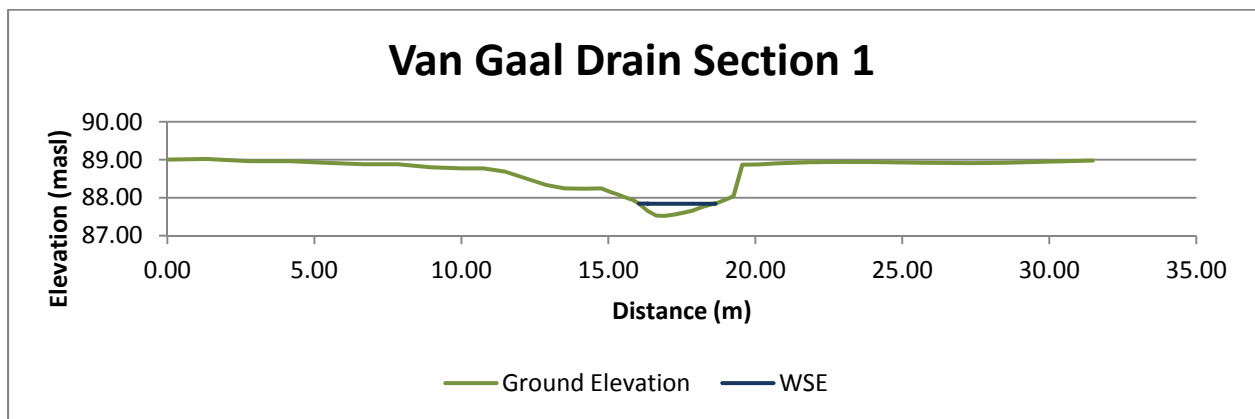
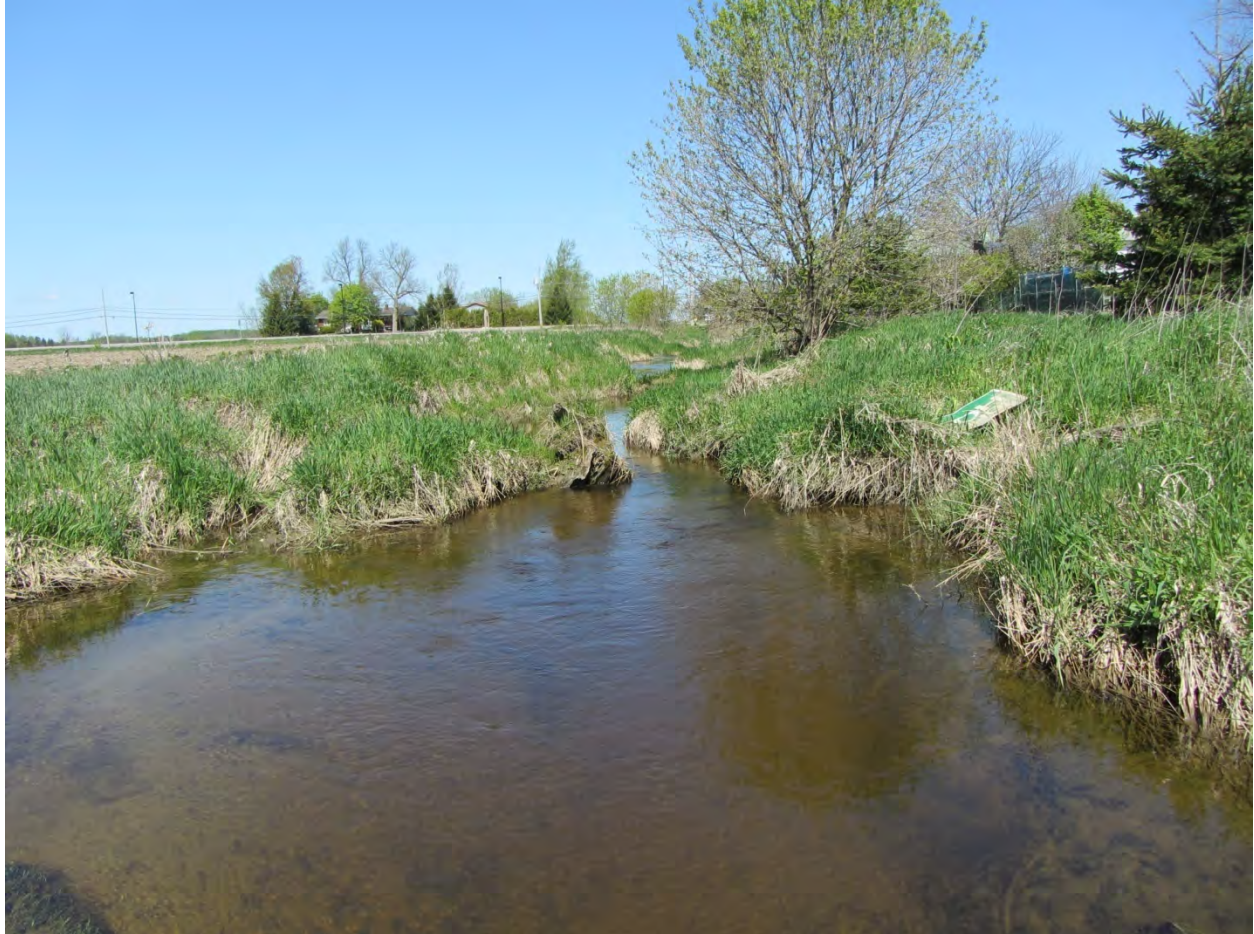
Section 1 is found in Reach 3 upstream of the VG-R3 inlet and just upstream of the Queen Charlotte Street drain. This section was selected as it represented both an erosional component (the banks are eroding and the channel is widening) and a depositional component (there is a silt accumulation on the bed). The cross-sectional plot showing the shape of the section is shown below; water elevation at the time of the survey is also indicated.

Following is a photo showing the drain at the section location.

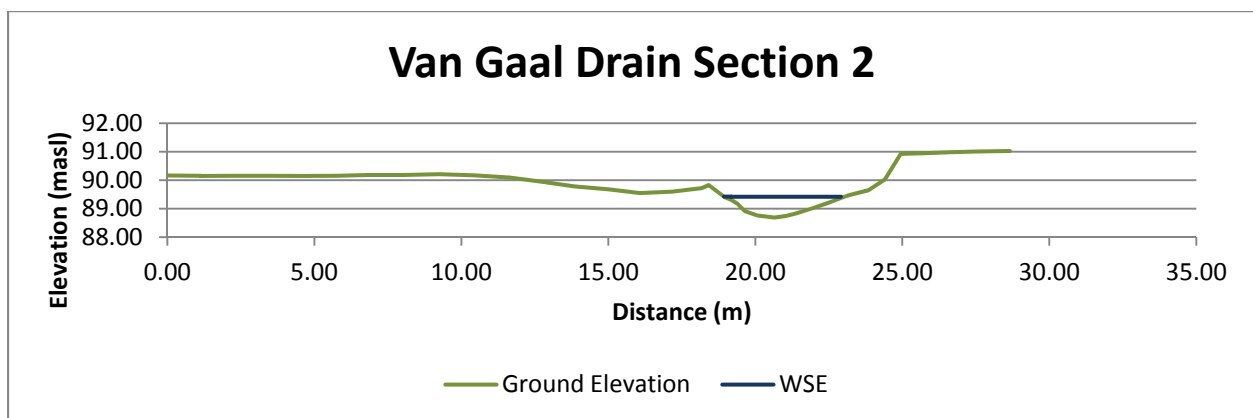
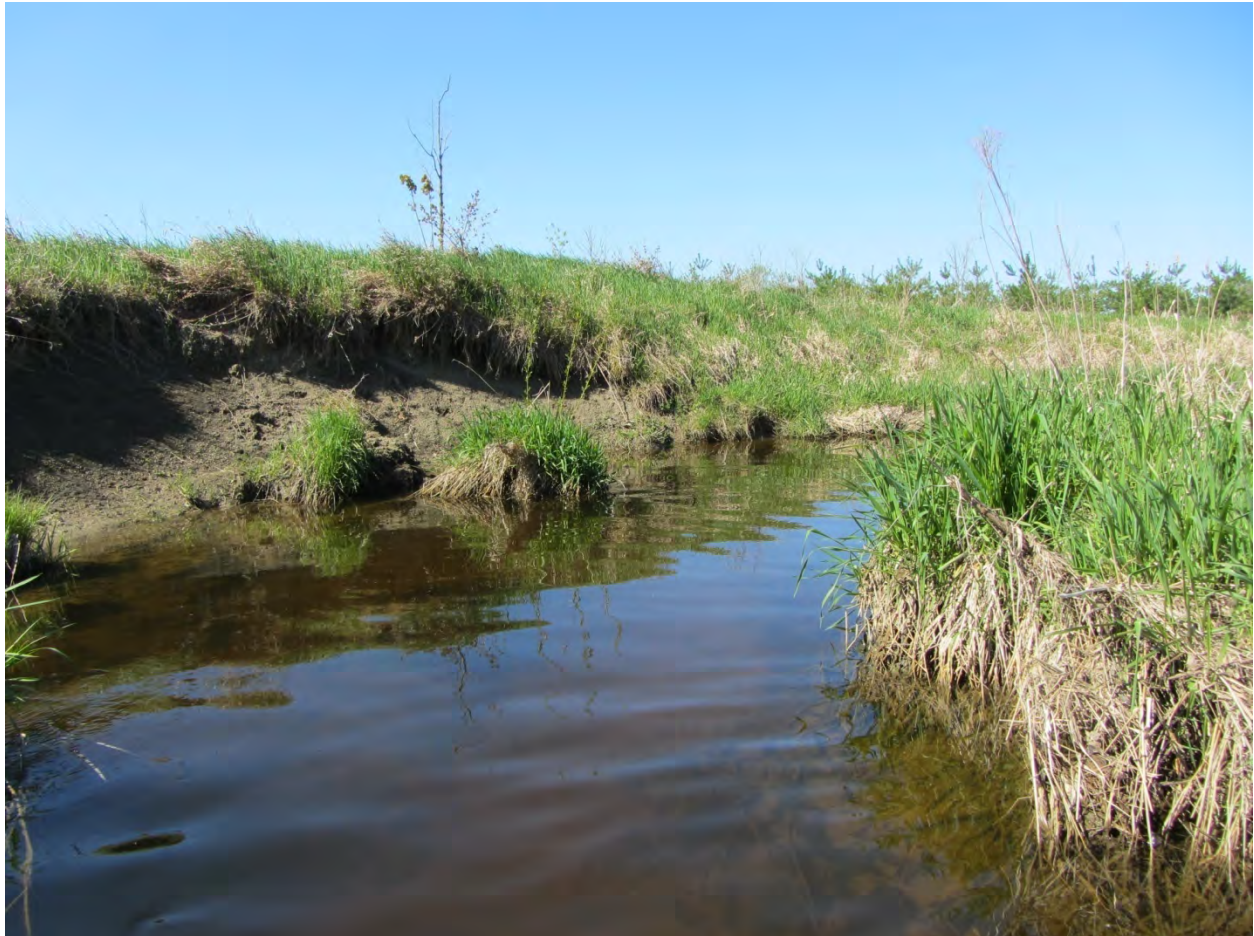
Section 2 is also located in Reach 3 and is located upstream of the Fortune Street culvert where the Drain takes an abrupt, 90-degree turn. The outside bank is rapidly eroding at this site and the section is, as seen in the section plot below, trying to adapt to the high sediment inputs.

Outside bank erosion is the dominant process operating at this location. A section photo follows.

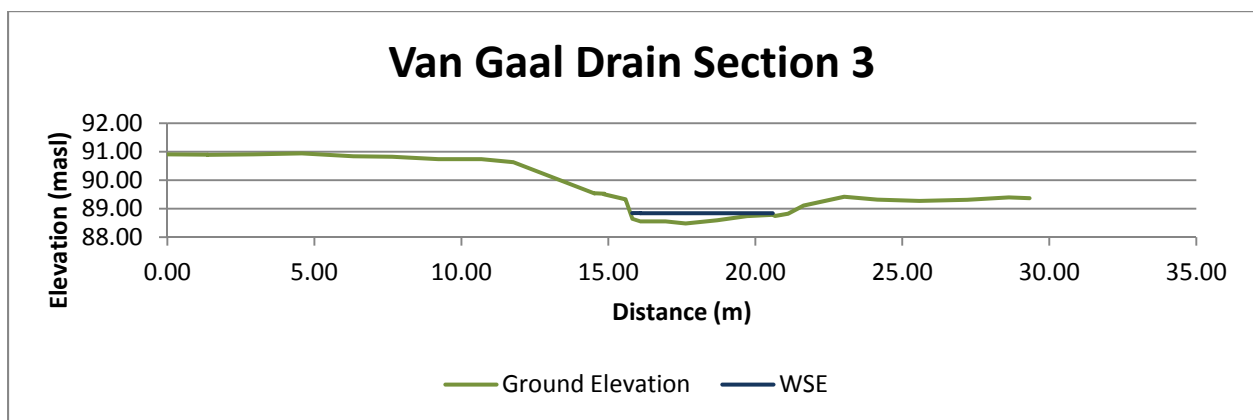
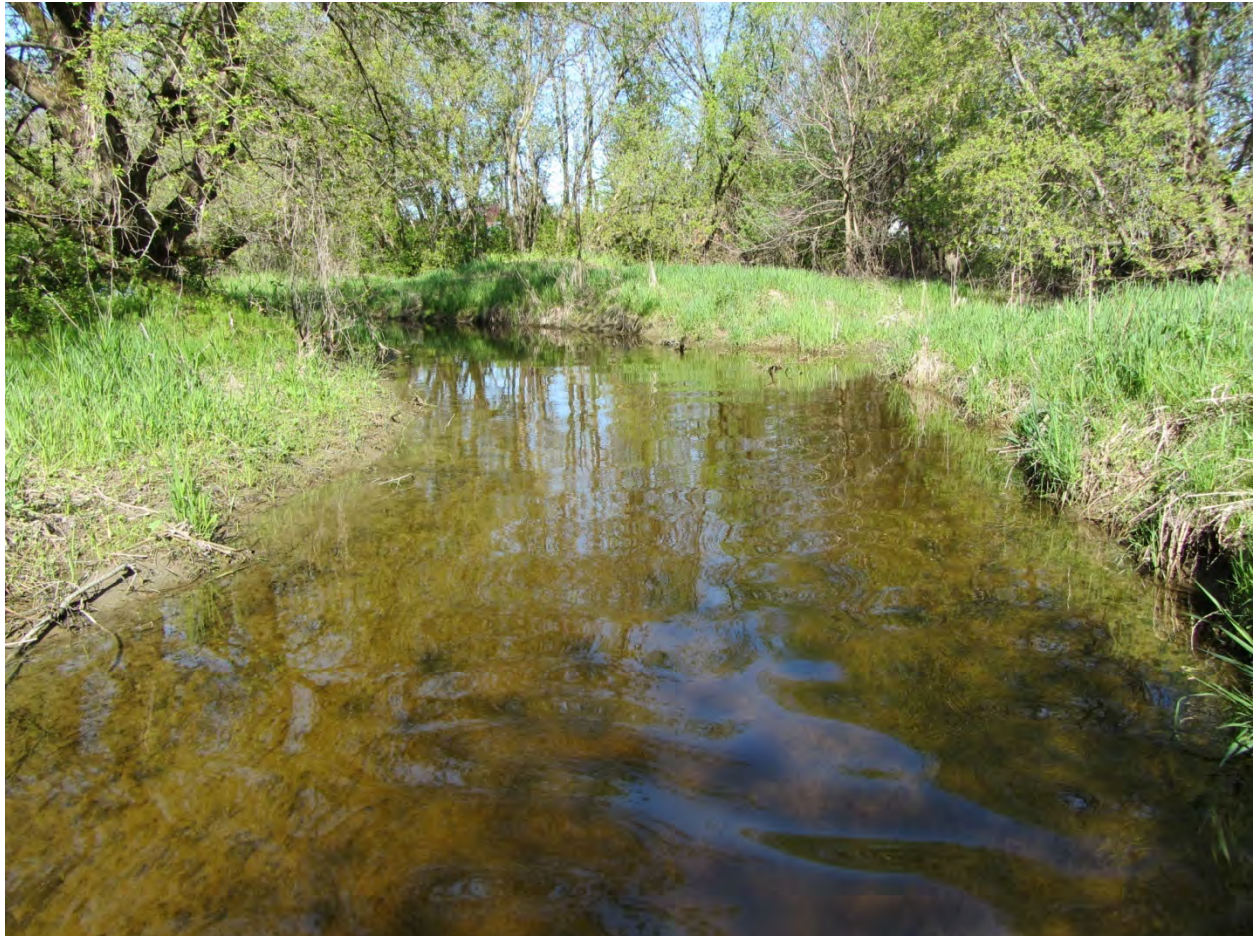
Section 3 is a depositional site upstream of Fowler Street in a section where there is strong floodplain access to the south. The lack of concentrated flow at higher stages results in a lower overall velocity and deposition of fines is the result.

Deposition and remobilization are the dominant processes operating at this location. A section photo follows.

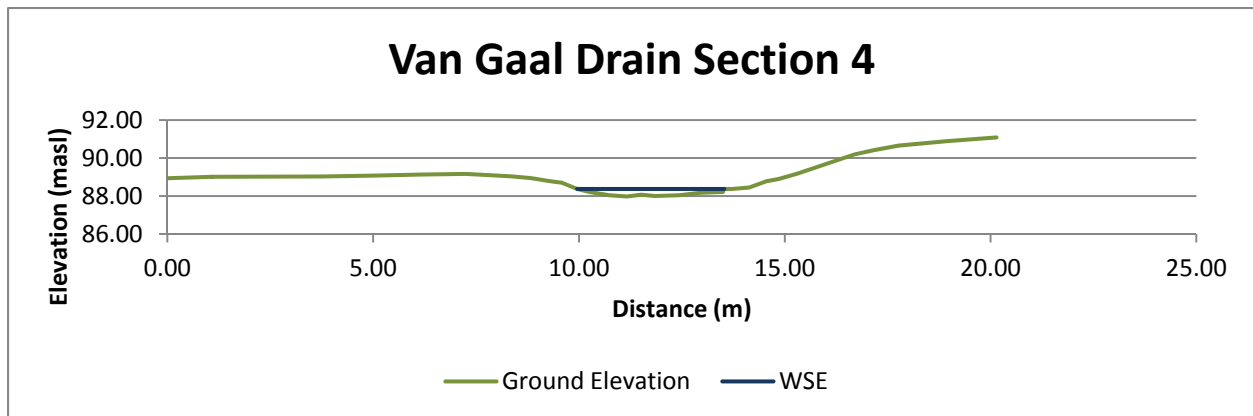
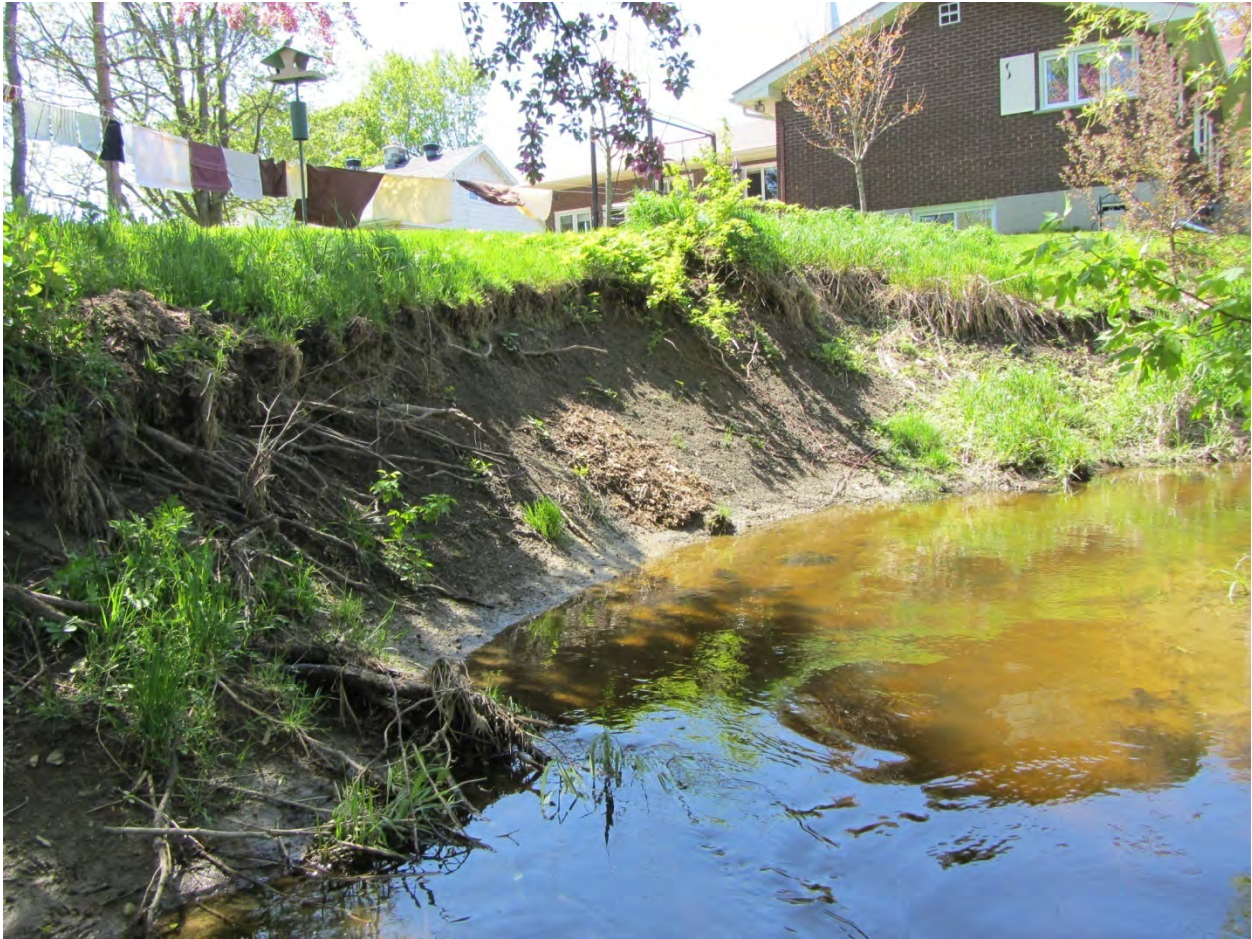
Section 4 is the only high severity/high priority erosion site in Reach 1 and it is located at a bend adjacent to a residence. The lack of vegetation protecting the top of bank, coupled with the sharp bend and erodible materials has resulted in rapid bank retreat.

Erosion is the dominant process here, even though this is in the backwater influence zone of the Jock River. A photo of the site follows.
